Preventive Maintenance Study - Final Report

WA-RD 871.2

Preventive Maintenance Study

Washington State – Statewide Locations

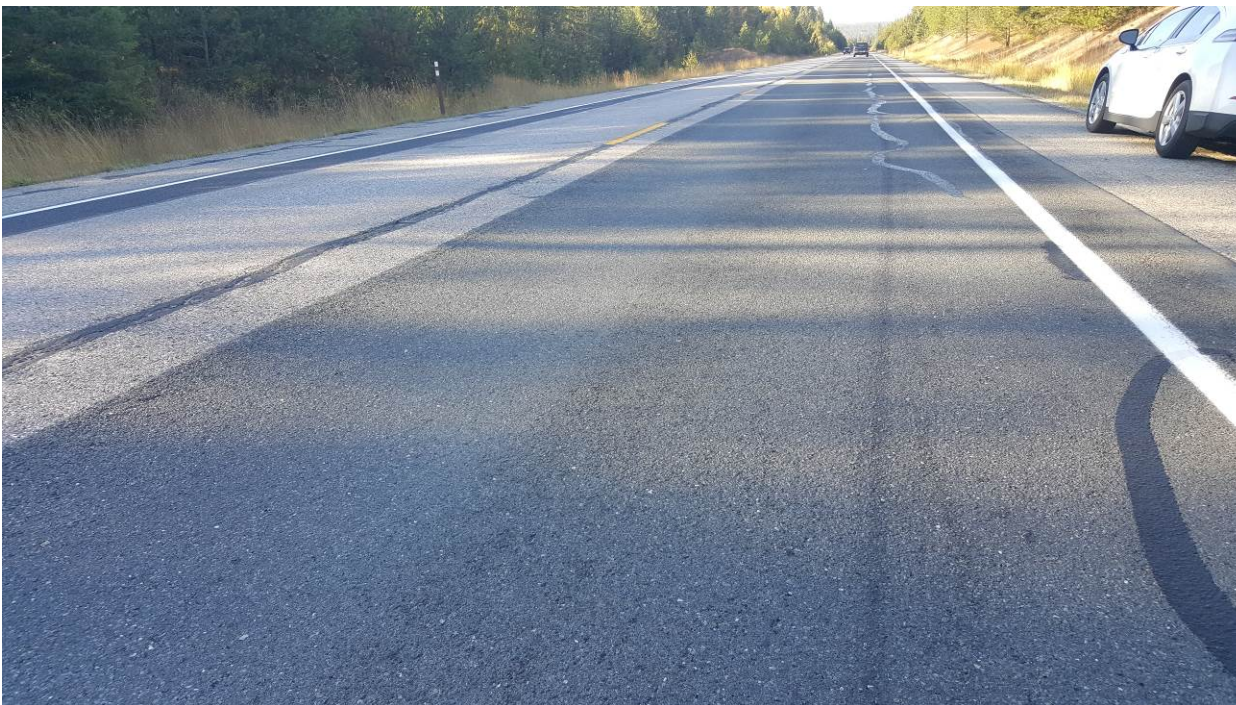
Figure 123. ER9a, SR395, two years after installation. Longitudinal reflection cracking has been sealed. Note slight flushing in the left wheel path.

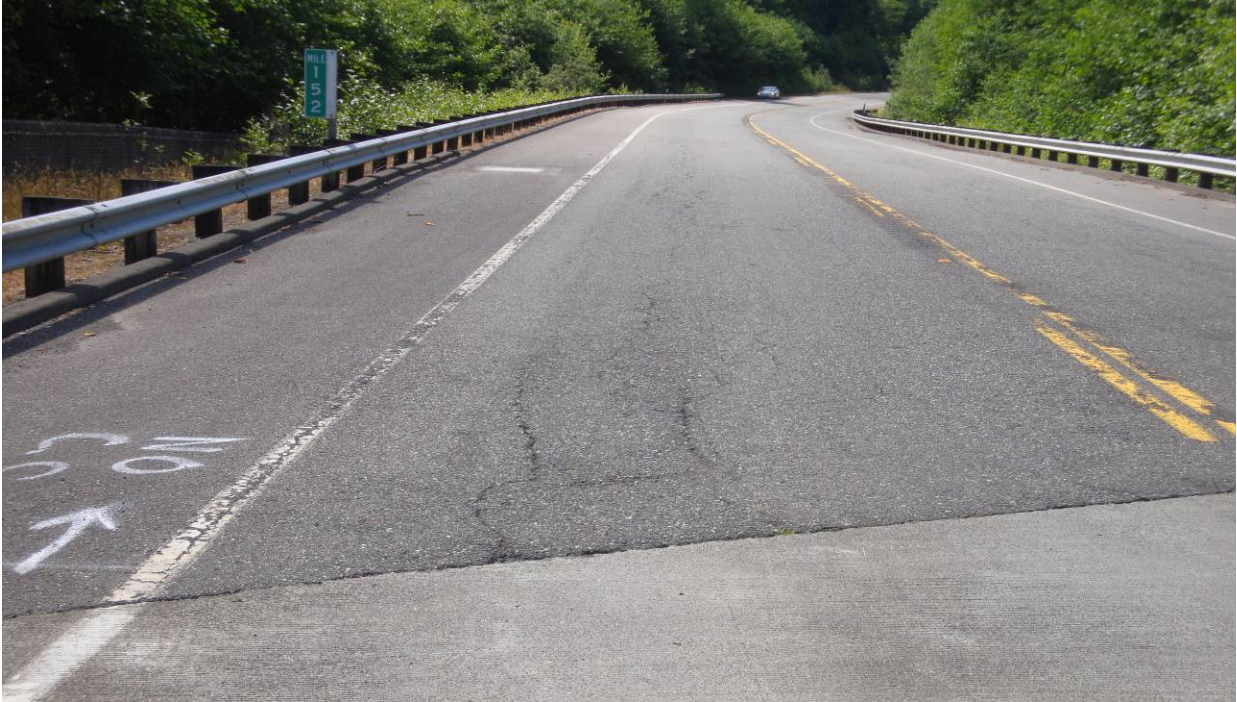
Figure 129. OR3a, SR101, condition in 2012, the year that the other sections were treated.

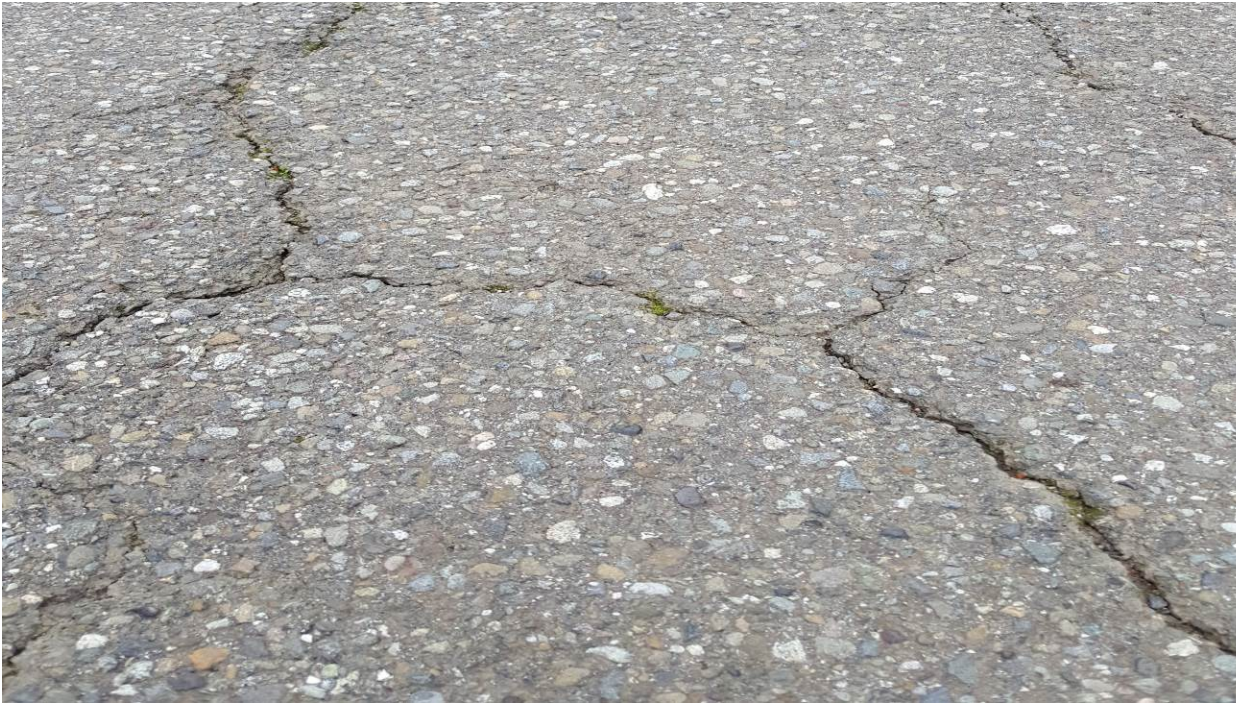
Figure 132. OR3a, SR101, three years after the other section were treated. Cracks are wide but not spalling.
