Review of Hot Bituminous Surface Treatments in Washington State

WA-RD 887.1

January 2019

WSDOT Special Project
Post-Construction Report

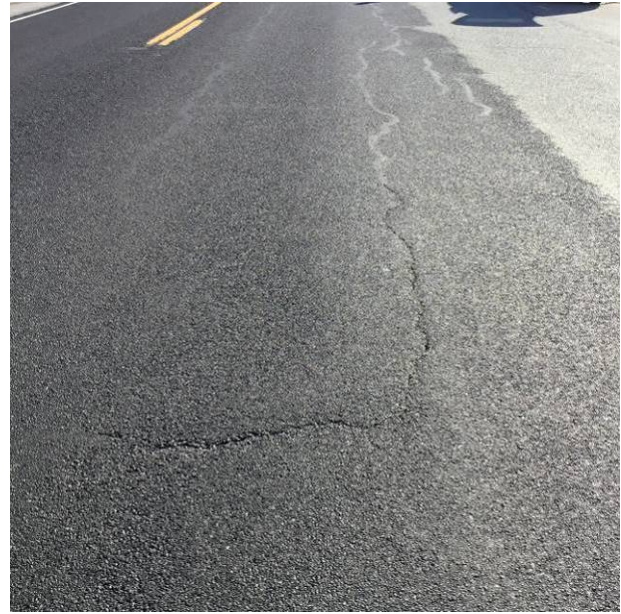
Figure 4. Longitudinal crack extending from crack that was sealed prior to the HBST at MP 223.76. (August 2017)

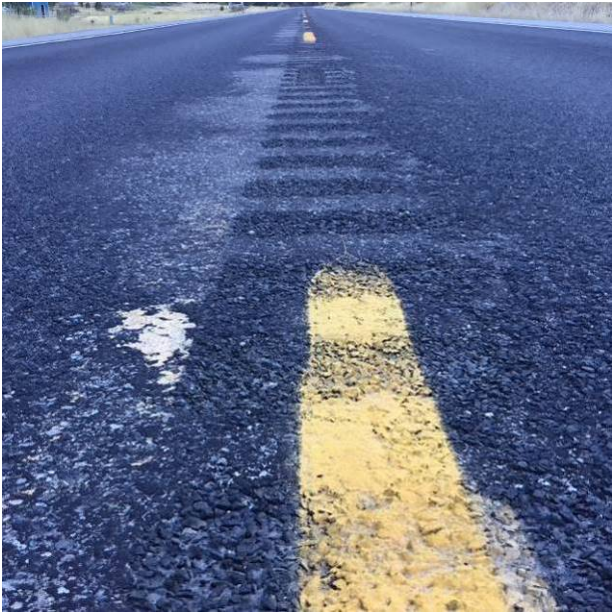
Figure 7. Snowplow damage at MP 227.50. (August 2017)

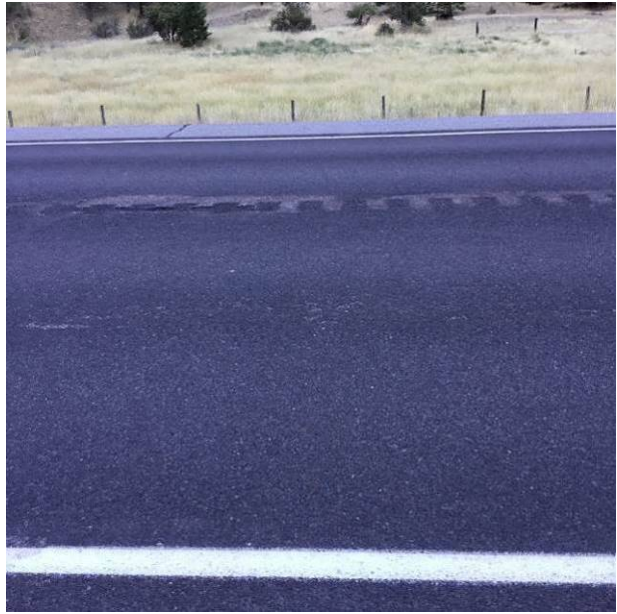
Figure 8. Snowplow damage at MP 227.50. (August 2017)

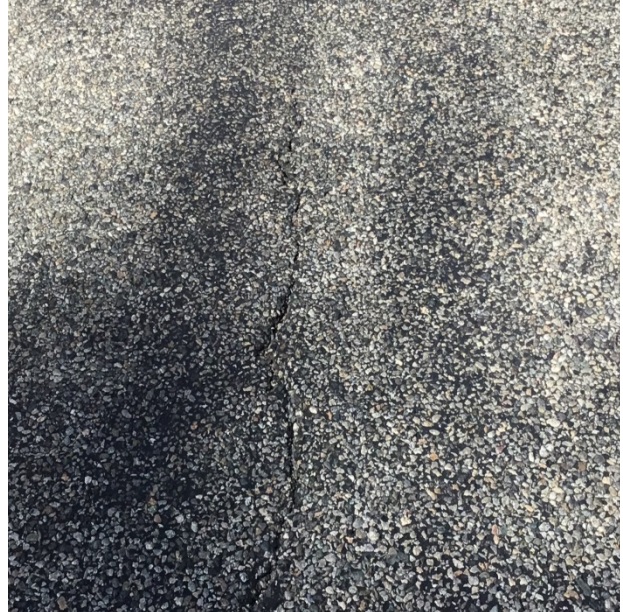
Figure 37. Longitudinal crack reflecting through the HBST at MP 4.00. (August 2017)

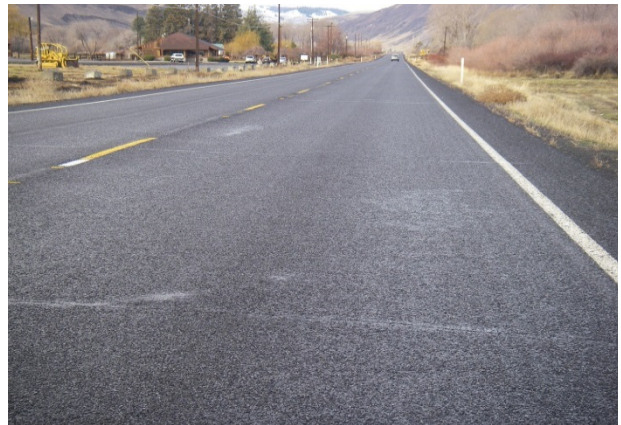
The project was inspected on December 11, 2016, six months after installation (Figures 48-59). The HBST was in generally good condition with some streaking and rich appearing wheel paths and transverse cracking.

Figure 53. Streaks from underlying crack sealant in HBST at the age of six months. (Dec. 2015)

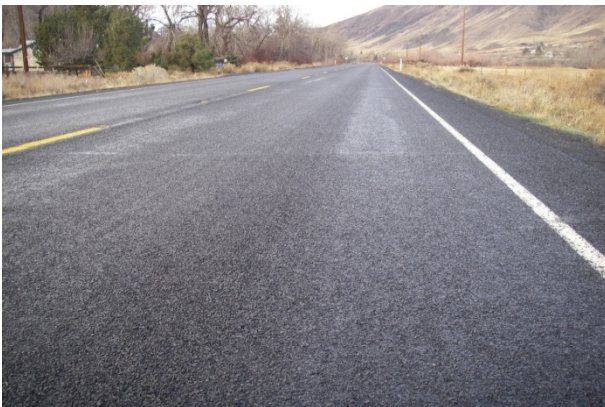
Figure 54. Rich areas in the wheel paths at the age of six months. (Dec. 2015)

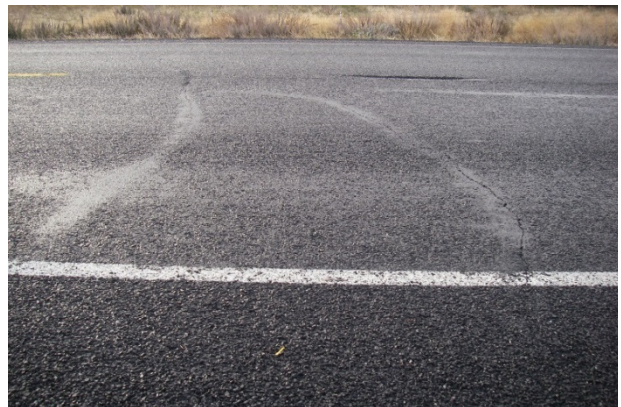
Figure 55. Transverse cracking at the age of six months. (Dec. 2015)

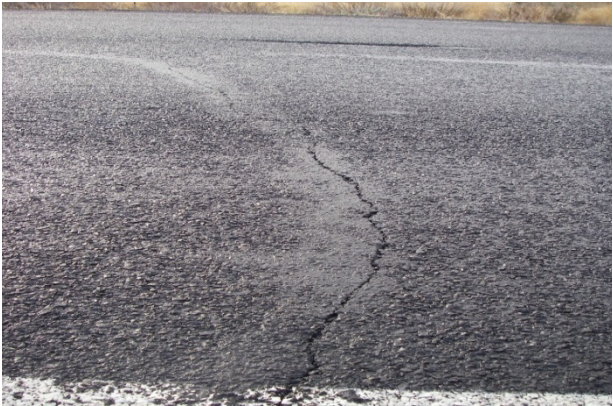
Figure 56. Transverse cracking at the age of six months. (Dec. 2015)

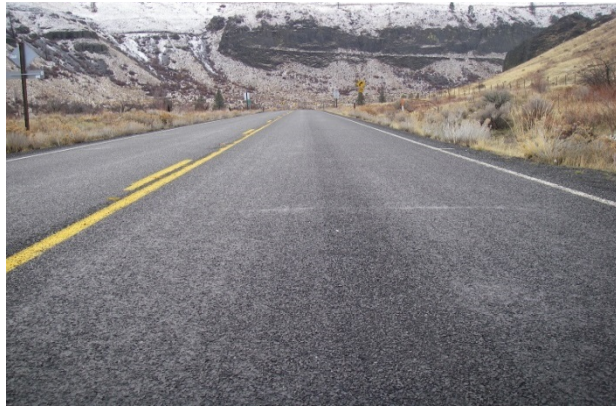
Figure 57. Streaking at the age of six months. (Dec. 2015)

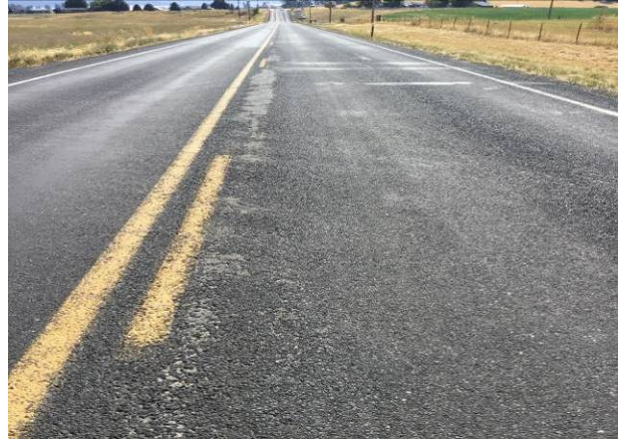
The 2017 review occurred on August 17 (Figures 67-72). Embedment ranged from 60-100% which accounts for the rich appearance of the HBST in the wheel paths. Raveling and snowplow damage was noted. The first two miles of the project look better than the roadway where the photos were obtained.

Figure 68. Centerline snowplow damage on HBST at MP 5.39. (August 2017).

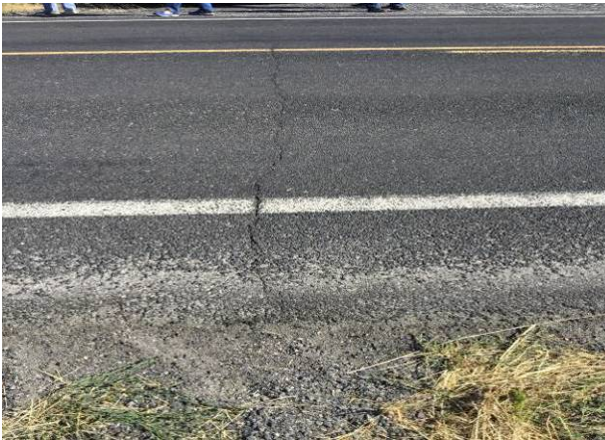
Figure 69. Transverse crack at MP 5.39. (August 2017)

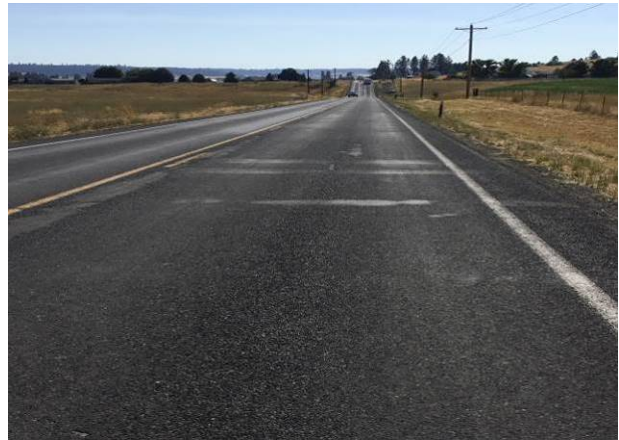
Figure 70. Transverse streaking at MP 5.39. (August 2017)

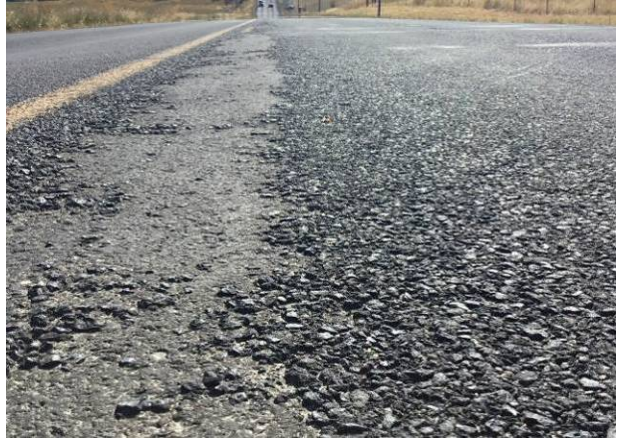
Figure 72. Snowplow damage at MP 5.39. (August 2017)

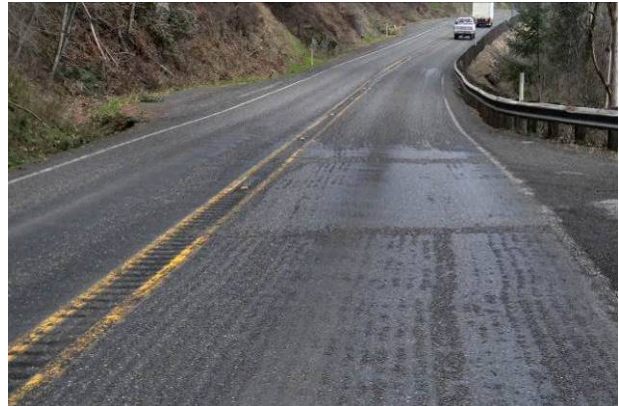
Figure 82. HBST showing aggregate loss. (Jan. 2016)

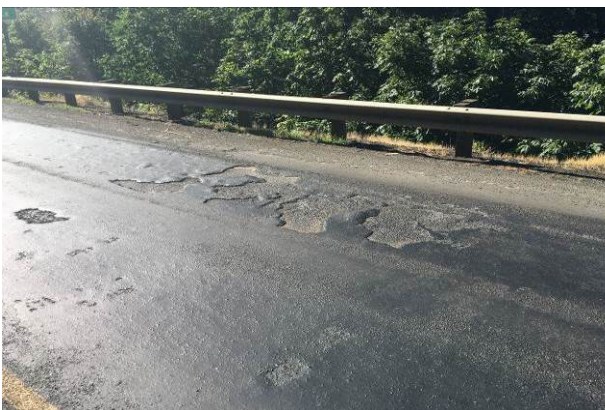
Figure 83. Delamination of HBST. (June 2016)

A change order was issued in 2016 to repair portions of the project with a grind and inlay due to potholes developing in the HBST. The limits of the repairs were from MP 44.07 to 44.60 in Stevenson and MP 62.57 to 67.10 in Bingen. The change order stated that the chip seal through Stevenson and Bingen was conducted at night and that the seal did not achieve the expected results. The chip seal in these towns were characterized as showing oil/asphalt bleeding and streaking. On the section beyond Bingen the initial performance was excellent, but over time the pavement began to lose aggregate especially along the tree-shaded segments. The shedding of aggregate was exacerbated by snowplows during the winter. During very hot summer temperatures oil came to the surface of the seal and was so soft that a boot would leave an imprint. Citizens complained that flying aggregate was causing windshield damage and oil was collecting on the undercarriages of their vehicles. Also, on June 3, 2016 a train derailment in Mosier, OR shut down I-84 in Oregon and traffic was detoured onto SR-14. As a result of hot weather, long delays and extra traffic, sections of the HBST delaminated.

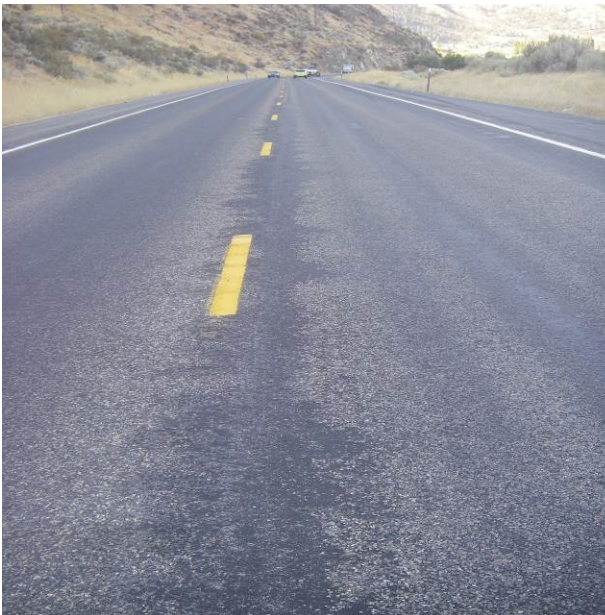
The SR-97 portion of the project was inspected on August 17 at MP 234.00 (Figures 98-101). The rich appearance of the HBST in the wheel paths was due to 100% embedment of the chips. Snowplow damage at the centerline was noted.

Figure 98. Looking north from MP 234.00 showing snowplow damage at the centerline and 100% embedment in the wheel paths. (August 2017)

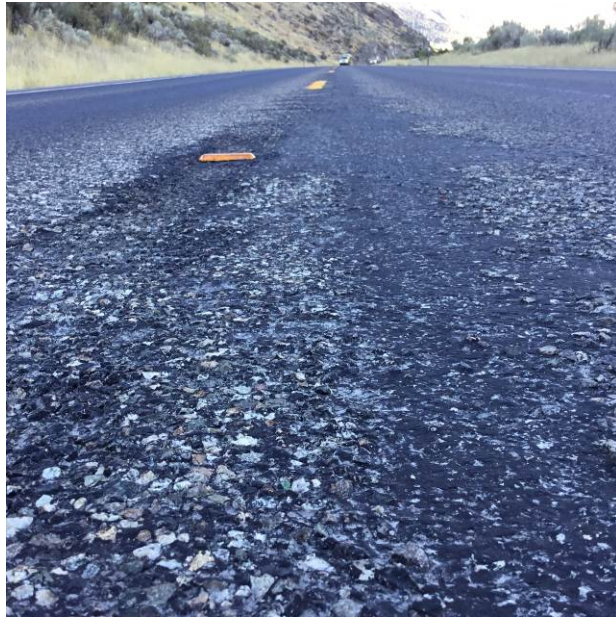
Figure 101. Snowplow damage at the centerline at MP 234.00. (August 2017)

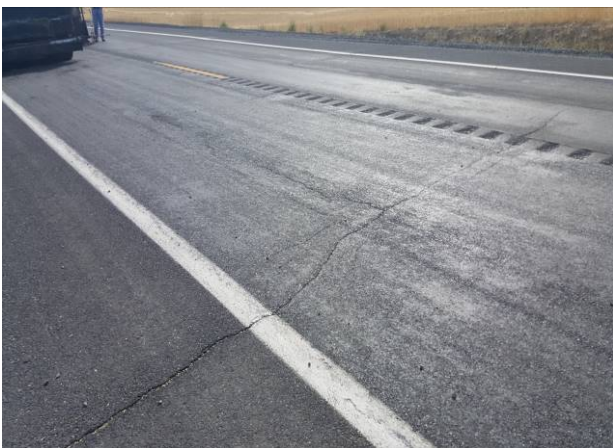
Figure 106. Transverse crack in US-2.
(August 2016)

A conventional BST was installed on US-2 from MP 167.35 to MP 189.18 using a cushion course in certain areas to prevent transverse cracking in the underlying BST from reflecting through the

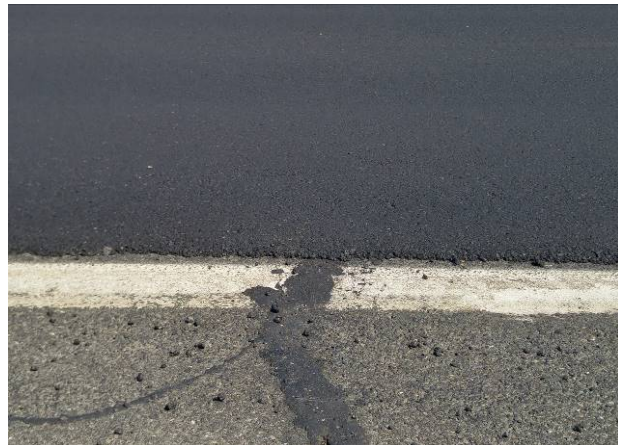
Figure 113. Pre-level on US-2 with over sealed transverse crack. (August 2016)

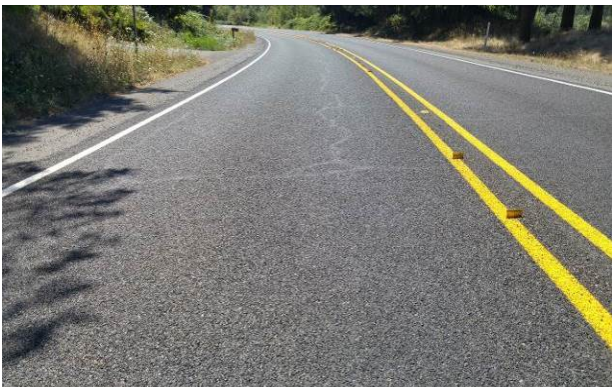
Figure 128. Shadows of crack sealant one month after paving. (August 2016)

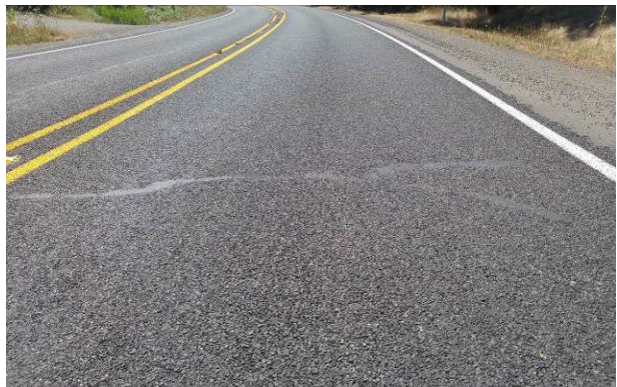
Figure 129. Shadows of crack sealant one month after paving. (August 2016)

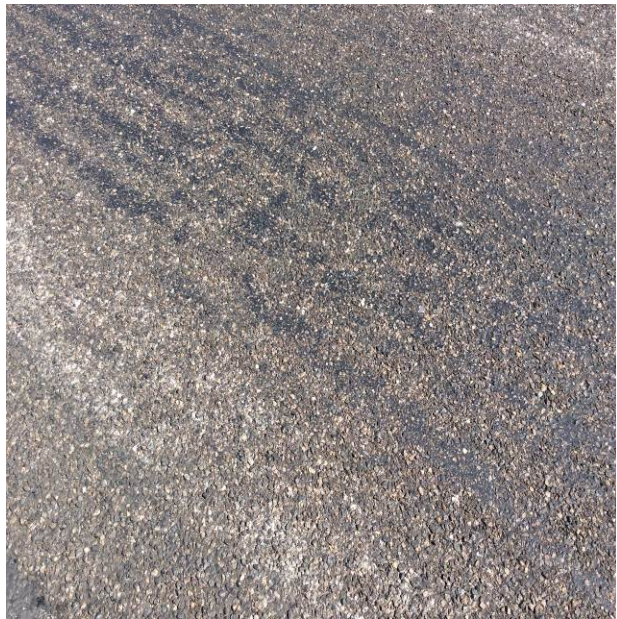
Figure 170. Close-up of the cornrows at MP 18.30.
(August 2017)

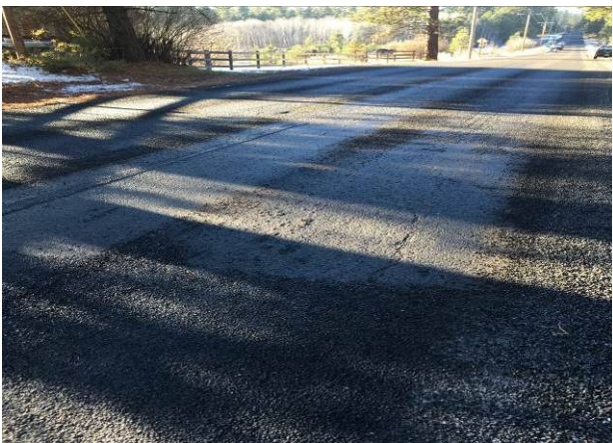
The Cle Elum to Roslyn section, MP 2.10 to MP 4.75 showed minor raveling where snowplows have scraped the high spots, but overall the surface was in good condition. From Roslyn to Ronald, MP 6.10 to MP 7.10, the wheelpaths have raveled (see Figures 176 and 177). In Ronald (MP 7.10 to MP 7.50) the HBST looks good with only minor raveling. From Ronald to the Forest Service Boundary (MP 7.5 to MMP 10.06) the HBST is in poor condition with complete raveling in the wheel paths or across the entire lane (Figures 178 and 179). Figure 180 shows covered chips on the snow berm on the side of the road.

Figure 176. Raveling on the section between Roslyn and Ronald.

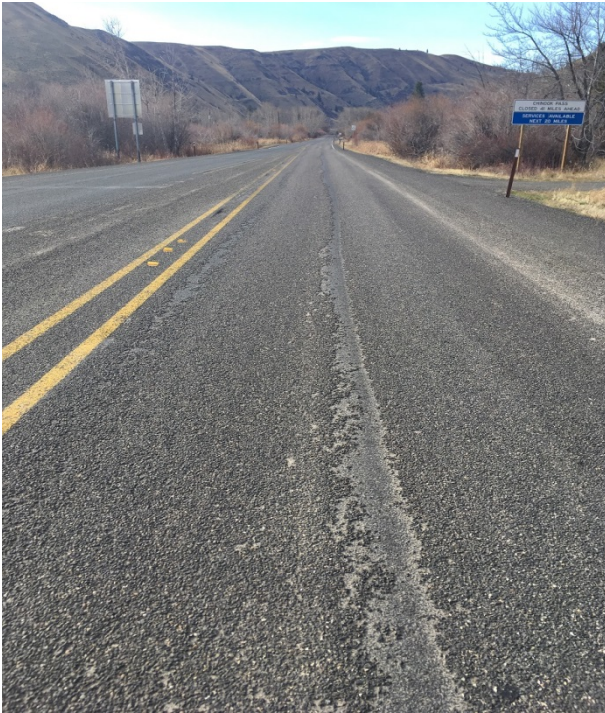
The SR-410 section was reviewed in February of 2018 by the South Central Region. Figures 192-199 show the condition of the HBST which had raveled, sometimes at the centerline, sometimes in the wheel paths and sometimes over the entire lane. The centerline raveling as shown in photos 192 to 195 is the result of placing the HBST on HMA patches. The patches were placed on substantial portions of the project to repair centerline rumble strips that had failed. Unfortunately, during the construction of the HBST HMA patches were not fog sealed to prevent excess AC-15P binder from being absorbed into the new asphalt leaving less asphalt to embed the pre-coated aggregate applied with the HBST. Applying a fog seal to the asphalt repair areas prior to the HBST would have prevented the raveling that occurred. The photos were taken on the two sections from MP 93.63 to 107.40 and MP 108.61 to 116.37. The third section is closed to traffic for the winter.

Figure 192. Raveling at MP 116.36. (February 2018)

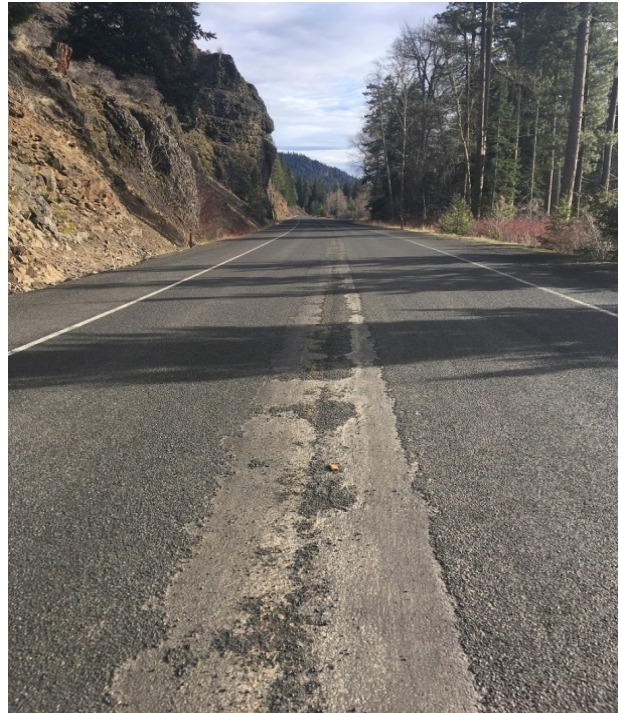
Figure 193. Raveling on SR-410. (February 2018)

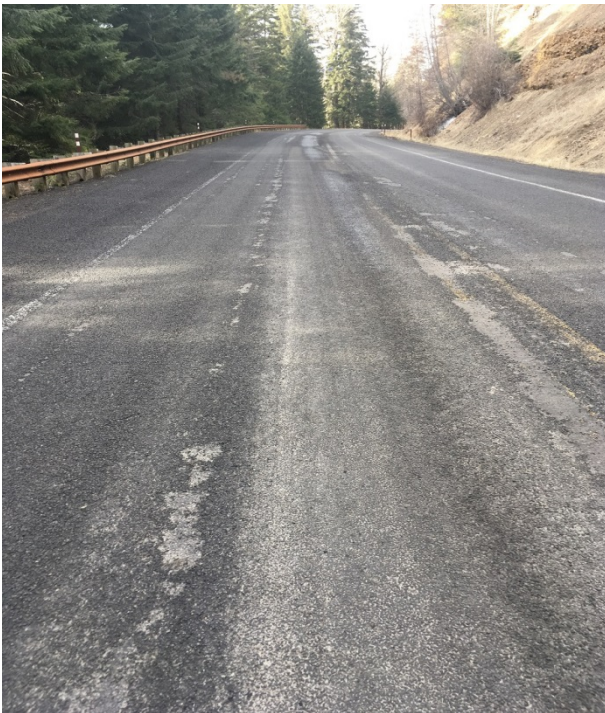
Figure 194. Raveling on SR-410. (February 2018)

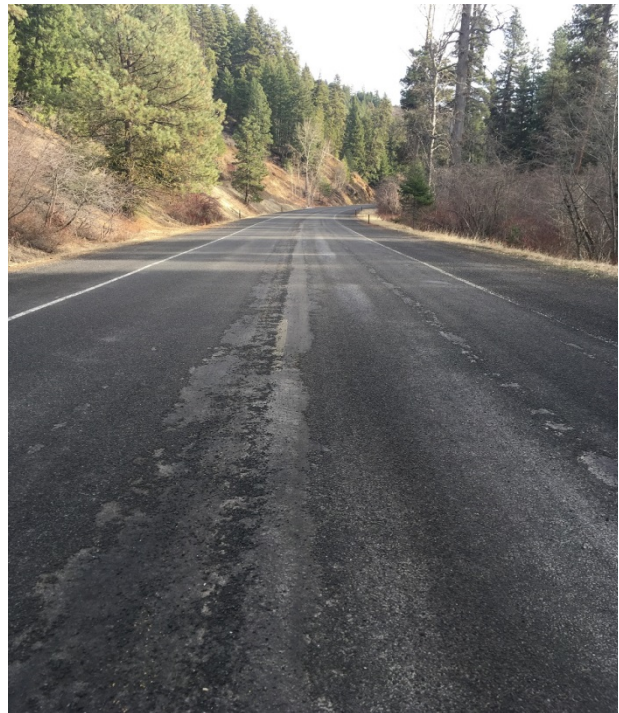
Figure 195. Raveling on SR-410. (February 2018)

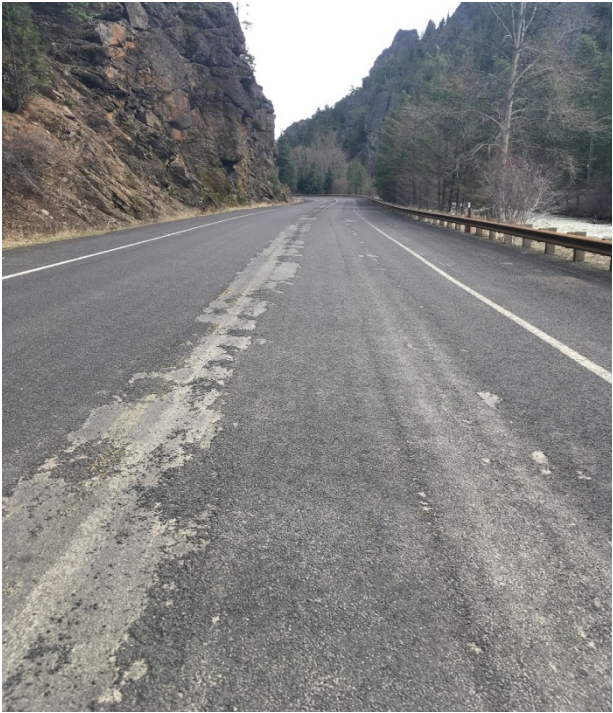
Figure 196. Raveling on SR-410. (February 2018)

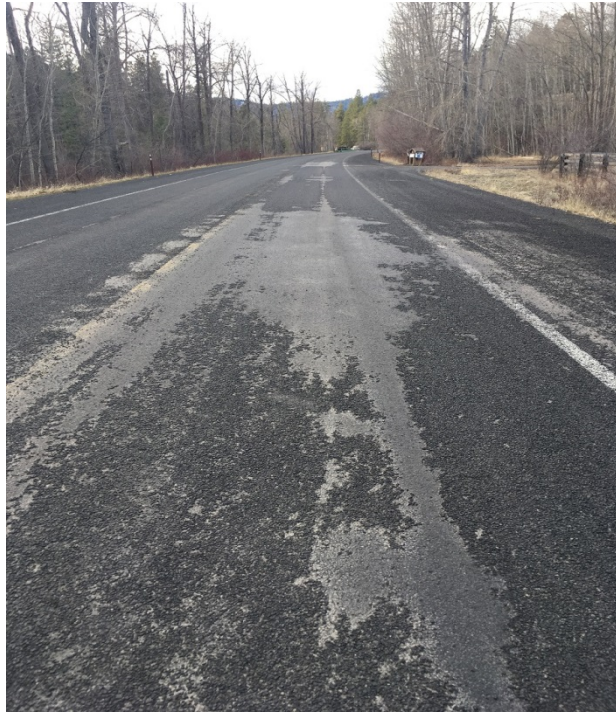
Figure 197. Raveling on SR-410. (February 2018)

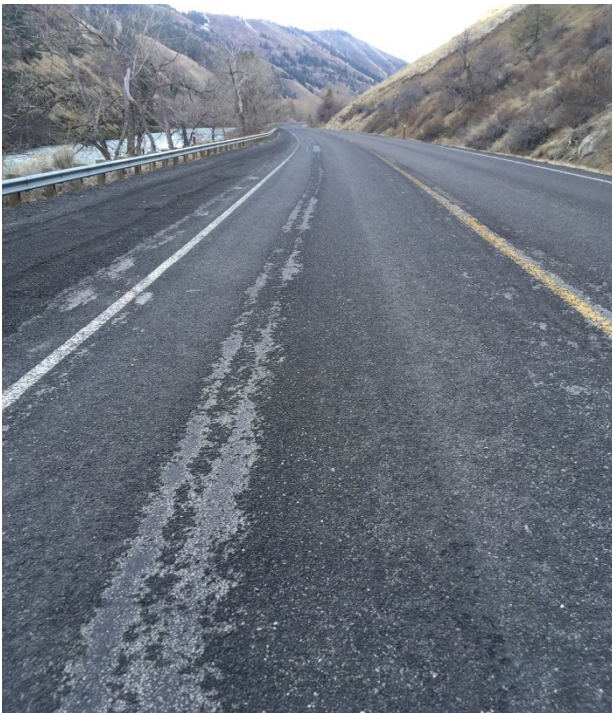
Figure 198. Raveling on SR-410. (February 2018)

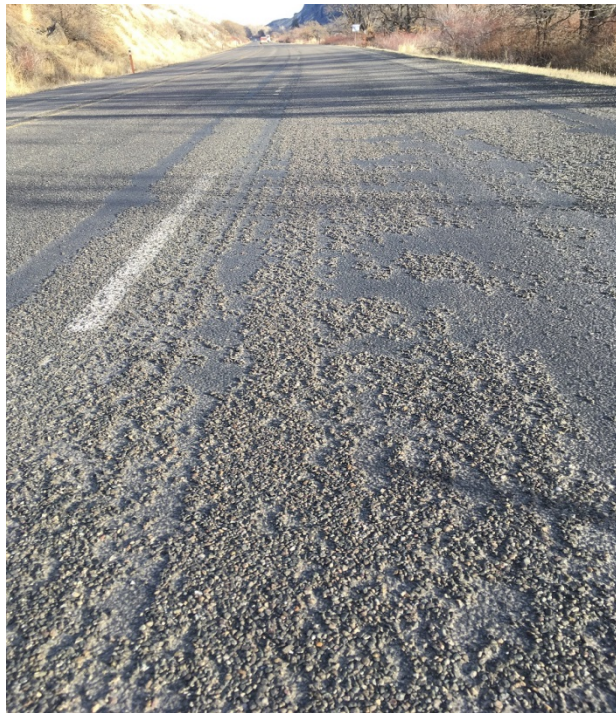
Figure 199. Raveling on SR-410. (February 2018)

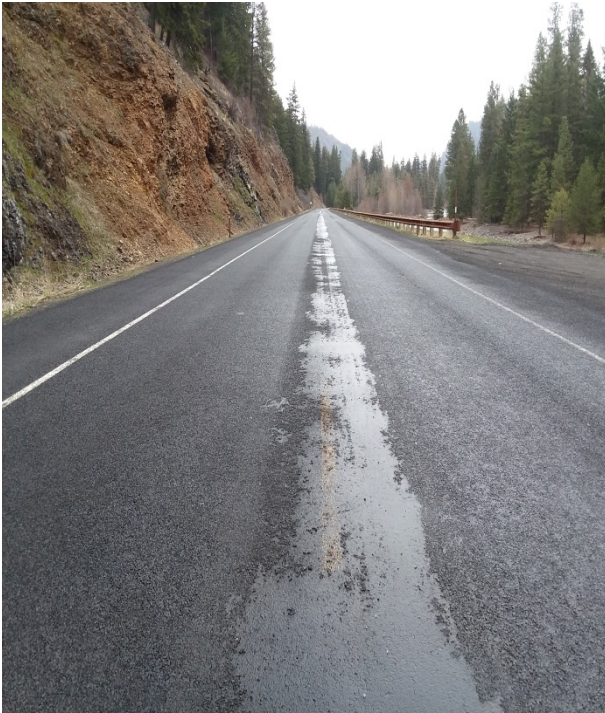
Figure 200. Centerline patch on SR-410. (April 2018)

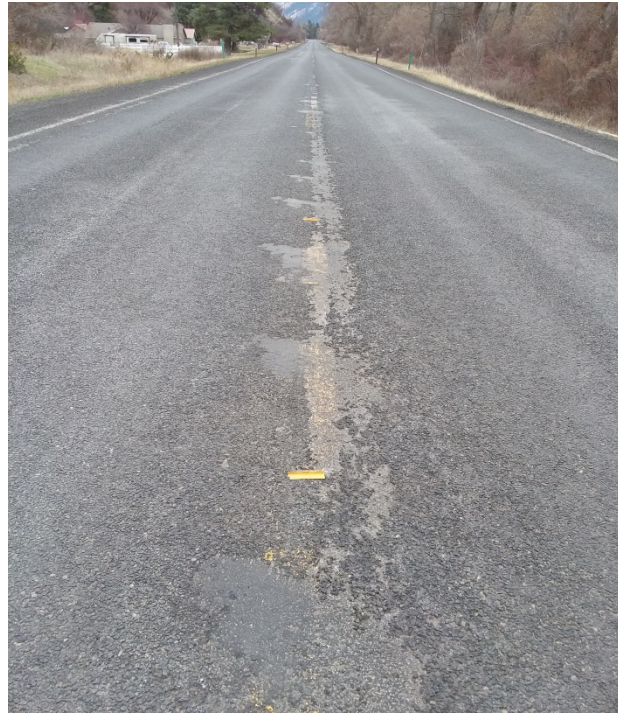
Figure 201. Typical distress on SR-410 (streaks or show plow damage). (April 2018)

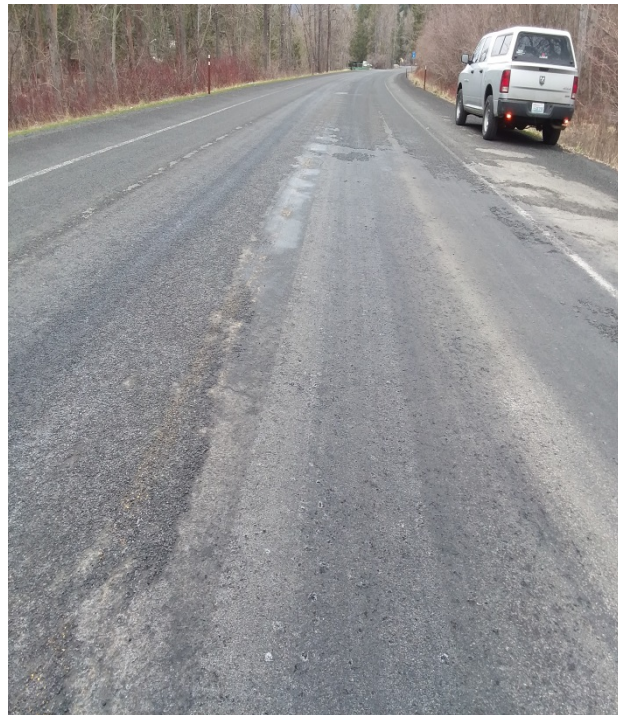
Figure 203. Isolated area of complete aggregate shedding. (April 2018).
