Field Analysis of Wood Guardrail Post Decay

WA-RD 890.1R

Research Report
Research Project T1462, Task 16
WA-RD 890.1R

Adam R. Phillips and Qiyang Luo
Department of Civil and Environmental Engineering
Washington State University
Pullman, WA 99164

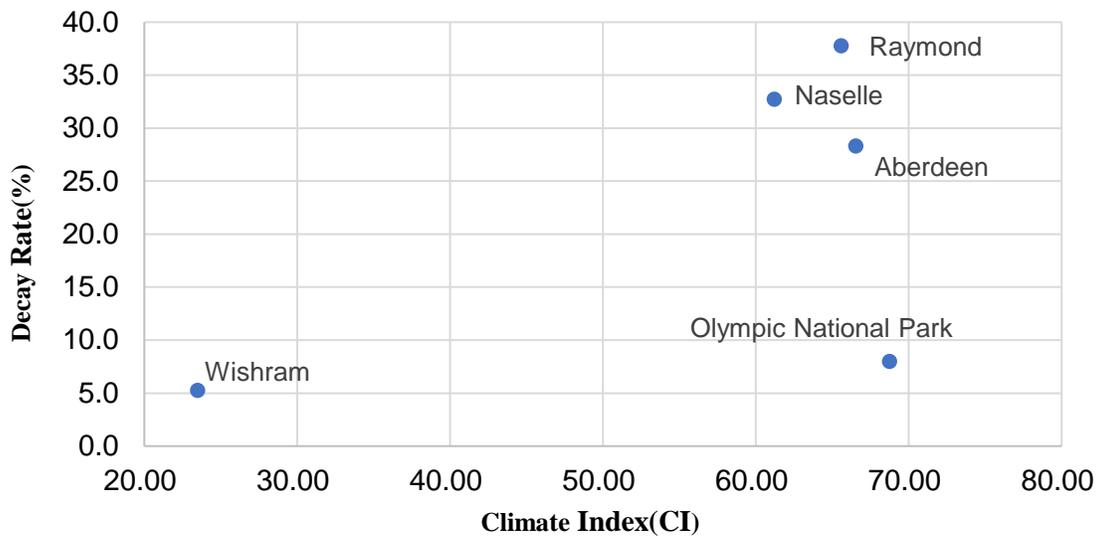
Figure 11. Decay rate versus climate index for inspection regions

Figure 11 clearly shows that the regions with higher climate index (CI) had significantly higher rates of decay. To understand more about the relationship between the climate index and wood post decay, the individual posts SWT velocity at the ground level (GL) were plotted versus the climate index of their location, shown in Figure 12. Based on the SWT Equation 1, a wave velocity for sound Hemlock was calculated to be approximately 37 in/ms in Equation 13. In Equation 13, E_D is the dynamic modulus of elasticity and was assumed to be equal to the average of the radial direction modulus, E_R , and tangential direction modulus, E_T , as all posts were tested along the radial or tangential direction. The radial and tangential moduli were calculated using their ratio compared to longitudinal modulus, $E_R/E_L = 0.058$ and $E_T/E_L = 0.031$, as provided by the *Wood Handbook* (FPL 2010). The longitudinal modulus for Hemlock, E_L , was taken as 1300 ksi, per the design modulus of elasticity for the Hem-Fir species group, which included Western Hemlock, from the NDS (AWC 2015). The gravitational acceleration constant, g , is equal to 386 in/sec² and the specific gravity of Western Hemlock is approximately 0.45 (FPL 2010).

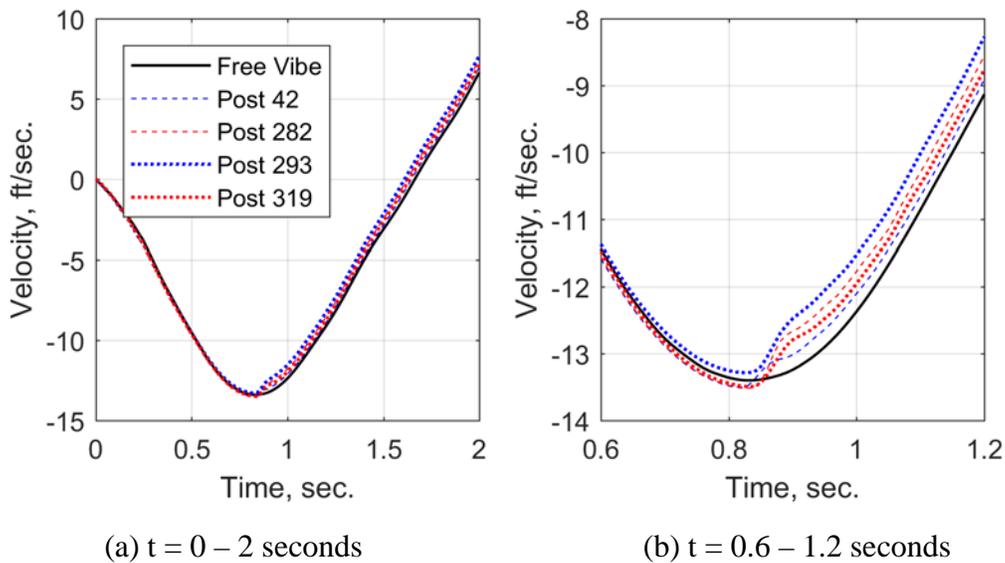
Figure 13. Pendulum velocity for posts with SWT velocities at the ground level between 0 and 20 in/ms

Figure 13 and 14 show the velocity response of the severely decayed and sound posts, respectively. It can be seen in Figure 13b that the average change in velocity immediately following impact was approximately 0.75 fps for the severely decayed posts. For the posts without noticeable decay, the average change in velocity immediately following impact was approximately 2.25 fps, or 3 times more than the severely decayed posts. This difference in the change in velocity shows that the decayed posts had less fracture energy than the sound posts.

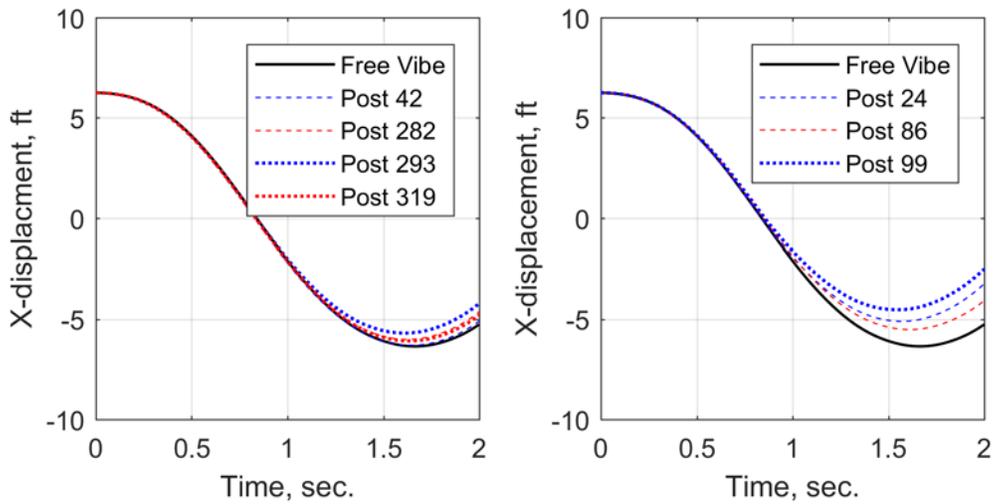
Figure 15. Global x-displacement for severely decayed and sound posts

Figure 15 shows the global x-displacement of the severely decayed and no noticeable decay posts respectively. Figure 15 demonstrates that the severely decayed posts did very little to slow down the pendulum, resulting in it achieving almost the same peak negative displacement as the free vibration tests. The posts without noticeable decay, shown in Figure 15b, had significantly less pendulum displacement after impact.

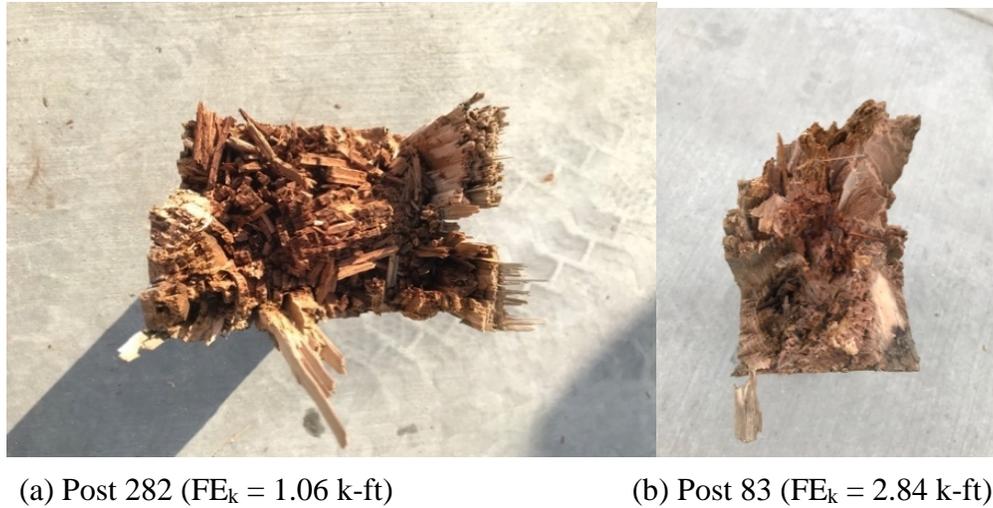
Figure 16. Photographs of broken posts from testing.

Figure 16 shows photographs of two fractured posts (Post 282 and Post 83) and their respective fracture energy, calculated using the difference in kinetic energy method. The interior of Post 282 was very soft and the wood crumbled with little effort, though the outside shell was relatively sound. Post 282 had a brash type of failure where the pendulum was able to break off the post with relative ease. Post 83 had no noticeable internal decay and the wood fibers can be seen to have participated more in the shearing failure of the post.

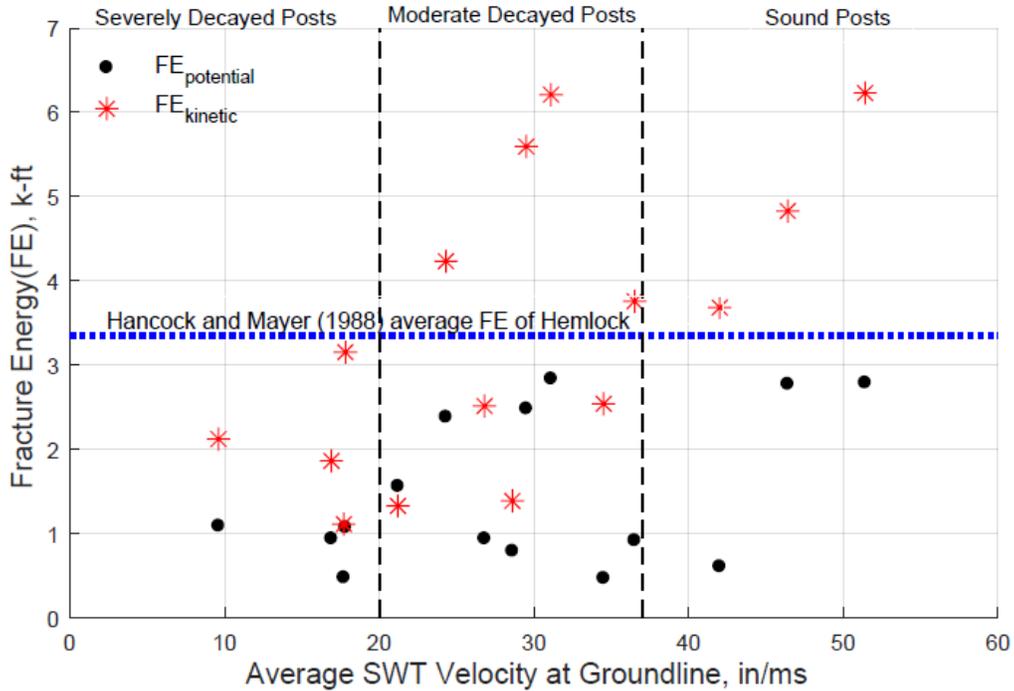
Figure 17. SWT velocity at ground level versus fracture energy

Lastly, Figure 17 presents the calculated fracture energies of the 15 posts using both methods. It can be seen that there is a substantial difference in calculated fracture energy between the two methodologies for an individual post, though the same trends exist. The fracture energy of new, stress-graded Hemlock posts, as tested by Hancock and Mayer (1988), is shown in Figure 17 to be 3.35 k-ft. None of the 15 posts achieved this fracture energy. There could be several reasons for this, but the most likely one is the age of the posts (>20 years in service) since the sound posts were not far below the Hancock and Mayer (1988) test data. None of the posts having severe decay, or SWT velocities at the ground level less than 20 in./ms, were able to attain half the fracture energy of the new sound posts from Hancock and Mayer (1988). Only half of the moderately decayed posts had fracture energy greater than half of the Hancock and Mayer (1988) tests.

Interestingly, two of the moderately decayed posts had approximately the same fracture energy as two of the posts with no noticeable decay.
