STREAM MONITORING REPORT 2010

SR 9: Nooksack Road Vicinity to Cherry Street All Weather Reconstruction (MP 93.00 to 97.18)

**Bone Creek Stream Re-alignment Site
Whatcom County, WA**

**Prepared by
WSDOT NORTHWEST REGION BIOLOGY**

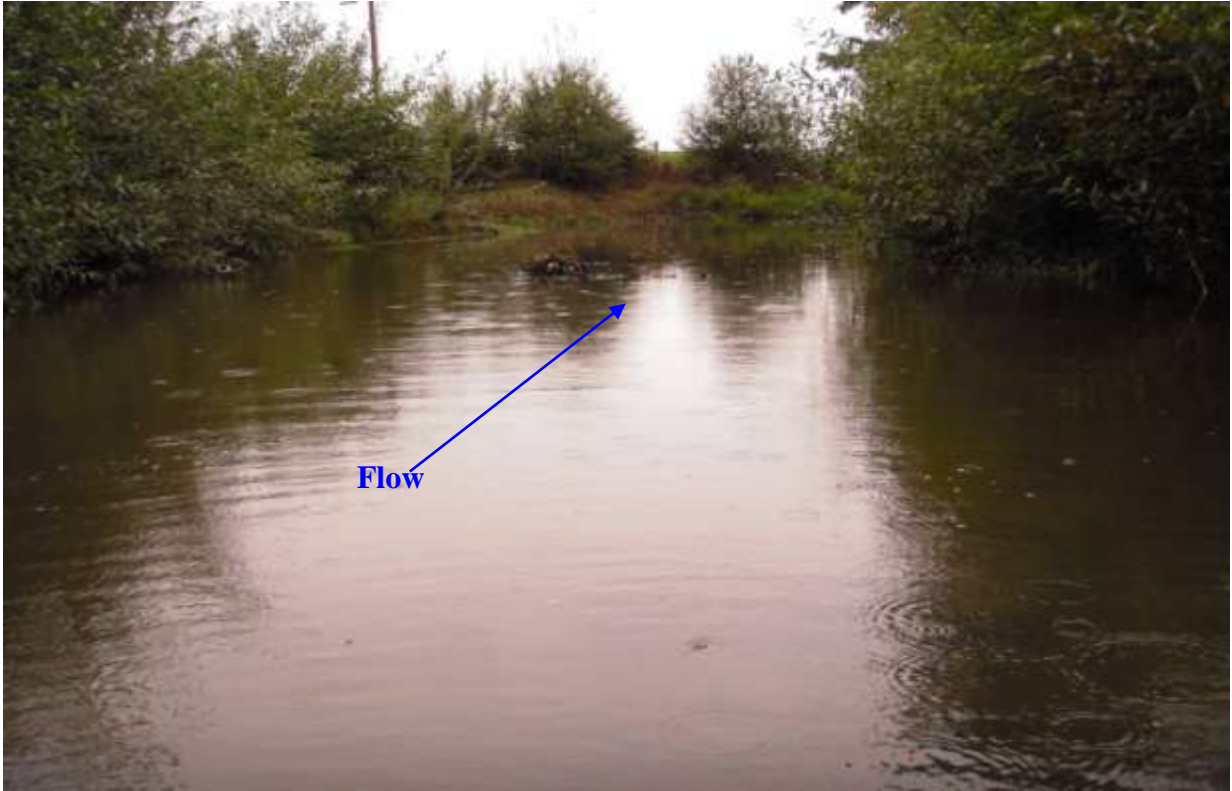
Figure 2. Photo facing northwest from mid-channel of cross-section 1 showing riparian and stream conditions and LWD.

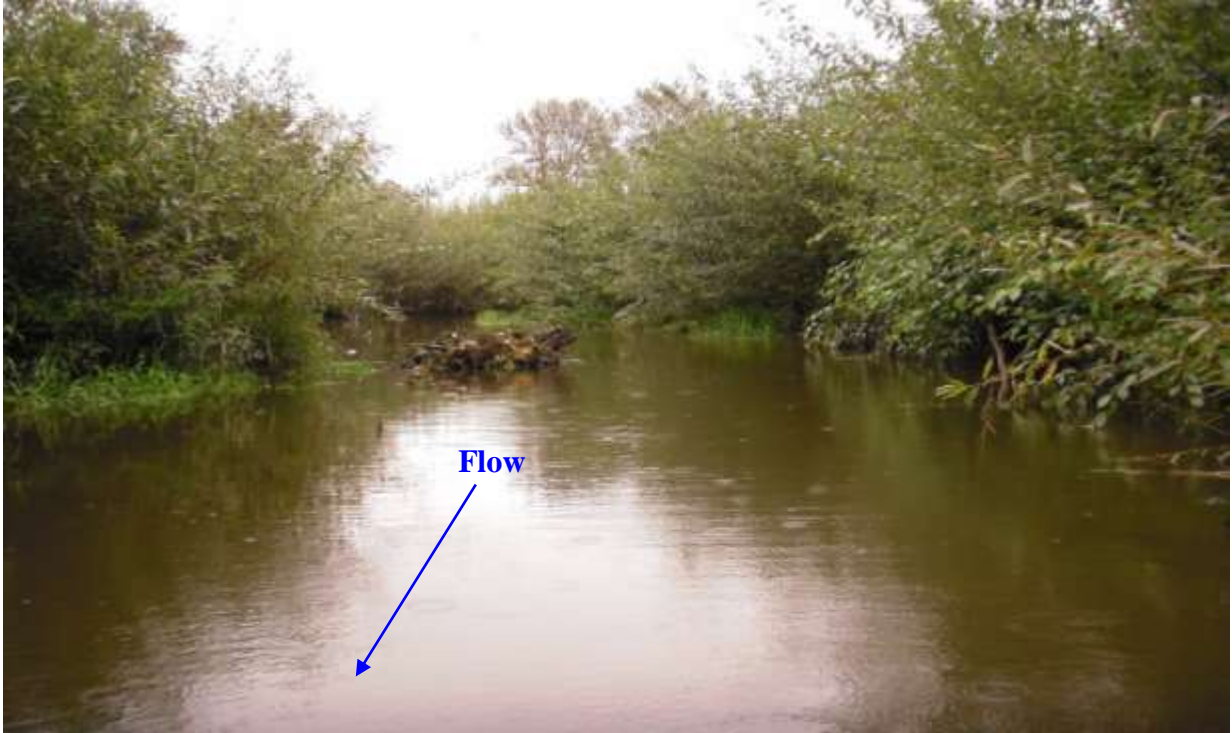
Figure 3. Photo facing southeast from mid-channel of cross-section 1 showing mostly submerged LWD and stream conditions.

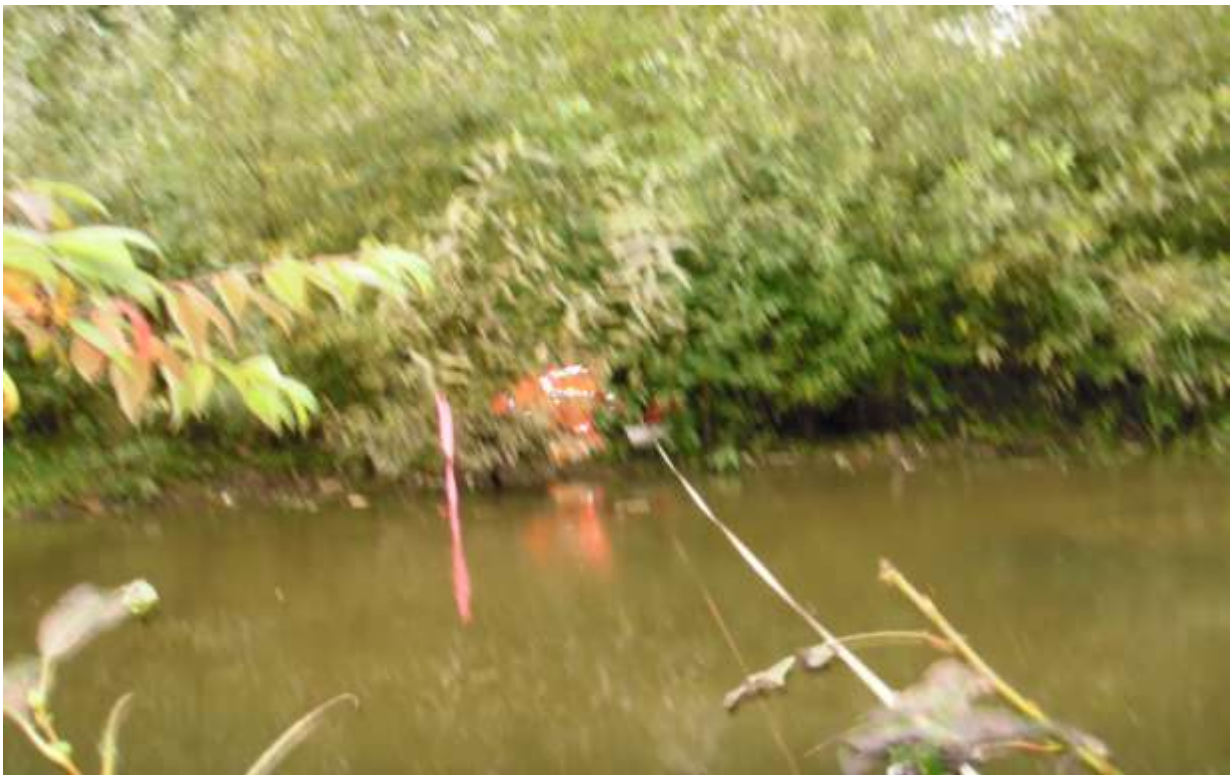
Figure 4. Photo facing southwest across channel showing benchmark 1 and riparian conditions.

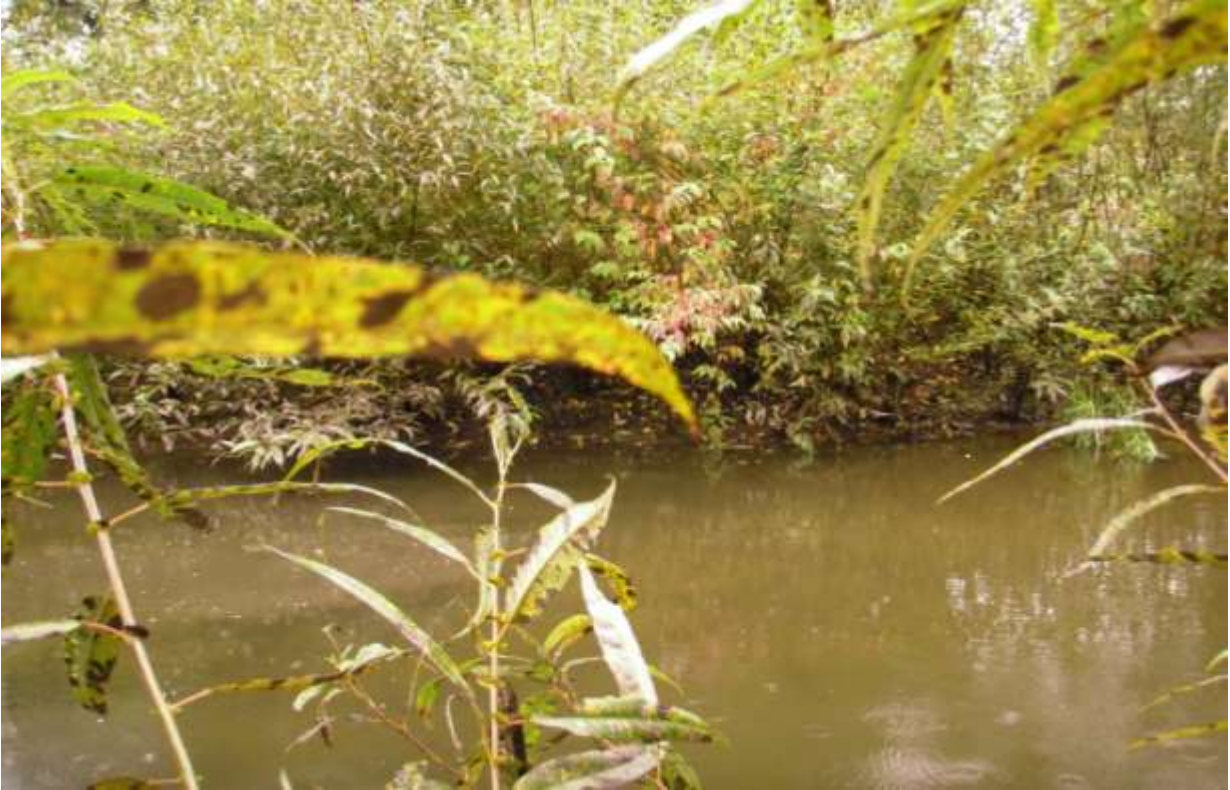
Figure 5. Photo facing northeast from mid-channel (looking at benchmark 2) showing riparian conditions.

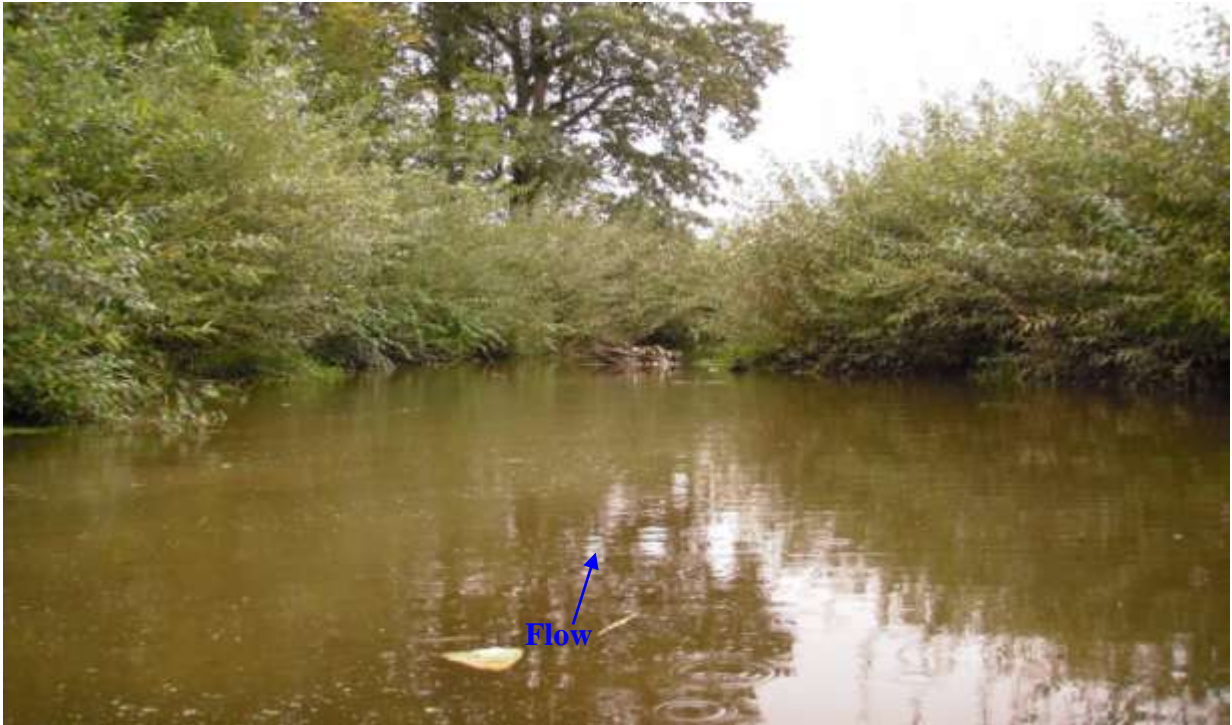
Figure 6. Photo facing northwest from cross-section 2 showing channel and riparian conditions.

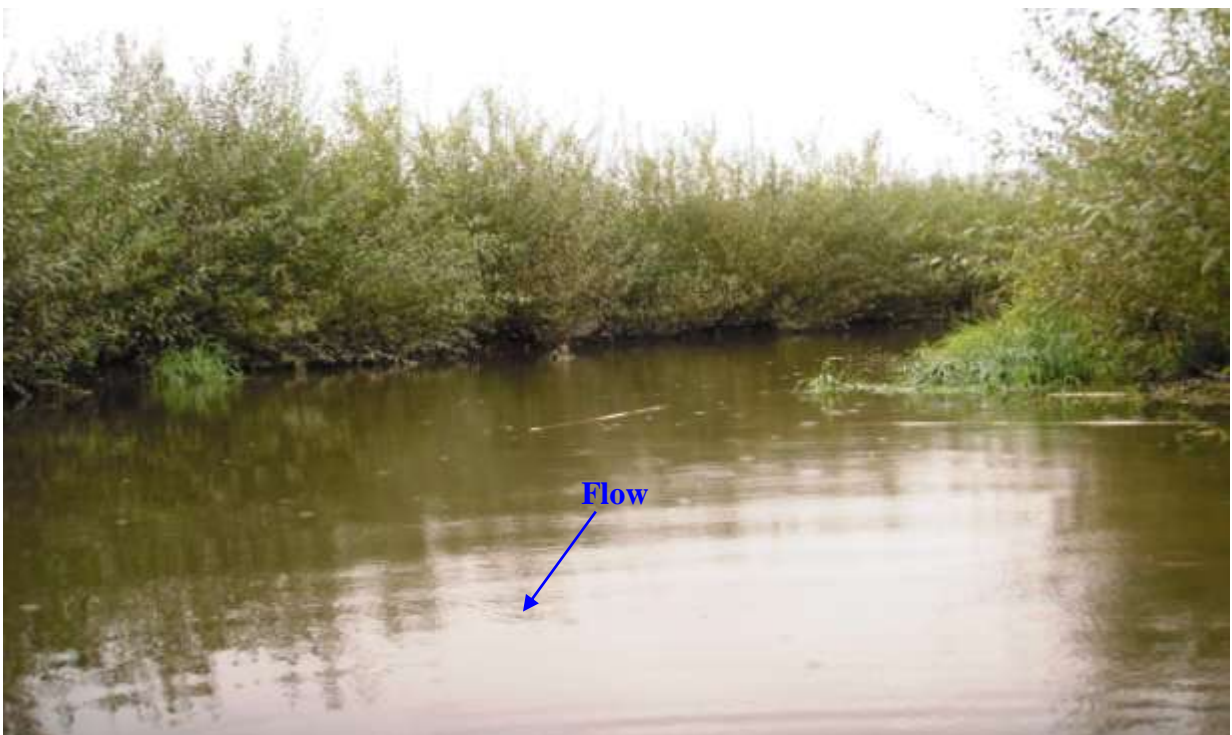
Figure 7. Photo facing southeast from mid-channel of cross-section 2 showing riparian and stream conditions.

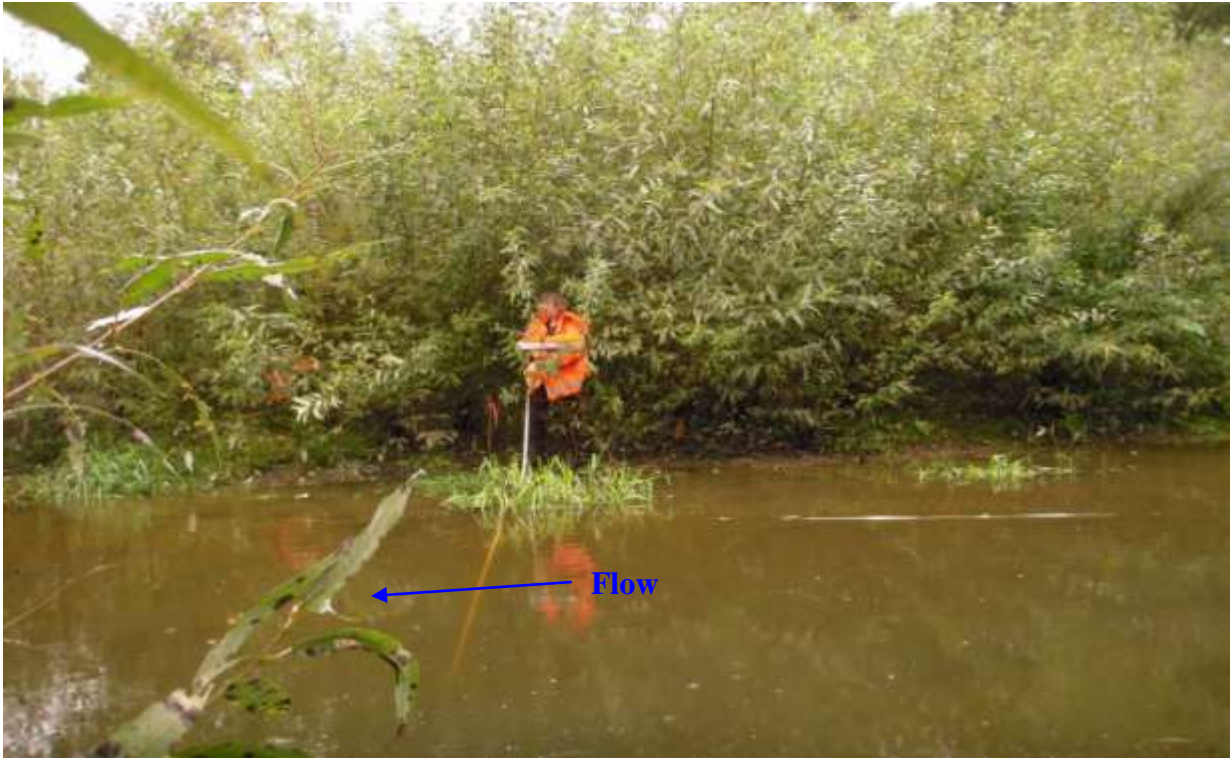
Figure 8. Photo facing northeast of benchmark 4, showing stream and riparian conditions.

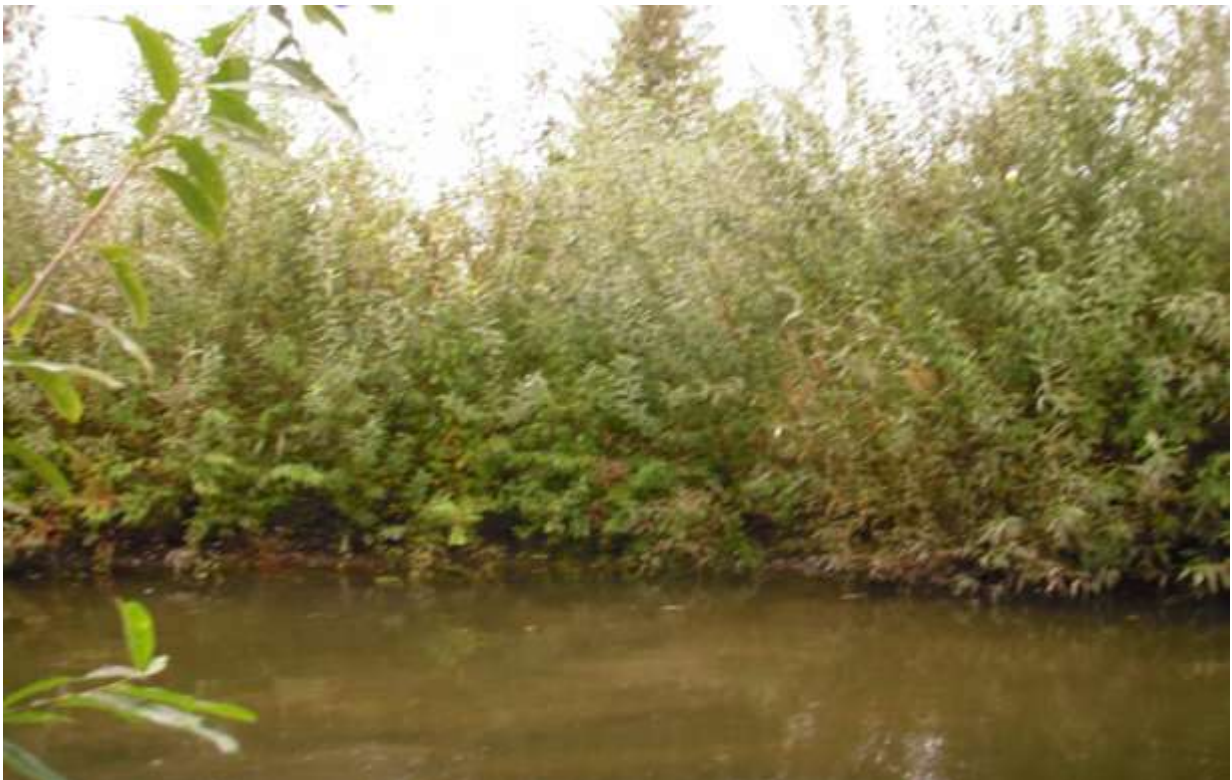
Figure 9. Photo facing southwest of benchmark 3, showing stream/riparian conditions.

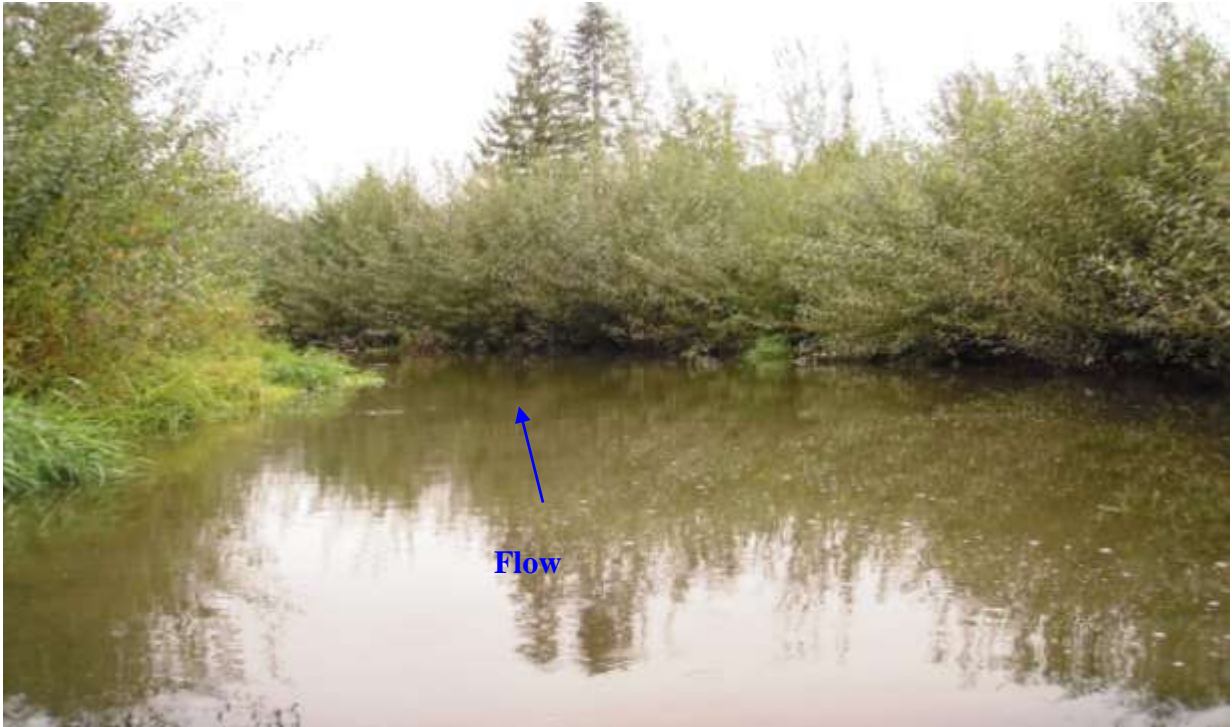
Figure 10. Photo facing northeasterly from mid-channel of cross-section 3, showing stream and riparian conditions.

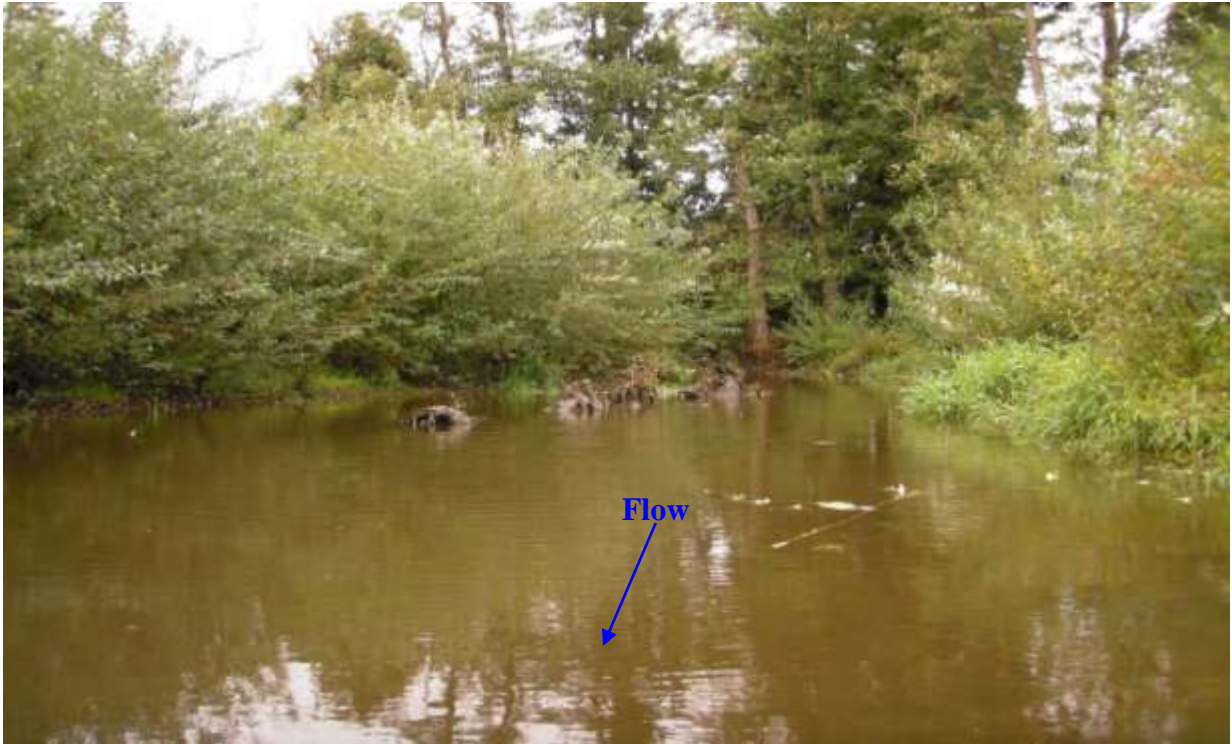
Figure 11. Photo facing southwest from mid-channel at cross-section 3, showing stream and riparian conditions.

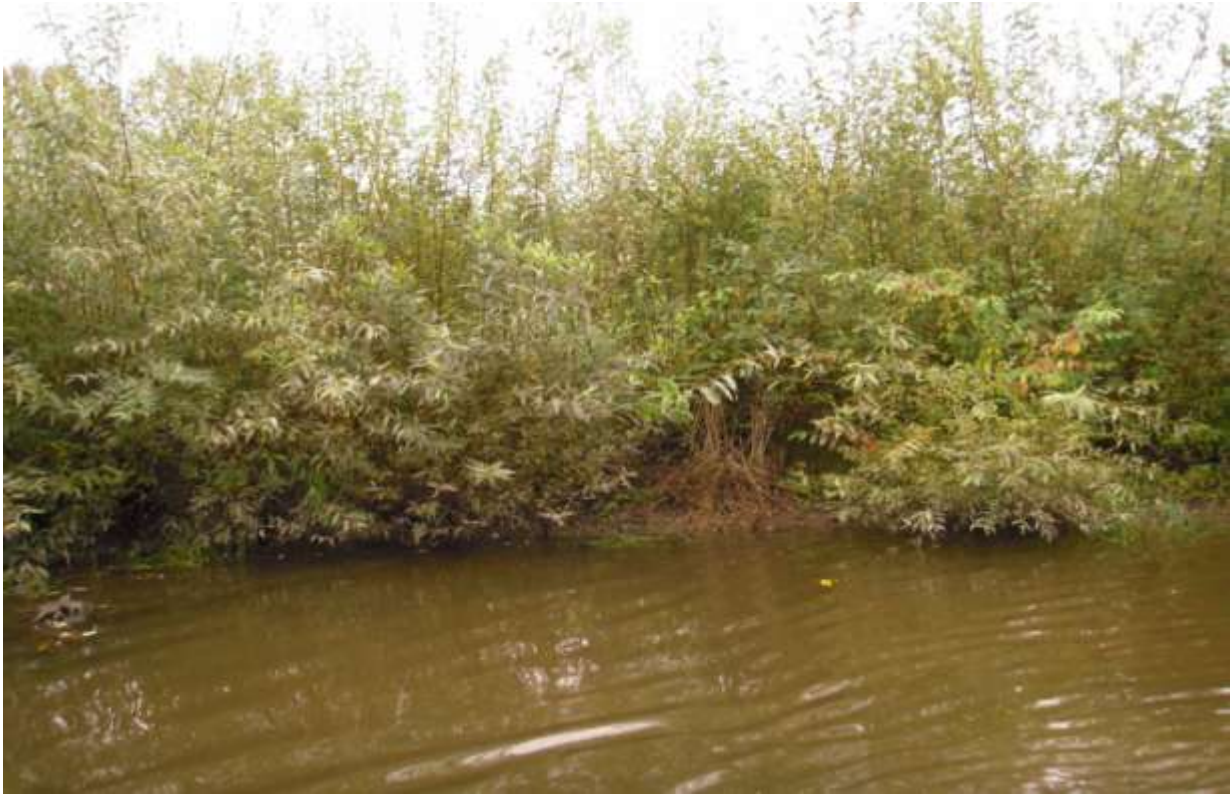
Figure 12. Photo facing benchmark 6 from mid-channel, showing riparian conditions.

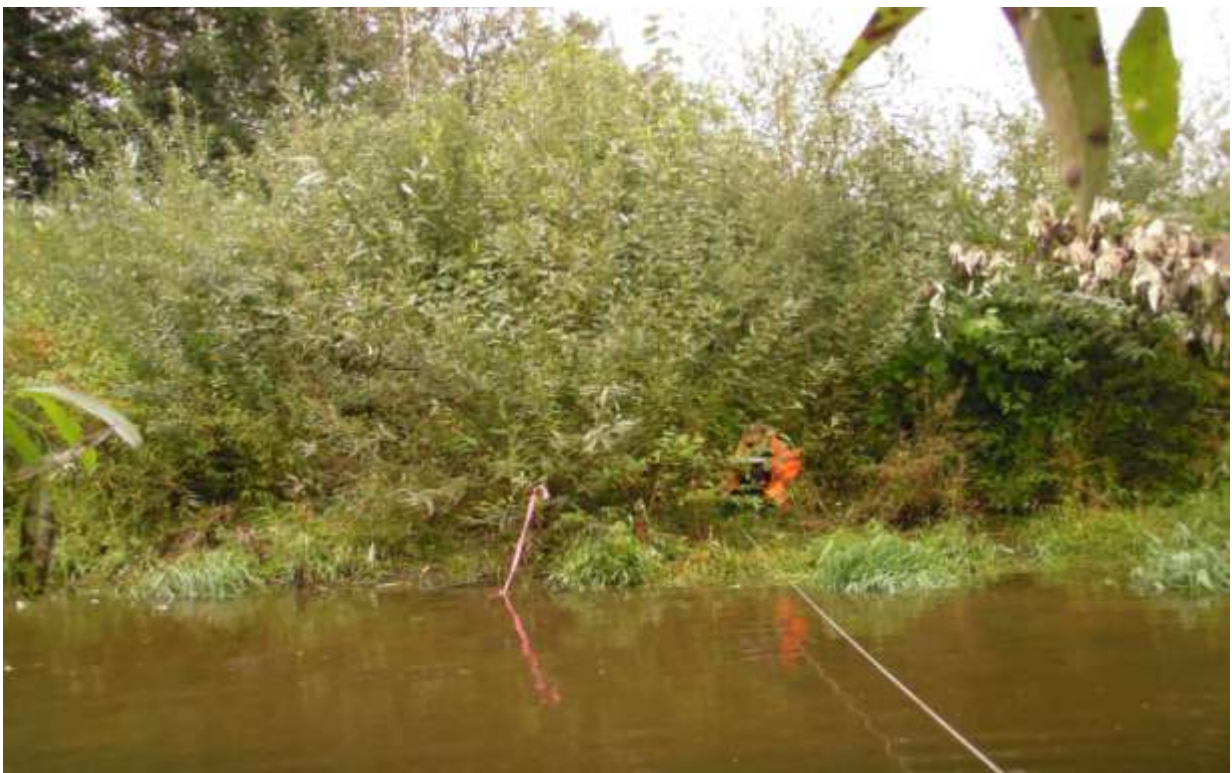
Figure 13. Photo from mid-channel facing benchmark 5 showing riparian conditions.

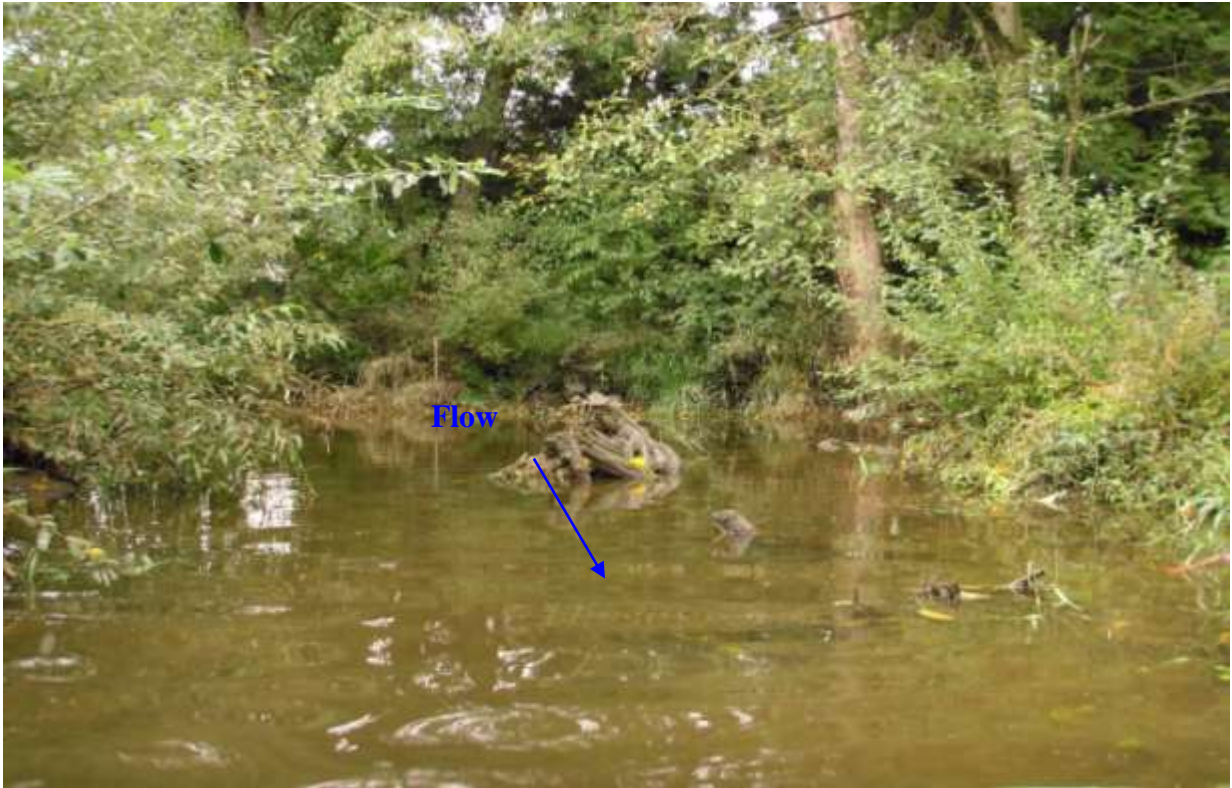
Figure 14. Photo facing westerly at cross-section 4 showing tips of LWD and stream conditions.

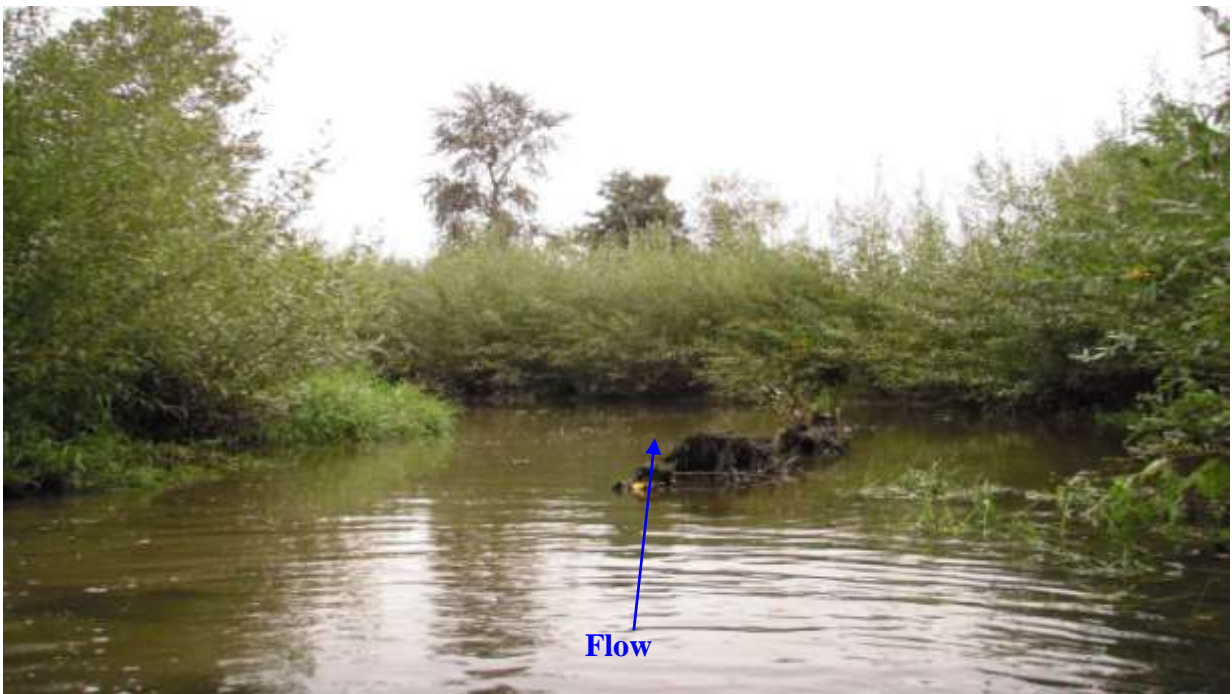
Figure 15. Photo facing easterly from mid-channel of cross-section 4 showing tips of LWD and stream conditions.

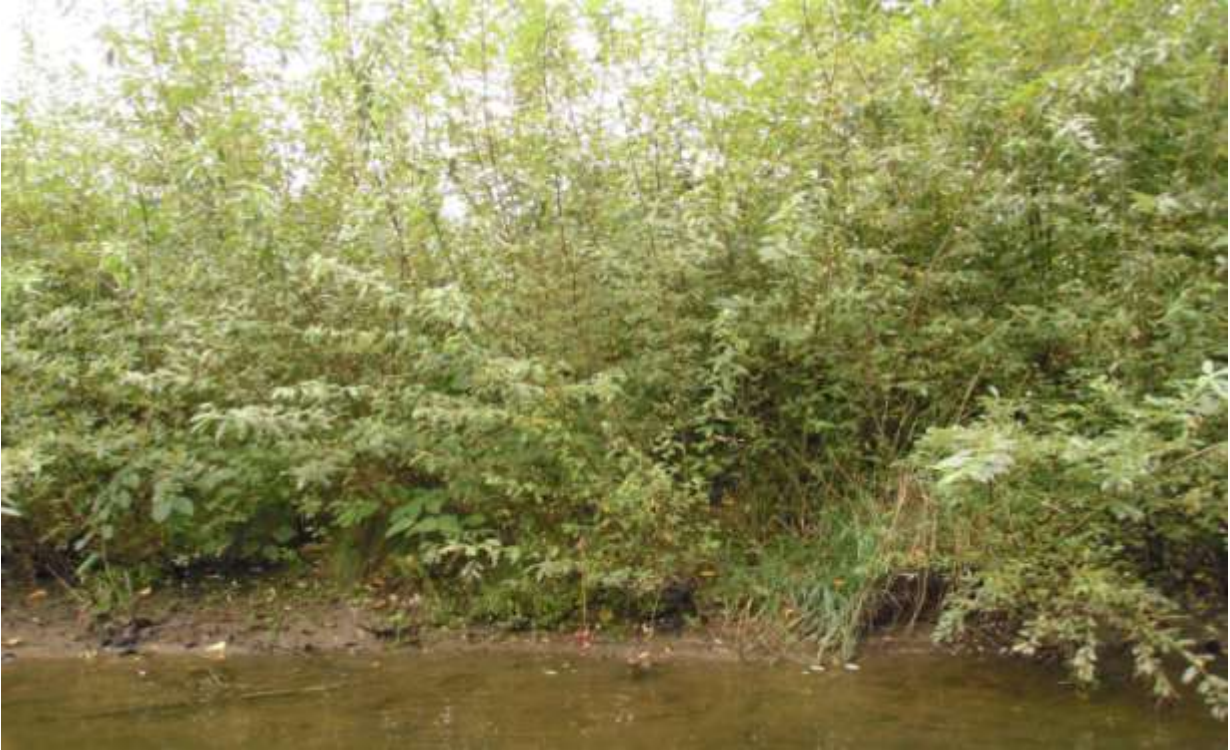
Figure 16. Photo facing southerly of benchmark 8 showing riparian conditions.

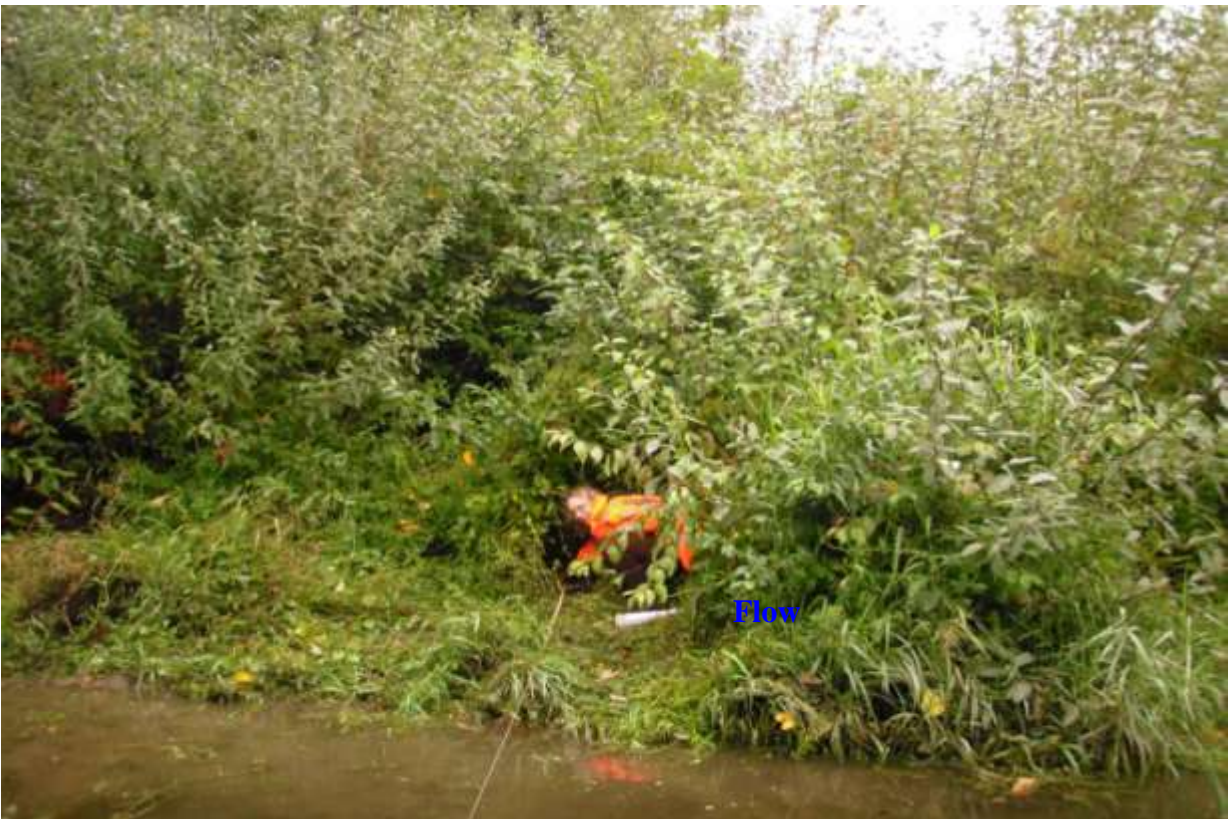
Figure 17. Photo facing northerly of benchmark 7 showing riparian conditions.
