P2 Bridge Preservation - Replacement/Rehab Projects

2009-11 Bien Priority Array

2009-11 Bien P2 Bridge Replacements/Rehab Candidates

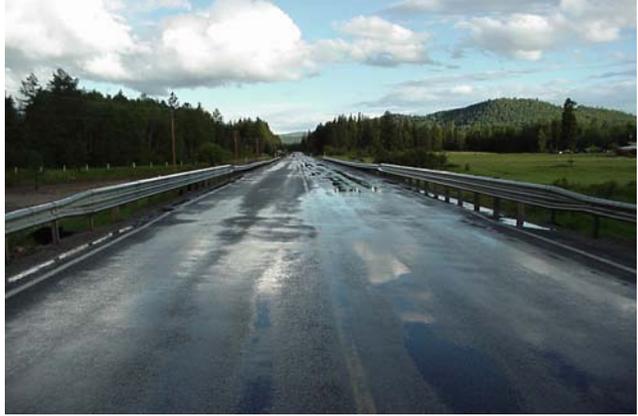
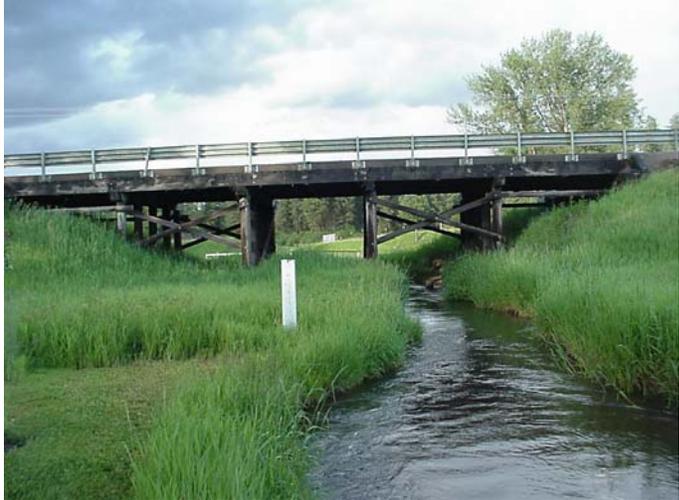
Scour: 8		Waterway: 8								
Proposed Bridge Replacement Information										
New Bridge Width: 36 ft.		Bridge \$'s: \$1,180,800								
New Bridge Length: 82 ft.		Total \$'s: \$2,952,000								
Priority Array #: 23										
PIN Number:										
WIN Number:		Repl/Rehab Year:								
Contract Number:		Ad Date:								
<p>THE BRIDGE IS CLASSIFIED "SD" DUE TO THE SUBSTRUCTURE CODE.</p> <p>There are 3 existing timber piles that are currently "Red - Tagged". Pile 3C has a 1/2" wide check and a steel splice collar at base; upper column was replaced. Pile 3D has a 1" shell and a 3" rot pocket. RED TAGGED. Pile 4A upper column has been replaced and steel spliced to lower driven piling. Pile 4B upper column has been replaced and steel spliced to lower driven piling. Pile 4C has a 1/2" wide check, a steel collar at the base, and a couple steel bands around splits at the top that are loose. Pile 4D upper column has been replaced and steel spliced to lower driven piling. Pile 4E upper column has been replaced and steel spliced to lower driven piling. Pile 5D is not centered under cap, 2" overhang of cap (cap lacks 3/4" for full bearing on pile), and has a 3/8" wide check from top 8ft down on the NW side, and 1" shell with a 9" rot pocket. RED TAGGED.</p>

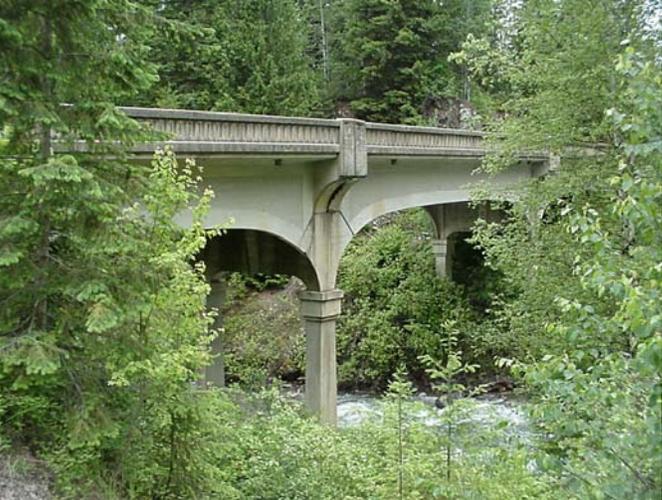
Superstr Code: 6	Safe Load: 5			
Substr Code: 5	Deck Geometry: 3			
Deck Code: 6	Underclearance: 9			
Scour: 3	Waterway: 8			
Proposed Bridge Replacement Information				
New Bridge Width: 36 ft.	Bridge \$'s: \$2,692,800

New Bridge Length: 187 ft.	Total \$'s: \$6,660,000			
Priority Array #: 27				
PIN Number: 603199A				
WIN Number: F03199D	Repl/Rehab Year:			
Contract Number:	Ad Date: 1/9/2006			
<p>The SR 31/Metaline Falls to Canadian Border-Reconstruction contract was completed in 2007. New HMA was added to this bridge along with adding riprap around a bridge pier.</p> <p>Bridge Replacement is warranted due to the potential scour risk and the bridge width of 22 feet.</p>

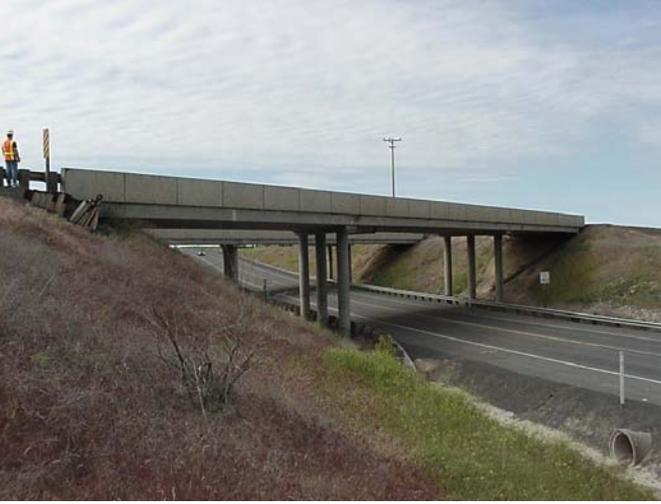
THIS BRIDGE IS CLASSIFIED "SD" BASED ON THE SUPERSTRUCTURE CONDITION.

Superstructure is coded as a "4" due to the longitudinal rusty cracks in the soffit of the hollow slab. note Top of slab covered with ACP. Edge of slab Leaching at slab to barrier interface. Vertical and diagonal hairline cracks on both edges of slab. Longitudinal crack in edge of slab at the NW corner approximately 15 ft. long. Soffit. Longitudinal cracks in soffit. Leaching along longitudinal joint at bottom centerline of slab in all spans. Longitudinal rust stained and leaching cracks, almost the full lengths of Span 1 and Span 2 (Photos #4 and #5). The northeast corner of Span 3 has a spall 4" x 4" x 1/2" deep.

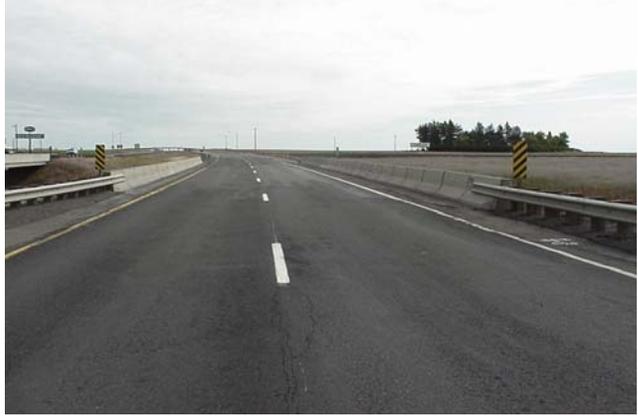
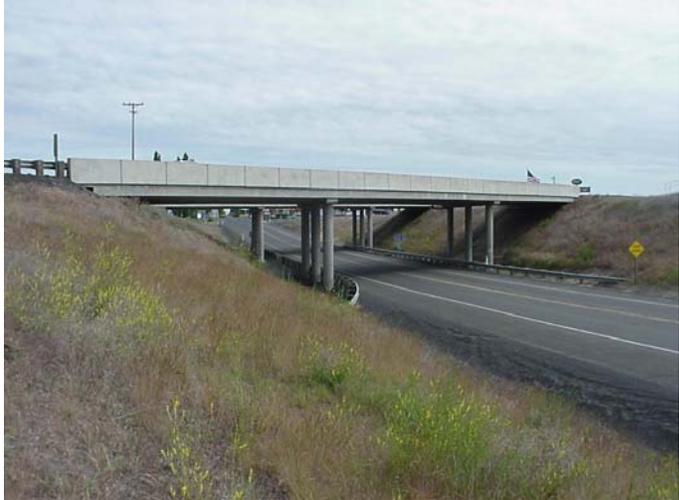
Proposed Bridge Replacement Information									
New Bridge Width: 36 ft.		Bridge \$'s: \$2,448,000							
New Bridge Length: 170 ft.		Total \$'s: \$6,264,000							
Priority Array #: 17									
PIN Number:									
WIN Number:		Repl/Rehab Year:							
Contract Number:		Ad Date:							
<p>THIS BRIDGE IS CLASSIFIED "SD" BASED ON THE SUPERSTRUCTURE and DECK CONDITION. Superstructure is coded as a "4" due to the longitudinal rusty cracks in the soffit of the hollow slab. Top of slab covered with ACP, see note 801. Edge of slab longitudinal crack, approximately 20 ft. long in north edge of Span 1; crack starts near west abutment. Another rust stained crack that is approximately 8 ft. long along north edge of the slab in Span 1. Vertical cracks in edges of the deck. 2005 interim inspection: There were no apparent changes to the overall delamination characteristics. All spans have a rusty leaching crack about 12" from the north edge. Transverse leaching cracks, some are rust stained. Random small spalls in the bottom of the slab, some are rust stained. A 4" diameter x 1/2" deep rust stained spall at the south end of Span 1 near midspan. There is a 25ft. long delamination with a rusty area on the north face of Span 3</p>
