De-Bonding of Hot Mix Asphalt Pavements in Washington State: An Initial Investigation

WA-RD 712.1

WSDOT Research Report

Final Technical Report TNW 2008-10 TransNow Budget No. 61-4026 and 61-5916 De-Bonding Cracking

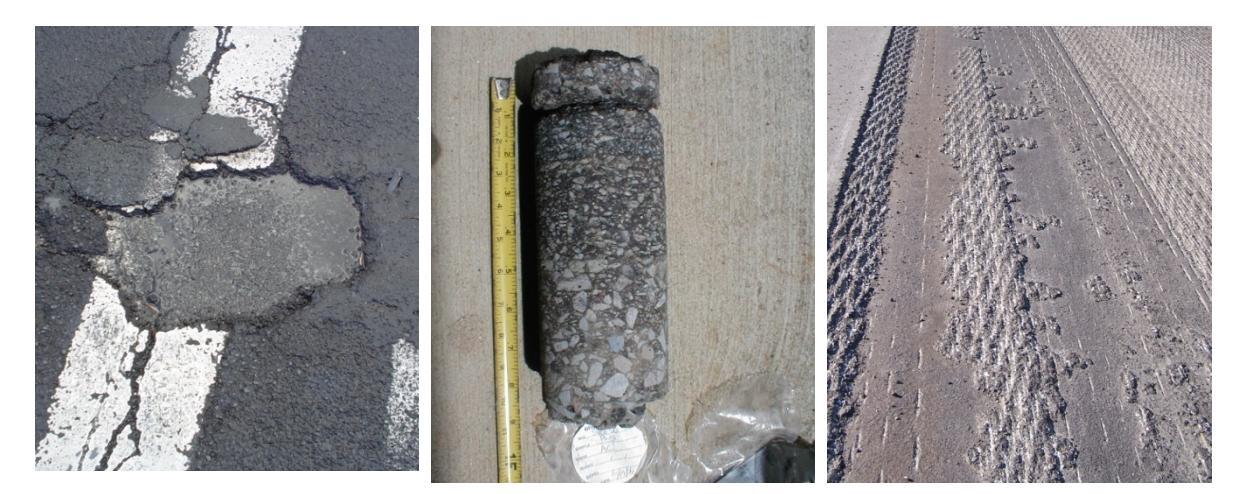
- 1. Shallow depth potholes in an existing pavement where the surface HMA layer has disintegrated.
- 2. Pavement cores that become detached at layer interfaces.
- 3. Areas of pavement that remain in place after milling operations but are unattached or loosely attached to the layer below.

Figure 1: Three types of evidence for de-bonding: shallow potholes (left), detached cores (middle) and loosely attached pavement after milling (right).

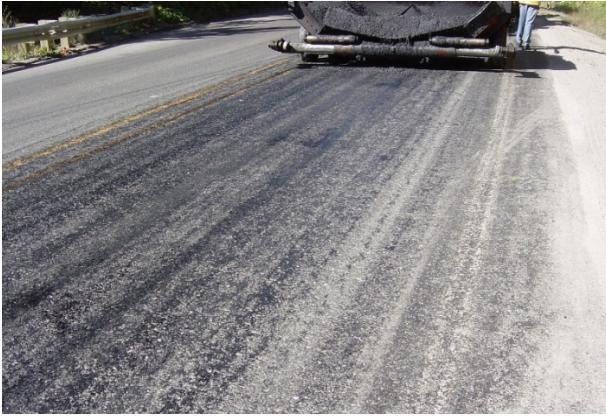
Spotty coverage SR 12

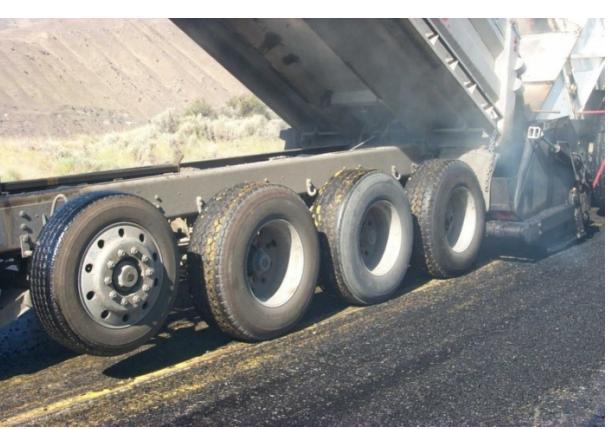
Tack pick-up on SR 2/97

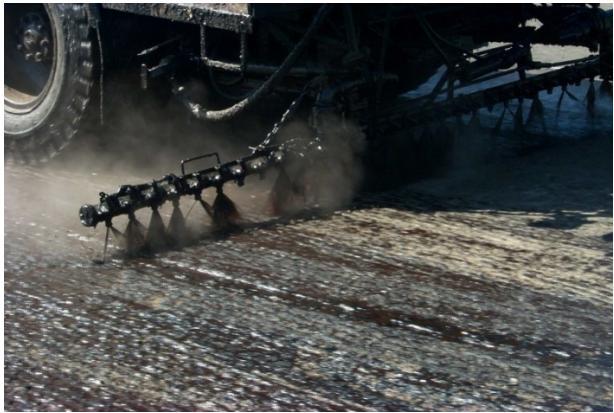
Clogged nozzles on SR 500

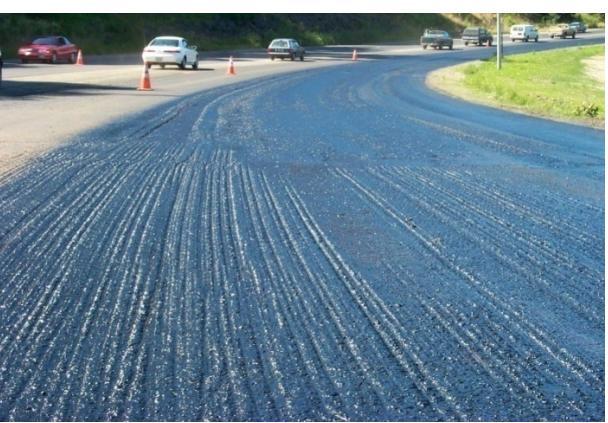
Good coverage on SR 101

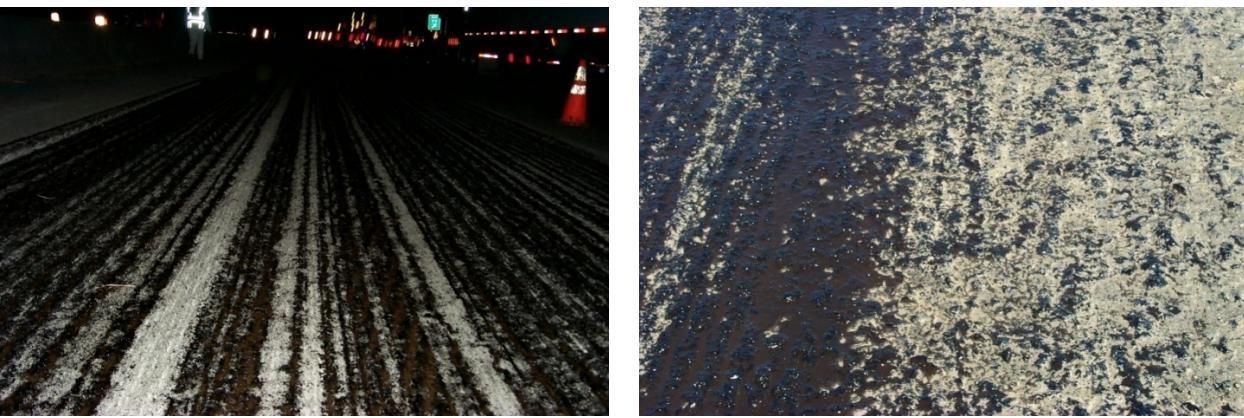
Streaky coverage on SR 5 Spotty coverage on SR 500 FIGURE 6: Photos of tack coat application.

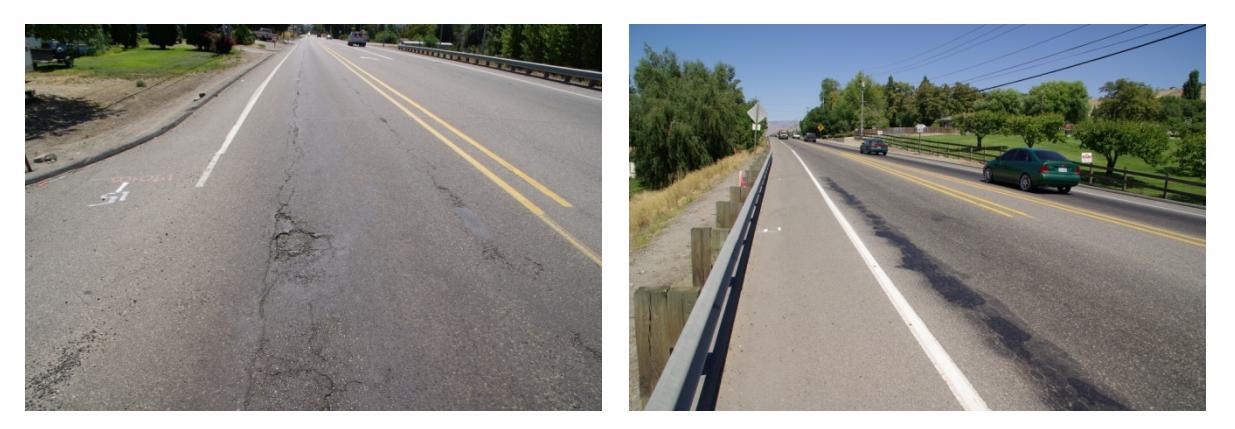
FIGURE 10 Typical views of SR 28 before the project showing substantial wheelpath cracking and flushing.

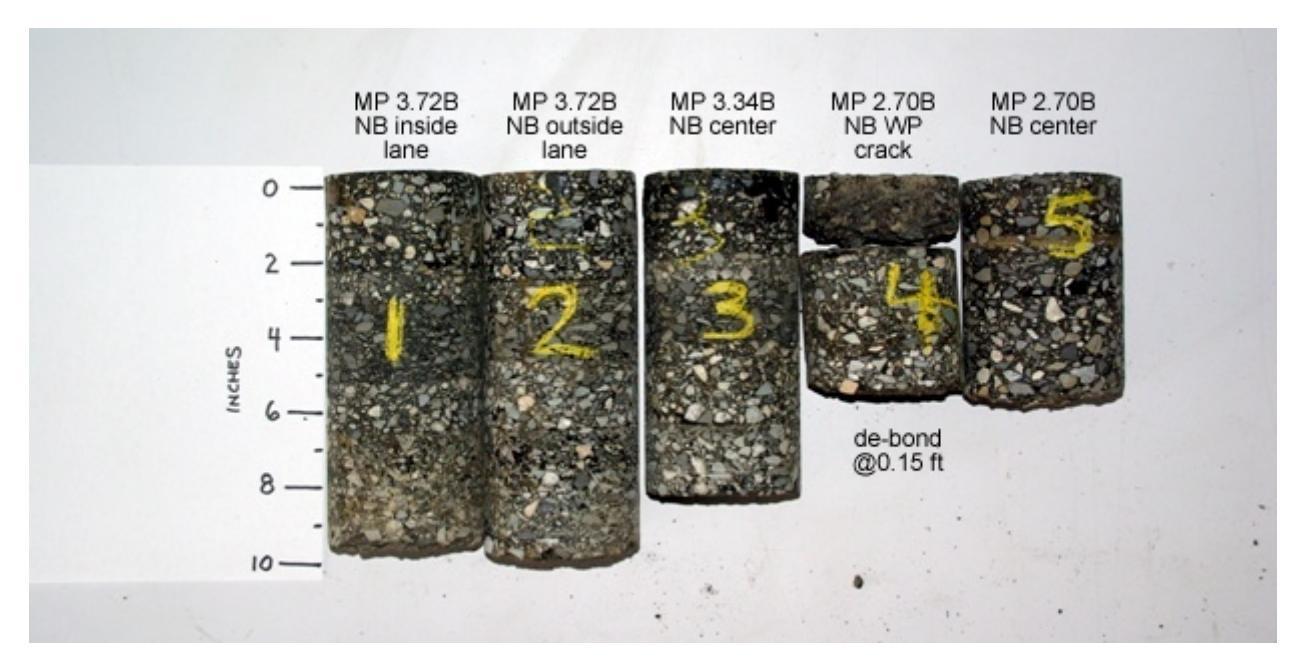
FIGURE 12: Cores from SR 28 from MP 2.70B to 3.72B. WP=wheelpath, NB=northbound, SB=southbound

These cores tend to show that de-bonding was occurring in areas of distress (i.e., the cracked wheelpath areas). This might suggest that bonding was adequate during construction and infiltration of water through the cracks or perhaps areas of low density caused the observed de-bonding. If de-bonding where the initiator, then it would be logical to assume that at least one area of de-bonding of the top lift would have been observed in the non-cracked cores. None were.

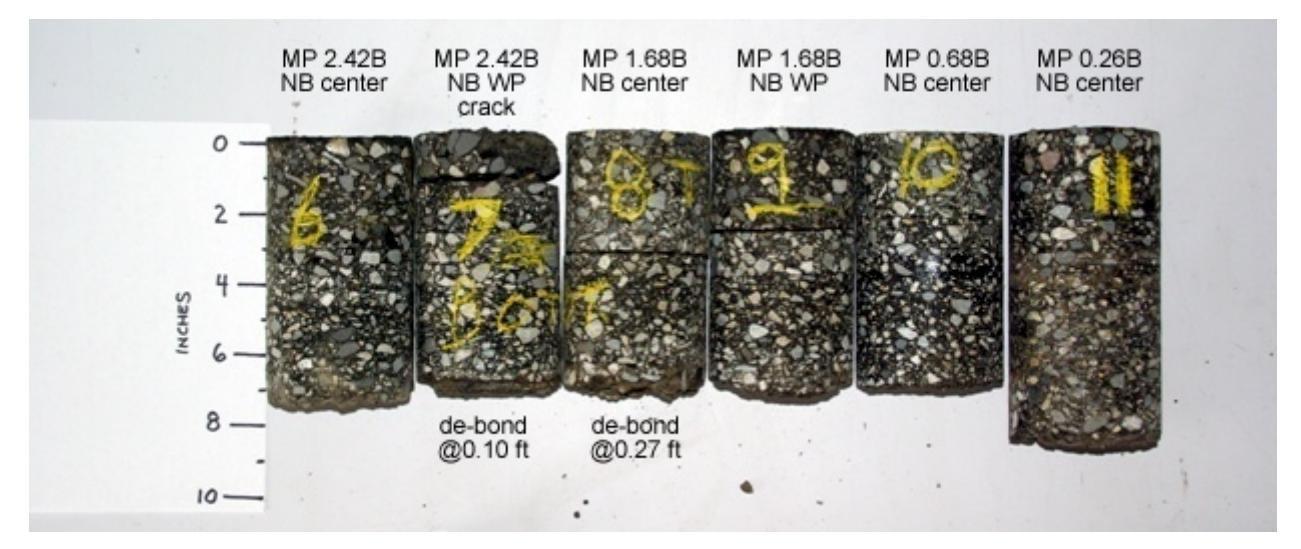
FIGURE 13: Cores from SR 28 from MP 0.26B to 2.42B. WP=wheelpath, NB=northbound, SB=southbound

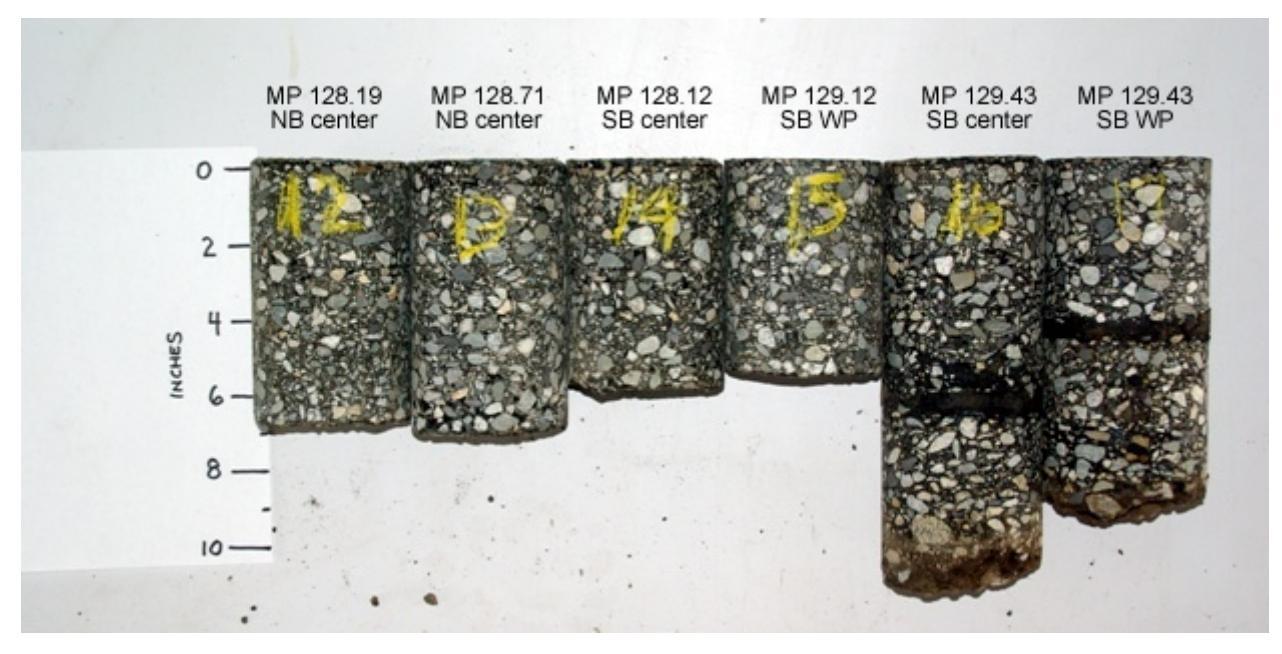
FIGURE 14: Cores from SR 2/97. WP=wheelpath, NB=northbound, SB=southbound

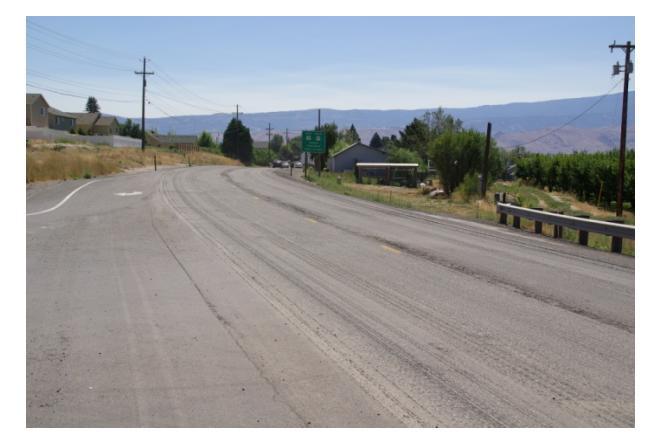
SR 2/97 Milling. Milled surfaces observed on 5 August 2008 on SR 2/97 showed generally good removal of this layer with some localized areas of de-bonding at what appeared to be the old longitudinal joint (Figures 15 and 16). This might suggest that perhaps infiltration of water through a porous longitudinal joint (there were no joint compaction specifications in 1994) caused the observed de-bonding. The longitudinal joint was likely intermittently cracked, however a positive determination could not be made because the project area on SR 2/97 had been covered with a bituminous surface treatment (BST) the year before. Observation of pavement condition photographs from 2007 for SR 2/97 just north of the project area showed intermittent cracking at the longitudinal joint.

FIGURE 15: Milled surface of SR 2/97.

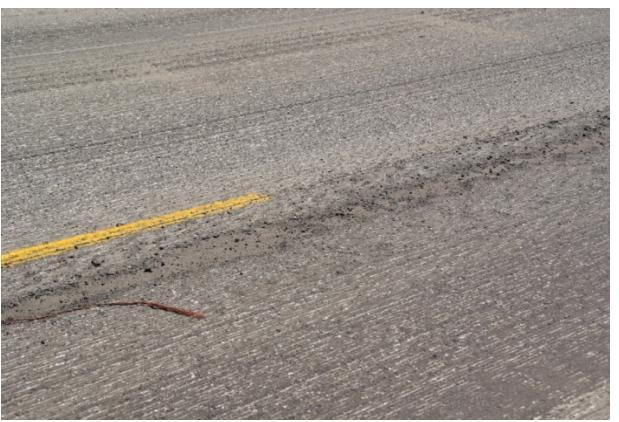
FIGURE 16: Milled longitudinal joint area.

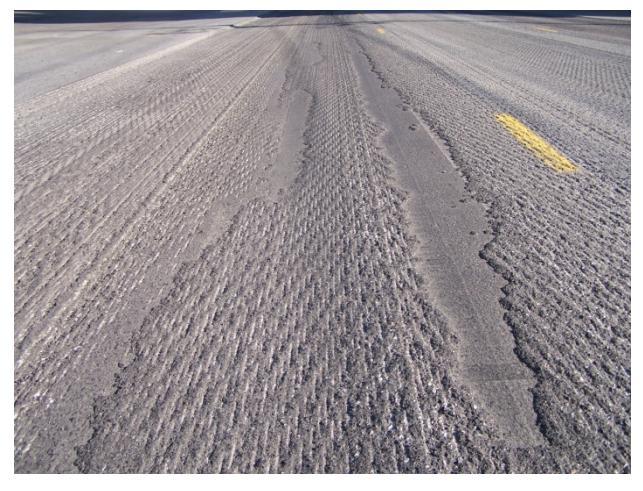
SR 28 Milling. Milled surfaces observed on 6 August 2008 on SR 28 showed generally uneven removal of the last overlay and revealed areas where a fabric that was placed with the previous overlay to slow reflective cracking had lifted up and de-bonded from the lower layers (Figures 17 and 18).

FIGURE 17: Milled surface of SR 28.

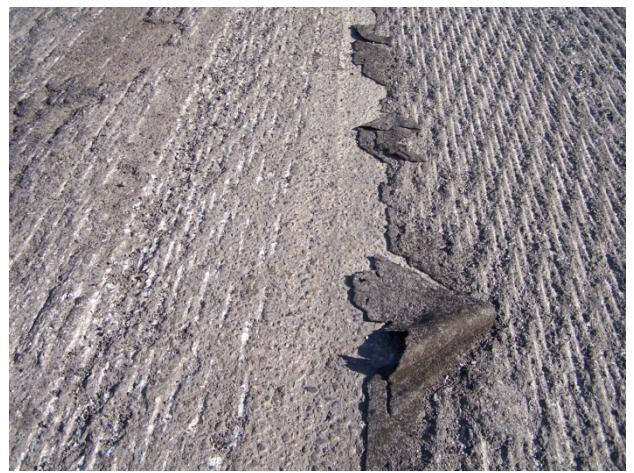
FIGURE 18: Milled surface of SR 28 showing fabric.

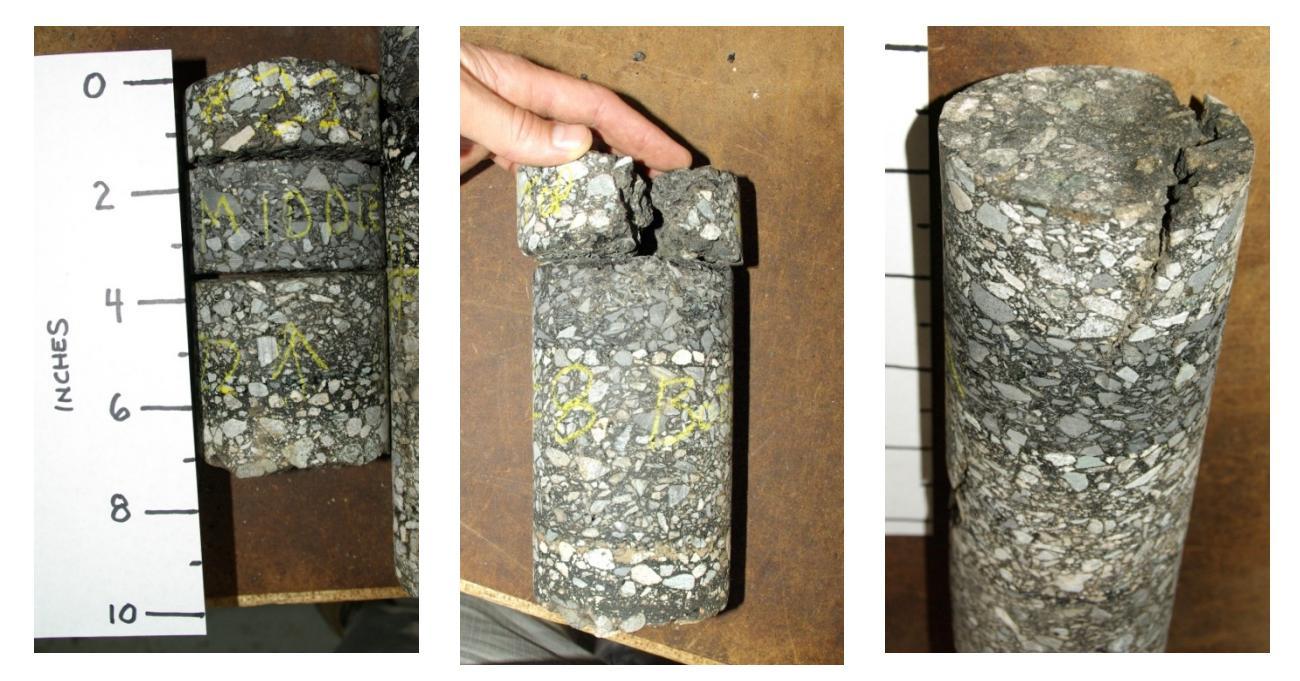
Also, some SR 2 cores exhibited classic signs of top-down cracking (Figure 22). Still other cores, reportedly taken near de-bonded cores exhibited no de-bonding or distress.

FIGURE 20: Poor tack.

FIGURE 21: Cracked surface.

FIGURE 22: Top-down crack.

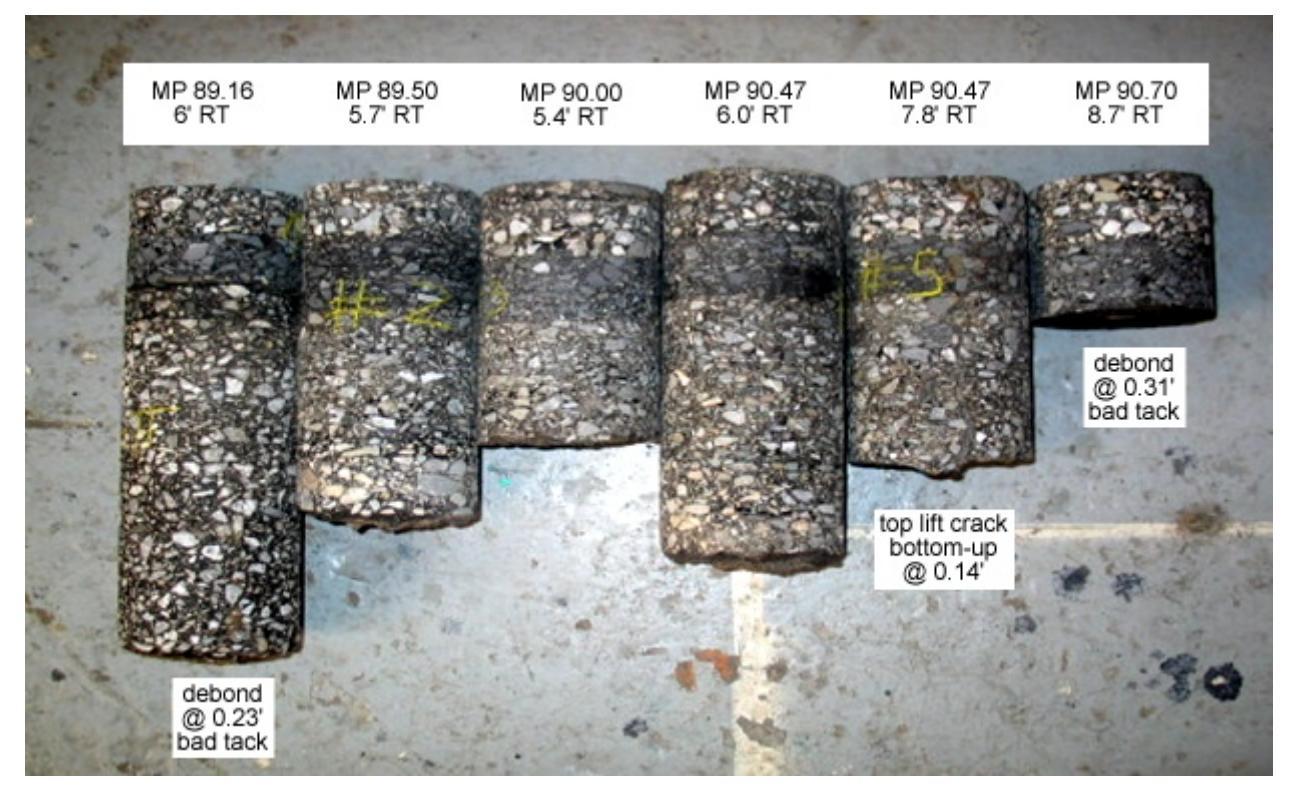
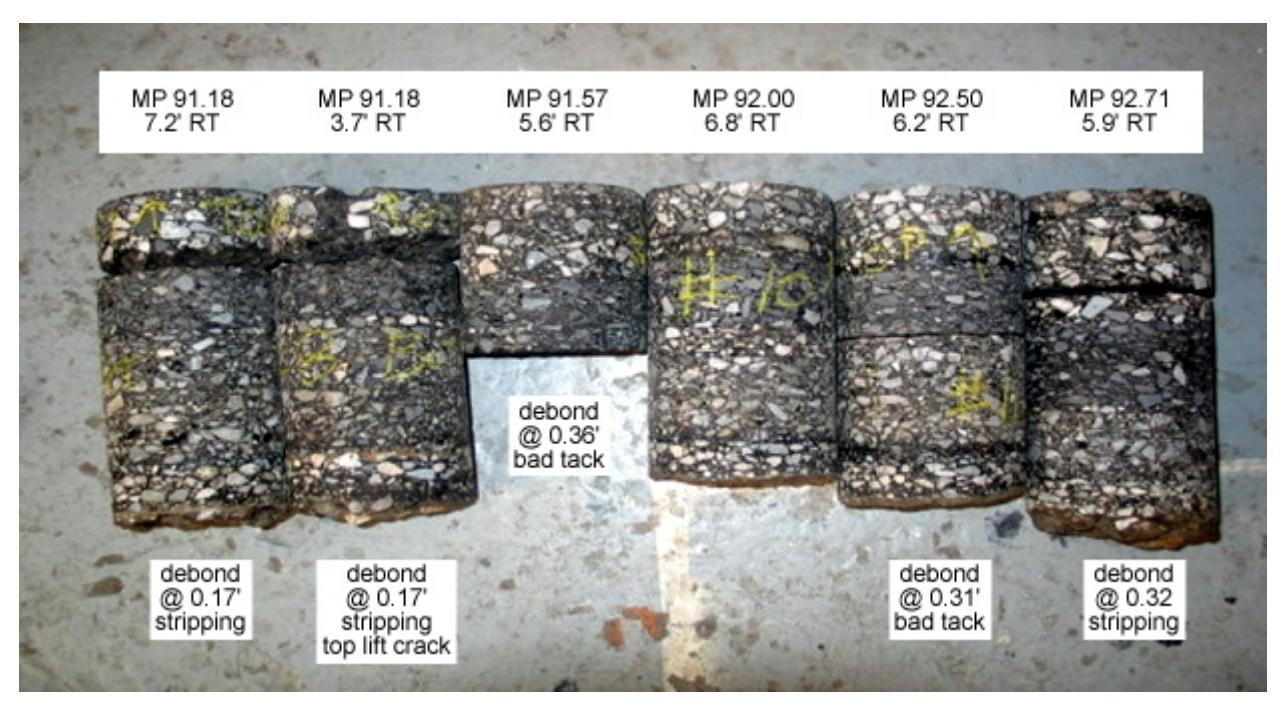
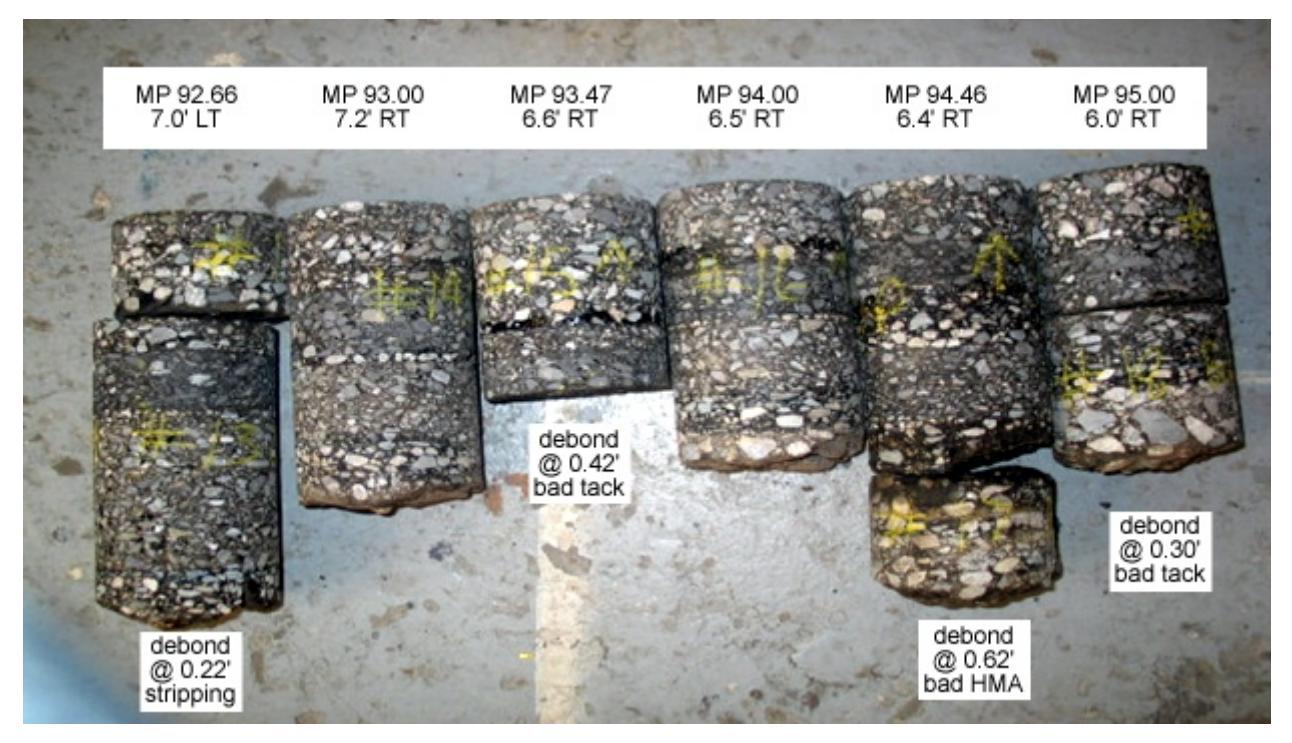
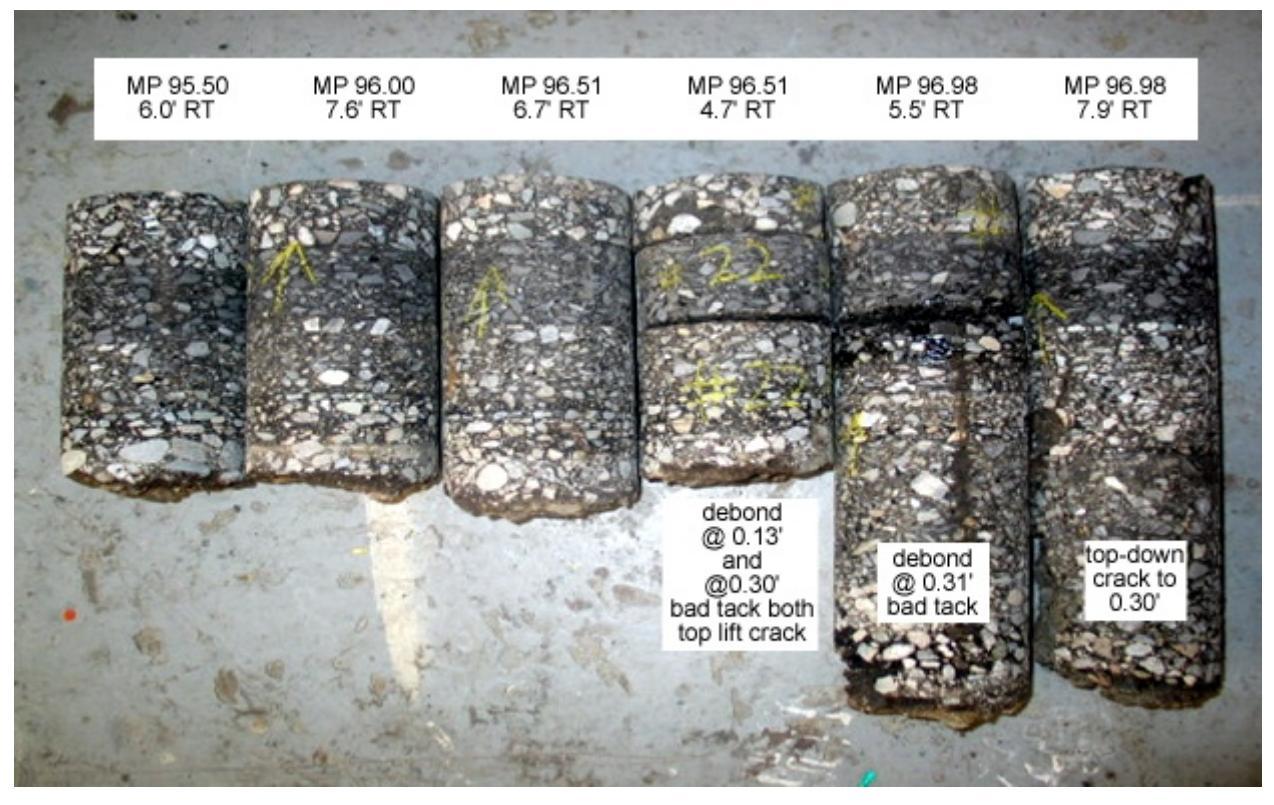
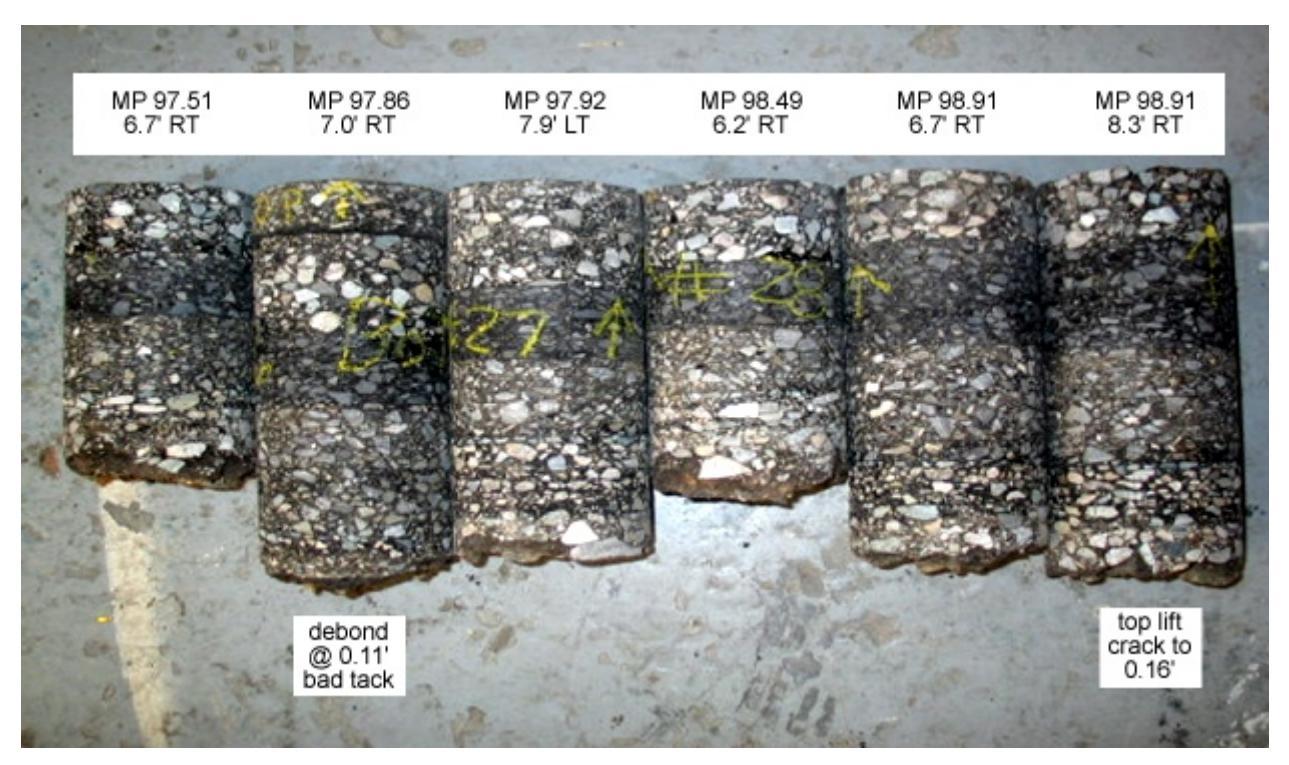
De-bonding below about 0.55 ft is likely separation of upper HMA lifts from lower BST layers and probably does not indicate HMA de-bonding as described in this study. These cores tend to suggest that de-bonding may be widespread with 14 cores de-bonded. Many are not associated with surface cracks suggesting that poor tack coat adhesion rather than water infiltration may be the primary cause. Of note, cracks in the wheelpath cores seem to extend only to the HMA layer interface and are often associated with a companion outside-the-wheelpath core (see MP 91.18, 96.98, 98.91) that is also de-bonded.

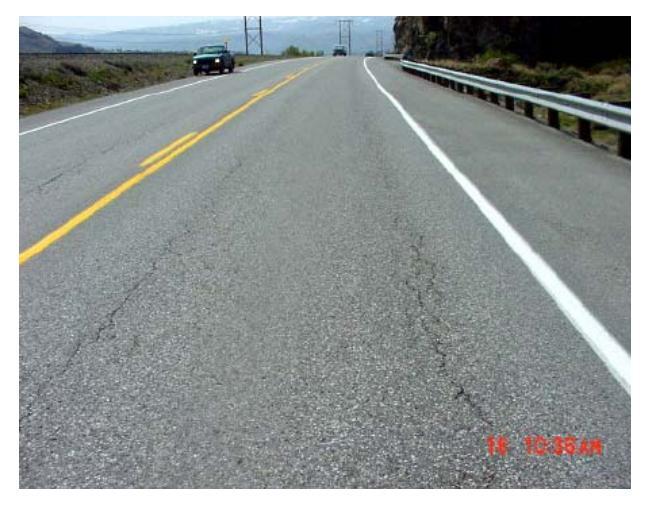
FIGURE 30: Looking south from MP 202.50 showing FIGURE 31: Looking south from MP 207.37 showing wheelpath longitudinal cracking.

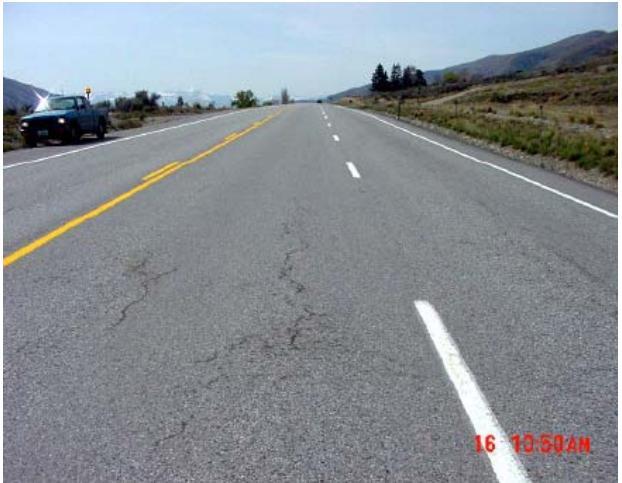
wheelpath cracking.

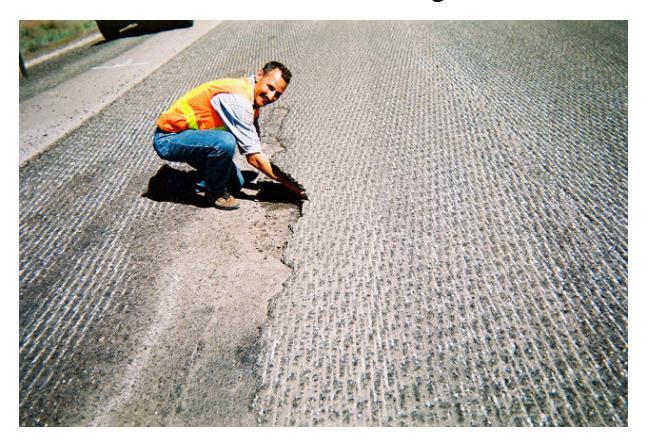
- **Construction-related temperature differentials**. Small de-bonded sections occurred in pairs in both wheelpaths (Figures 33 and 34) similar to how construction-related temperature differentials occur. Because these temperature differentials can result in low-density HMA we speculate that they may have let water infiltrate the surface HMA layer, which contributed to de-bonding.
- Gear box and auger drag streaks. Streaks of low density HMA can form behind a paver gear box or auger drags (Figure 34) because the auger cannot place enough HMA or places segregated HMA behind these auger attachment points (Figure 35). We speculate that this low density material may have let water infiltrate in surface HMA layer, which contributed to de-bonding.

FIGURE 33: Milled surface of SR 97A showing de-bonded area.

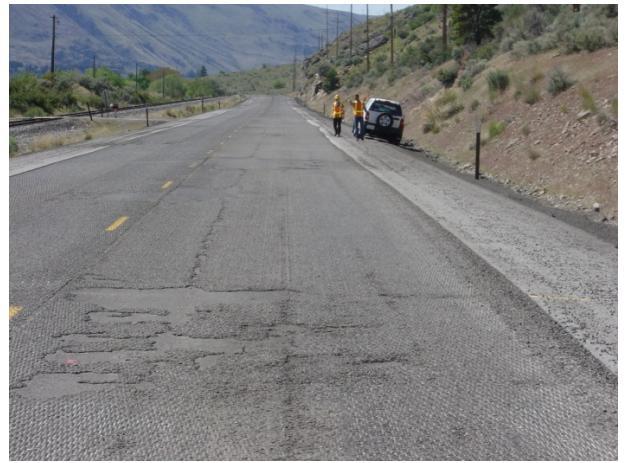
FIGURE 34: Milled surface of SR 97A showing debonded area probably from construction-related temperature differentials and gear box streaking.

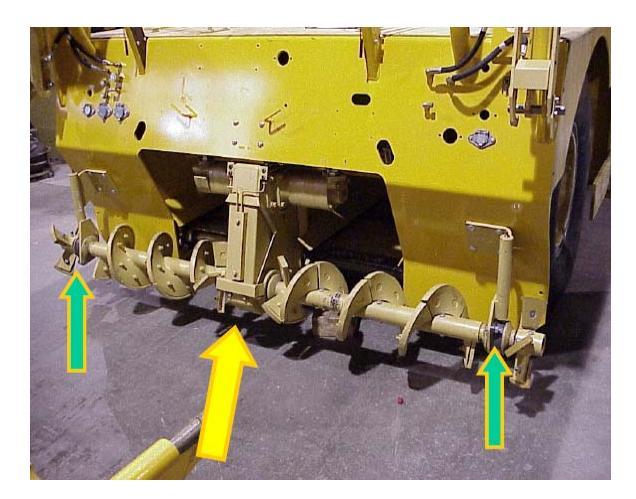
FIGURE 35: The three parallel streaks in Figure 30 were likely caused by the low density HMA areas behind a paver's gear box (yellow arrow) and auger drags (green arrows). This low density is caused because the paver's auger cannot place enough HMA or places HMA that is segregated behind these attachment points.
