Hydroacoustic Monitoring during Beach Pile Driving at Hood Canal Bridge on June 14th, 2004

Summary Field Report

Prepared by :
Battelle Marine Sciences Laboratory
Sequim, Washington

Prepared for the
Washington State Department of Transportation

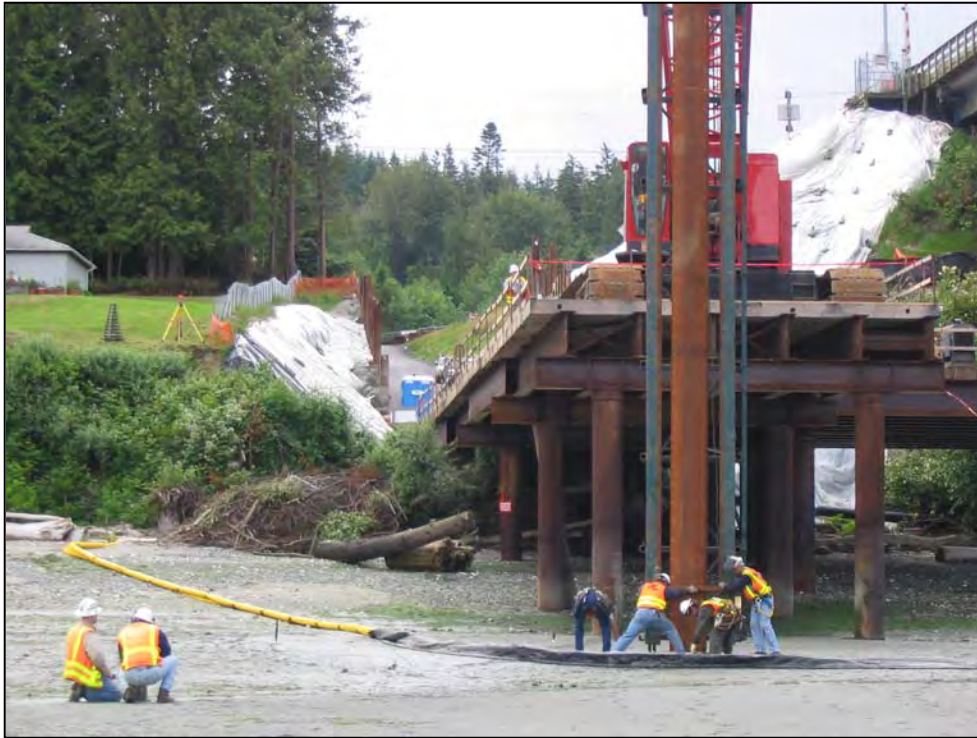
Figure 1. Pile driving preparation at Hood Canal Bridge East Approach, June 14, 2004.

Hydroacoustic monitoring of three “dry” test piles (Pile #'s 710, 721, and 781) occurred on June 14, 2004 at the Hood Canal Bridge on an incoming tide (Figure 1). Two hydrophones were deployed for this monitoring. The first hydrophone, referred to as the “vessel hydrophone”, was tethered off the side of the research vessel, *R/V Strait Science*, at the same stationary location for the duration of the day in approximately 16 feet of water. The vessel hydrophone was located at about mid-water column depth (8 feet). A second hydrophone, referred to as the “float hydrophone” was deployed using a float and anchor system (Figures 2 and 3) tethered to the vessel. The hydrophone float was located in four feet of water with the hydrophone location at mid-water column depth (2 feet). With each successive pile driving event, the float hydrophone was re-located shoreward to maintain the same depth in the water column as the tide came in. The GPS position of both hydrophones was monitored and recorded. Additional data were collected onshore including pile position, distance to the waterline (stand-off distance), and duration and time for each driven pile.. A biologist on board the vessel actively scanned for signs of fish immediately preceding and during each pile driving event. No observations of fish, either alive or dead, were noted during the day.

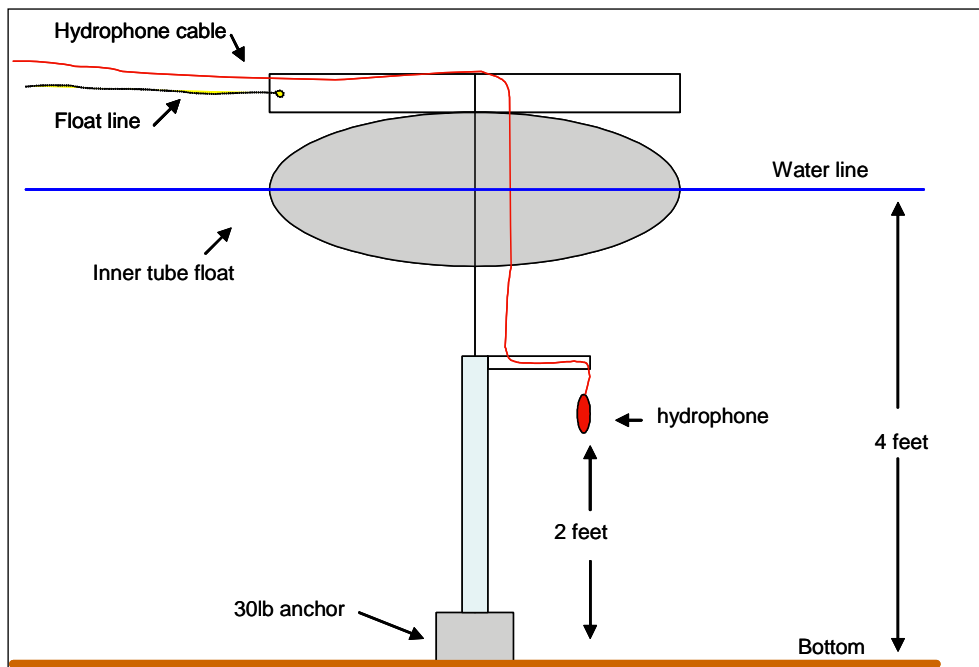
Figure 2. Schematic of floating hydrophone platform.

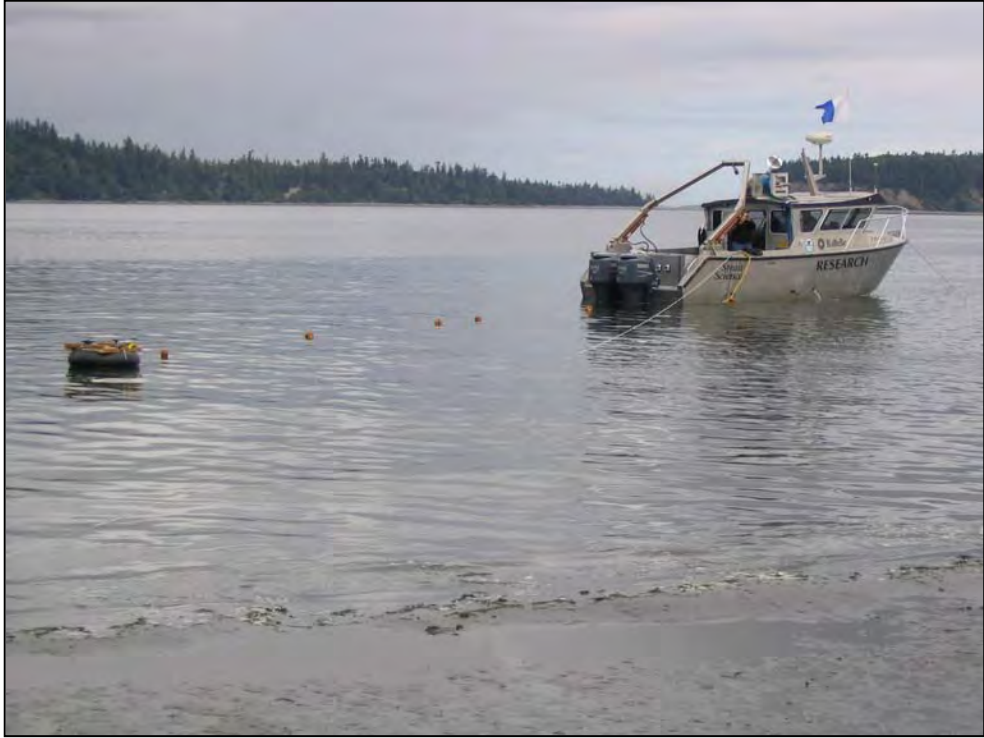
Figure 3. Float hydrophone platform tethered to R/V Strait Science at Hood Canal Bridge test monitoring site.

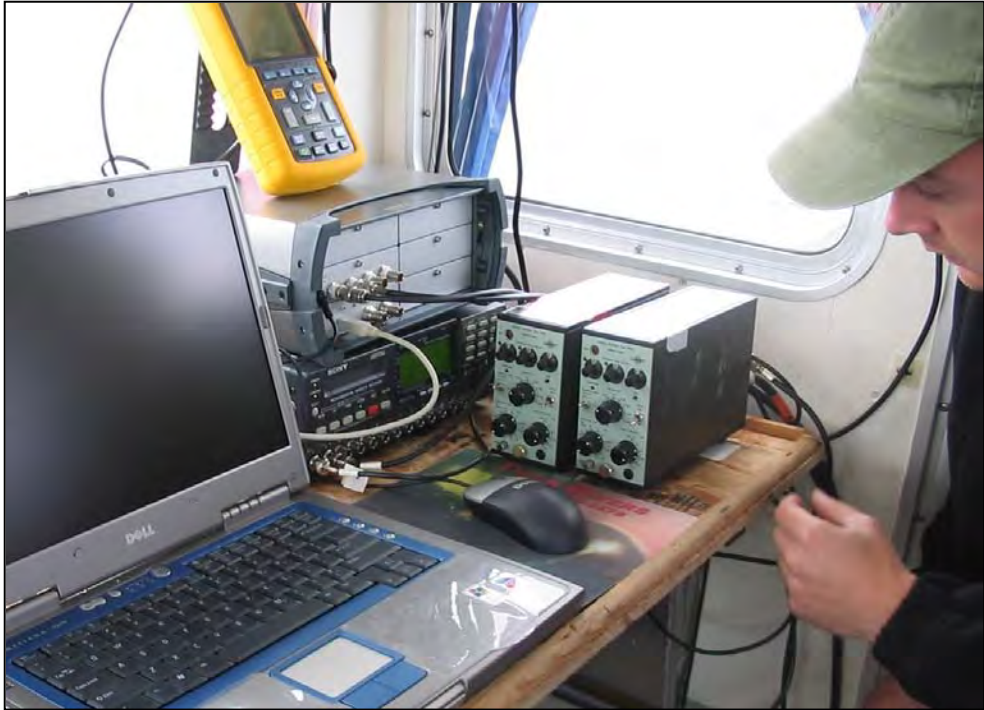
Figure 4. Equipment used to collect underwater sound pressure data (Hydrophones not shown).

The impact sound signals were recorded with a dynamic signal analyzer connected to a laptop computer and observed in real-time on the computer screen (Figure 4). The data were also stored on DAT tape using a Sony instrument quality DAT cassette recorder. The DAT tape provides a redundant backup to the data acquired with the signal analyzer. At the initiation of data acquisition a field calibration unit was used to verify that the through system performance of the signal analysis and DAT recording system was correct. Hydrophone calibration signals were acquired by both the signal analyzer and the DAT recording. These signals were later processed to provide scaling factors to convert electrical units to engineering units. Following calibration checks, for each of the three piles data acquisition was initiated with the onset of “dry firing” and terminated at cessation of pile driving activity.

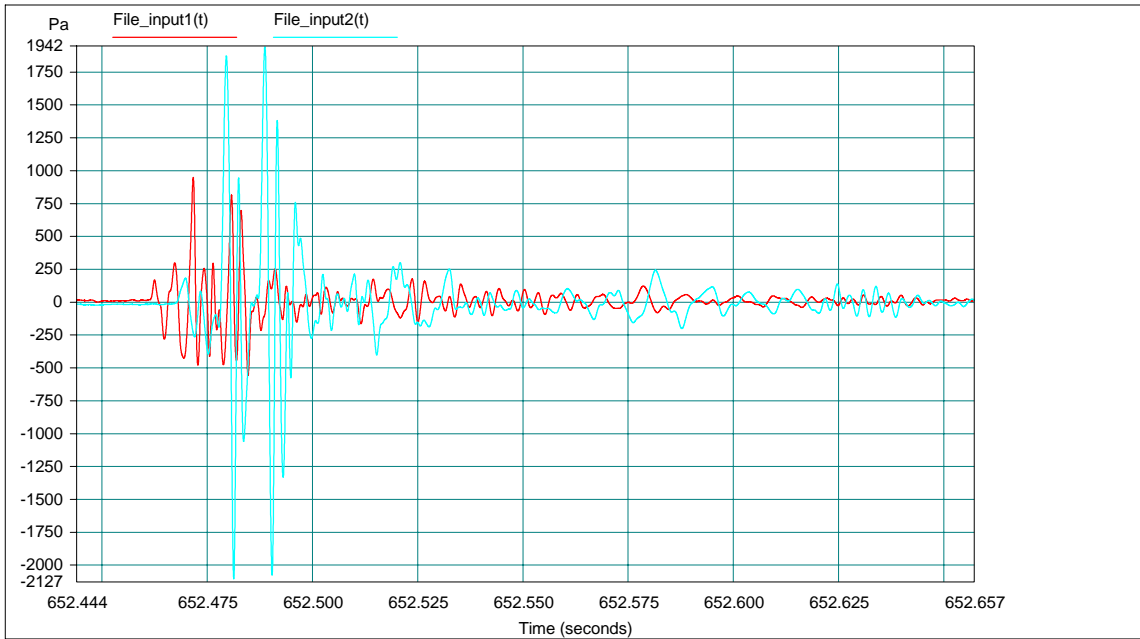
Figure 6. Sound pressure levels (Pascals) for a given impact (Pile 710). Red is float hydrophone and blue is vessel hydrophone.

The waveforms for the sound pressure signals from the pile impacts were similar for all three piles and sampling locations. Using Pile 710 as an example (Figure 6), the sound pressure wave from the impact reaches the float hydrophone first, as expected. The sound pressure is centered around the total pressure present at the hydrophone location. The duration of the segment of the sound impulse containing the most energy in the signal generated by an impact event is 0.025 sec (25 msec). This segment was followed by a longer segment of signal much lower in amplitude lasting about 0.15 sec (150 msec). The impact frequency was about 7 impacts per 10 sec (one impact every 1.4 sec, Figure 7). Background noise levels at the time of the observations, as indicated by signal levels immediately before a pile driving impact event, appeared to be low, less than 50 Pa (<154 dB_{peak}/μPa), however additional analysis of the acquired data would be required to better describe the background noise conditions at the time of the test.

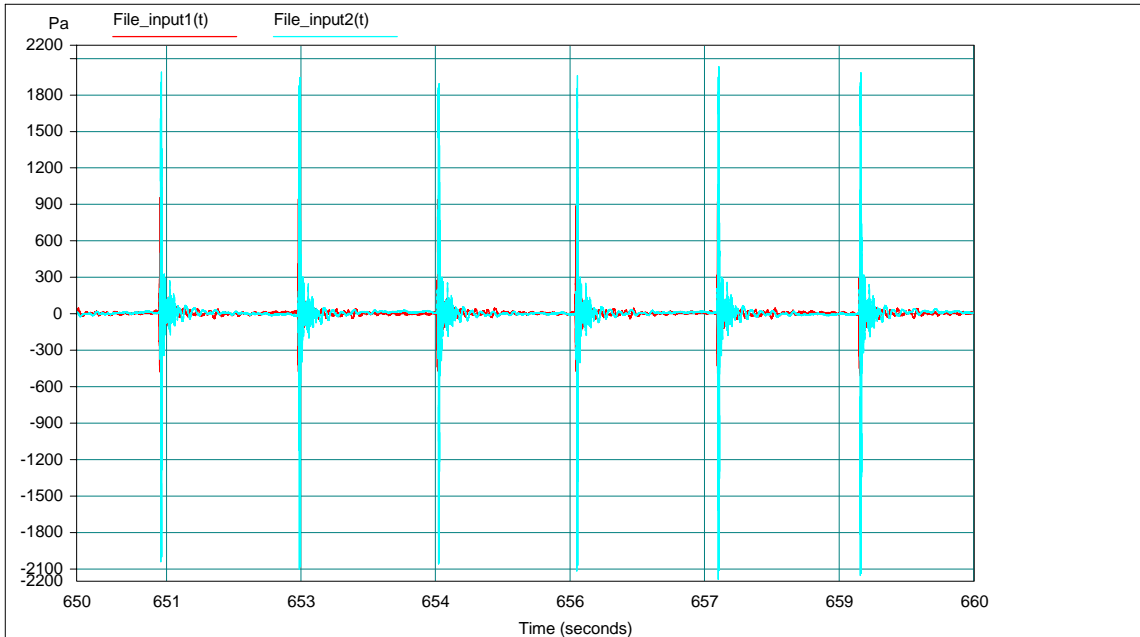
Figure 7. Series of impacts (Pile 710). Red is float hydrophone and blue is vessel hydrophone.

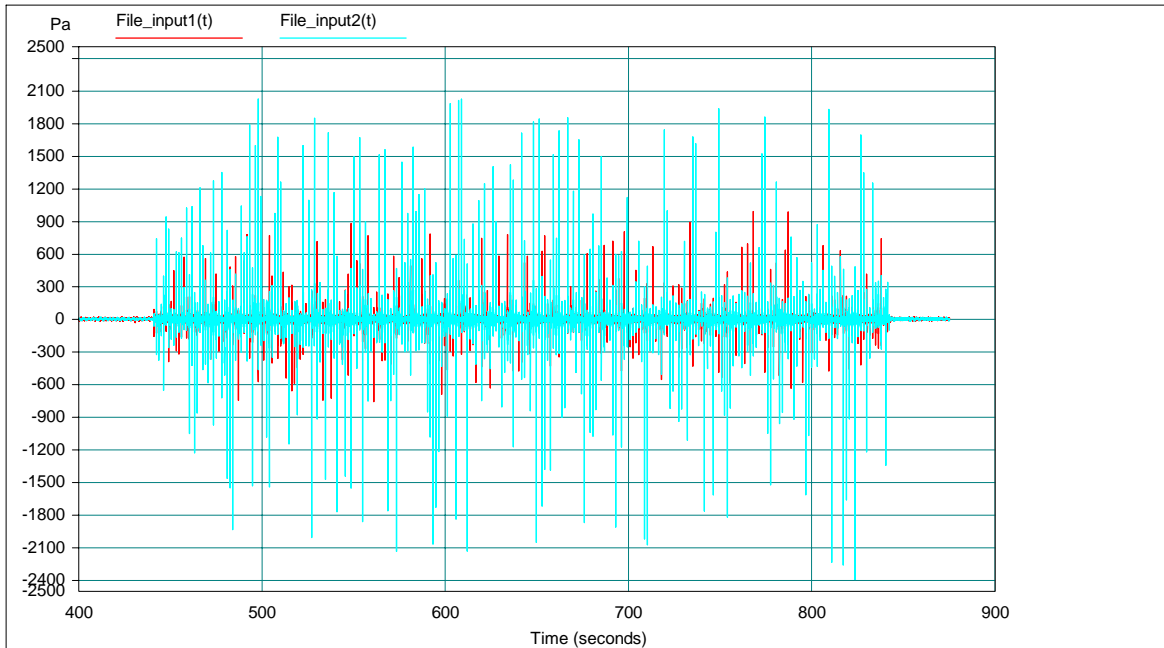
Figure 8. Pressures (Pascals) for the total event for Pile 710. Red is float hydrophone and blue is vessel hydrophone.

The peak amplitudes of the impact pulses were quite variable over the driving durations (Figure 8). Peak values varied over a range of approximately 6 dB or a factor of 2 in pressure amplitude. Generally, the peak amplitudes of direct path impact signals from a pile driven in water to a monitoring hydrophone located at a range of 10m or so is less variable. Summary statistics for peak and RMS values for samples of individual impact

Figures 8, 10, and 11 show all of the sound pressure data (in Pascals) acquired during driving of each test pile. These visual data were observed by WSDOT and resource agency staff in the field on June 14.

- Pile 710 – Peak sound pressures were lower at the float than the vessel. Peak sound pressures at the float did not exceed the 180 dB_{peak} (1 kPa_{peak}) criterion whereas those at the vessel did. Exceedance of the criterion at the boat hydrophone was approximately 25%, 75%, and 50% for the subsamples of impacts taken at the beginning, middle, and end of driving (Table 2).
- Pile 721 – Peak sound pressures for both hydrophones showed a high rate of exceedance of the 180 dB_{peak} criterion. Exceedance of criterion at the float hydrophone was approximately 0%, 75% and 50% for the subsampled impacts (Table 3). Exceedance of criterion at the boat hydrophone was higher at approximately 5%, 75% and 75% for the subsampled impact data.
- Pile 781 – All peak sound pressures were below the 180 dB criterion.

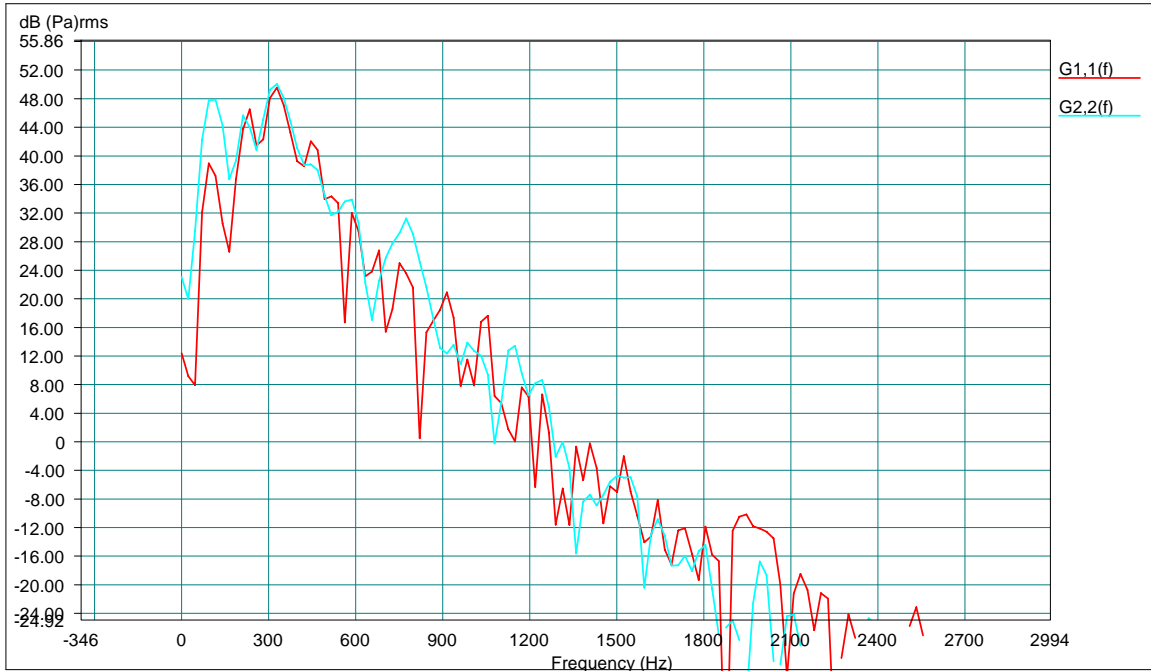
Figure 9. Frequency spectrum (Pile 721). Red is float hydrophone and blue is vessel hydrophone.
Signals by Total Event

The frequency spectrum (Figure 9) for a few impulses were examined. In general the spectra for the analyzed impact pulses were typical for the sound generated by impact pile driving on smaller diameter steel pile. Most of the sound energy was in the 100-300 Hz range. The energy had diminished greatly by 1200 Hz.

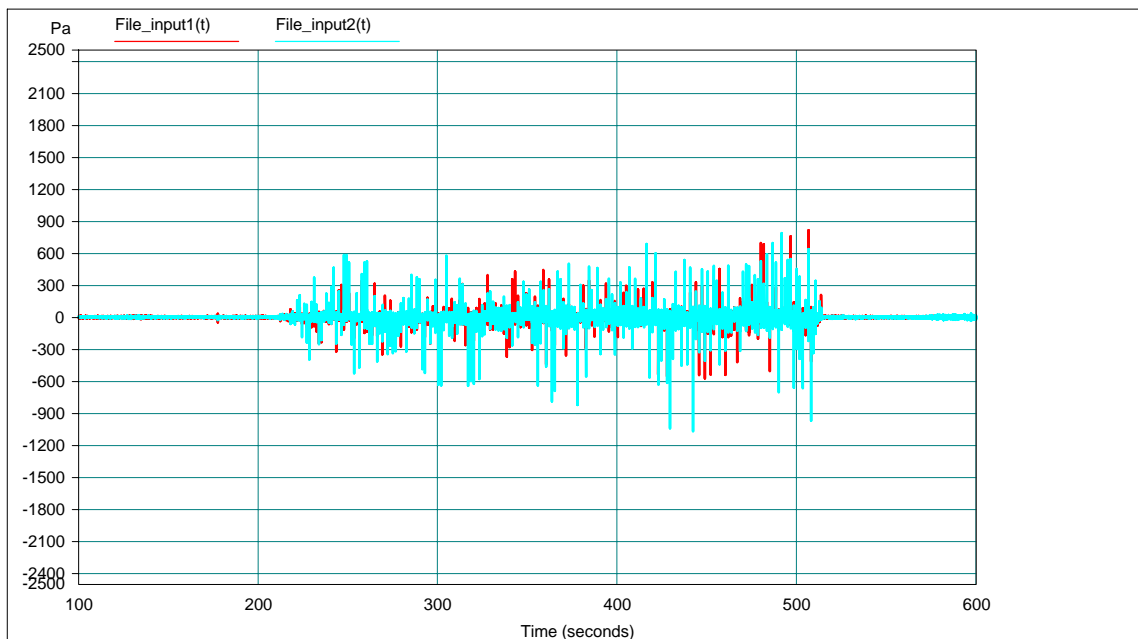
Figure 10. Pressures (Pascals) for the total event for Pile 721. Red is float hydrophone and blue is vessel hydrophone.

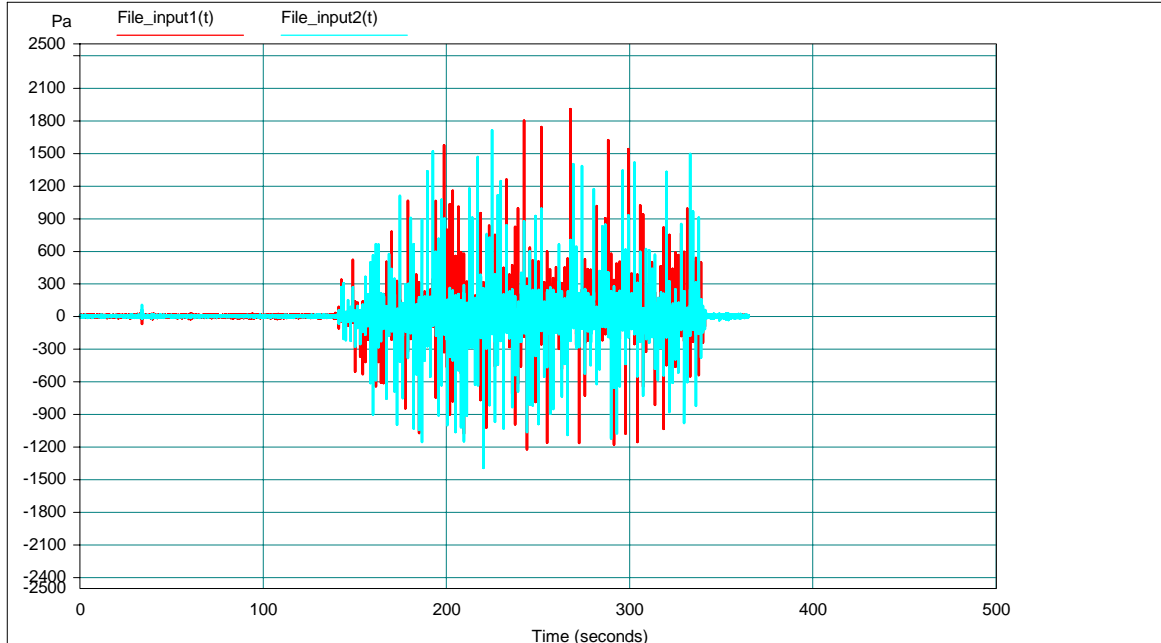
Figure 11. Pressures (Pascals) for the total event for Pile 781. Red is float hydrophone and blue is vessel hydrophone.
