*WASHINGTON STATE PARKS CAPE DISAPPOINTMENT WAVE
BARRIER PROJECT*

**UNDERWATER SOUND LEVELS
ASSOCIATED WITH PILE DRIVING AT
THE CAPE DISAPPOINTMENT BOAT
LAUNCH FACILITY, WAVE BARRIER
PROJECT**

*Prepared by:
Jim Laughlin
Washington State Department of
Transportation
Office of Air Quality and Noise
15700 Dayton Avenue North,
P.O. Box 330310
Seattle, WA 98133-9710*

March 2006

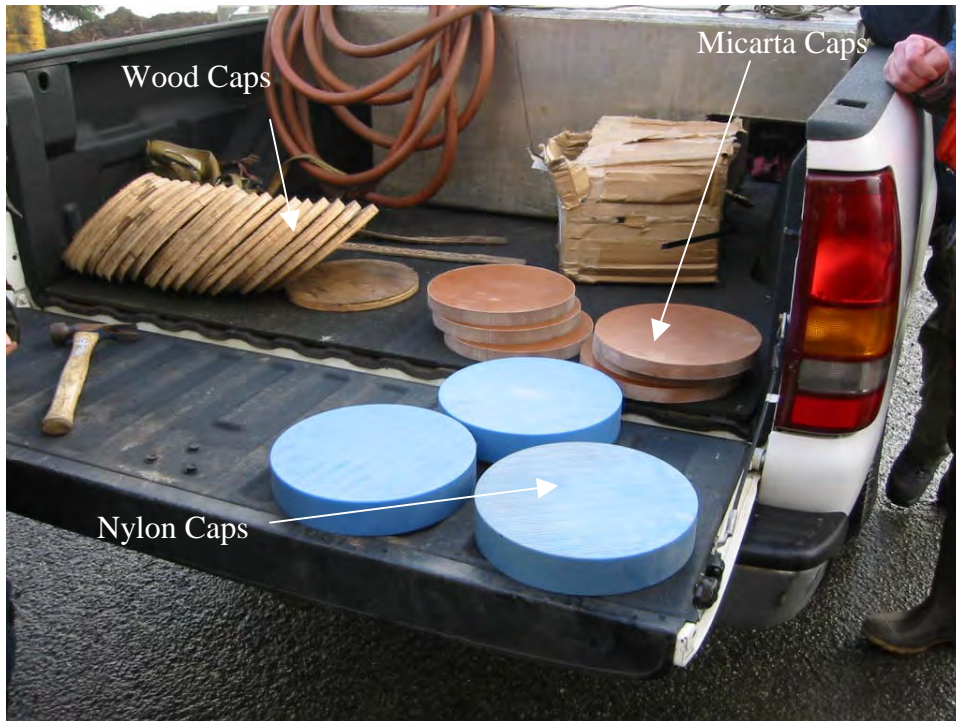
Figure 1: Pile cap types tested in this monitoring project (Conbest pile cap not shown).

The piles were driven to replace the existing wood wave barrier. The five piles were monitored while being driven with different pile cap materials at different water depths at the facility. The pile cap materials used were wood (plywood), Conbest, Micarta, and Nylon (Figure 1). The Conbest material is not shown in Figure 1 but is similar to Micarta in size and thickness but looks like a layered aluminum disk in composition. The bubble curtain was tested with on/off cycles during each pile driving event. Figure 2 shows the piles with ‘wings’ and Figure 3 shows the locations of monitored piles.

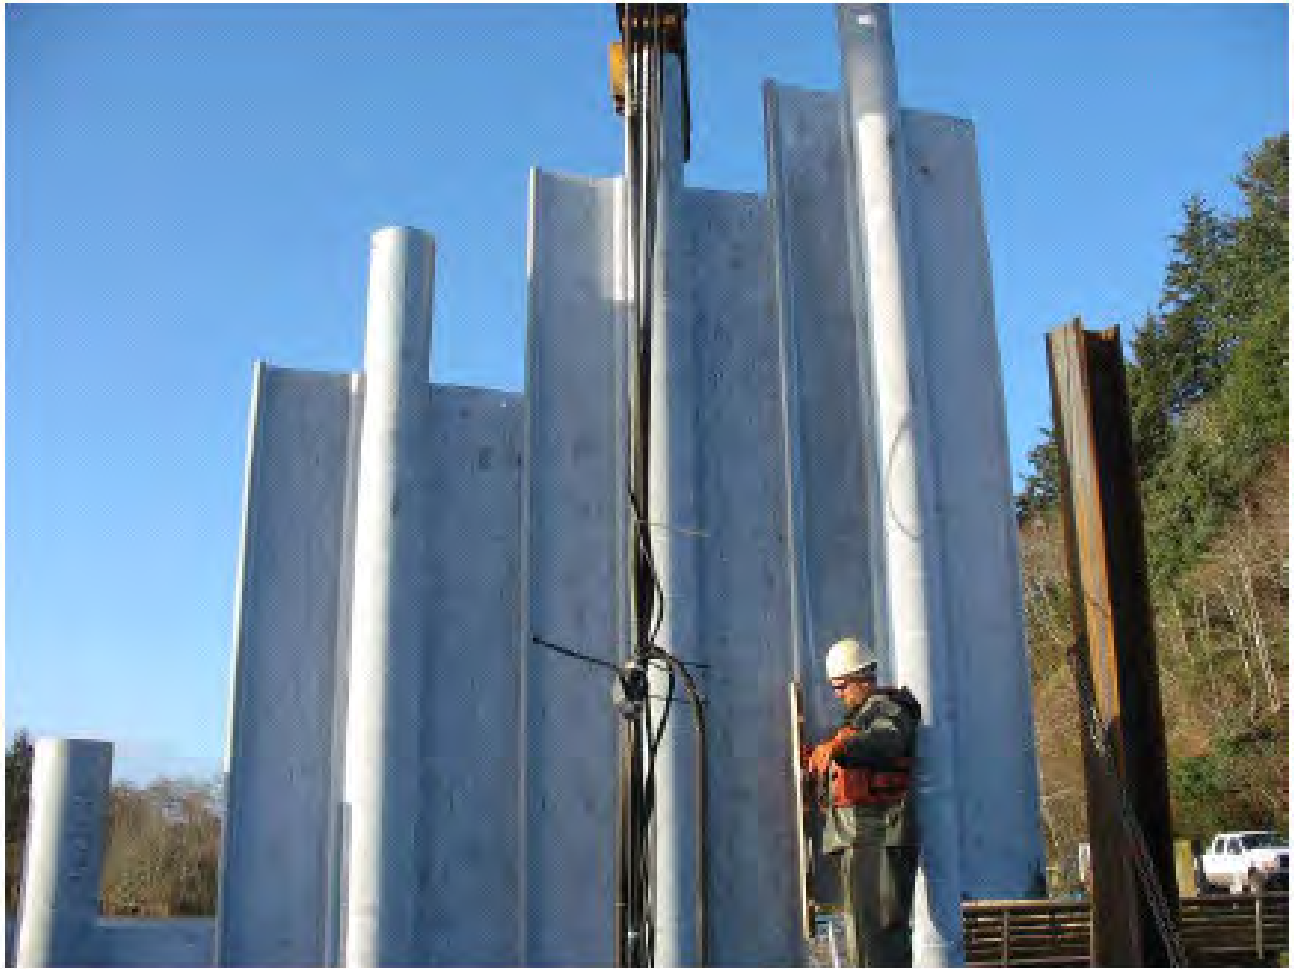
Figure 2: 12-inch diameter steel piles with interlocking ‘wings’ used to create the wave barrier (photo courtesy of Washington State Parks and Recreation, R. Johnson).

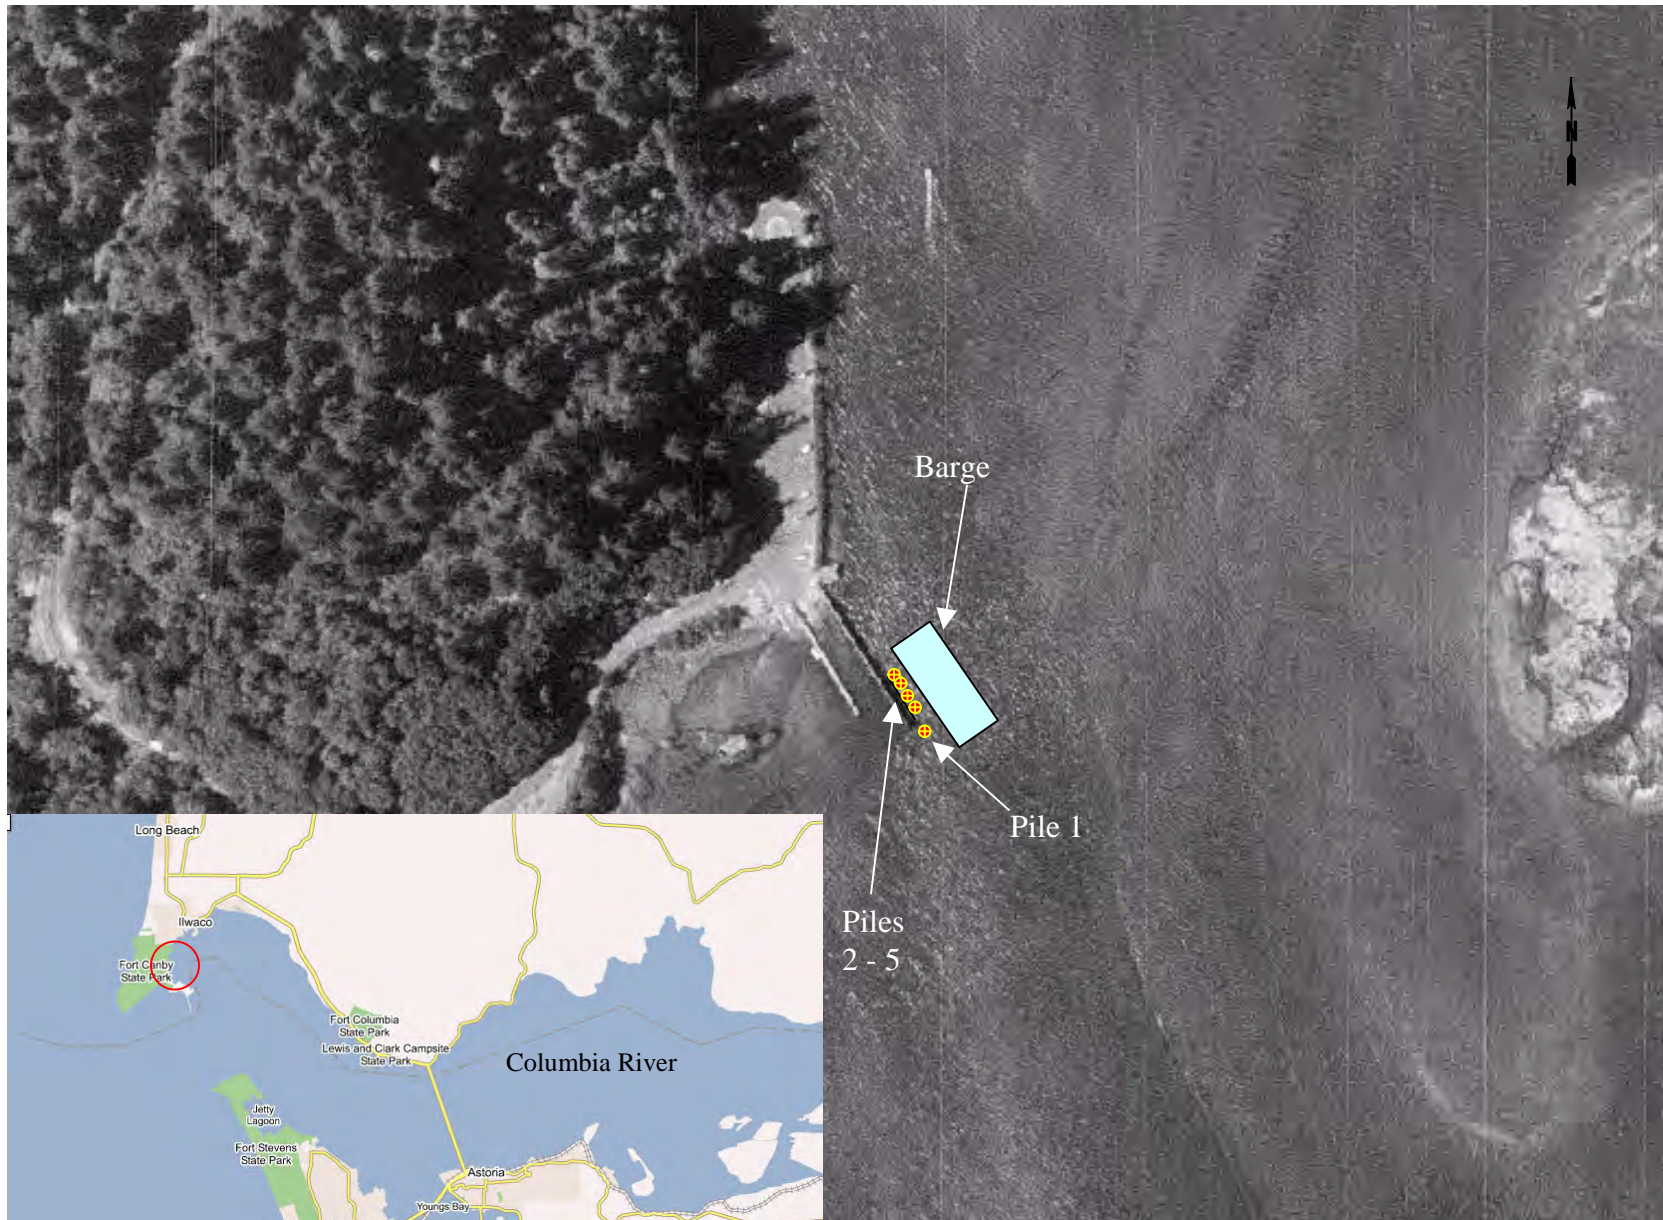
Figure 3: Location of underwater noise monitoring sites at the Cape Disappointment Wave Barrier project. Note: Piles are not to scale.

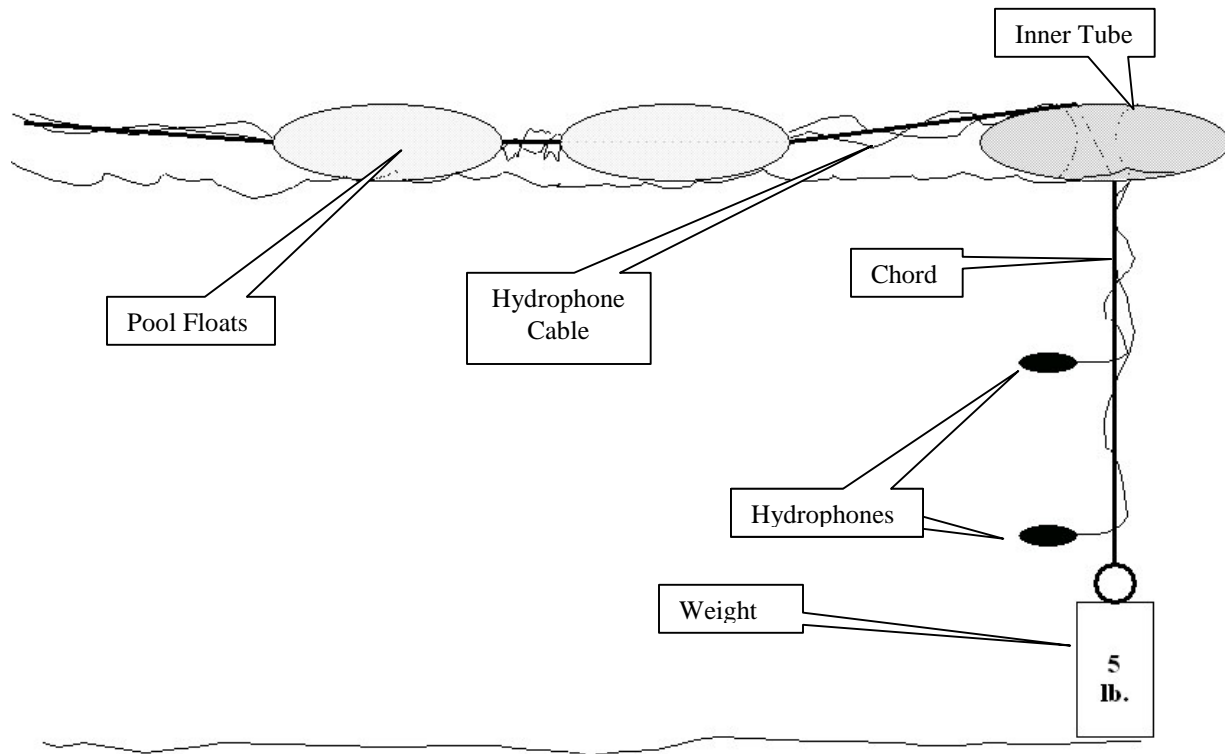
Figure 5: Diagram of hydrophone deployment.

The location of the hydrophones is determined by allowing a clear line of sight between the pile and the hydrophone, with no other structures nearby. The distance from the pile to the hydrophone location was measured using a Bushnell Yardage Pro rangefinder. The hydrophone was attached to a weighted nylon cord anchored with a five-pound weight. The cord and hydrophone cables were attached to surface floats that kept the hydrophones at the proper location in the water column (Figure 5). For pile 1, the hydrophones were in a location with no other obstructions near it. For piles 2 through 5, the hydrophones were located between the pile and the barge.

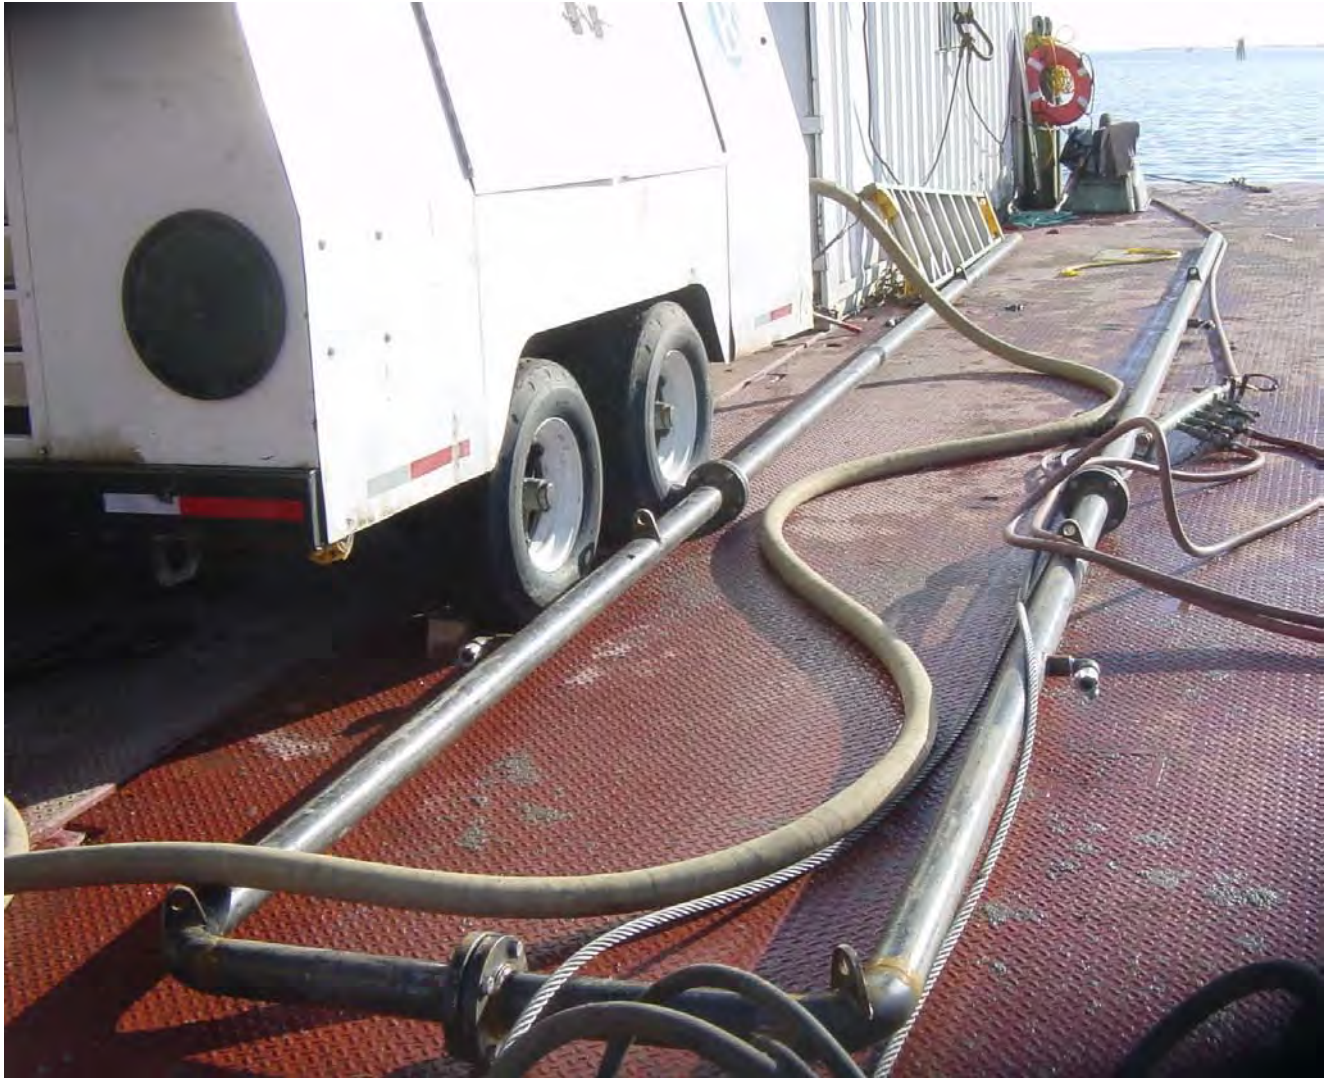
Figure 6: “U” shaped bubble curtain for use on wave barrier piles.

Two bubble curtain designs were used by the contractor at the Cape Disappointment Boat Launch facility. The first was a standard single ring placed at the bottom of pile 1 based on the design of Longmuir and Lively (2001). The second bubble curtain was a “U” shaped design that enabled the curtain to be fitted around the base of several piles that were interlocked together in a wall design (Figure 6).

It is important to note that during the use of the “U” shaped bubble curtain on piles 2 through 5 the tidal current swept some of the bubble curtain away from the pile being driven. This happened after high tide as water began to recede rapidly. However, as can be seen in the analysis that follows it had little or no impact on the effectiveness of the bubble curtain.

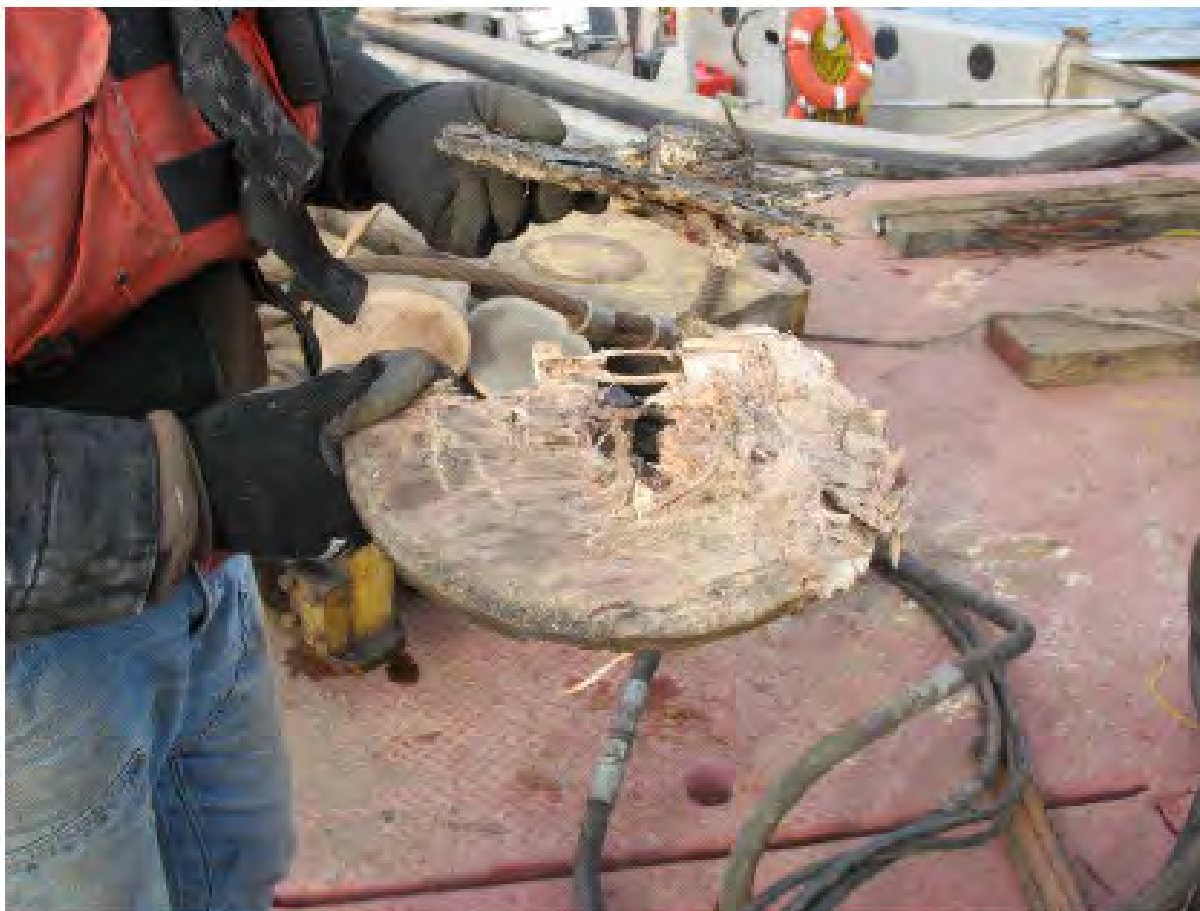
Figure 7: Fractured and compressed wood pile cap after being used on piles 5, 6, and 7 (photo courtesy of Washington State Parks and Recreation, R. Johnson)

The highest absolute peak from the midwater and bottom hydrophones is 181 dB_{peak} for wood. The highest midwater RMS was 170 dB_{RMS} and bottom RMS was 169 dB_{RMS}. The highest midwater and bottom SEL for the peak strike were both 157 dB_{SEL}. Rise times for the wood pile cap were quite long indicating a substantial reduction of the transfer of energy from the hammer. Figure 7 shows a wood pile cap that has been compressed and shattered after use on only three piles.

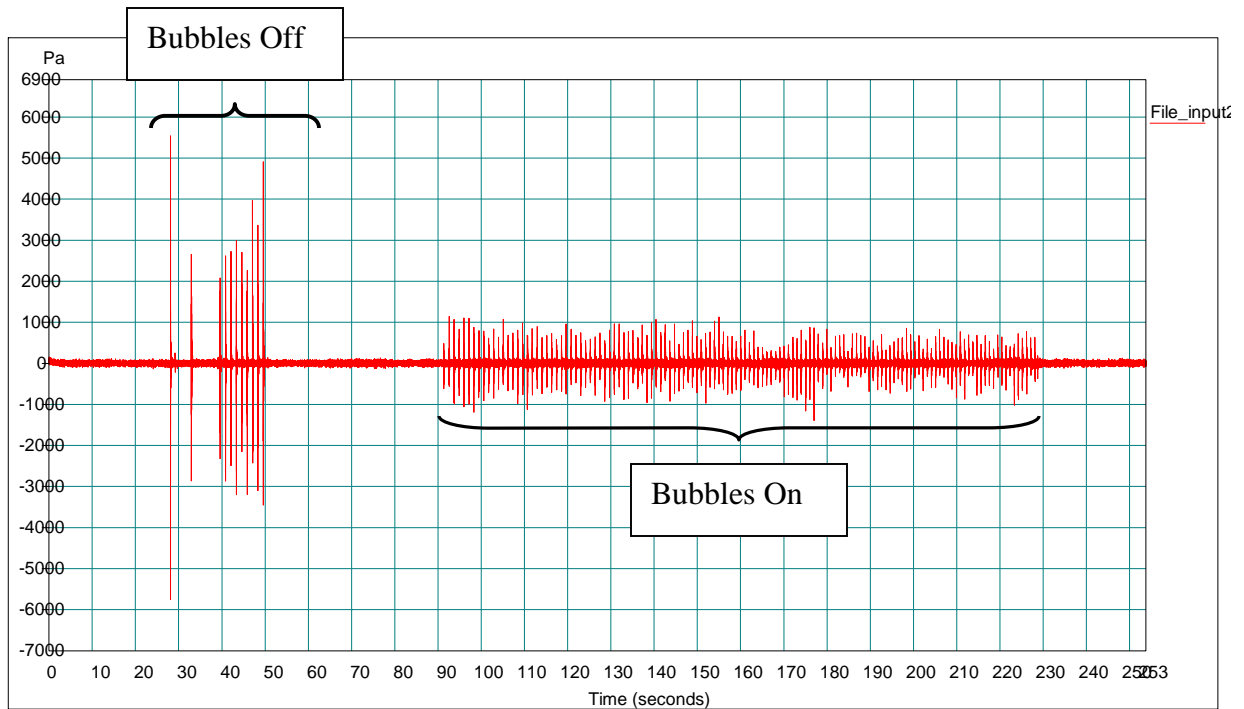
Figure 8: Waveform recording indicating the effects on amplitude with bubble curtain on versus bubble curtain off for pile 3.

The average peak sound reductions achieved with the bubble curtain ranged between 7 and 11 dB. This can be seen visually in Figure 8. This indicates that the bubble curtain was functioning slightly better than anticipated.

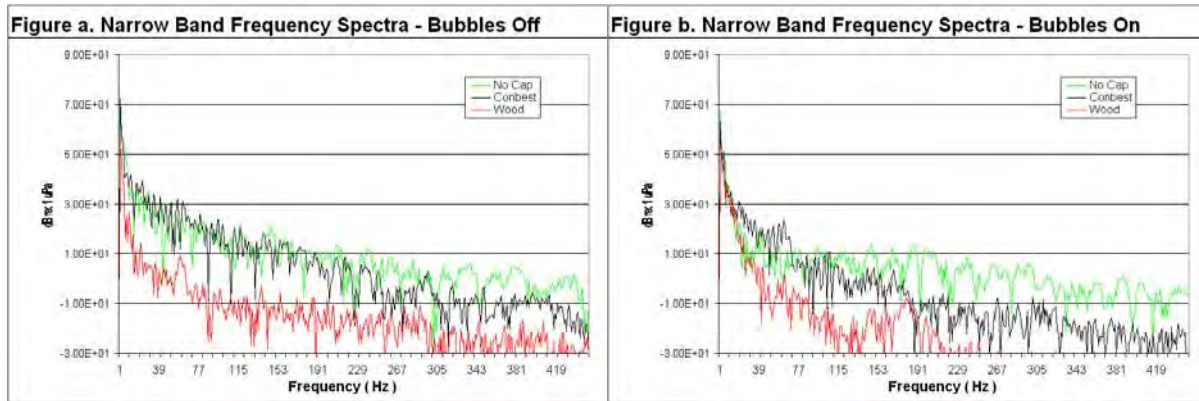
Figure 9: Spectral Frequency Analysis comparing Conbest and wood pile caps versus no caps with bubble curtain on and off.

A spectral frequency analysis was conducted on the peak pile strike (Figures 9 and 10). Figure 9 indicates that for the single pile the wood pile cap as having the greatest effect of lowering the sound levels of all frequencies even with the bubble curtain off. The Conbest pile cap was able to reduce only the higher frequencies above approximately 600 Hz with the bubble curtain off. With the bubble curtain on the frequencies for Conbest were lowered from

approximately 190 Hz and above. With no pile cap there was little change in frequency levels with or without the bubble curtain.

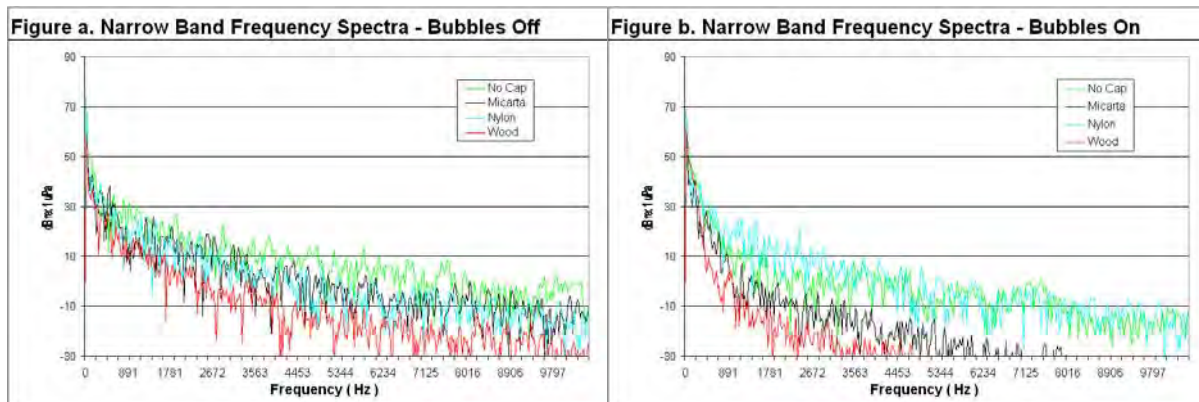
Figure 10: Spectral Frequency Analysis comparing Micarta, Nylon, and wood pile caps versus no caps with bubble curtain on and off.

Figure 10 indicates that for the piles with ‘wings’ when the bubble curtain is off the wood pile cap was able to reduce frequency levels at all frequencies. Nylon and Micarta were able to reduce frequencies above approximately 600 Hz, similarly to Conbest above. When the bubble curtain was turned on the performance of the wood and Micarta pile caps were enhanced whereas only a slight improvement was observed for Nylon. Micarta is able to reduce frequencies above approximately 450 Hz with the bubble curtain on. Nylon actually exhibited sound levels higher than with no cap at frequencies between approximately 900 and 3500 Hz and then no difference when compared to no cap with all other frequencies.

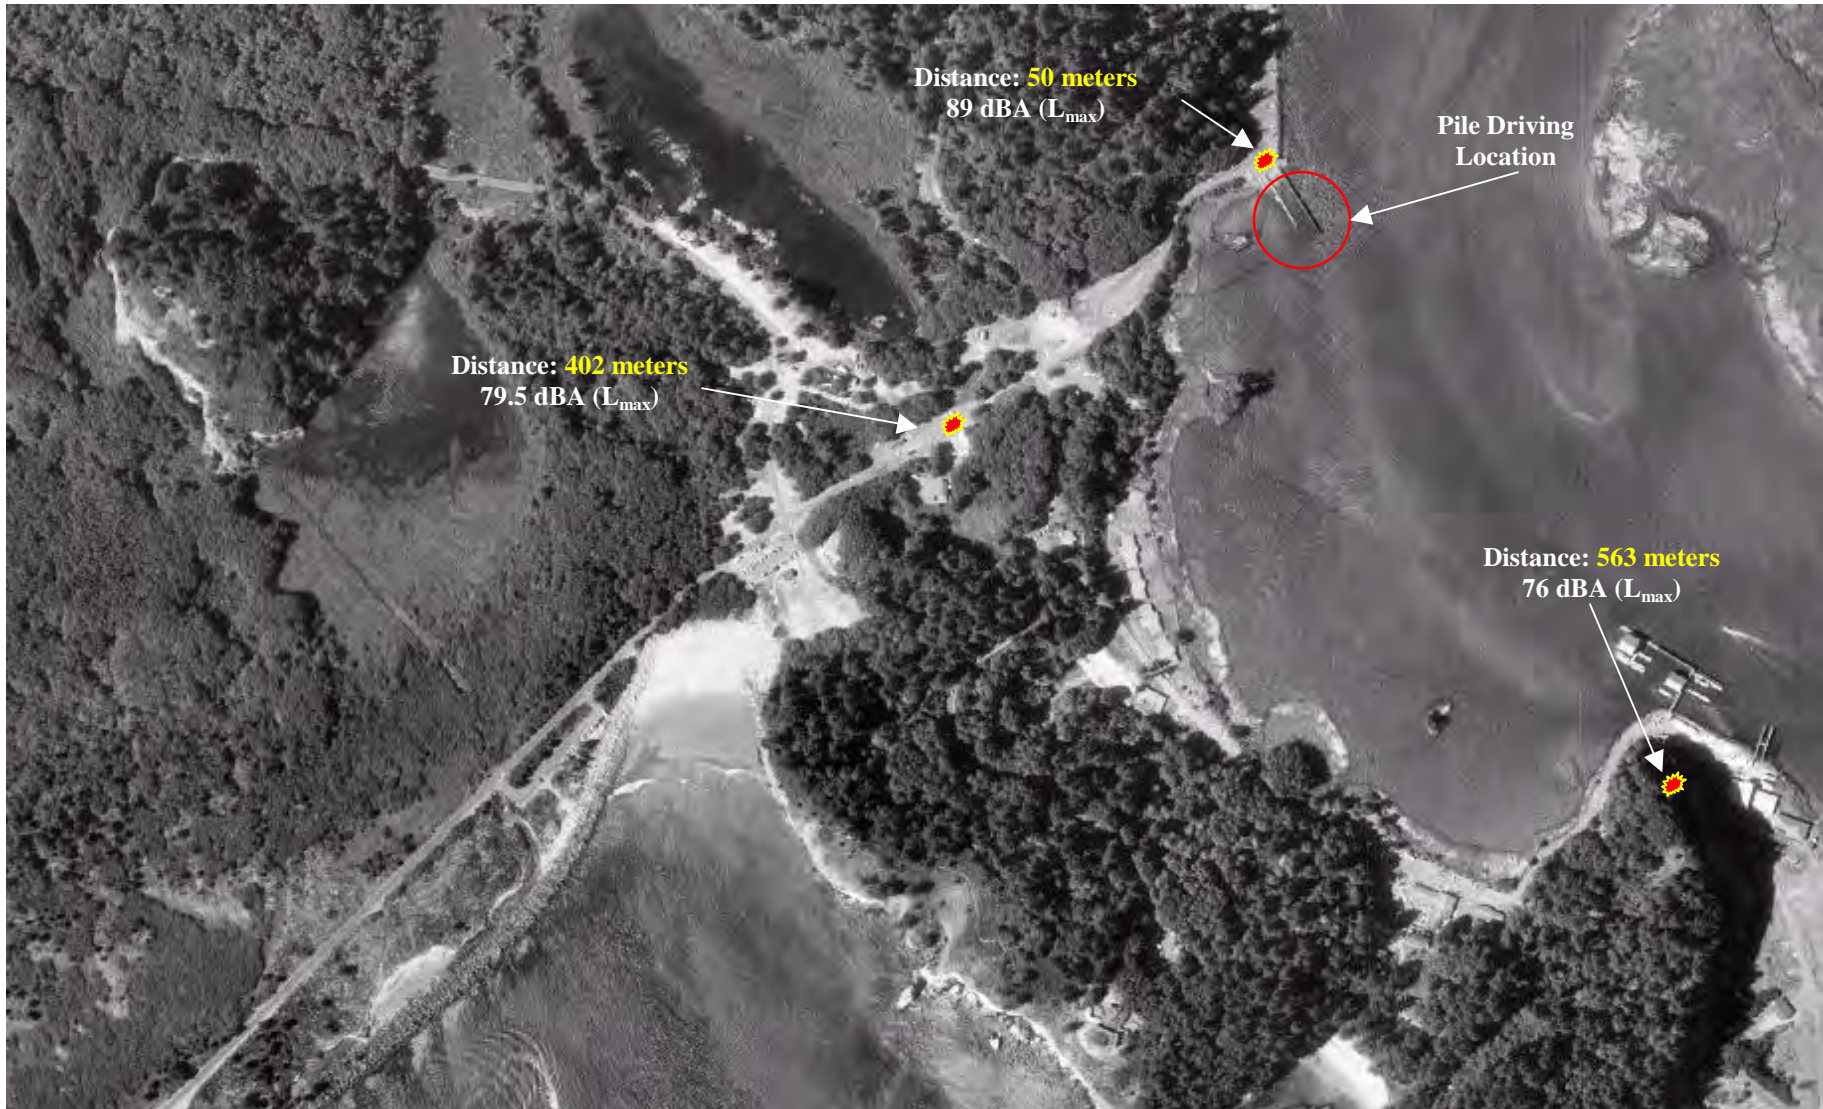
Figure 11: Airborne measurement locations (☀) with A-weighted maximum values.

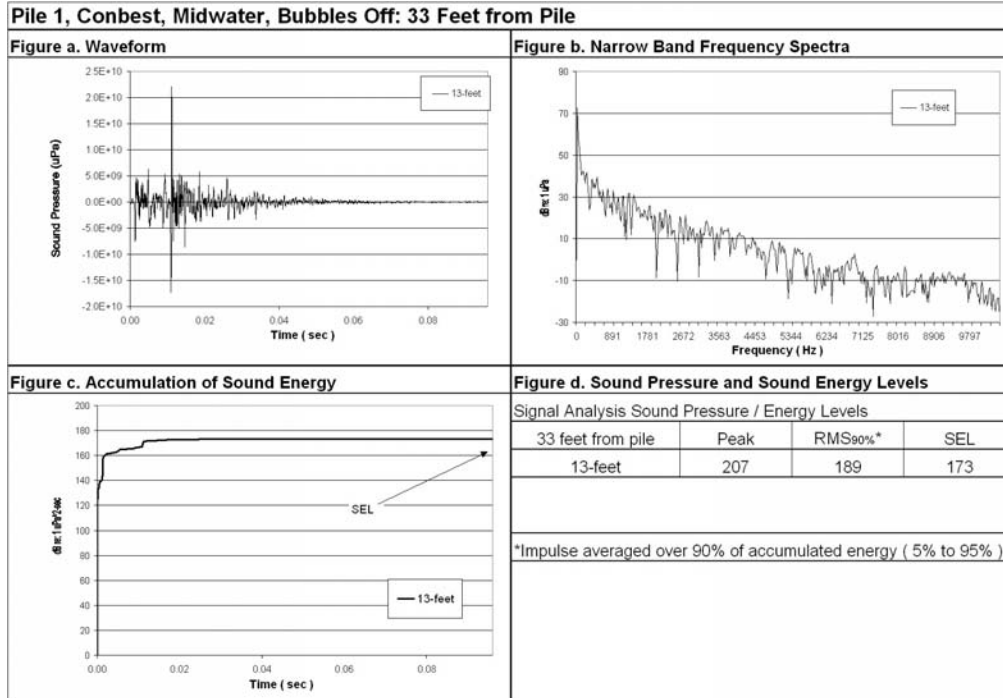
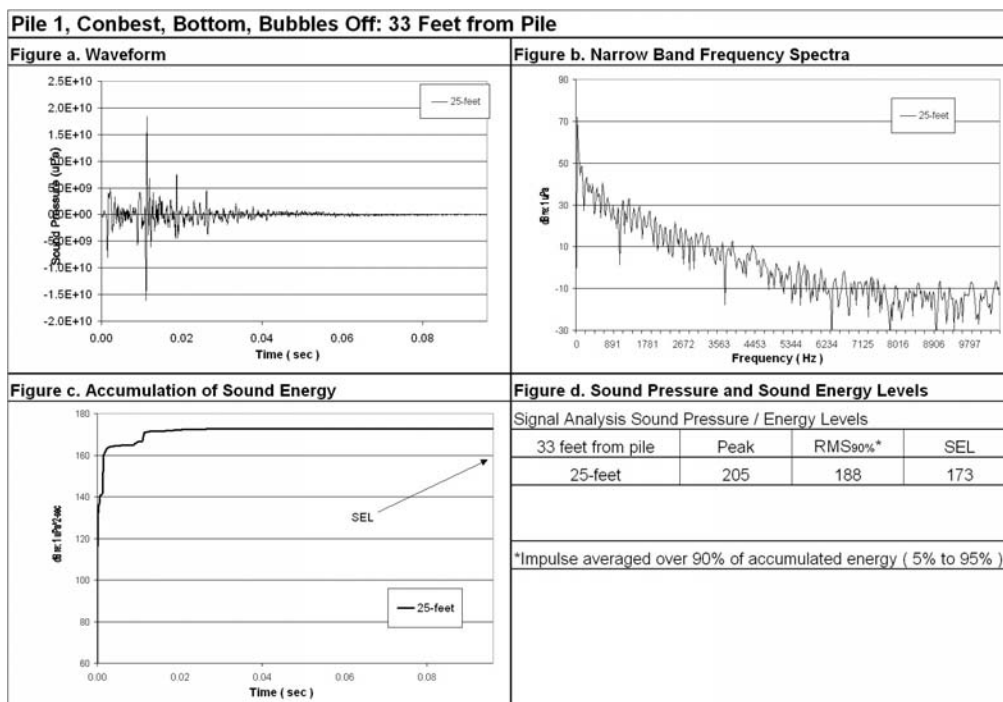
PILE 1 – CONBEST - BUBBLE CURTAIN OFF

Figure 12: Waveform Analysis of Pile 1 Sound Pressure Levels with Conbest pile cap and Bubble Curtain Off, Midwater and Bottom.

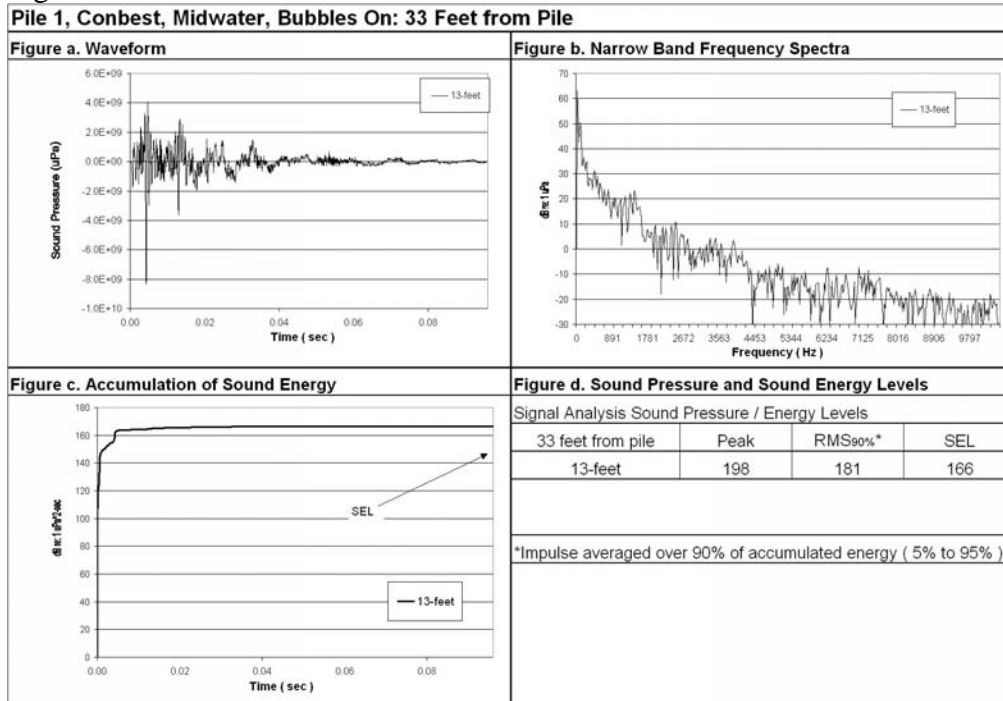
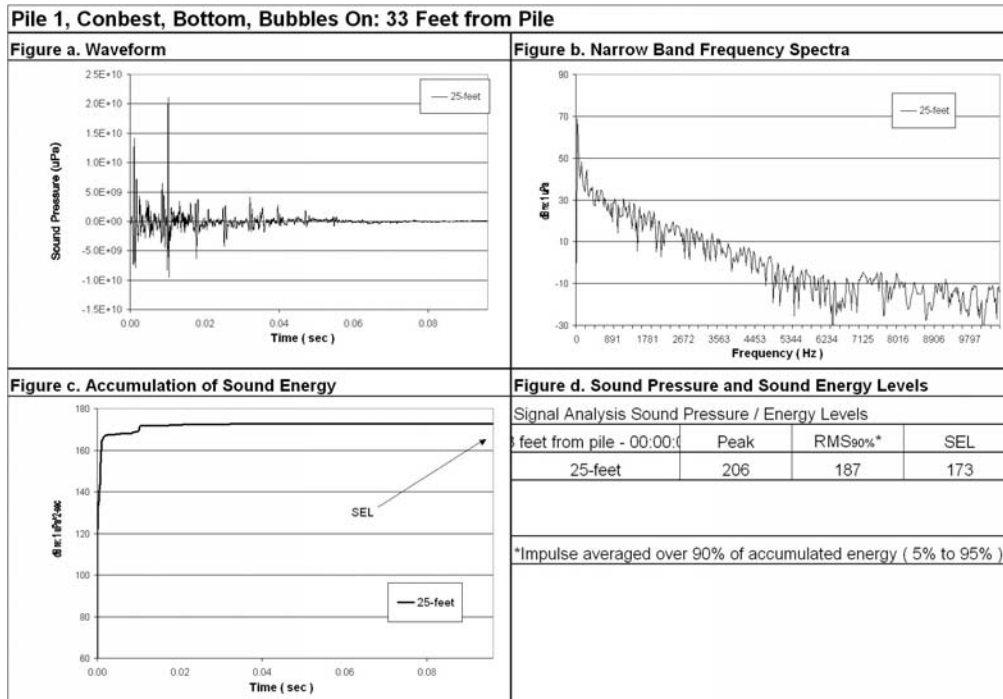
PILE 1 – CONBEST BUBBLE CURTAIN ON

Figure 13: Waveform Analysis of Pile 1 Sound Pressure Levels with Conbest Pile Cap and Bubble Curtain On, Midwater and Bottom.

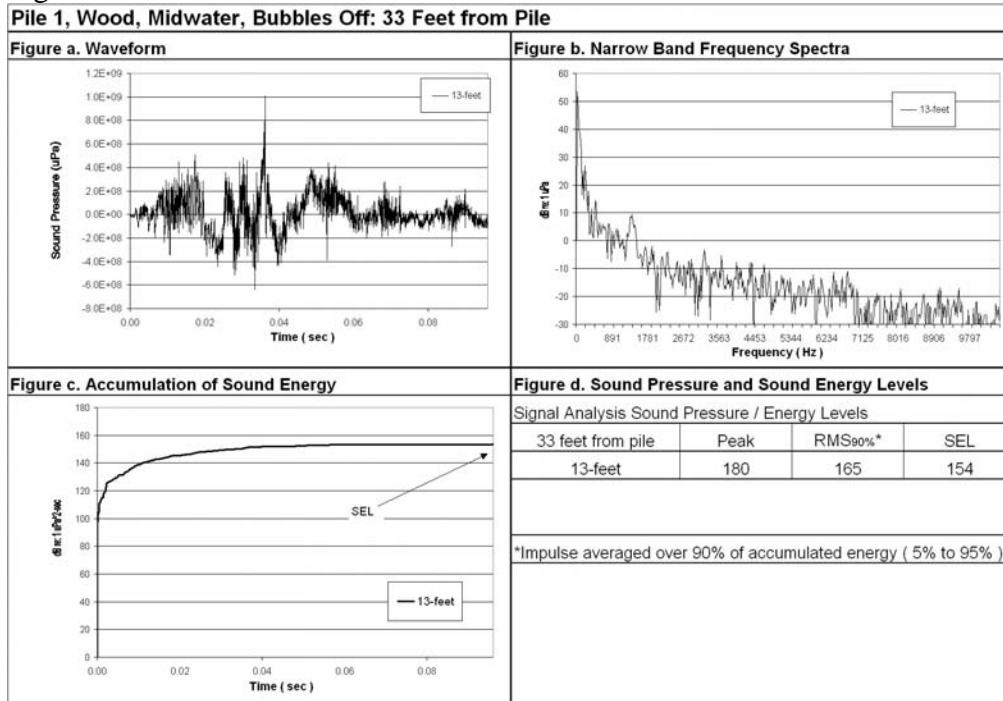
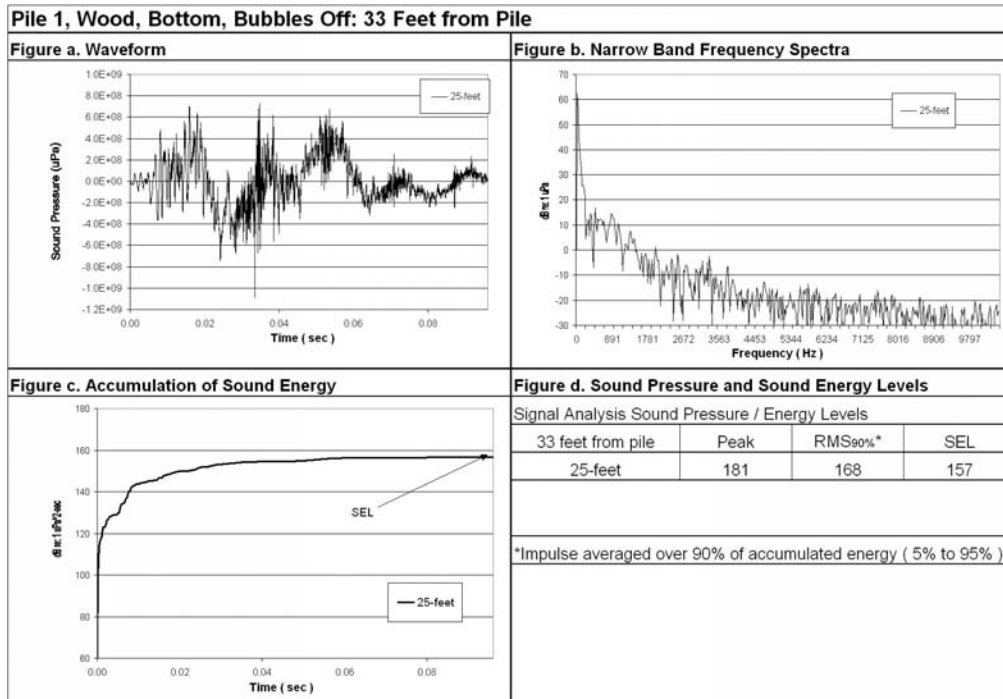
PILE 1 – WOOD BUBBLE CURTAIN OFF

Figure 14: Waveform Analysis of Pile 1 Sound Pressure Levels with Wood Pile Cap and Bubble Curtain Off, Midwater and Bottom.

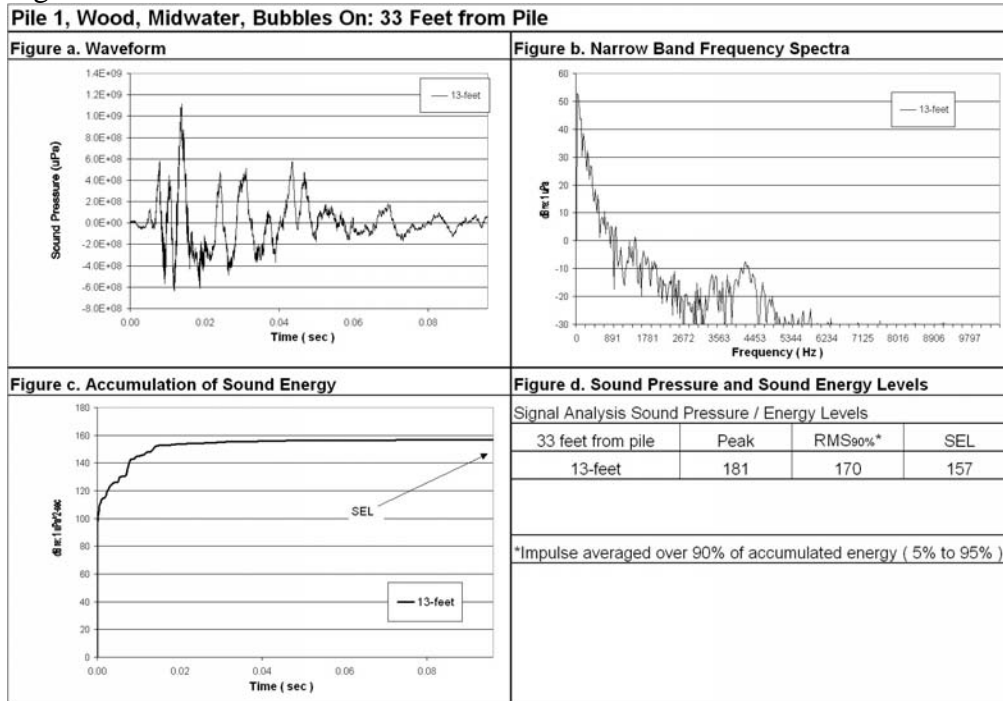
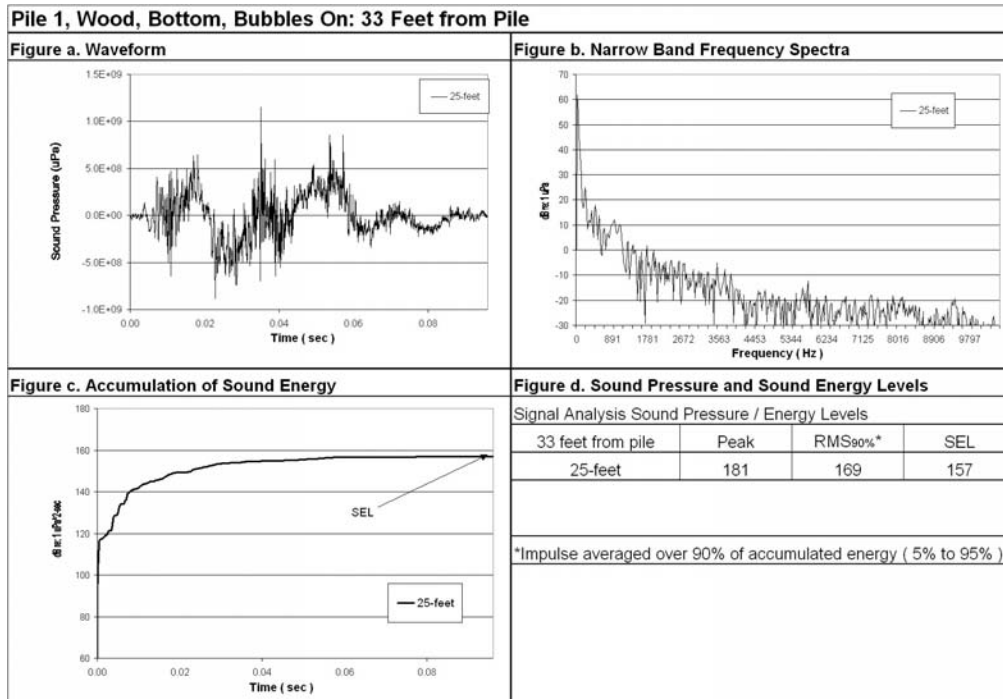
PILE 1 – WOOD BUBBLE CURTAIN ON

Figure 15: Waveform Analysis of Pile 1 Sound Pressure Levels with Wood Pile Cap and Bubble Curtain On, Midwater and Bottom.

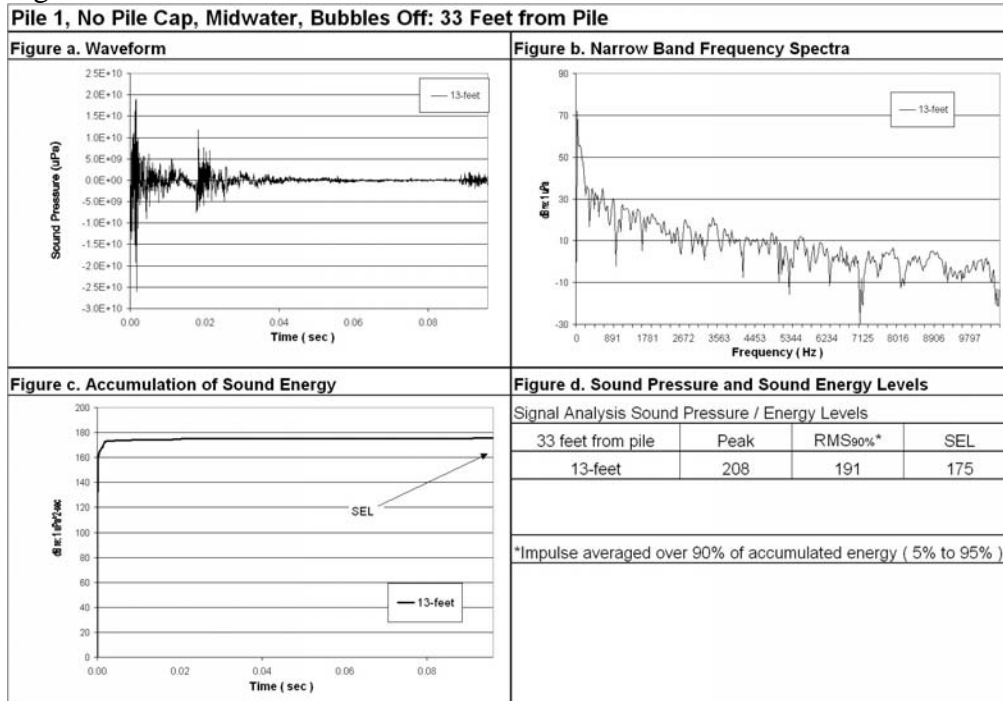
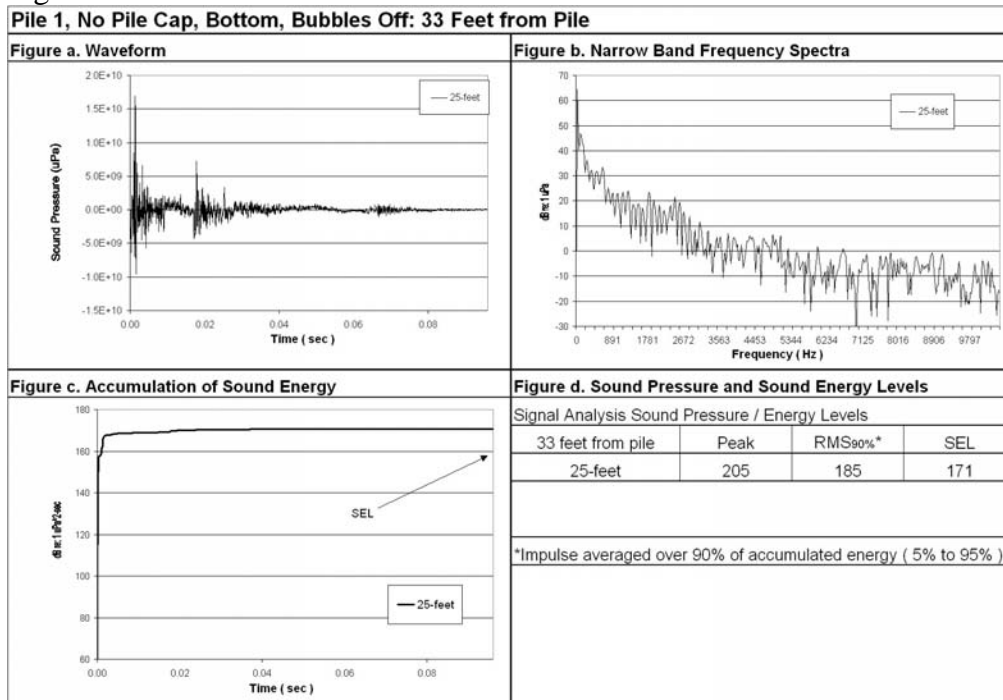
PILE 1 – NO PILE CAP BUBBLE CURTAIN OFF

Figure 16: Waveform Analysis of Pile 1 Sound Pressure Levels with No Pile Cap and Bubble Curtain Off, Midwater and Bottom.

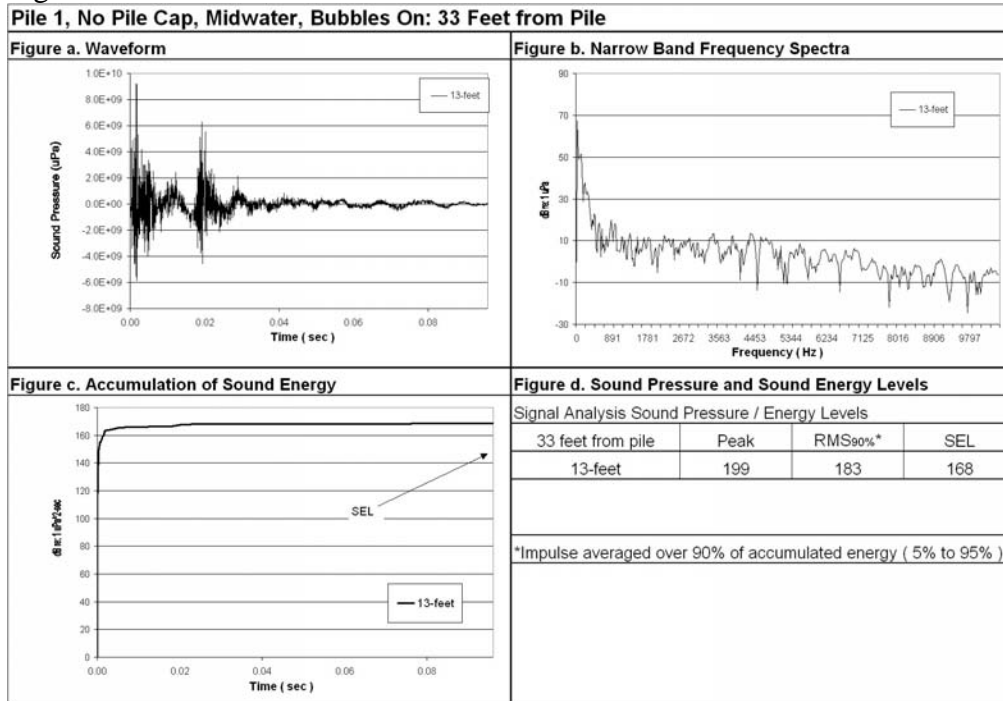
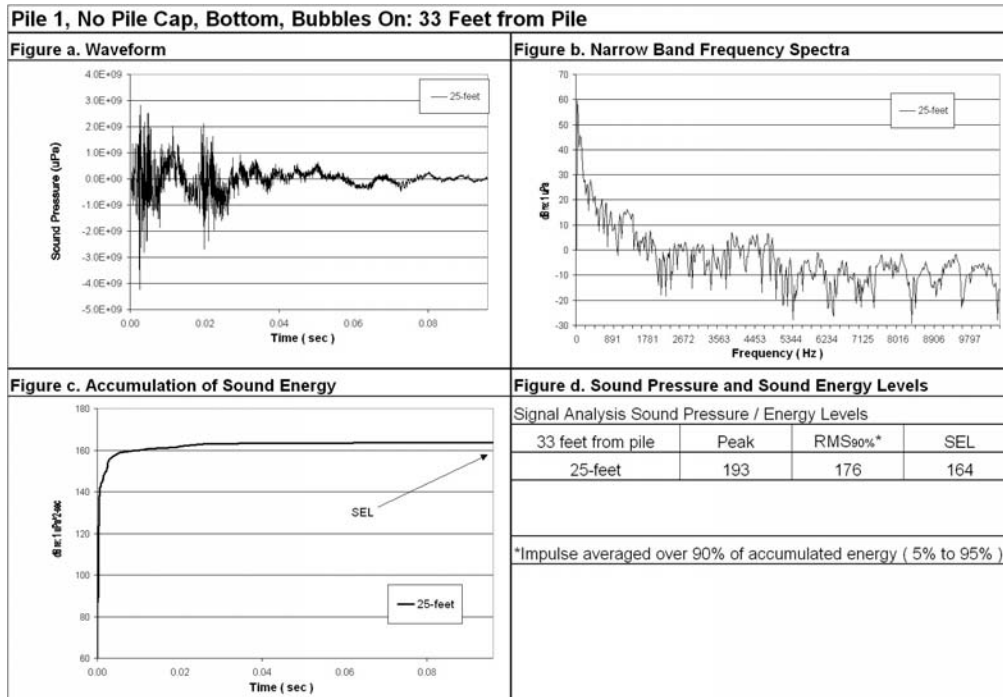
PILE 1 – NO PILE CAP BUBBLE CURTAIN ON

Figure 17: Waveform Analysis of Pile 1 Sound Pressure Levels with No Pile Cap and Bubble Curtain On, Midwater and Bottom.

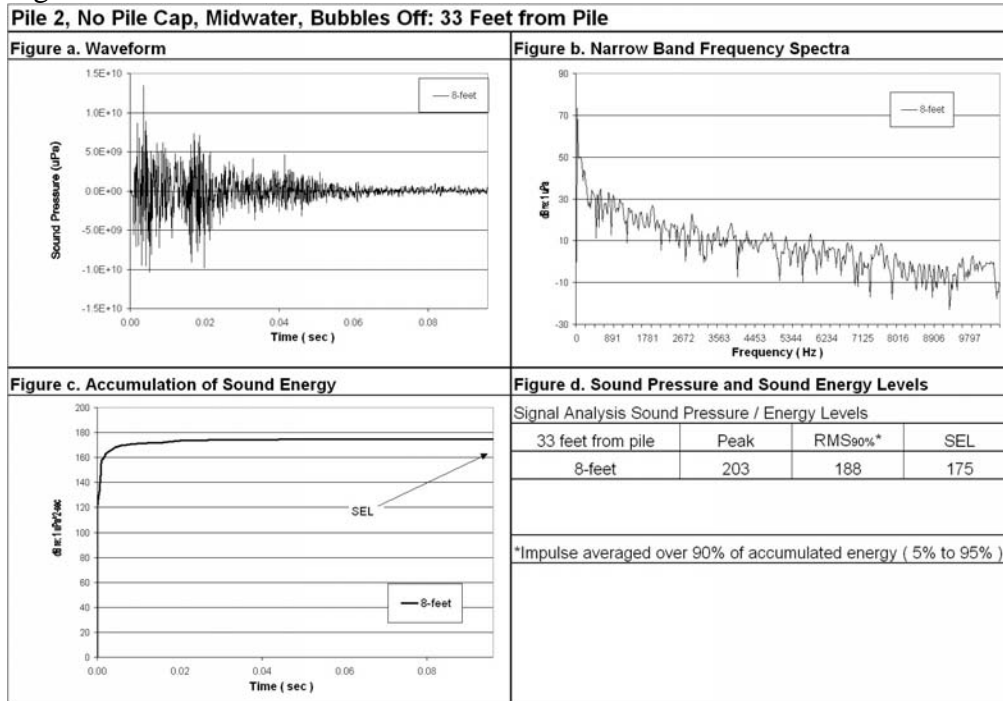
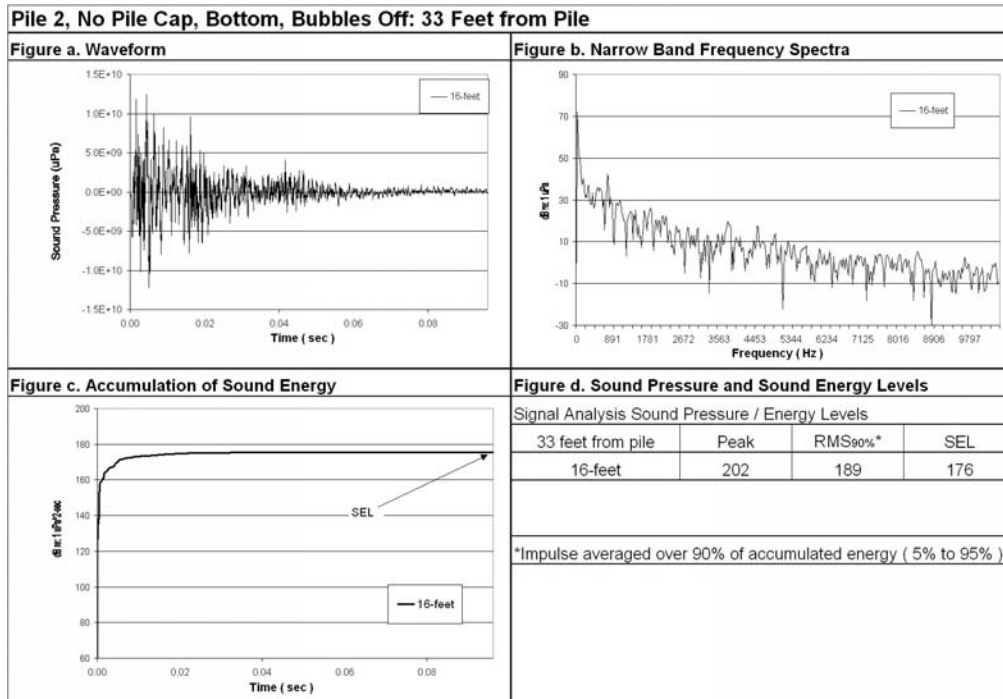
PILE 2 – NO PILE CAP, BUBBLE CURTAIN OFF

Figure 18: Waveform Analysis of Pile 2 Sound Pressure Levels with No Pile Cap and Bubble Curtain Final Off, Midwater and Bottom.
