*WASHINGTON STATE PARKS CAPE DISAPPOINTMENT WAVE
BARRIER PROJECT*

**UNDERWATER SOUND LEVELS
ASSOCIATED WITH PILE DRIVING AT
THE CAPE DISAPPOINTMENT BOAT
LAUNCH FACILITY, WAVE BARRIER
PROJECT**

*Prepared by:
Jim Laughlin
Washington State Department of
Transportation
Office of Air Quality and Noise
15700 Dayton Avenue North,
P.O. Box 330310
Seattle, WA 98133-9710*

March 2006

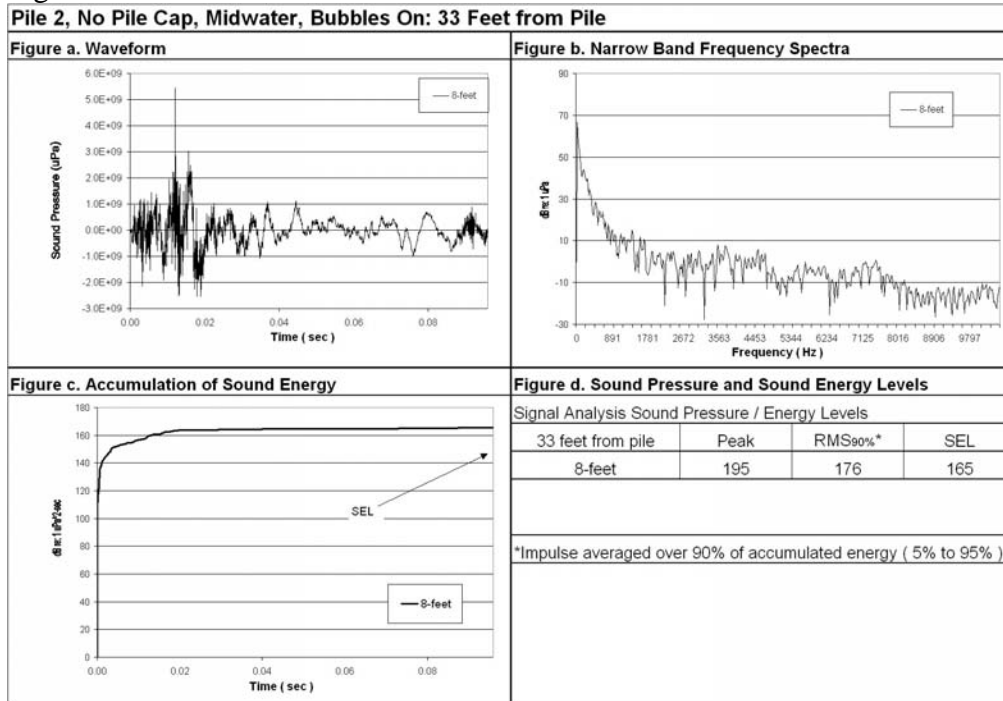
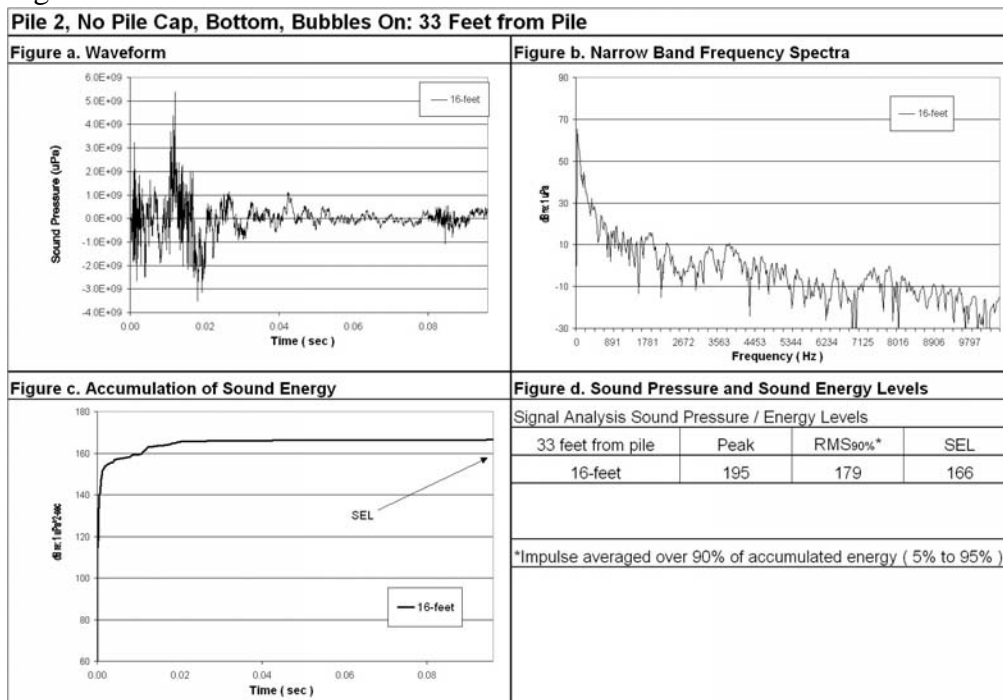
PILE 2 – NO PILE CAP, BUBBLE CURTAIN ON

Figure 19: Waveform Analysis of Pile Number 2 Sound Pressure Levels with No Pile Cap and Bubble Curtain On, Midwater and Bottom.

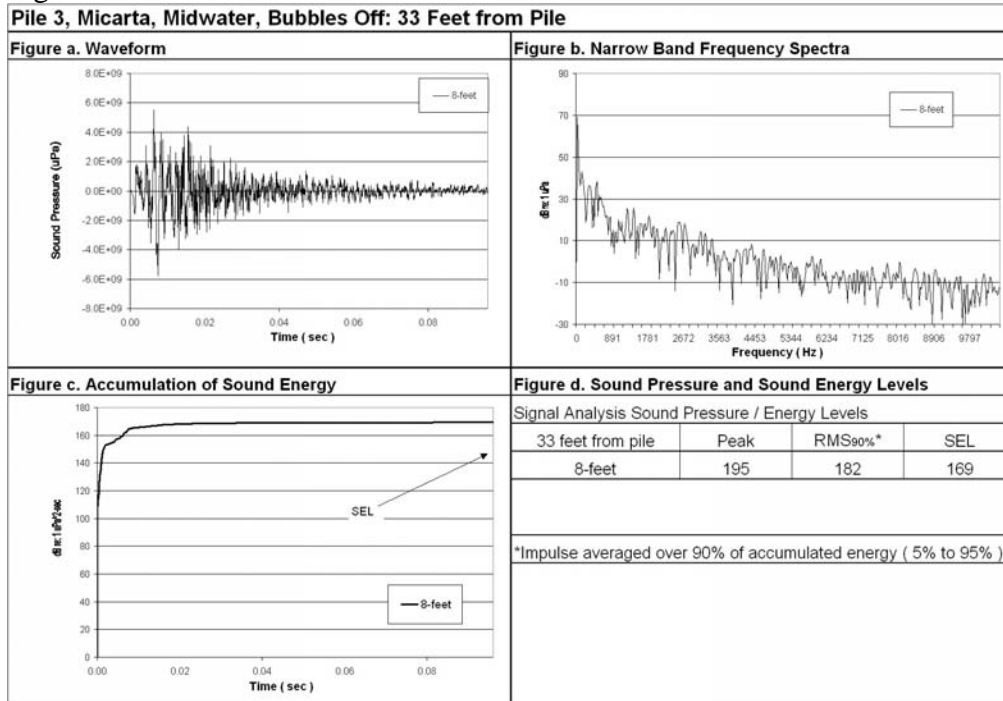
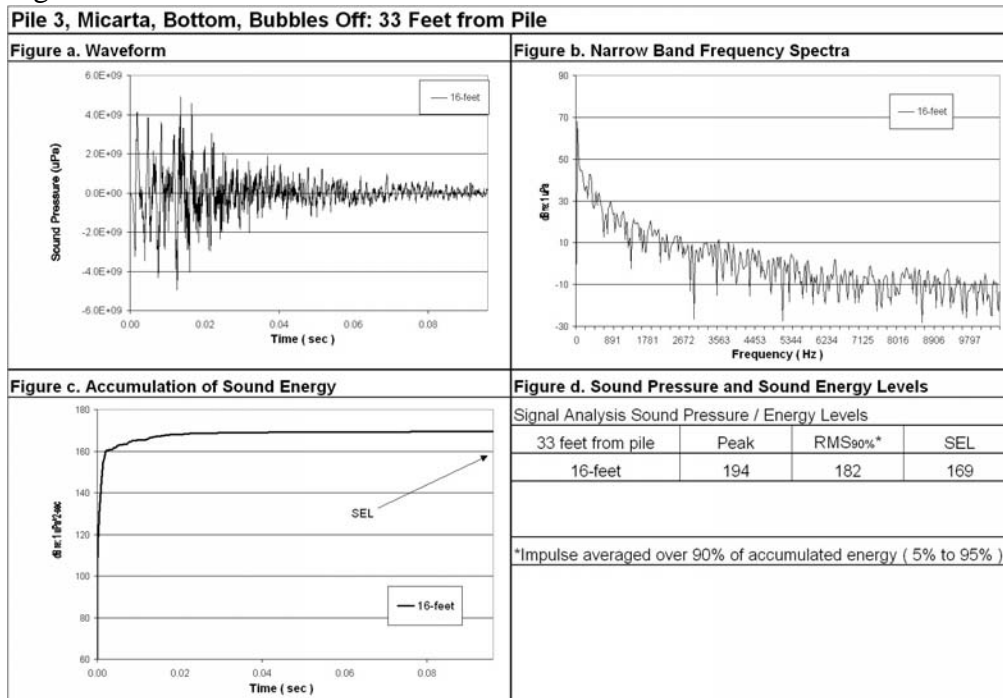
PILE 3 – MICARTA PILE CAP, BUBBLE CURTAIN OFF

Figure 20: Waveform Analysis of Pile Number 3 Sound Pressure Levels with Micarta Pile Cap and Bubble Curtain Off, Midwater and Bottom.

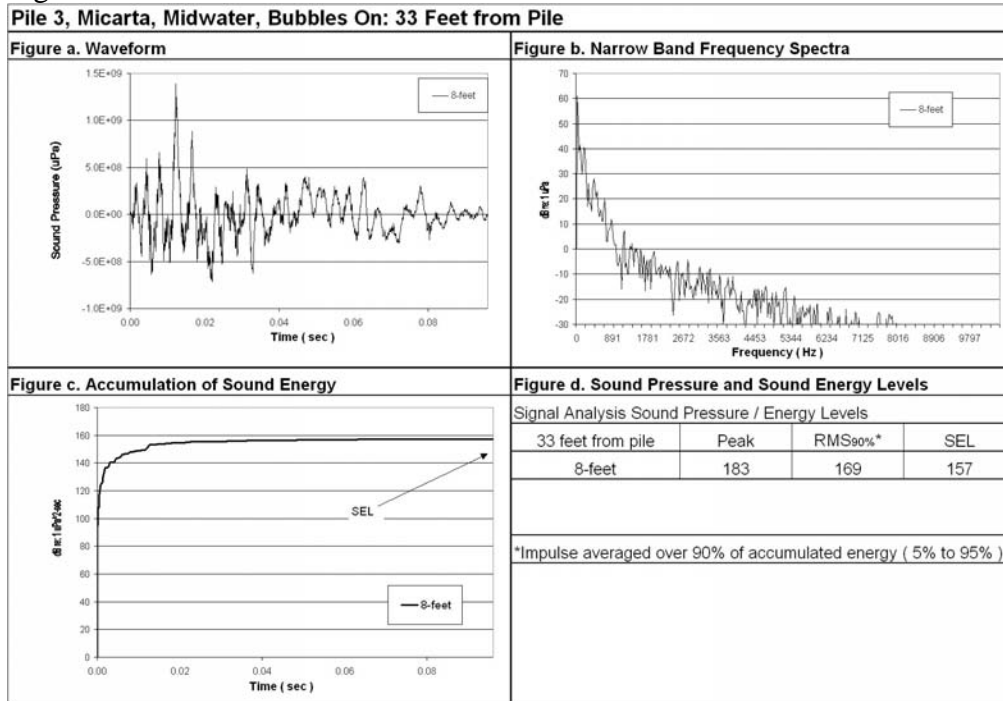
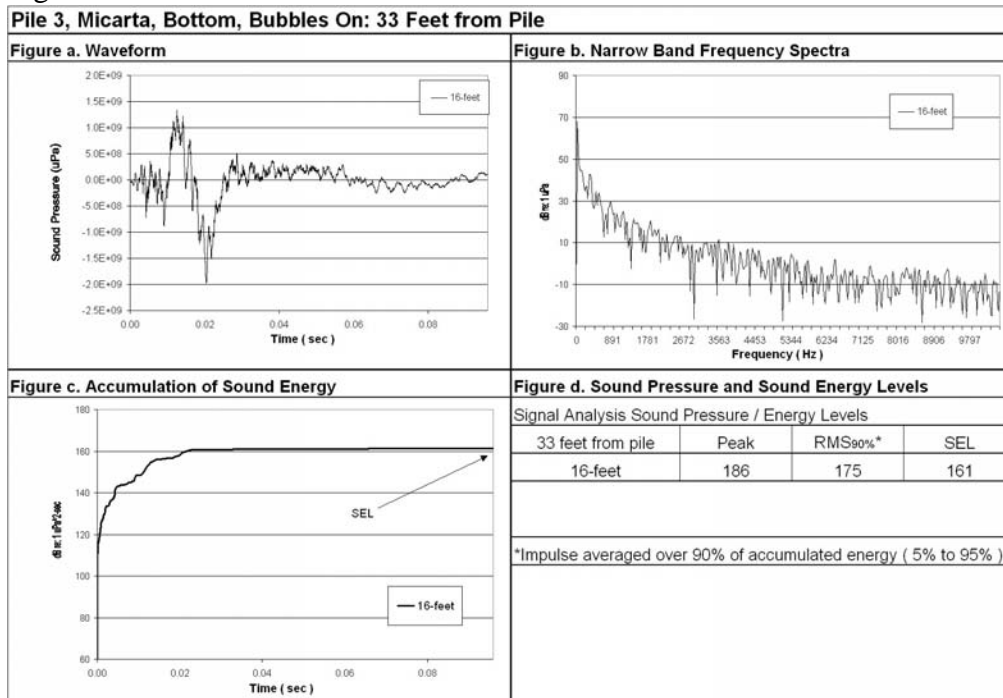
PILE 3 – MICARTA PILE CAP, BUBBLE CURTAIN ON

Figure 21: Waveform Analysis of Pile Number 3 Sound Pressure Levels with Bubble Curtain Second Off, Midwater and Bottom.

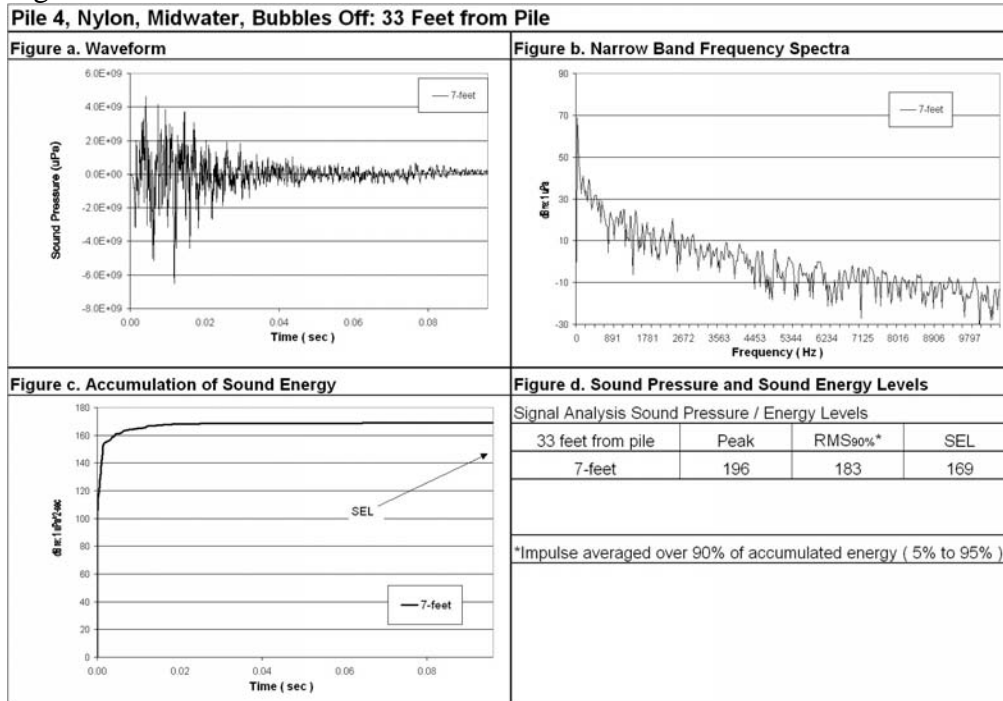
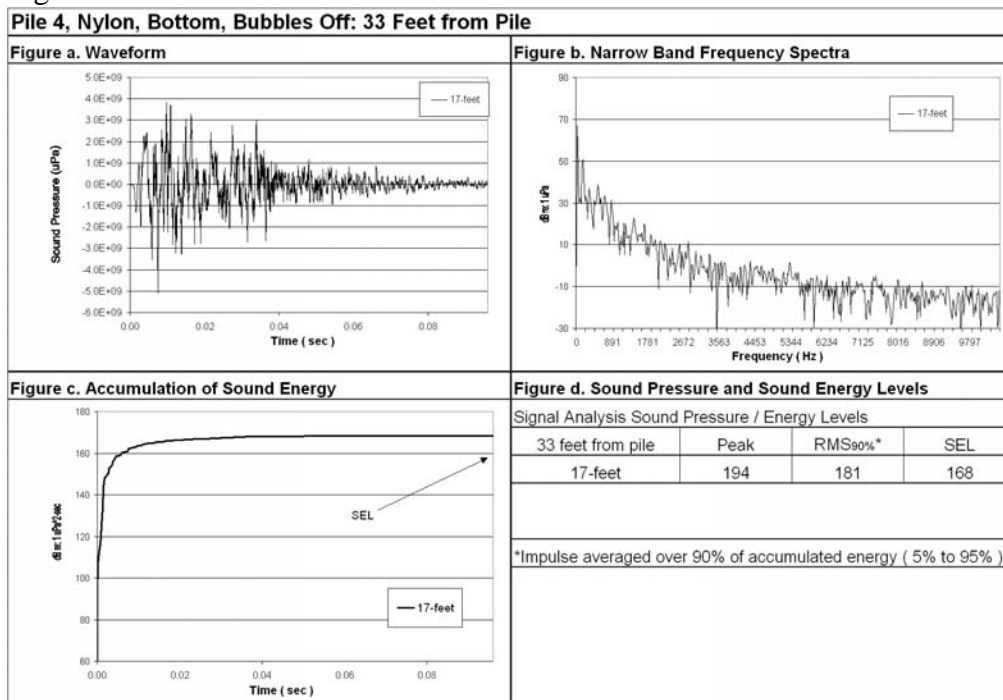
PILE 4 – NYLON PILE CAP, BUBBLE CURTAIN OFF

Figure 22: Waveform Analysis of Pile Number 4 Sound Pressure Levels with Nylon Pile Cap and Bubble Curtain Off, Midwater and Bottom.

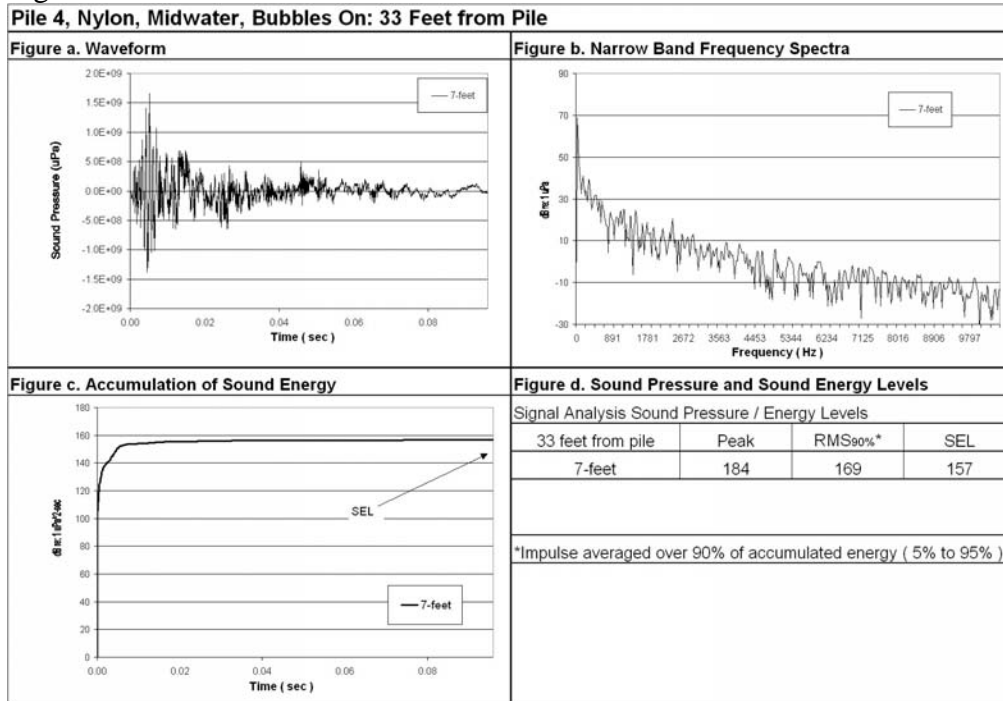
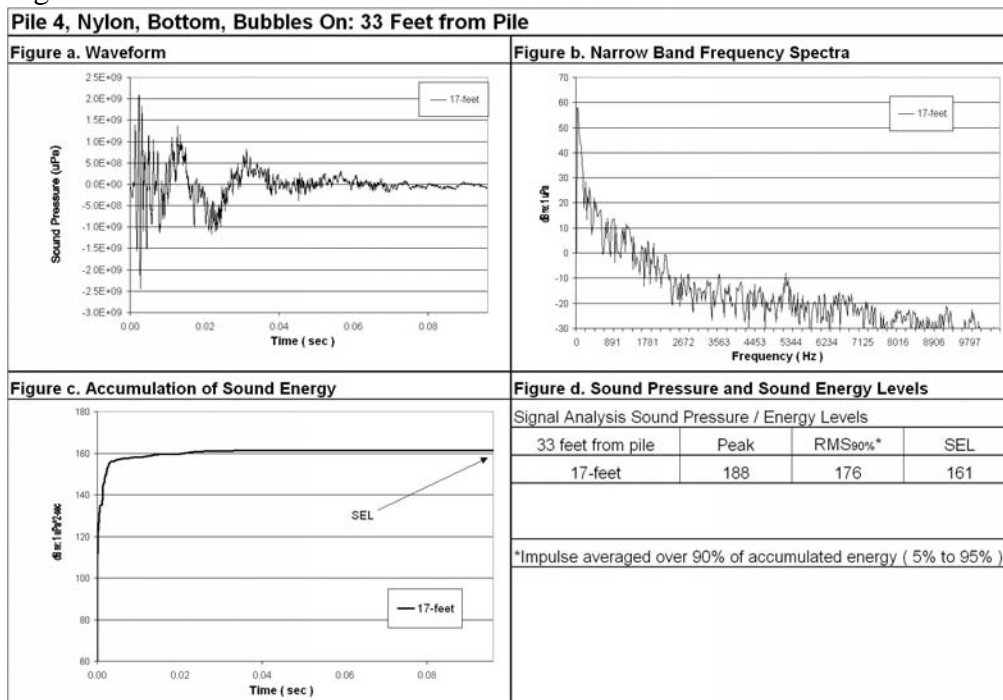
PILE 4 – NYLON PILE CAP, BUBBLE CURTAIN ON

Figure 23: Waveform Analysis of Pile Number 4 Sound Pressure Levels with Nylon Pile Cap and Bubble Curtain On, Midwater and Bottom.

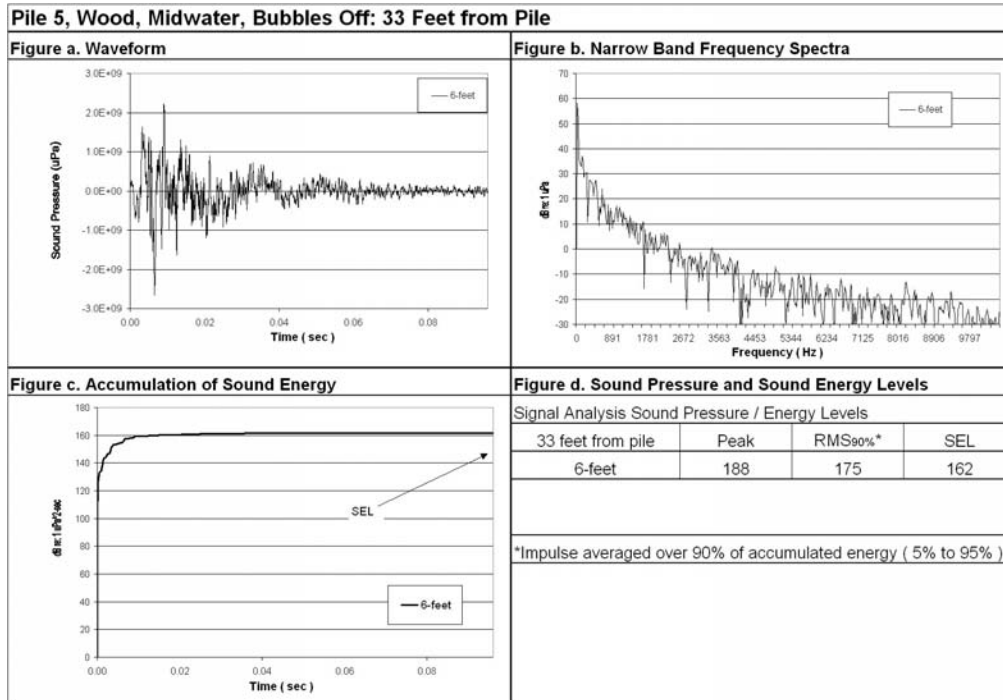
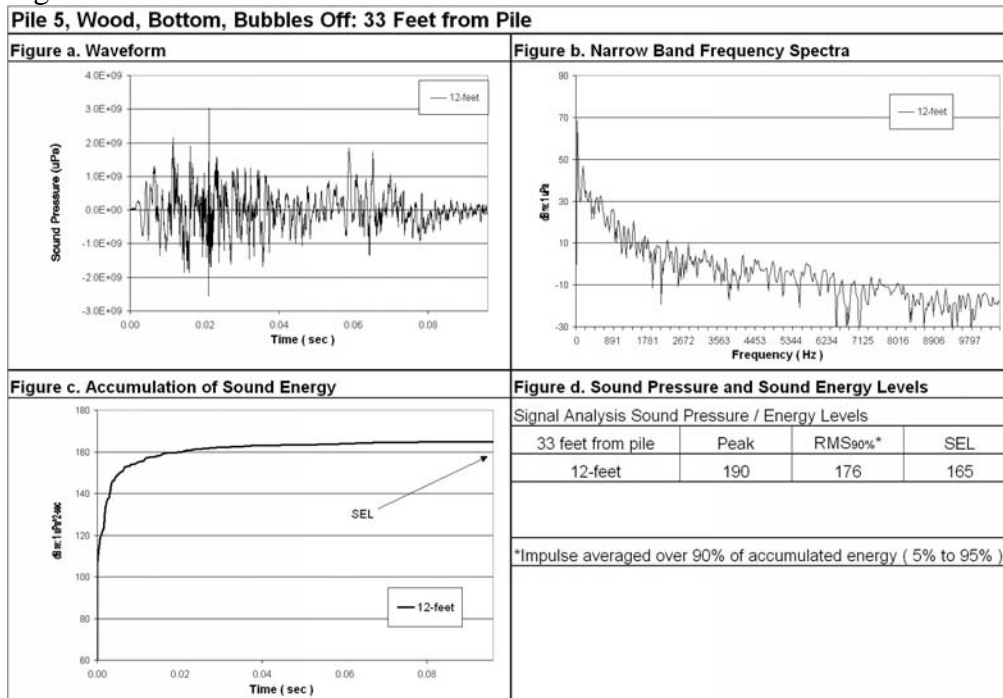
PILE 5 – WOOD PILE CAP, BUBBLE CURTAIN OFF

Figure 24: Waveform Analysis of Pile Number 5 Sound Pressure Levels with Wood Pile Cap and Bubble Curtain Off, Midwater and Bottom.

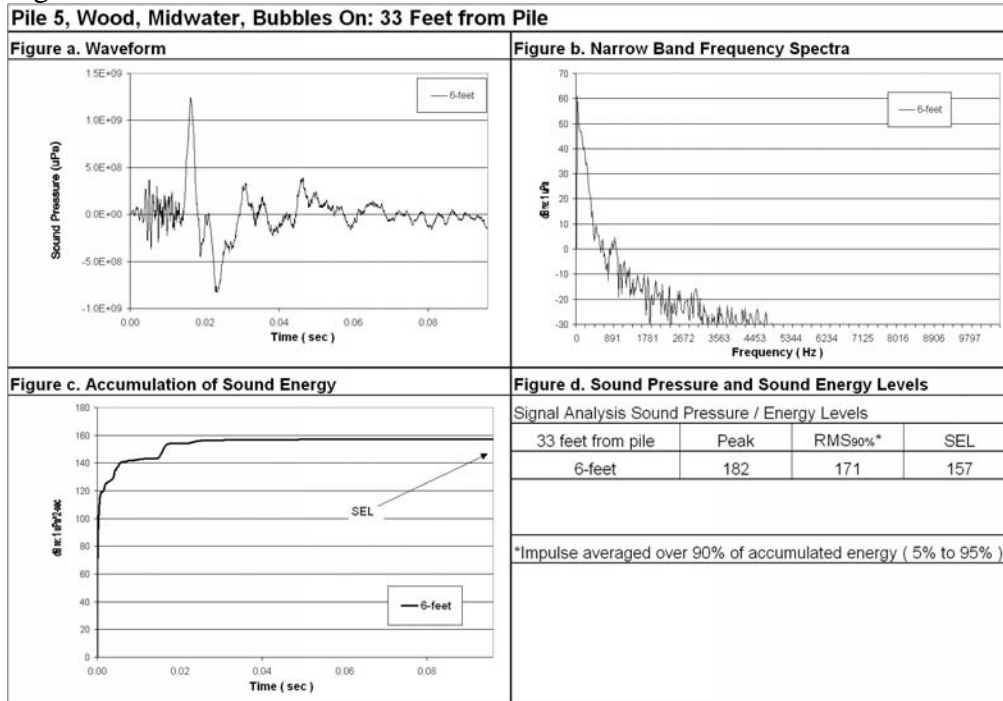
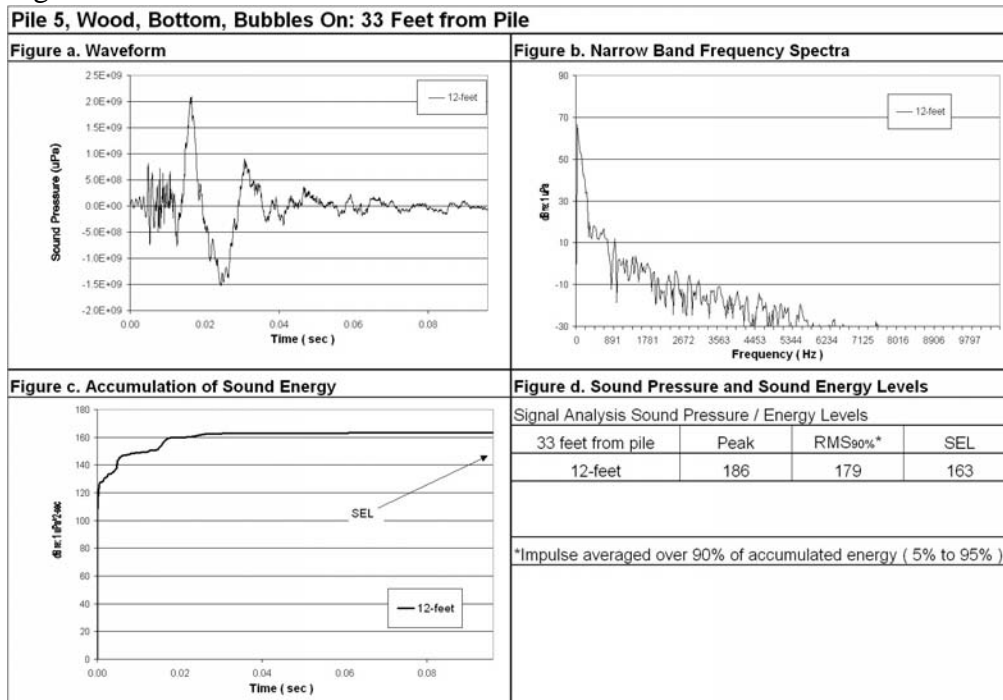
PILE 5 – WOOD PILE CAP, BUBBLE CURTAIN ON

Figure 25: Waveform Analysis of Pile Number 5 Sound Pressure Levels with Wood Pile Cap and Bubble Curtain On, Midwater and Bottom.
