CHRONIC ENVIRONMENTAL DEFICIENCY 2020 ANNUAL REPORT

WSDOT Environmental Services and Hydraulics Offices

WSDOT Chronic Environmental Deficiency (CED) Program Annual Report 2020

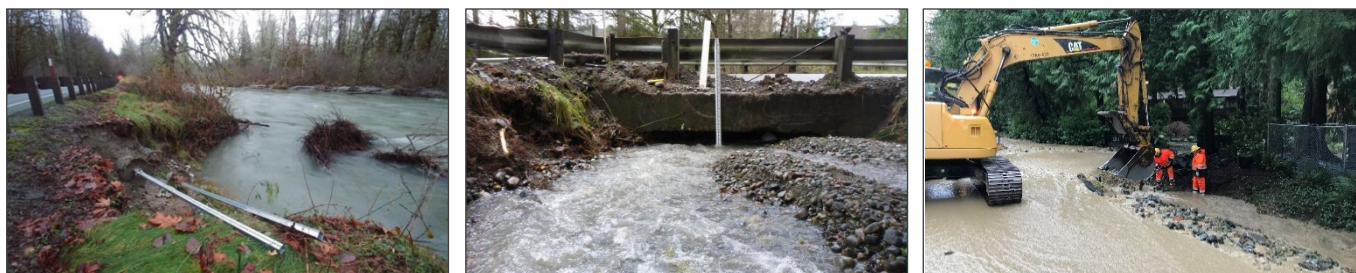
Figure 1. Typical CED sites - Sauk River Side Channel CED, Mud Creek CED, May Creek Tributary CED.

A Chronic Environmental Deficiency (CED) is a location along a state highway that is adjacent to a waterbody, and where recent, frequent repairs or maintenance (typically 3 times in 10 years) to WSDOT infrastructure cause adverse impacts to fish or fish habitat. These sites are often subject to frequent streambank erosion, sedimentation, flooding, washouts, or other environmental threats that if left unaddressed can require emergency repairs, result in road closures, and reduce the safety of the traveling public (Figure 1).

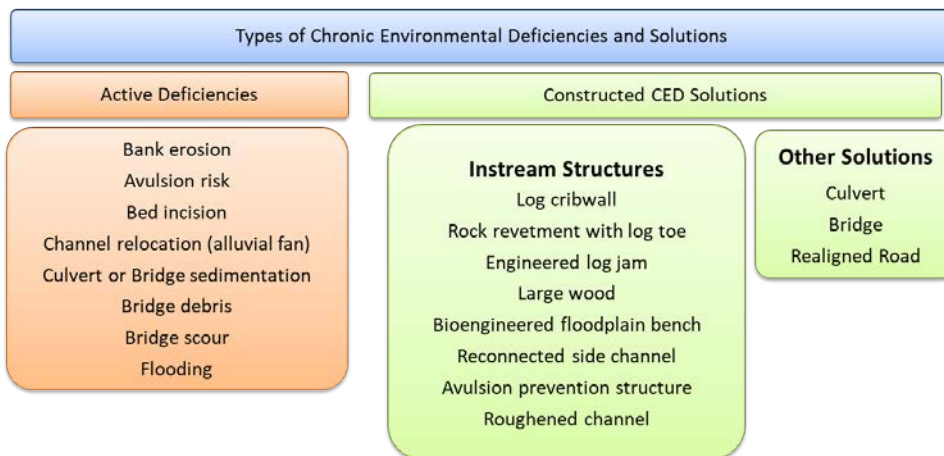
Figure 2. Types of CED problems and CED solutions.

CED solutions are based on a Site and Reach Assessment, which is a study conducted by a hydrologist or geomorphologist that evaluates the processes occurring in the watershed and identifies the mechanism for failure. It discusses alternative solutions and provides a recommendation. It describes the context of the problem so that the best possible targeted solution can be developed. Figure 2 below shows the types of CED problems and CED solutions often constructed in the CED Program.

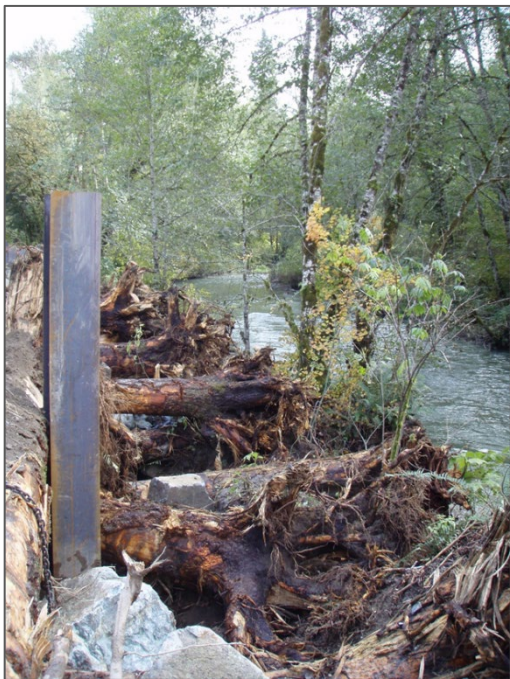
Figure 4. Sauk River Side Channel log cribwall, 2008.

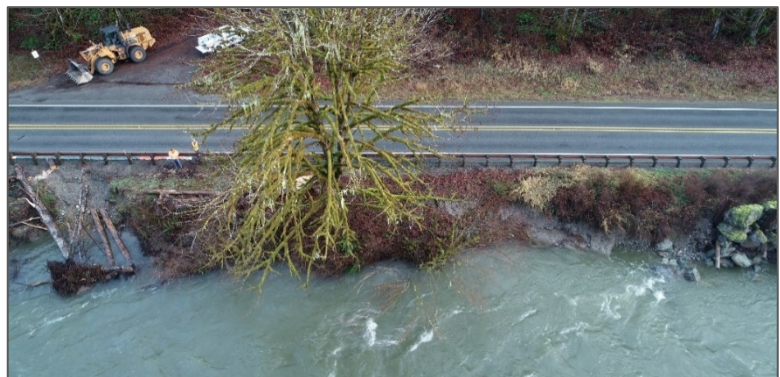
Figure 3. Riverbank failure November 2018.

During a high-flow event in November 2018, a section of the riverbank failed along the highway embankment between two of the existing cribwalls. The erosion caused several trees that were protecting the bank to fall in, putting the entire bank at risk of unraveling along the highway embankment. This necessitated an emergency repair that month, and then a larger fish-friendly maintenance repair in summer 2019. This repair was intended to be forward compatible with a more comprehensive CED repair in the future.

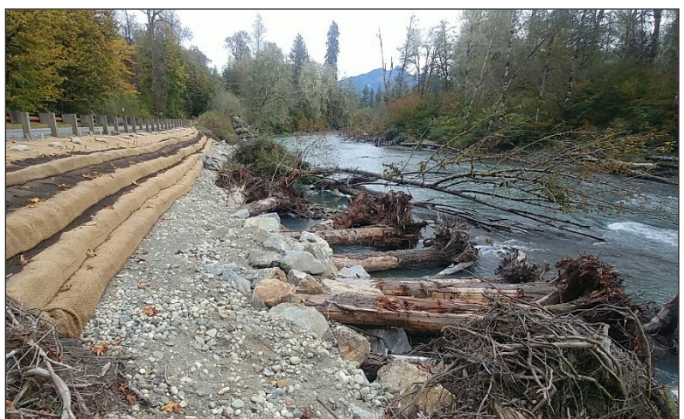
Figure 5. Sauk Side Channel interim maintenance repair, September 2019.

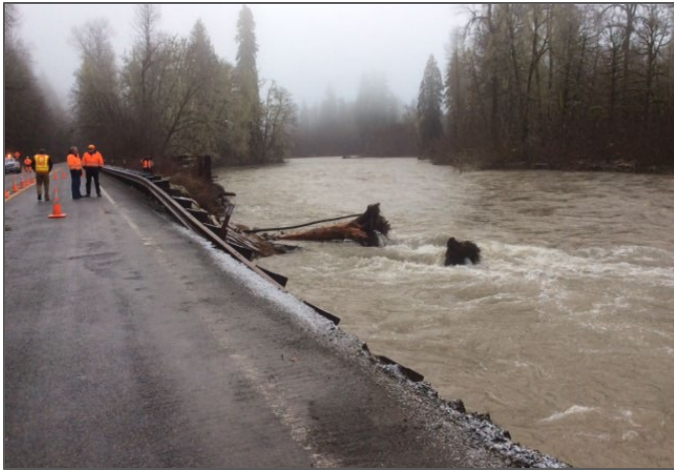
Figure 6. SR 530 after February 2020 high flow event.

Several months later, a high flow event in February 2020 washed away a large stable log jam that had been blocking the inlet to the side channel from Sauk River flows. The side channel significantly widened and washed out the newly constructed rock and log toe revetment and part of SR 530. Due to a lack of detour, traffic had to be routed into one lane, which also resulted in a month-long disruption to the traveling public.

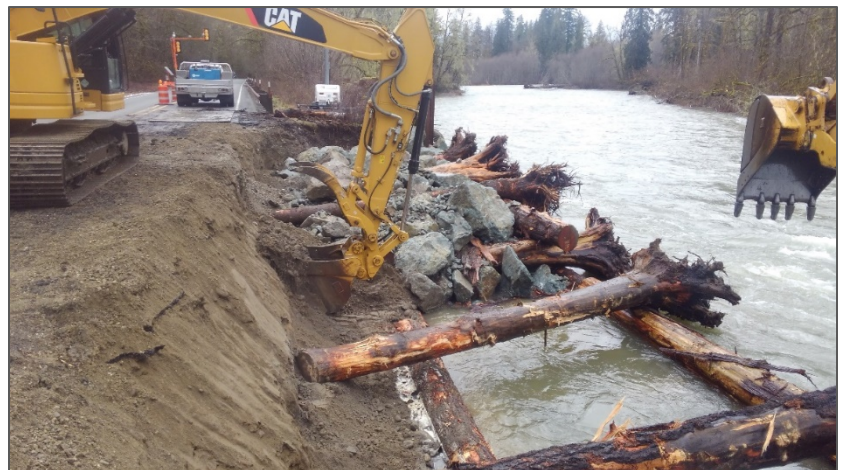
Figure 7. SR 530 Sauk River Side channel CED during construction of the emergency repair in February 2020. This project was constructed during high flows.

The repair was installed during emergency conditions and high winter flows. This is not the ideal time to install large wood, as the buoyancy of the wood makes it difficult to place it along the toe of the bank during these flows. Regardless, the cribwall provides hydraulic complexity and cover at lower stream flows.

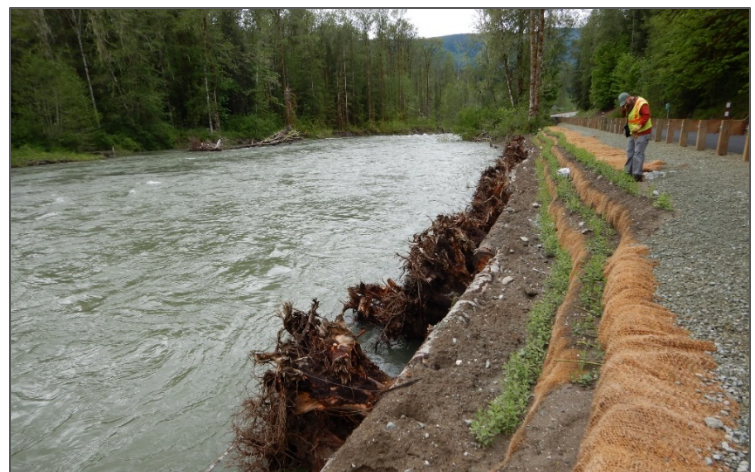
Figure 8. Sauk River Side Channel post-construction, May 2020.

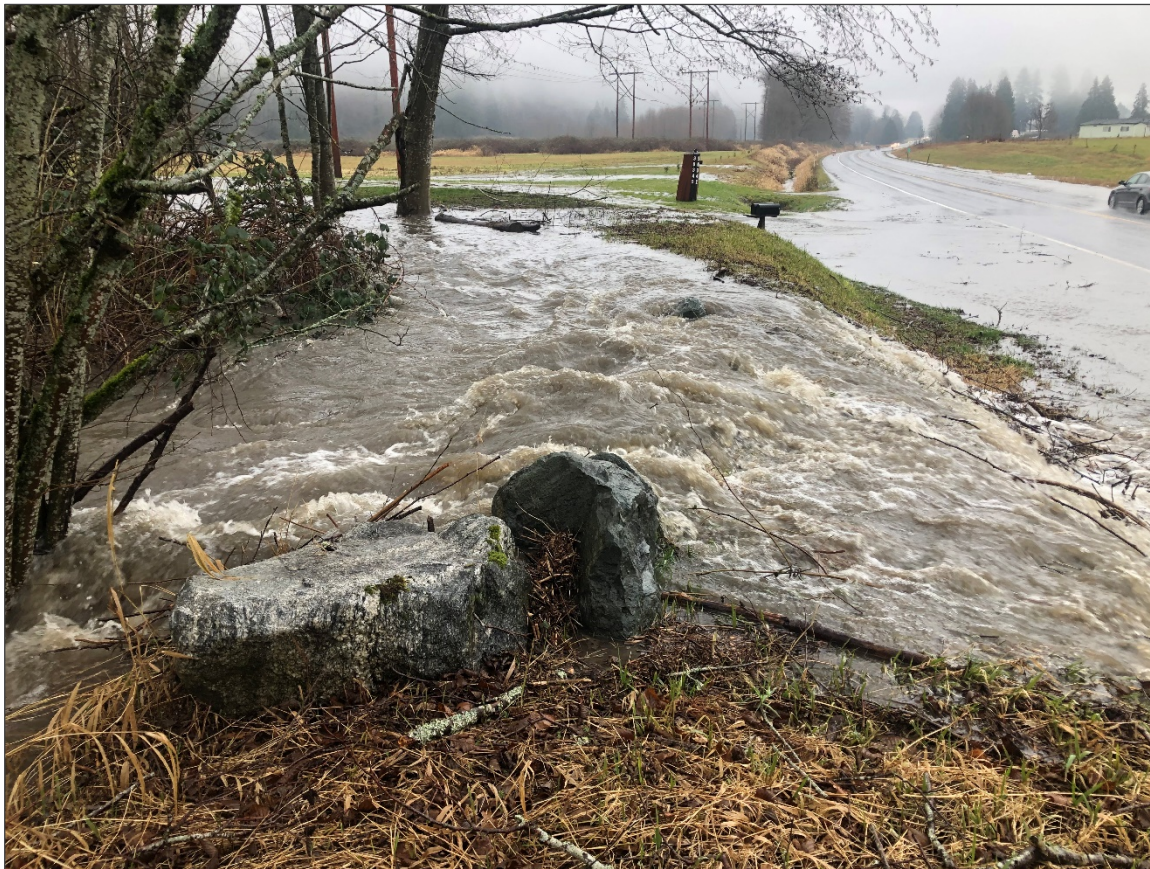
Figure 10. SR 20 Childs Cr CED. Childs Creek overtops a berm and floods SR 20 during a high flow event in February 2021. WSDOT recently completed a site and reach assessment and held a CED concurrence for this CED.

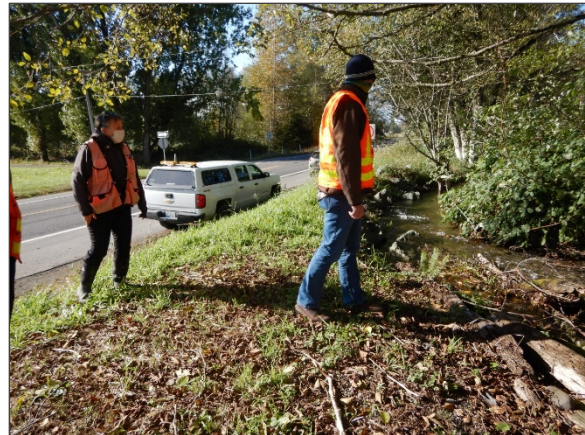
Figure 11. Childs Creek 400 feet upstream of the SR 20 crossing, October 2020. Note the 90-degree bend and the height above SR 20 in this reach.

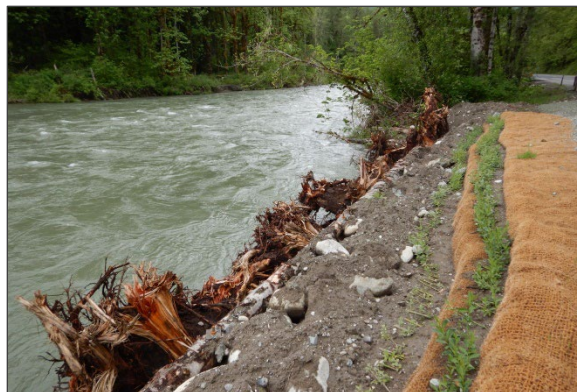
Figure 13. Sauk Side Channel CED, April 2020. This cribwall was installed during an emergency repair in February. Remaining vulnerable streambanks that would be protected are in the background.

By February 2020, most of the large log jam had floated away, and then a high flow event washed out a recent repair and one lane of the highway. In response, WSDOT constructed a robust log cribwall along several sections of the reach, which consisted of a dense layer of rootwads installed as low into the water as possible. Two sections of the riverbank in this reach remain vulnerable to scour and at risk of catastrophic failure. WSDOT received approval for funds from FHWA to complete this repair.

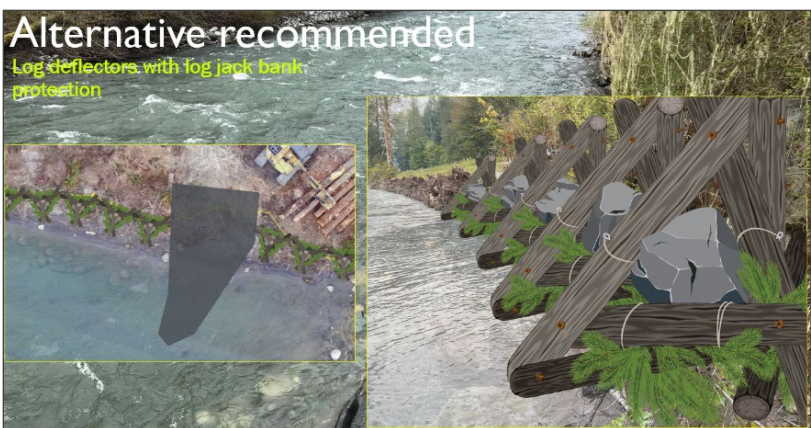
Figure 15. Sauk River Side Channel log jack concept.

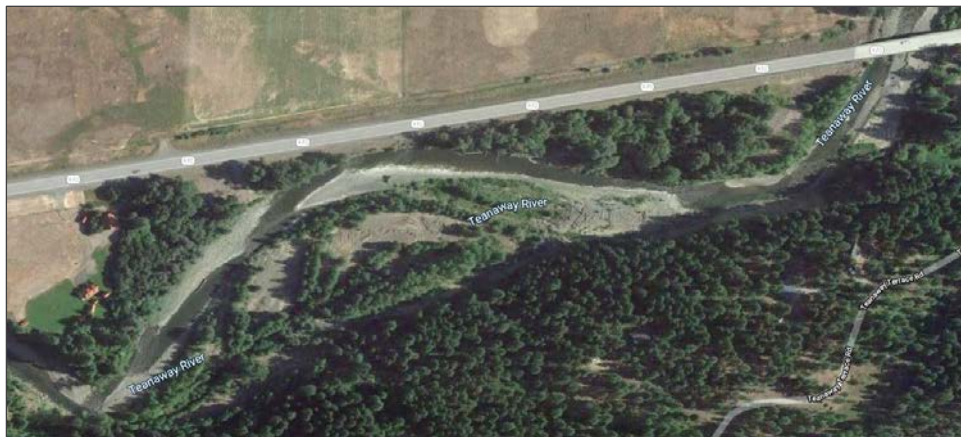
Figure 16. SR 970 Teanaway River CED project vicinity. The river has been encroaching on SR 970 since 1991, which has resulted in erosion and flooding of the roadway multiple times over the years. A CED project is scheduled for construction in 2022.

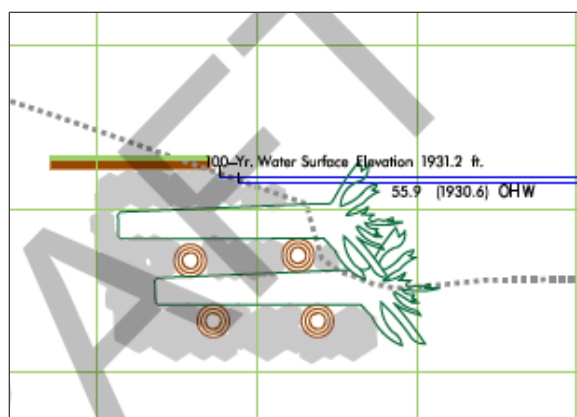
Figure 17. Teanaway River log cribwall concept.

This structure is intended to increase hydraulic diversity and instream cover along the banks. The soil wraps with riparian plantings would help re-establish a riparian zone along the revetment to provide additional cover and stream shading. The structure would arrest continued erosion of the adjacent streambanks and associated sedimentation of spawning areas.

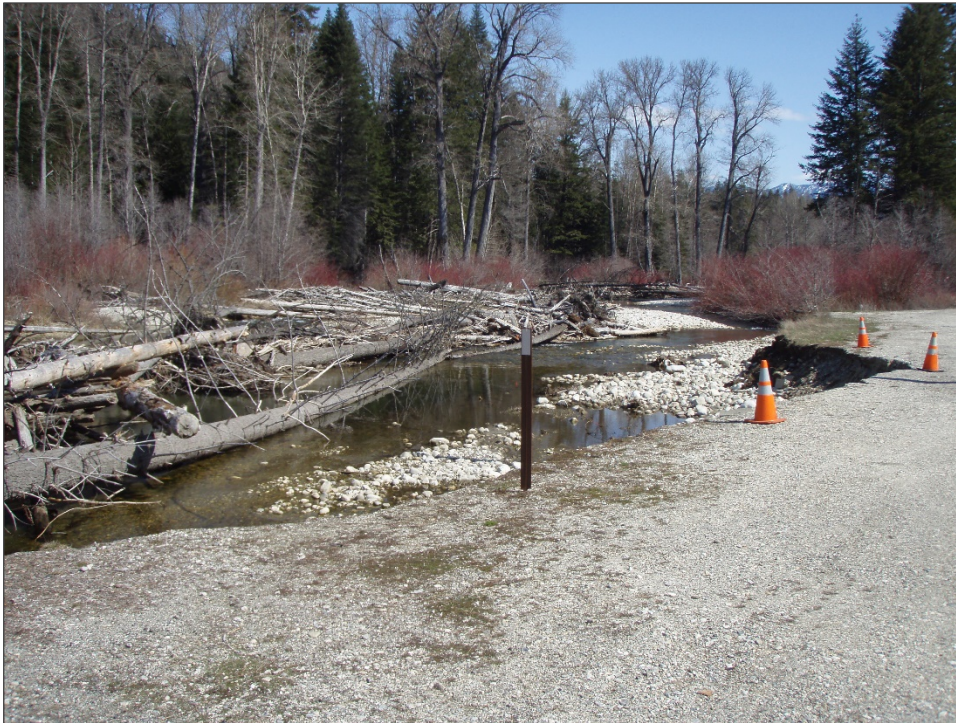
Figure 18. SR 207 Nason Creek embankment failure, April 2011. This CED project is the top priority for the CED program due to high fish benefit, high risk to infrastructure, and a partnership opportunity with the Yakama Nation. The project is planned for construction 21-23 in partnership with the Yakama Nation as the project lead.

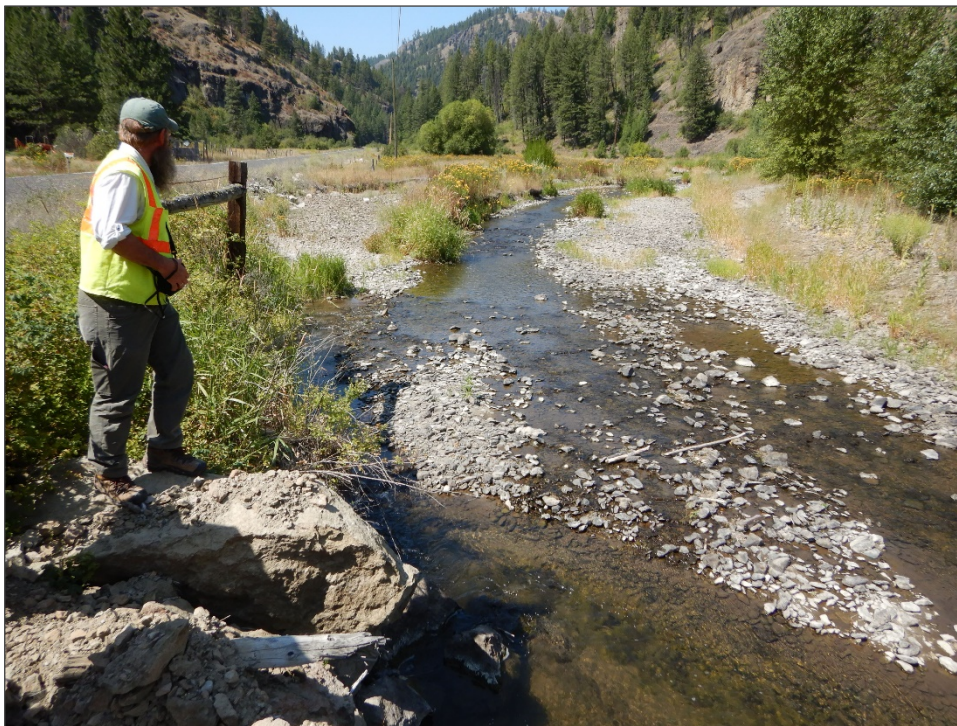
Figure 20. SR 21 Sanpoil River 4 CED, August 2019. The Sanpoil River has been migrating adjacent to the highway at this location and frequently changes course. Eastern Region maintenance staff plan to construct a rock with log toe revetment and bioengineered floodplain bench in summer 2021.

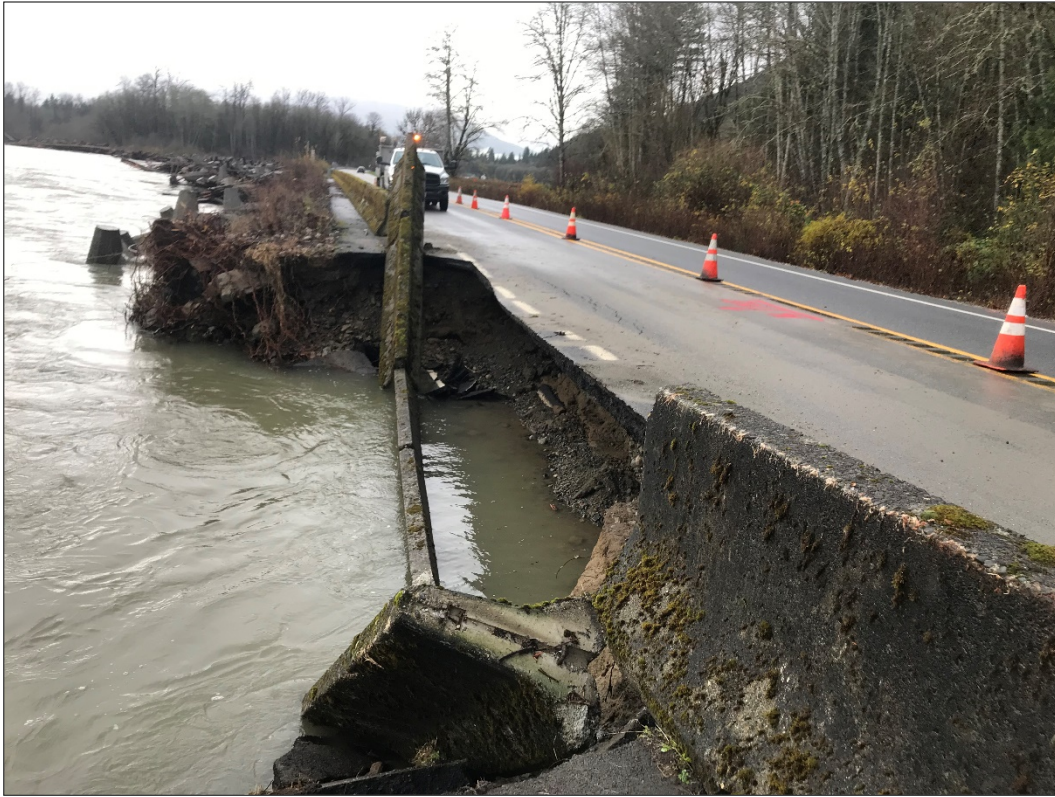
Figure 21. SR 20 Skagit River 2 CED at MP 101 after a high flow event in November 2017. WSDOT is preparing an assessment in conjunction with two other studies to fix this CED.

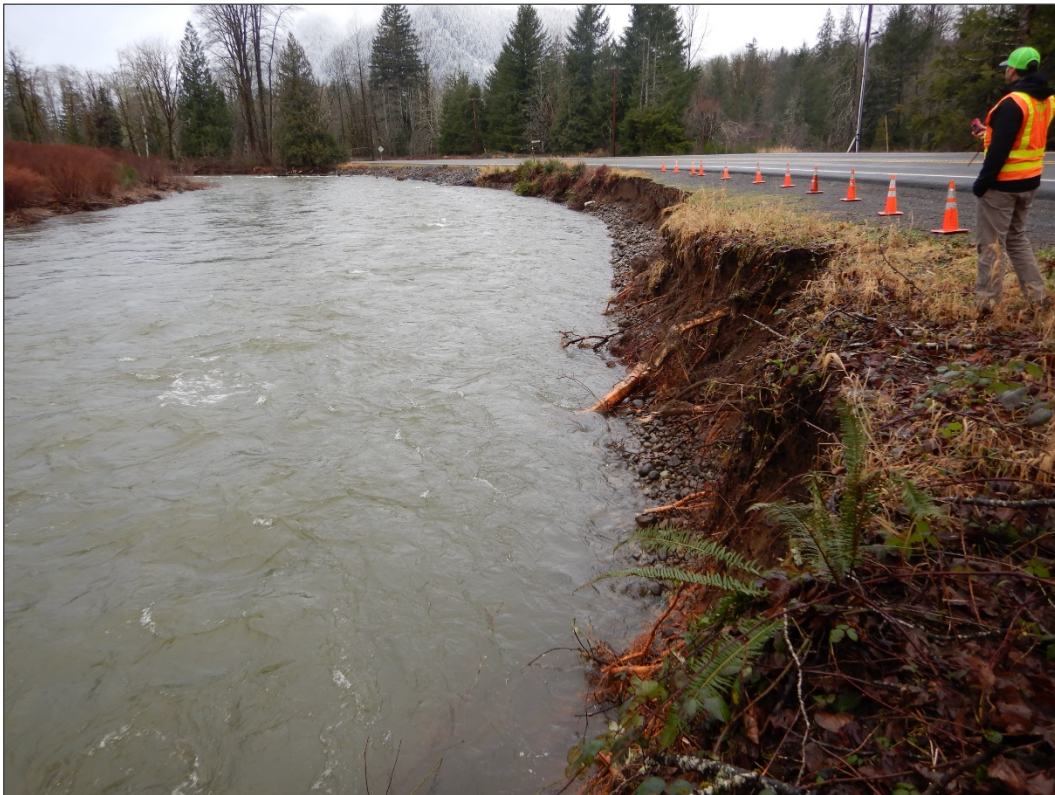
Figure 22. SR 508 Tilton River Morton CED following a high flow event in January 2020, which eroded the embankment upstream of a 2018 CED maintenance repair (shown in background of photo). WSDOT plans to prepare an update to the recently completed 2019 site and reach assessment in order to address current conditions.

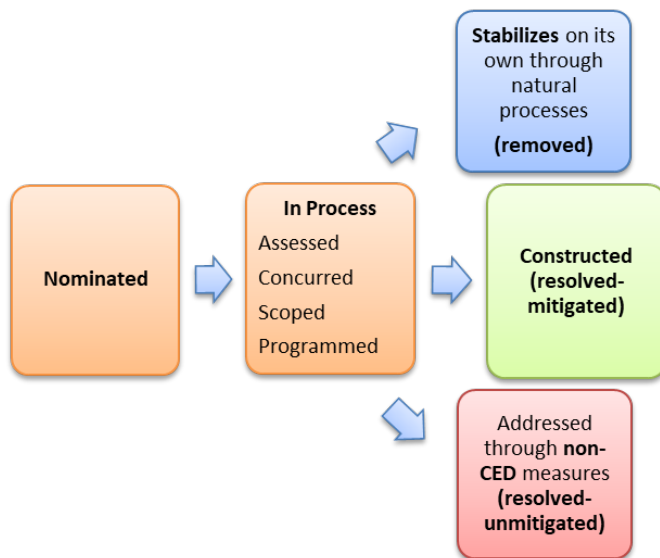
Figure 23. CED status and process.

WSDOT updates the inventory and status of CED sites throughout the year. CED staff review the CED inventory with regional staff, conduct site visits at all potential new CEDs, review Hydraulic Project Approval (HPA) records, and contact WSDOT maintenance to collect updated information on each CED and identify new problem areas. This information is used to document the status of all CEDs. Figure 23 outlines the CED process and the path of a CED from active to resolved or stabilized.

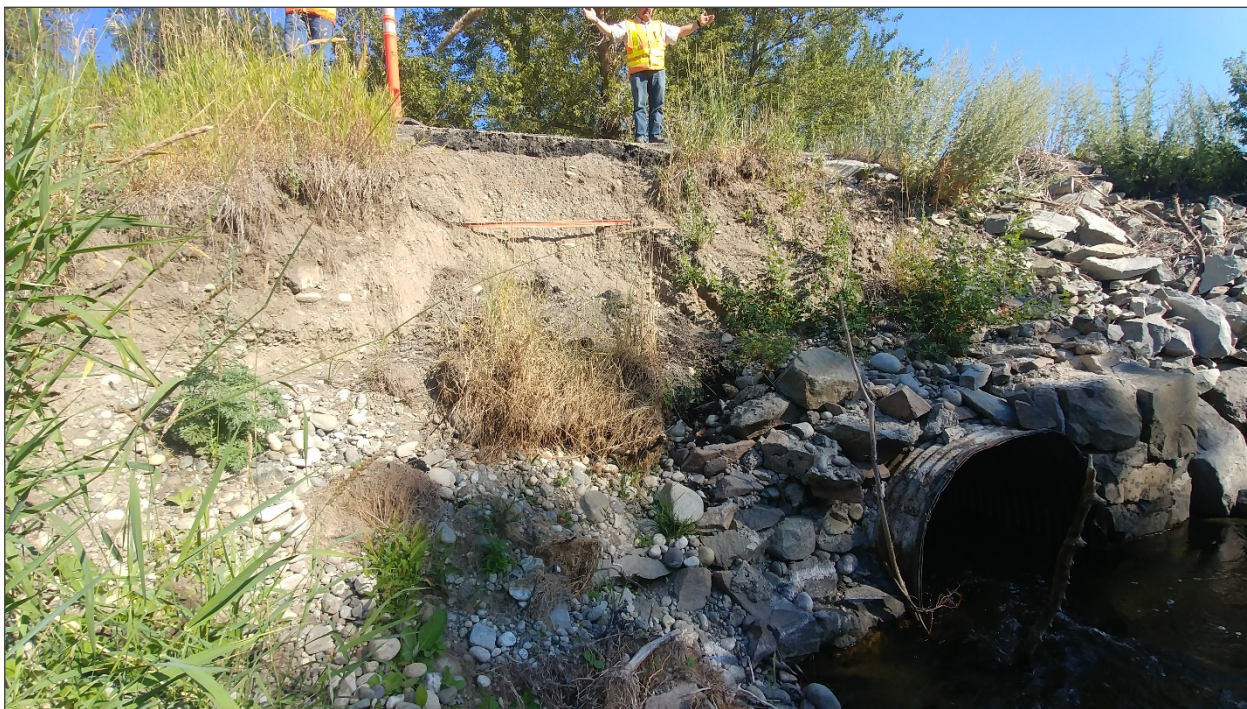
Figure 26. SR 21 Curlew Cr culvert CED, July 2018. Curlew Cr currently approaches the crossing at an angle and erodes the streambank and highway embankment. WSDOT maintenance frequently dredges the inlet of the channel during the frequent emergencies when the culvert gets blocked with sediment.

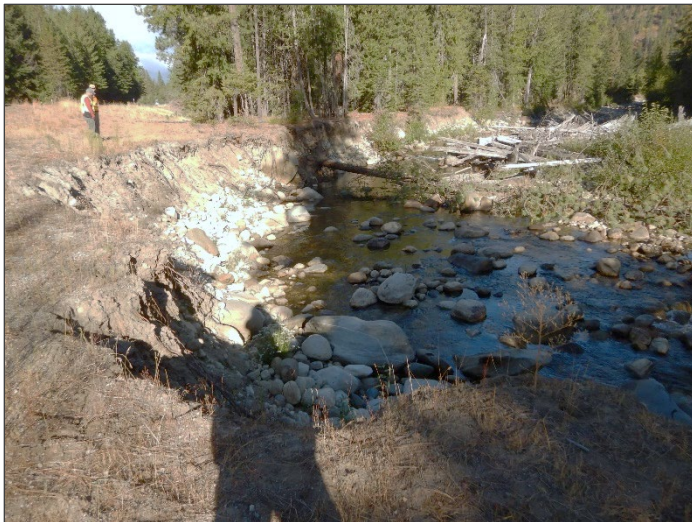
Figure 29. US 2 Nason Cr Kahler CED, September 2018.

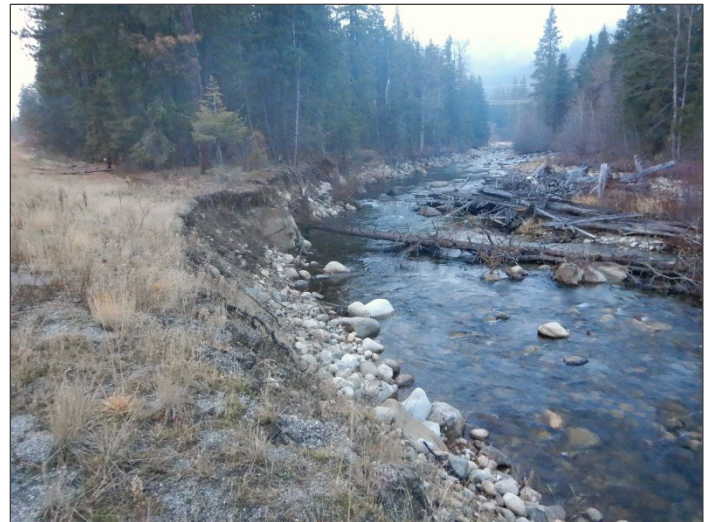
Figure 28. US 2 Nason Cr Kahler CED, November 2019. This site is actively eroding toward US 2.

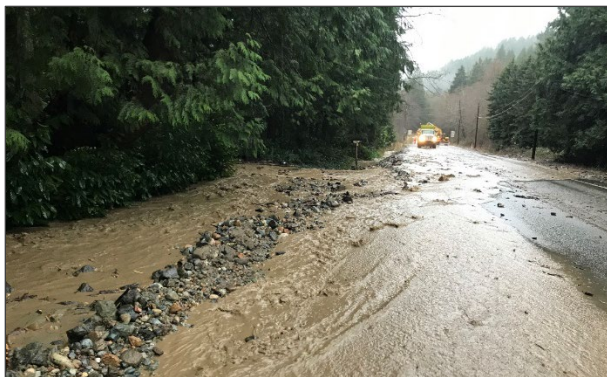
Figure 32. SR 900 May Cr Tributary CED, February 2020. This site was added to the CED list in April 2020.

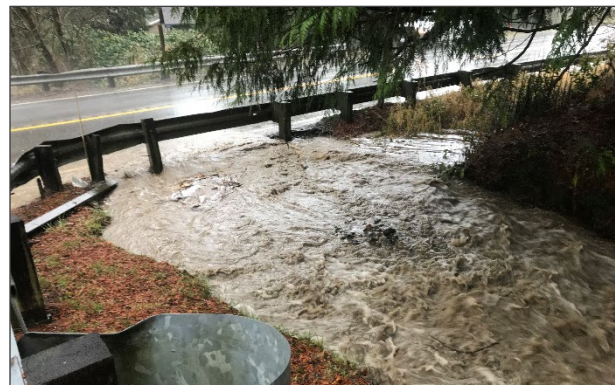
Figure 31. SR 202 Mud Cr CED, December 2019. WSDOT is preparing a site and reach assessment and PHD for a CED / Fish Passage repair at this location.

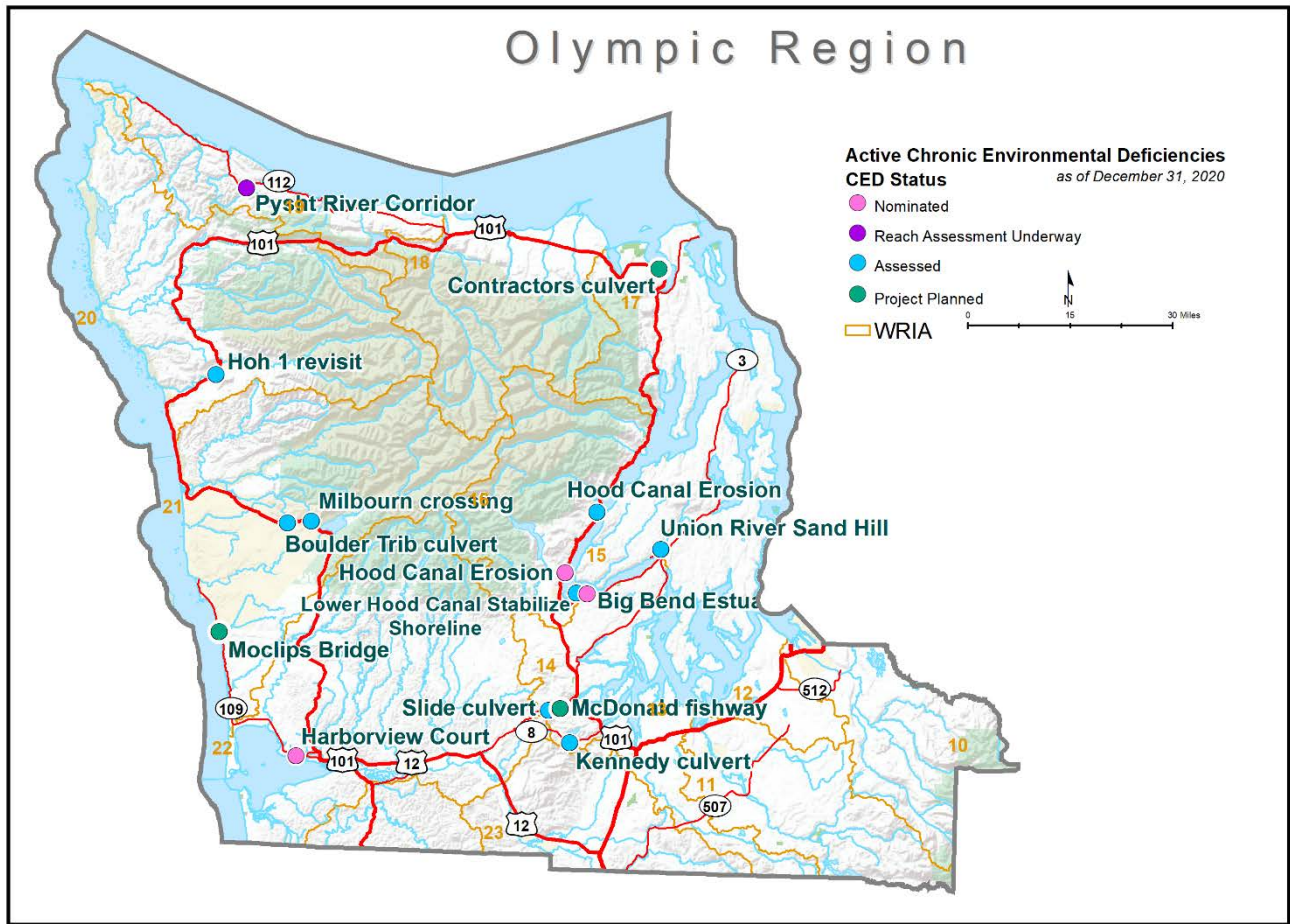
Figure 34. Active CEDs in Olympic Region.

There are 15 active CEDs in Olympic Region. Two of the active CEDs, US 101 Contractors Creek crossing, and SR 108 McDonald Creek crossing are currently in the 21-23 Fish Passage delivery plan for construction (Table 11 and Figure 34).

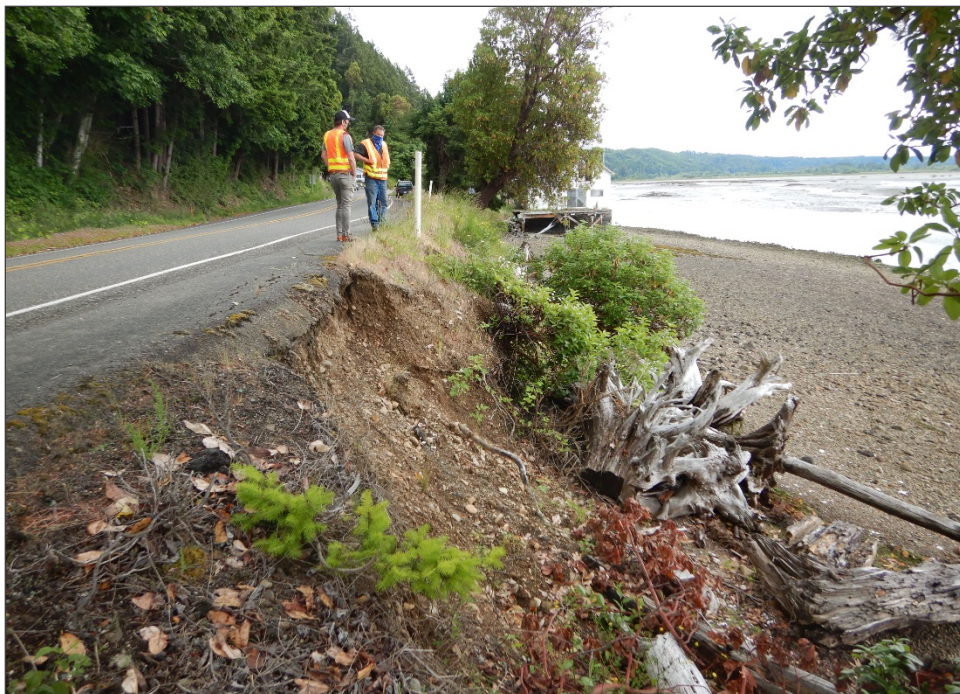
Figure 35. SR 106 Lower Hood Canal Stabilize shoreline CED at MP 5.3, July 2020. This CED consists of a series of small bank washouts along the Hood Canal Shoreline between MP 4.3 and 16.1. This CED is an ongoing effort to address individual sites with various embankment protection techniques including bioengineering and beach nourishment (where feasible).

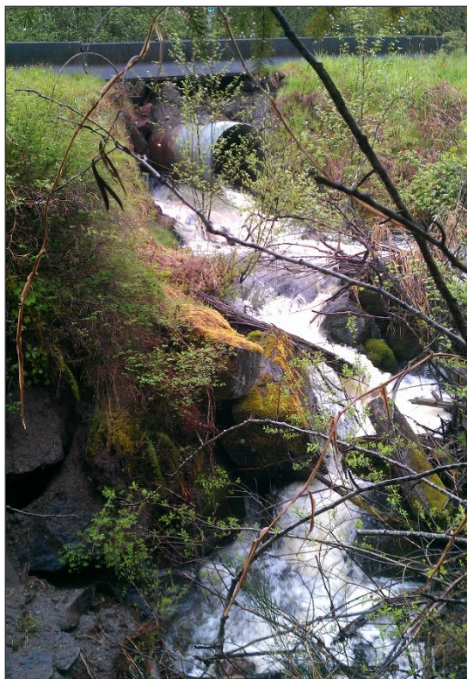
Figure 39. SR 504 Wooster Creek CED, April 2014. The failing culvert had developed a 10-foot cascading elevation drop downstream of the pipe.

The Wooster Creek CED was constructed in 2018. Prior to CED project construction, high sediment loading from the eruption of Mount Saint Helens and interrupted instream processes due to the existence of an undersized culvert under SR 504 had resulted in development of a ten-foot cascading drop downstream of the culvert and creation of a forested wetland upstream (Figure 38 and Figure 39). To provide a continuous stream channel, the new channel would need to be regraded to remove the elevation drop and reach equilibrium. If the regrade was constructed mechanically, it would require up to 400 feet of channel construction upstream of the culvert, which would have significant impacts to the forested wetland upstream. WDFW and WSDOT agreed during the concurrence that despite the risk, allowing the stream channel to regrade naturally would have the least construction impacts and would minimize long-term impacts to the stream corridor and wetland habitat upstream.

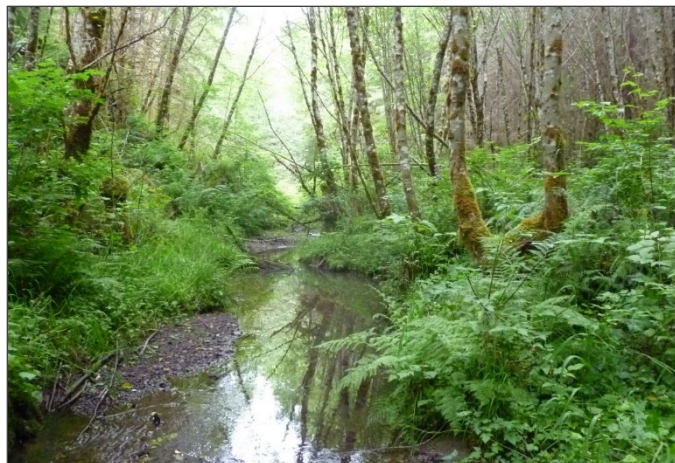
Figure 38. Forested wetland upstream of Wooster Cr crossing prior to construction, April 2014.

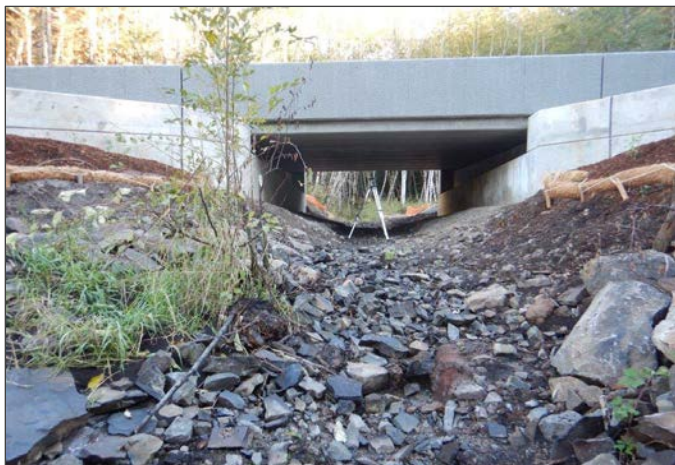
Figure 41. Outlet of the Wooster Creek crossing immediately after construction, October 2018.

In fall 2018, the failing barrier culvert was replaced with a 19-foot span bridge with 35-foot-deep abutments that were designed to allow for up to 14 feet of vertical regrade of the streambed, and would allow the streambed to regrade naturally downstream and upstream of the crossing (Figure 40 and Figure 41).

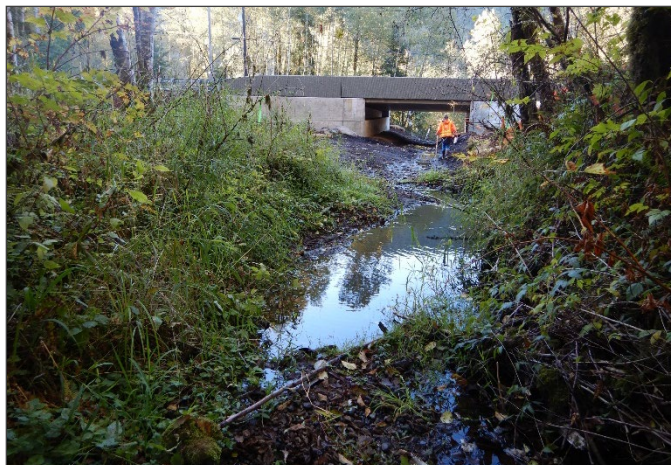
Figure 40. Wooster Creek CED project upstream of the SR 504 crossing, post construction, October 2018.

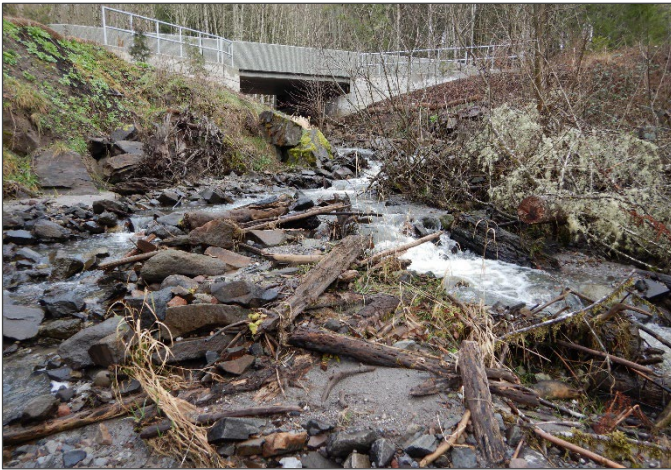
Figure 44. Downstream of Wooster Cr crossing 1.5 years after construction, February 2020.

This site has been closely monitored by WSDOT’s Fish Passage Monitoring Program and WDFW spawning survey crews. A WSDOT fish passage biologist collected channel measurements through the project area immediately post construction, at 6 months, 11 months, 16 months, and 24 months post-construction, and evaluated the success of the project at providing adequate fish passage. The streambed downstream and through the crossing has regraded significantly since construction - up to 3.2 feet at the outlet as of December 2020, and the streambed slope through the project area has decreased to an average 5.6%. The biologist observed pool development, streambed substrate sorting, and braiding of the channel upstream and downstream (Figures 41 to 44 and cover photo).

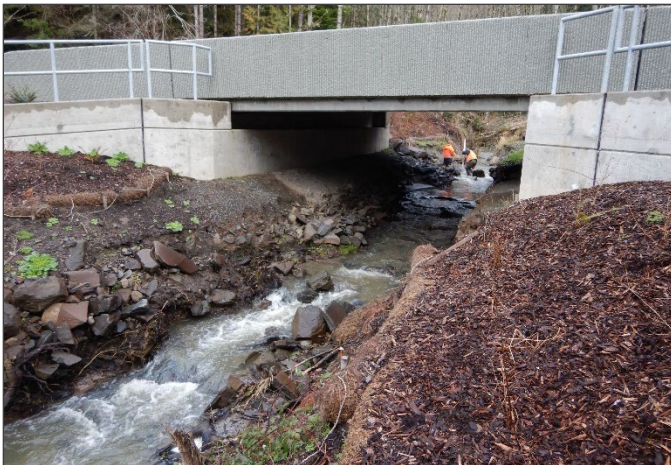
Figure 43. Channel regrade under the Wooster Cr Bridge, February 2020.

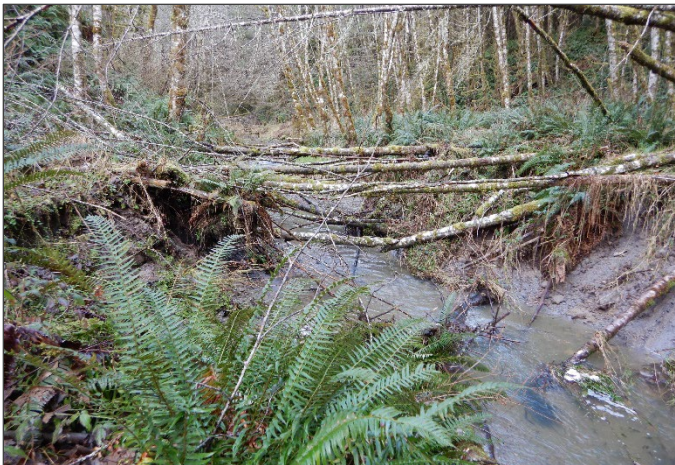
Figure 42. Channel regrade and wood recruitment upstream of the crossing in the forested wetland, 1.5 years post-construction.

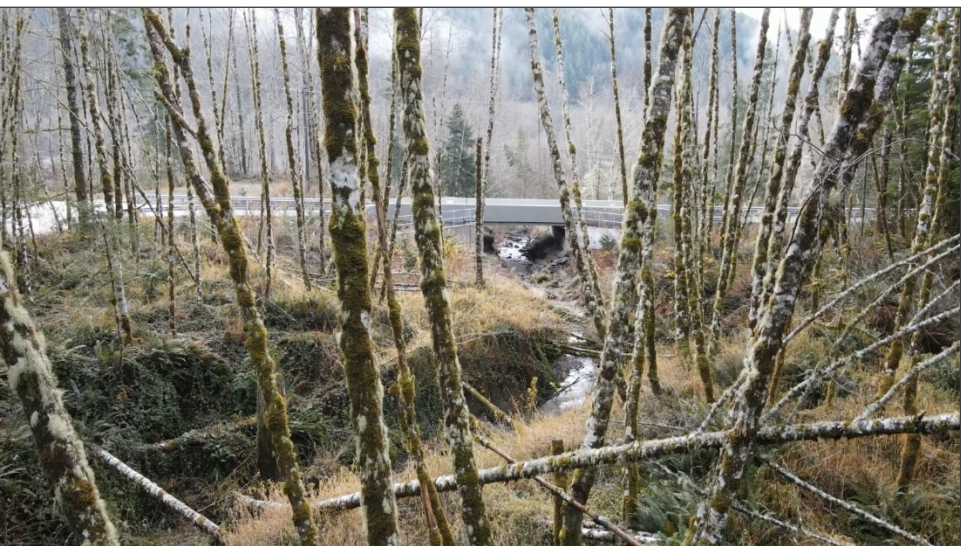
Figure 45. Drone photo of the upstream channel, December 2020.

Upstream of the crossing, incision has recruited streambank trees into the channel providing channel complexity and structure as the channel incises through the wetland. Downstream, temporary debris deposits have formed steps as streambed substrate and wood moves through crossing, gradually reducing the steep cascade in the downstream channel. WDFW spawning survey crews observed five coho redds upstream of the crossing in fall 2020.
