# FINAL WETLAND AND STREAM ASSESSMENT REPORT

## I-5/US 101 McAllister Creek & Mud Bay Bridges - Repair Bridge Piles

Thurston County, Washington

August 11, 2021

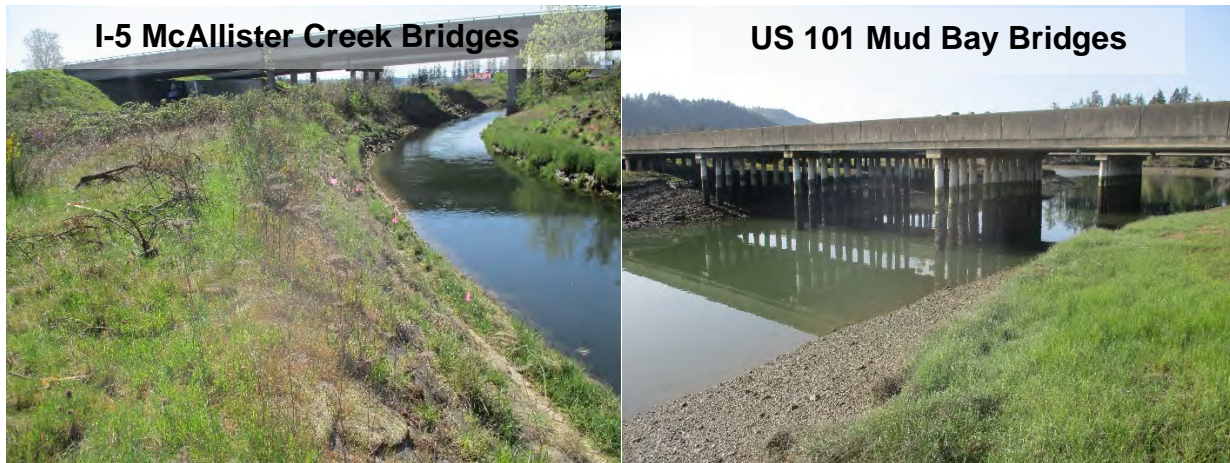
**Figure 2. Landscape setting photos taken on April 19, 2021 at McAllister and April 6, 2021 at Mud Bay**

The landscape in and around the project area is typical of south Puget Sound estuaries. Typical estuarine soils of fine texture overlaying parent material or fill for infrastructure support predominantly native, salt tolerant vegetation, tolerant of regular and occasional tidal inundation. Surrounding upland areas are mixed coniferous and deciduous forests dominated by native trees and shrubs. The banks of McAllister Creek, for the reach within the project limits, are armored with a sackcrete retaining wall, functioning as a dike. Some sections of bank armoring also include rip rap. The shoreline at Mud Bay in the study area is free from armoring, however, fill material was presumably placed to form the US 101 Bridge approaches. Tidal waters are free in this location to influence estuarine and beach formation processes (Figure 2).

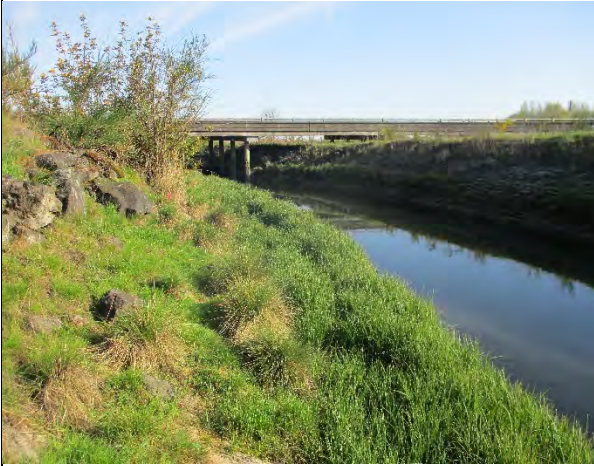
**Table 3. I-5 McAllister Creek - Wetland 1 summary**

<b>I-5 MCALLISTER CREEK WETLAND 1 – INFORMATION SUMMARY</b>		
<b>Location:</b>	West bank of McAllister Creek, between I-5 southbound (SB) lanes and SB on ramp.

<b>Local Jurisdiction</b>	Thurston County
	<b>Ecology Rating (2014)</b>	II
	<b>Local Rating</b>	II
	<b>Thurston County Buffer Width</b>	220 feet
	<b>Wetland Size</b>	~4.14 acres
	<b>Cowardin Class</b>	EEM
	<b>HGM Class</b>	estuarine
	<b>Wetland Data Sheet(s)</b>	Appendix B; Sampling Point W1-SP1
<b>Upland Data Sheet(s)</b>	Appendix B; Sampling Point W1-SP2	
<b>Wetland Delineation</b>		
<b>Dominant Vegetation</b>	Trees – none Shrubs – none Herbaceous – Lyngbye's sedge, inland saltgrass, pickleweed	
<b>Soils</b>	Soils are significantly disturbed due to establishment on a dike retaining wall made of a sackcrete and rip rap. Although hydric soils were not observed, hydric conditions are present. The area has hydrophytic vegetation present and receives daily tidal water inputs, as well as seasonal and occasional riverine hydrologic inputs. Problematic hydric soils are present.

<b>Hydrology</b>	Daily tidal inundation and riverine inputs from McAllister Creek are the primary hydrology source for this wetland. Indicators Saturation (A3), Water Marks (B1), Sediment Deposits (B2), Aquatic Invertebrates (barnacles) (B13), Geomorphic Position (D2), and FAC-Neutral Test (D5) met.	
<b>Rationale for Delineation</b>	Tidally influenced EEM wetland that has strong salt tolerant hydrophytic vegetation community typical of Puget Sound estuaries and tidally influenced areas.	
<b>Wetland Rating</b>		
<b>Rationale for Local Rating</b>	The Thurston County Municipal Code classifies wetlands based on the Washington State Wetland Rating System (Thurston County 2021b). Wetland 1 rates as a Category II.	
<b>Wetland Buffers</b>		
<b>Buffer Condition</b>	Buffers are present west of the wetland but are primarily disturbed herbaceous grass and forb communities formed on fill between the I-5 main line and SB on ramp and provide little buffer function. The buffer also includes a maintenance access road and parking turn around further limiting buffer functions.

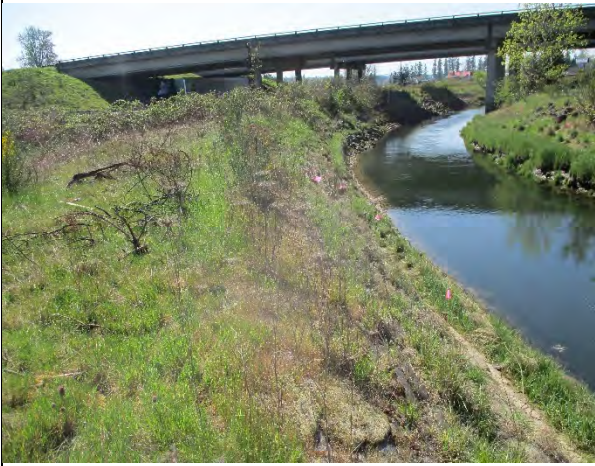
**Table 4. I-5 McAllister Creek - Wetland 2 summary**

<b>I-5 MCALLISTER CREEK WETLAND 2 – INFORMATION SUMMARY</b>		
<b>Location:</b>	East bank of McAllister Creek, between I-5 SB lanes and SB on ramp.

<b>Local Jurisdiction</b>	Thurston County
	<b>Ecology Rating (2014)</b>	II
	<b>Local Rating</b>	II
	<b>Thurston County Buffer Width</b>	220 feet
	<b>Wetland Size</b>	~4.14 acres
	<b>Cowardin Class</b>	EEM
	<b>HGM Class</b>	estuarine
	<b>Wetland Data Sheet(s)</b>	Appendix B; Sampling Point W2-SP1
	<b>Upland Data Sheet(s)</b>	Appendix B; Sampling Point W2-SP2
<b>Wetland Delineation</b>		
<b>Dominant Vegetation</b>	Trees – none Shrubs – none Herbaceous – Lyngbye's sedge, pickleweed	
<b>Soils</b>	Soils are significantly disturbed due to establishment on a dike retaining wall made of a sackcrete. Although hydric soils were not observed, hydric conditions are present. The area has hydrophytic vegetation present and receives daily tidal water, as well as seasonal and occasional riverine hydrologic inputs. Problematic hydric soils are present.

<b>Hydrology</b>	Daily tidal inundation and riverine inputs from McAllister Creek are the primary hydrology source for this wetland. Indicators Water Marks (B1), Sediment Deposits (B2), Geomorphic Position (D2), and FAC-Neutral Test (D5) met. Sample point location occurs in tidally influenced areas with a salt tolerant, hydrophytic vegetation community. The bank was glistening about 12 inches below the Lyngbye's sedge bench during the sit visit and seaweed - Rockweed ( <i>Fucus</i> sp.) was observed just below the sample point location.	
<b>Rationale for Delineation</b>	Tidally influenced EEM wetland that has strong salt tolerant, hydrophytic vegetation community typical of Puget Sound estuaries and tidally influenced areas.	
<b>Wetland Rating</b>		
<b>Rationale for Local Rating</b>	The Thurston County Municipal Code classifies wetlands based on the Washington State Wetland Rating System (Thurston County 2021b). Wetland 2 rates as a Category II.

<b>Wetland Buffers</b>		
<b>Buffer Condition</b>	Buffers are present east of the wetland on the dike. Buffers are disturbed and provide little buffering function. Vegetation is a mix of native and introduced herbaceous species with some scattered Scotch broom individuals.

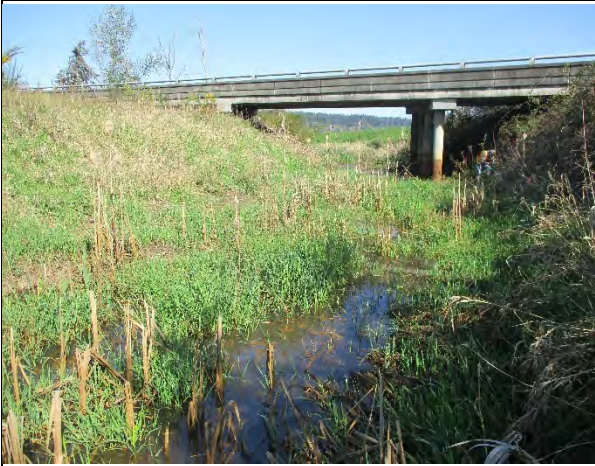
**Table 5. I-5 McAllister Creek - Wetland 3 summary**

<b>I-5 MCALLISTER CREEK WETLAND 3 – INFORMATION SUMMARY</b>		
<b>Location:</b>	Slough channel west of Brown Farm Rd., east of McAllister Creek, between I-5 SB lanes and SB on ramp.

<b>Local Jurisdiction</b>	Thurston County
	<b>Ecology Rating (2014)</b>	II
	<b>Local Rating</b>	II
	<b>Thurston County Buffer Width</b>	160 feet
	<b>Wetland Size</b>	~1.23 acres
	<b>Cowardin Class</b>	PEM
	<b>HGM Class</b>	depressional
	<b>Wetland Data Sheet(s)</b>	Appendix B; Sampling Point W3-SP1
	<b>Upland Data Sheet(s)</b>	Appendix B; Sampling Point W3-SP2
<b>Wetland Delineation</b>		
<b>Dominant Vegetation</b>	Trees – none Shrubs – Sitka willow ( <i>Salix sitchensis</i> ) Herbaceous – reed canarygrass, broadleaf cattail, bird's-foot trefoil	
<b>Soils</b>	Soil was inundated and soil pit was not excavated. The soil meets the definition of a hydric soil due to prolonged presence of inundation, soil saturation, and high water table during the growing season, along with presence of a hydrophytic vegetation community.

<b>Hydrology</b>	This wetland is a channel that appears to currently be functioning as a closed depression. The wetland is surrounded by Brown Farm Rd. to the east and the east bank of the McAllister Creek dike to the west. The northern, down gradient portion has an apparently non-function tide gate, acting as a closed depression. It appears a high groundwater table is the primary source of hydrology for this wetland and provides a long duration of wetland hydrology throughout the growing season. Indicators Surface Water (A1), High Water Table (A2), Saturation (A3), Geomorphic Position (D2), and FAC-Neutral Test (D5) met.	
<b>Rationale for Delineation</b>	Depressional wetland which supports hydrophytic vegetation, has hydric soils, and shallow inundation, high water table, and soil saturation in April. Hydrophytic vegetation and wetland hydrology indicators were helpful in determining the wetland boundary.

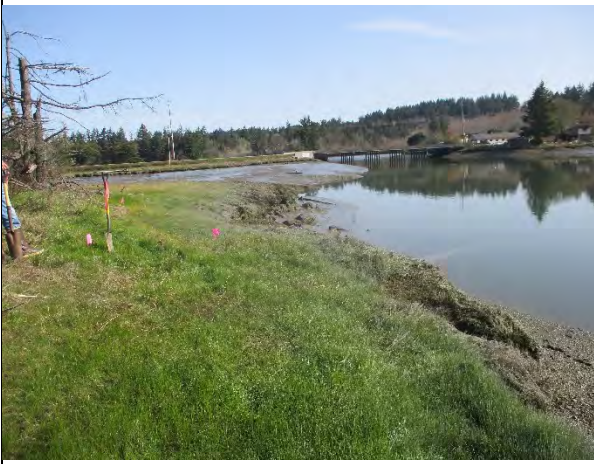
**Table 6. US 101 Mud Bay - Wetland 1 summary**

<b>US 101 MUD BAY WETLAND 1 – INFORMATION SUMMARY</b>		
<b>Location:</b>	Northwest side of Mud Bay, below US 101 Mud Bay Bridges.

<b>Local Jurisdiction</b>	Thurston County
	<b>Ecology Rating (2014)</b>	II
	<b>Local Rating</b>	II
	<b>Thurston County Buffer Width</b>	220 feet
	<b>Wetland Size</b>	~1.92 acres
	<b>Cowardin Class</b>	EEM
	<b>HGM Class</b>	estuarine
	<b>Wetland Data Sheet(s)</b>	Appendix B; Sampling Point W1-SP1
	<b>Upland Data Sheet(s)</b>	Appendix B; Sampling Point W1-SP2
<b>Wetland Delineation</b>		
<b>Dominant Vegetation</b>	Trees – none Shrubs – none Herbaceous – black rush, pickleweed, inland saltgrass	
<b>Soils</b>	Soil matrices of 10YR 4/2 and 2.5Y 6/3 were observed throughout the upper 16 inches of the soil surface. Redoximorphic concentrations or depletions were not observed. This wetland occurs in a tidally influenced area where tidal inundation and tidally driven high groundwater regularly provide hydrologic inputs. Despite the soil not meeting an indicator it is a hydric soil due to regular wetland hydrology inputs during the growing season, the hydrophytic, salt-tolerant vegetation community, and the landscape setting and geomorphology.

<b>Hydrology</b>	Daily tidal inundation and associated groundwater from Mud Bay are the primary hydrology source for this wetland. Indicators Saturation (A3), Geomorphic Position (D2), and FAC-Neutral Test (D5) met.	
<b>Rationale for Delineation</b>	Estuarine wetland with a salt tolerant, hydrophytic vegetation community. Wetland occurs in the intertidal zone of Puget Sound and regularly has surface and subsurface tidal water inputs.	
<b>Wetland Rating</b>		
<b>Rationale for Local Rating</b>	The Thurston County Municipal Code classifies wetlands based on the Washington State Wetland Rating System (Thurston County 2021b). Wetland 1 rates as a Category II.	
<b>Wetland Buffers</b>		
<b>Buffer Condition</b>	Buffers west of the wetland are dominated by an herbaceous community of primarily introduced grasses and other forb species. Some trees and shrubs are present. Scotch broom and Himalayan blackberry are also scattered. The buffer provides limited buffering functions for habitat, water quality, and screening. The wetland is bordered by the tidal water of Mud Bay to the east.

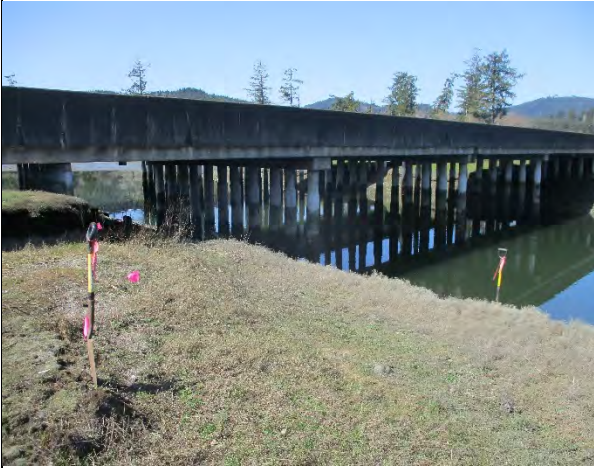
**Table 7. US 101 Mud Bay - Wetland 2 summary**

<b>US 101 MUD BAY WETLAND 2 – INFORMATION SUMMARY</b>		
<b>Location:</b>	Southeast side of Mud Bay, below US 101 Mud Bay Bridges.

<b>Local Jurisdiction</b>	Thurston County
	<b>Ecology Rating (2014)</b>	II
	<b>Local Rating</b>	II
	<b>Thurston County Buffer Width</b>	220 feet
	<b>Wetland Size</b>	~2.49 acres
	<b>Cowardin Class</b>	EEM
	<b>HGM Class</b>	estuarine
	<b>Wetland Data Sheet(s)</b>	Appendix B; Sampling Point W2-SP1
	<b>Upland Data Sheet(s)</b>	Appendix B; Sampling Point W2-SP2
<b>Wetland Delineation</b>		
<b>Dominant Vegetation</b>	Trees – none Shrubs – none Herbaceous – pickleweed, black rush, Puget Sound gumweed	
<b>Soils</b>	Soil matrices of 2.5Y 4/3 were observed throughout the upper 16 inches of the soil surface. Redoximorphic concentrations or depletions were not observed. This wetland occurs in a tidally influenced area where tidal inundation and tidally driven high groundwater regularly provide hydrologic inputs. Despite the soil not meeting an indicator it is a hydric soil due to regular wetland hydrology inputs during the growing season. The hydrophytic, salt-tolerant vegetation community, and the landscape setting and geomorphology further support this assertion.

<b>Hydrology</b>	Daily tidal inundation and associated groundwater from Mud Bay are the primary hydrology source for this wetland. Indicators Drift Deposits (B3), Geomorphic Position (D2), and FAC-Neutral Test (D5) met.	
<b>Rationale for Delineation</b>	Estuarine wetland with a salt tolerant, hydrophytic vegetation community. Wetland occurs in the intertidal zone of Puget Sound and regularly has surface and subsurface tidal water inputs.	
<b>Wetland Rating</b>		
<b>Rationale for Local Rating</b>	The Thurston County Municipal Code classifies wetlands based on the Washington State Wetland Rating System (Thurston County 2021b). Wetland 2 rates as a Category II.	
<b>Wetland Buffers</b>		
<b>Buffer Condition</b>	Buffers east of the wetland are dominated by an herbaceous community of primarily introduced grasses and other forb species. Native woody saplings and shrubs are also present with several scattered Scotch broom. A small clump of Douglas-fir is present in the buffer. The buffer provides limited buffering functions for habitat and water quality. The small woody plant community does provide some screening functions. The wetland is bordered by the tidal water of Mud Bay to the west.

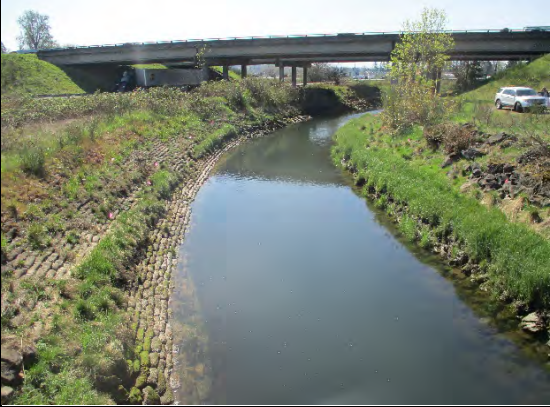
**Table 9. McAllister Creek summary.**

<b>MCALLISTER CREEK - INFORMATION SUMMARY</b>

<table><tr> <td><b>Stream Name</b></td> <td>McAllister Creek</td> </tr></table>

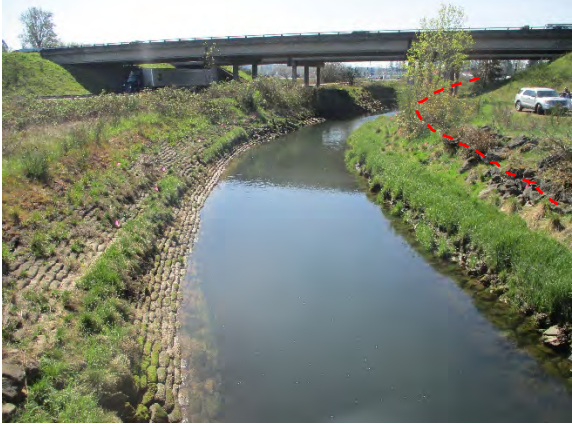
**Table 10. HTL summary I-5 McAllister Creek Bridges.**

HTL I-5 MCALLISTER CREEK BRIDGES - INFORMATION SUMMARY

<table><tr> <td><b>Waterbody Name</b></td> <td>Nisqually Flats, Nisqually Reach</td> </tr></table>

To locate the HTL at I-5 McAllister Creek Bridges biologists found field indicators of the 12.94-foot higher high tide line on the day of field work and estimated an additional 3.31 feet up from that point to find the HPT elevation of 16.25 feet. To locate the HTL at US 101 Mud Bay Bridges biologists found field indicators of the 13.65-foot higher high tide line on the day of field work and estimated an additional 2.6 feet up from that point to find the HPT elevation of 16.25 feet. Once the HPT elevation was determined at each site, biologists searched for HTL field indicators, and at both sites confirmed field indicators correlated with the HPT elevation.

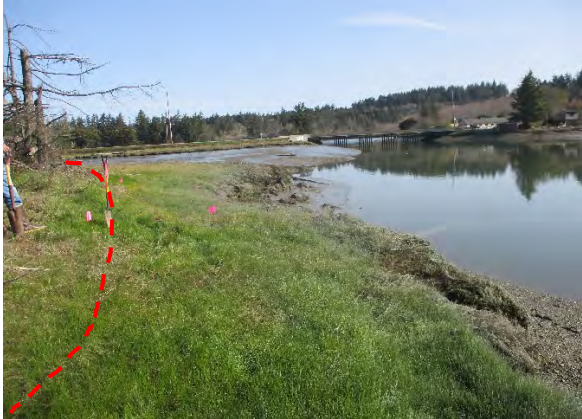
**Table 11. HTL summary US 101 Mud Bay Bridges.**

HTL I-5 MUD BAY BRIDGES - INFORMATION SUMMARY

<table><tr> <td><b>Waterbody Name</b></td> <td>Mud Bay, Eld Inlet</td> </tr></table>

Field indicators in relation to HPT were used to place the HTL at an elevation of 16.25 feet relative to mean lower low water (MLLW) of 0 at Budd Inlet, South of Gull Harbor Station 9446807 at both I-5 McAllister Creek Bridges and US 101 Mud Bay Bridges. The observed HTL field indicators matched the 10-year average of the HPT of 16.25 feet. The PEO applied the 16.25 foot elevation of HTL across both sites based on topographic elevations. Field indicators (Figure 7; Figure 8), summary of HTL info (Table 10; Table 11), 10-year average HPT data (Appendix E), and plan sheets showing HLT boundary (Appendix F) are provided.
