**SR 539 Widening Project: Horton Road to Tenmile Road (MP
1.64 to MP 6.26) (Strand Road) Mitigation Site
WIN #A53902D**

2010 MONITORING REPORT

Wetland Assessment and Monitoring Program

Issued March 2011

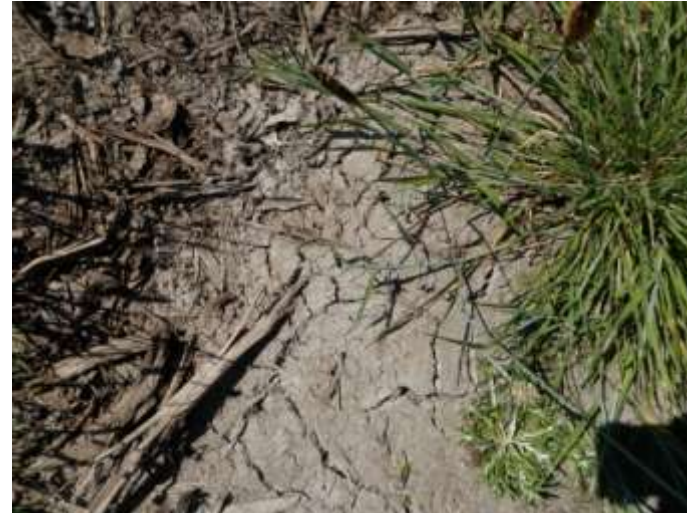
The wetland monitoring staff did not receive information regarding this site in time for hydrology monitoring. However, during vegetation monitoring in the summer, hydrology indicators were observed including soil cracks, water marks, and erosion of mulch from run-off (Photo 1). The high survival rate of facultative and wetter species also suggests the presence of wetland hydrology.

Photo 1
Soil cracks in the scrub-shrub wetland (July 2010)

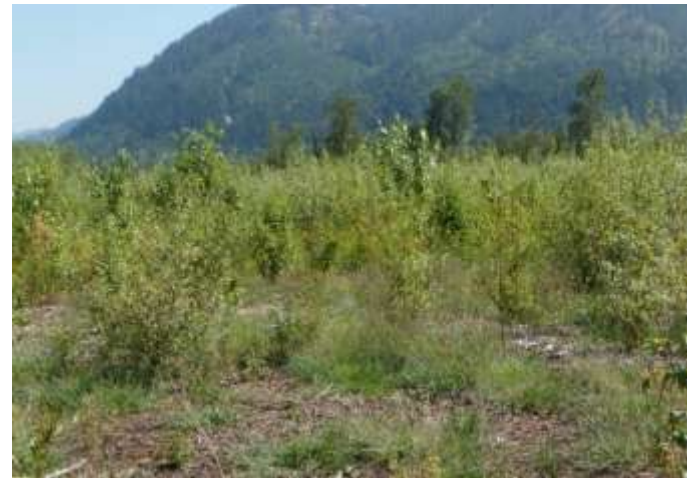
Survival of woody species across the site is 96% ($CI_{80\%} = 95-96\%$). Most species displayed vigorous growth (Photo 2). Dominant species include willows (*Salix* spp.), redosier dogwood (*Cornus sericea*), roses (*Rosa* spp.), and twinberry honeysuckle (*Lonicera involucrata*).

Photo 2
Woody cover in the wetland (July 2010)
