Tarlatt Slough Mitigation Site

USACE NWS-2009-048

2014 MONITORING REPORT

Wetlands Program

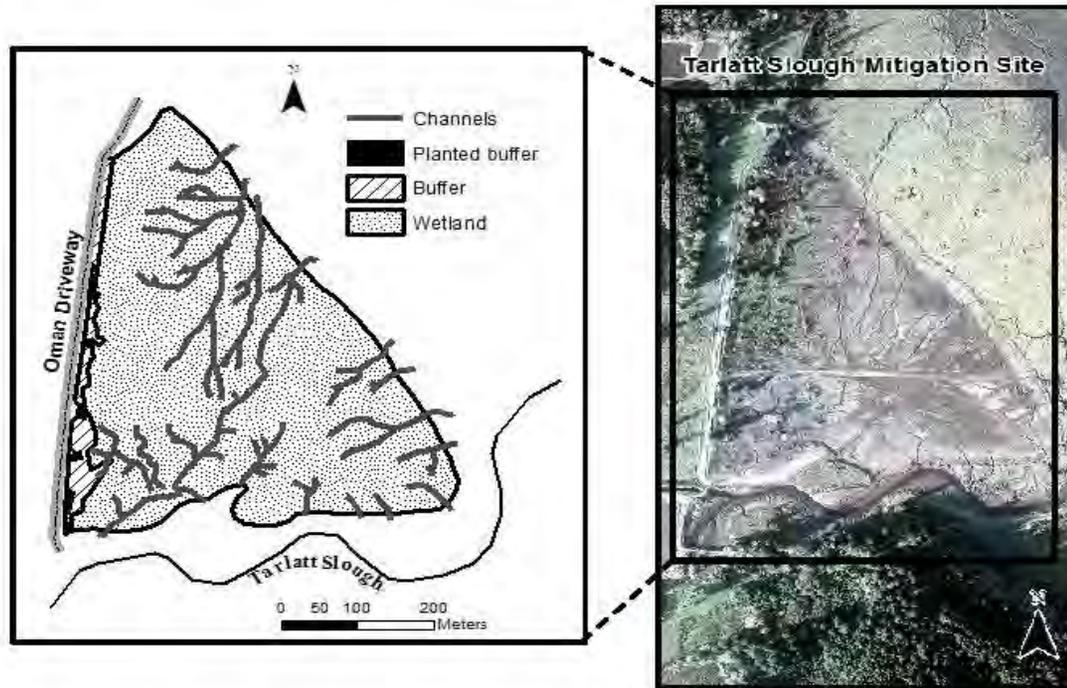
Figure 1 Site Sketch

The Tarlatt Slough Mitigation Site contains an upland buffer area along the west side with five planting areas, and channels running through the re-established and rehabilitated wetland. Appendix 2 includes site directions.

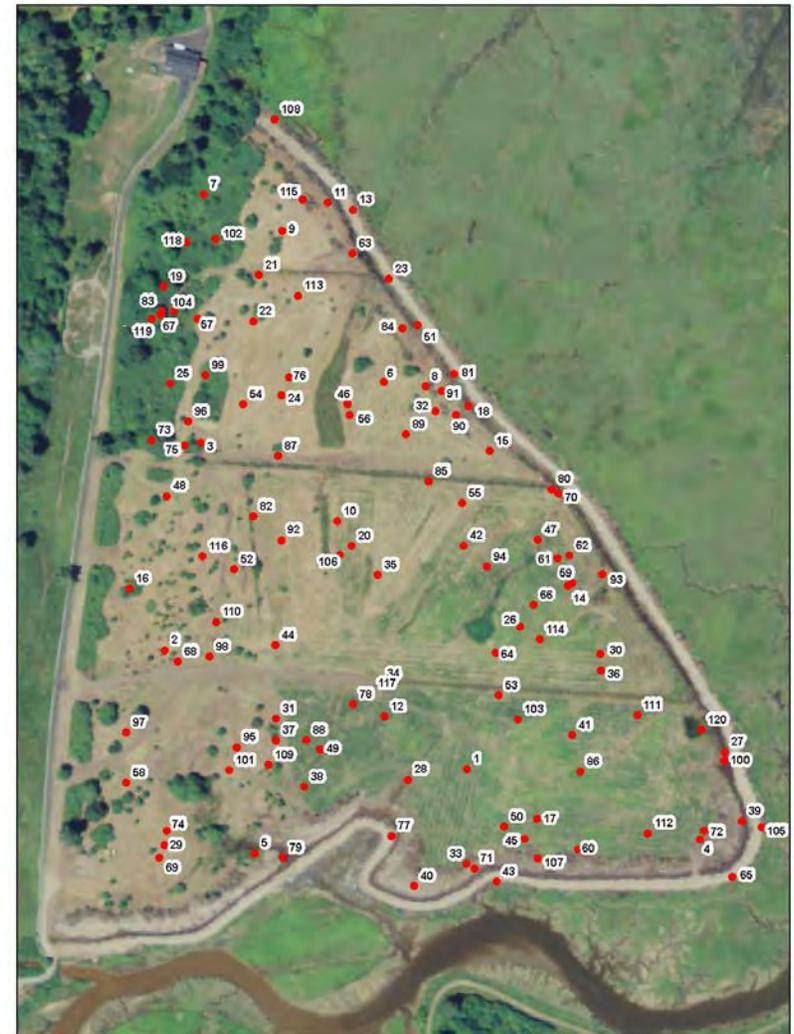
Figure 2 Site Sampling Design (2014)

Several methods were used to evaluate vegetation at the site. Permanent photo points were established for photo documentation of wetland vegetation establishment during the growing season (Performance Standard 4) (Appendix 2). To assess plant community development, 120 permanent plots were set up across the site to monitor the vegetation community over time (Performance Standard 5) (Figure 2). All plant species were identified. Density in the planted buffer was calculated by counting all native woody plants within the planted areas and dividing that number by the area of the planted buffer zone (Appendix 1) (Performance Standard 6). Class A weeds and Pacific County-designated Class B weeds were searched for and identified (Performance Standard 7). Cover of non-designated Class B weeds and non-native blackberries in the upland buffer and wetland was visually estimated (Performance Standards 8 and 9).

Photo documentation and mapping were used to assess tidal and channel performance standards. WSDOT staff photographed the extent of tidal inundation during a high tide event predicted by NOAA (2014) to exceed nine-and-a-half feet above sea level at the Tarlatt Slough Tide Station (Performance Standard 1) (Photo 1). Photo points were established to record and assess natural channel processes and development (Performance Standard 2) (Appendix 2). The restored channel network was mapped using a 2013 aerial photograph to determine the total length of tidal channel present (Performance Standard 3) (Appendix 3).

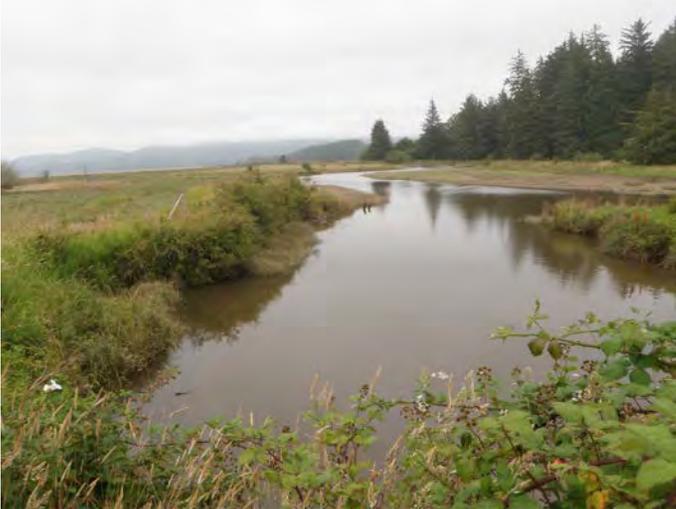
Photo 1
One hour before high-tide (July 14, 2014)

Evidence of natural tidal cycles across the restored tidal wetland was found (Photo 1). High-tide occurred at 4:32 PM on July 14, and was 8.85 feet above sea level at the Tarlatt Slough Tide Station (NOAA 2014). Photo 1 was taken at the Tarlatt Slough mitigation site at 3:31 PM, when the tide was approximately 8.00 feet above sea level.

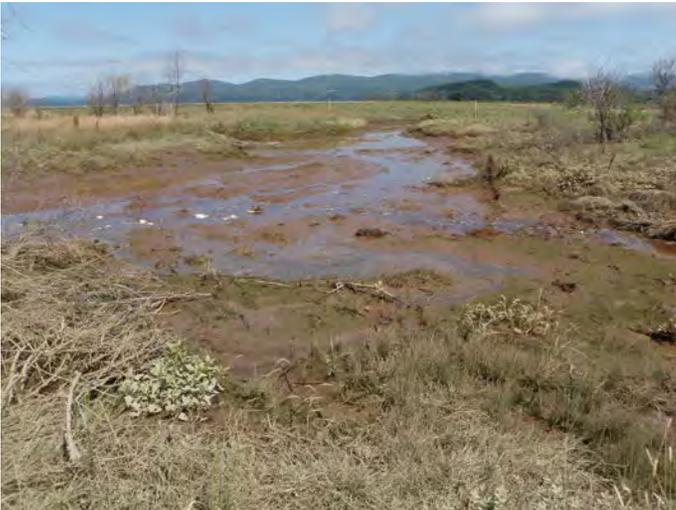
Photo 2
Restored natural channel (July 2014)

Natural channel processes appear to be developing (Photo 2). Photo documentation was taken at fixed photo points (Appendix 2).

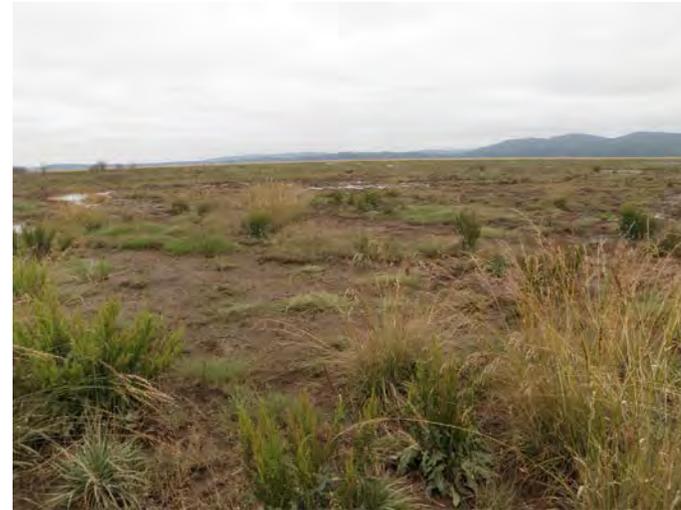
Photo 3
Wetland vegetation (July 2014)

Vegetation in the wetland is recolonizing and becoming established (Photo 3). Photo documentation was taken at fixed photo points (Appendix 2).

Dominant species are inland saltgrass (*Distichlis spicata*) and tufted hairgrass (*Deschampsia caespitosa*) (Photo 3).

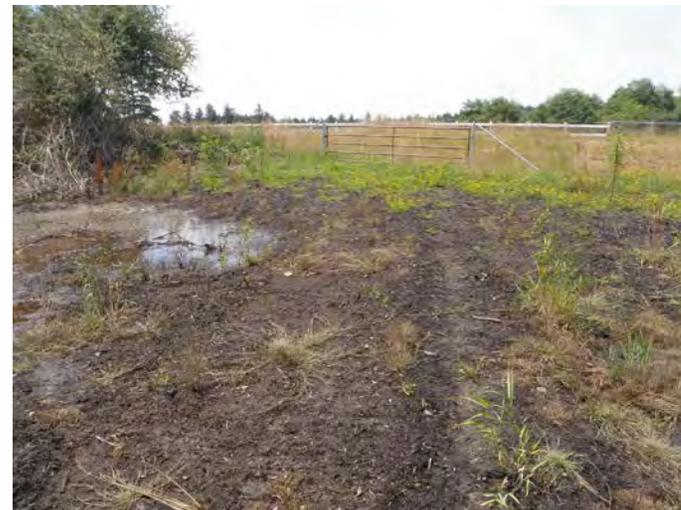
Photo 4
Density in buffer (July 2014)

Density in the buffer is 5.7 native woody plants/100ft² (Photo 4). This value exceeds the performance standard target. Nootka rose (*Rosa nutkana*) is the dominate species, and Sitka spruce (*Picea sitchensis*) and Pacific crabapple (*Malus fusca*) were also observed.

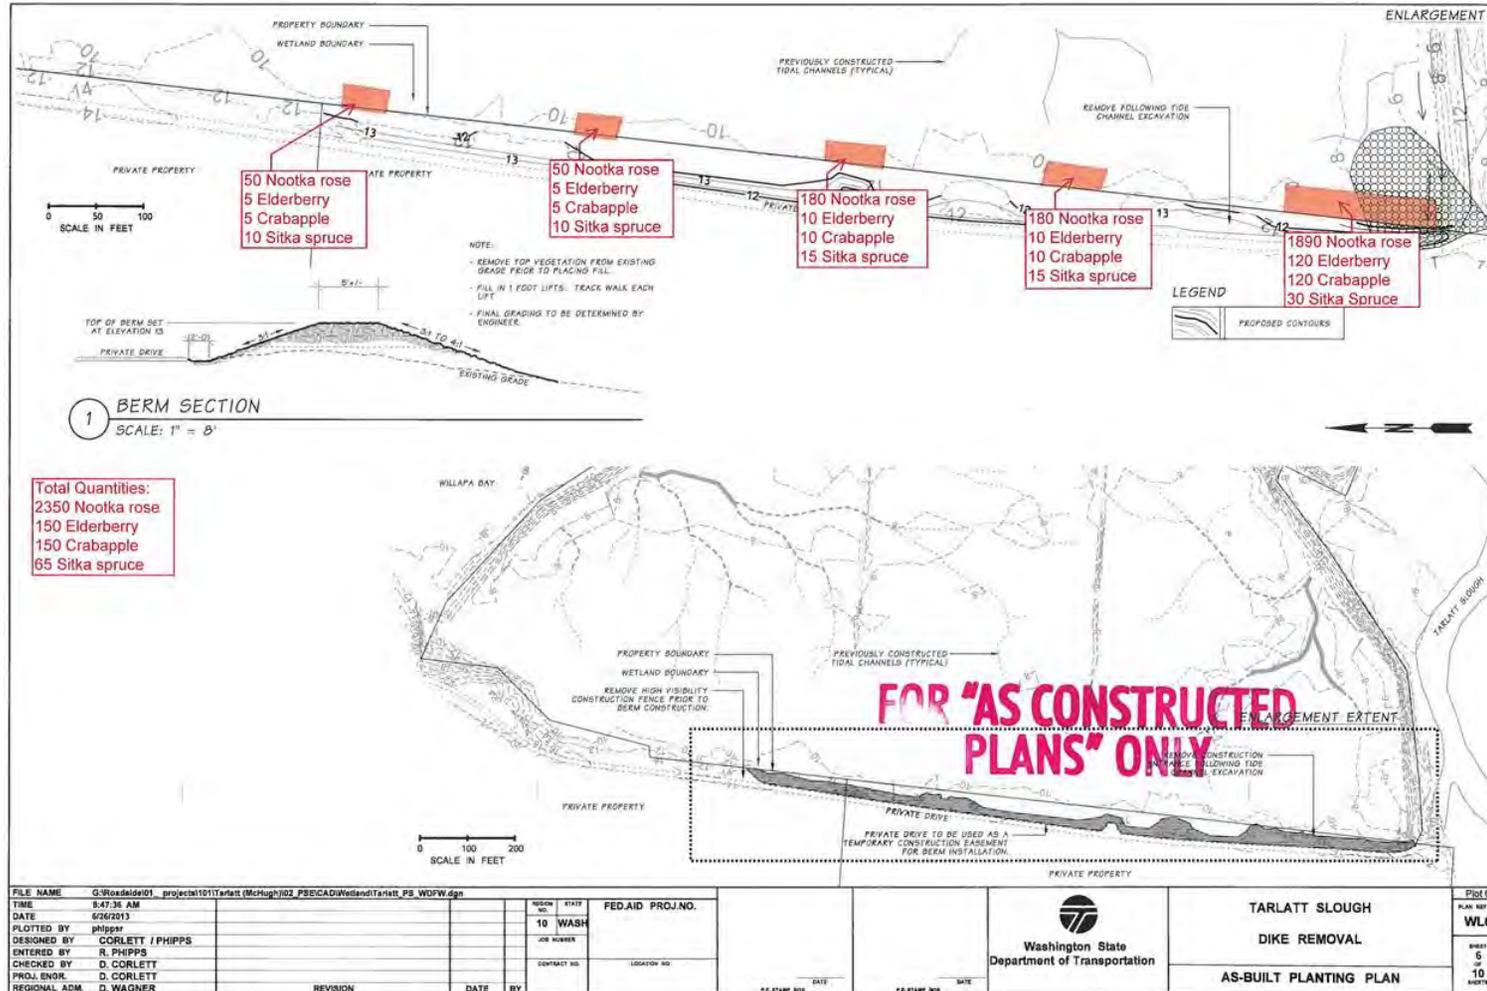
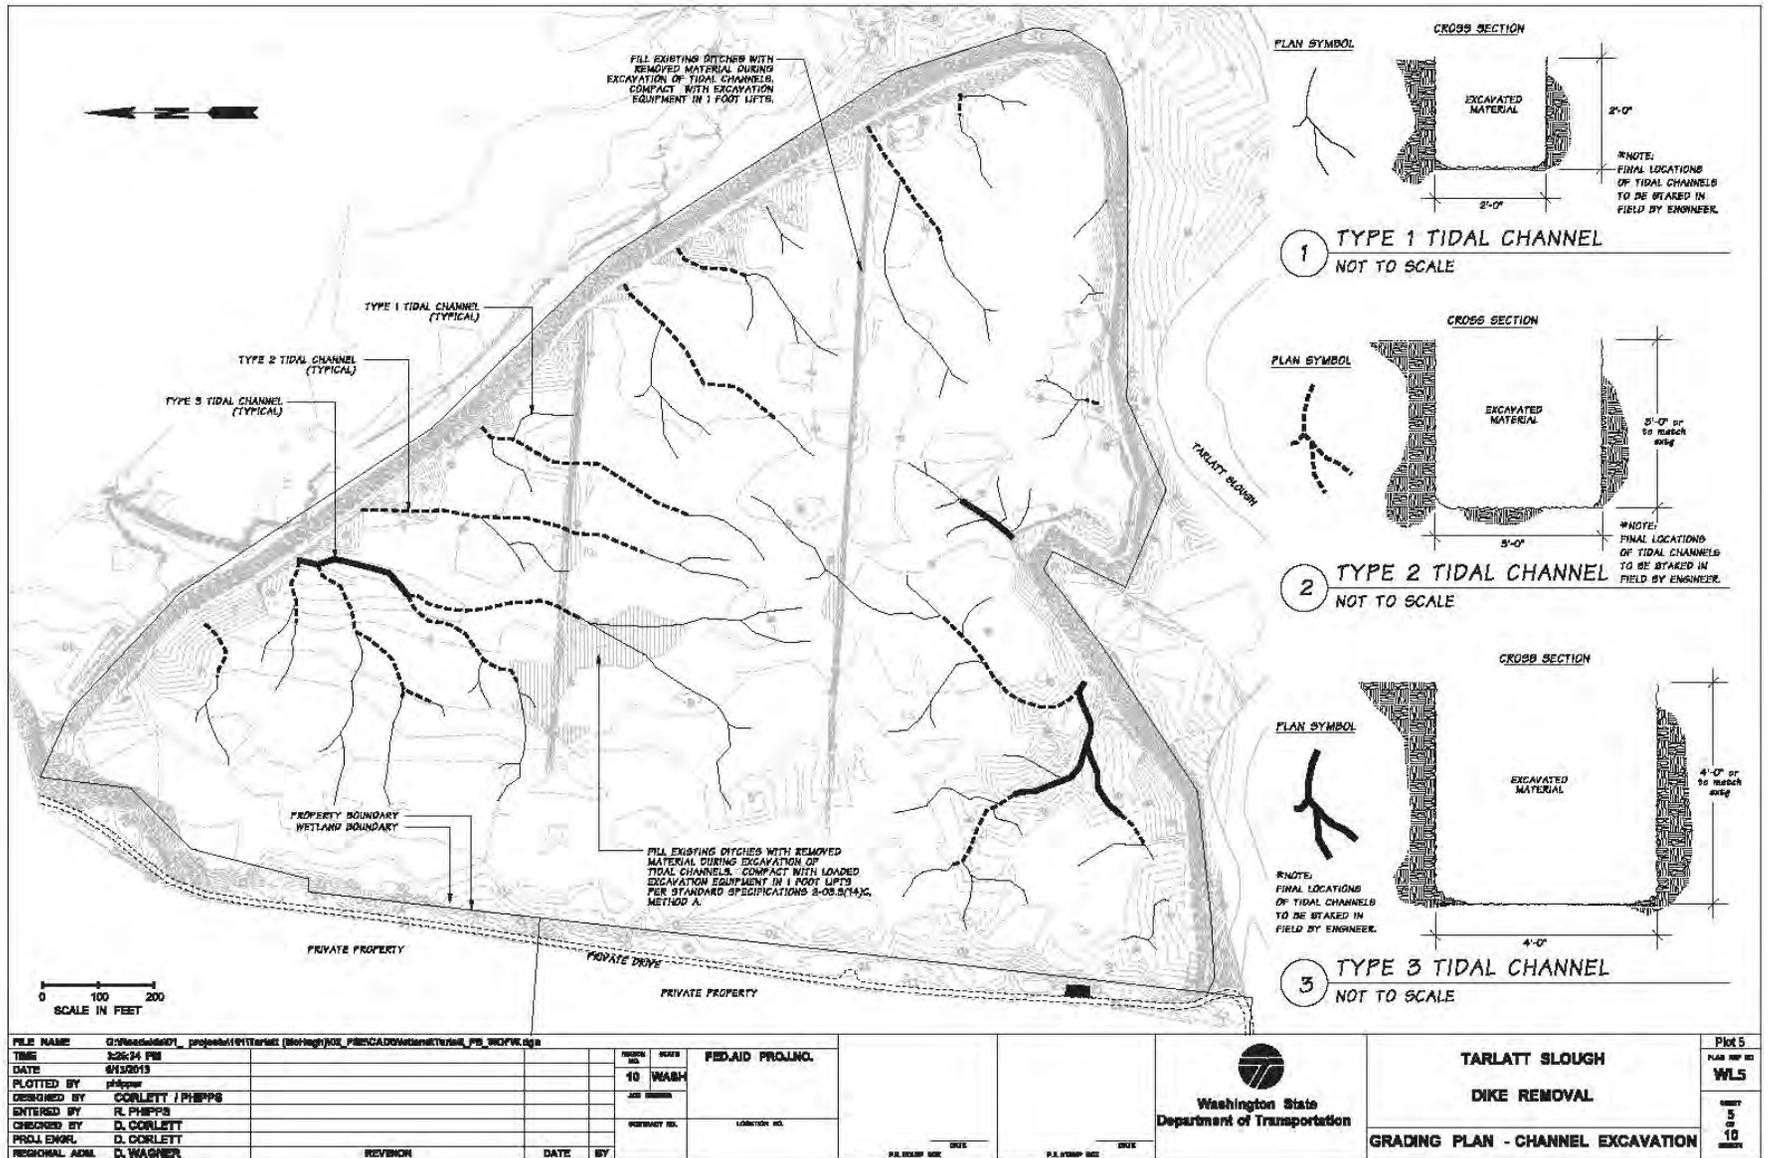
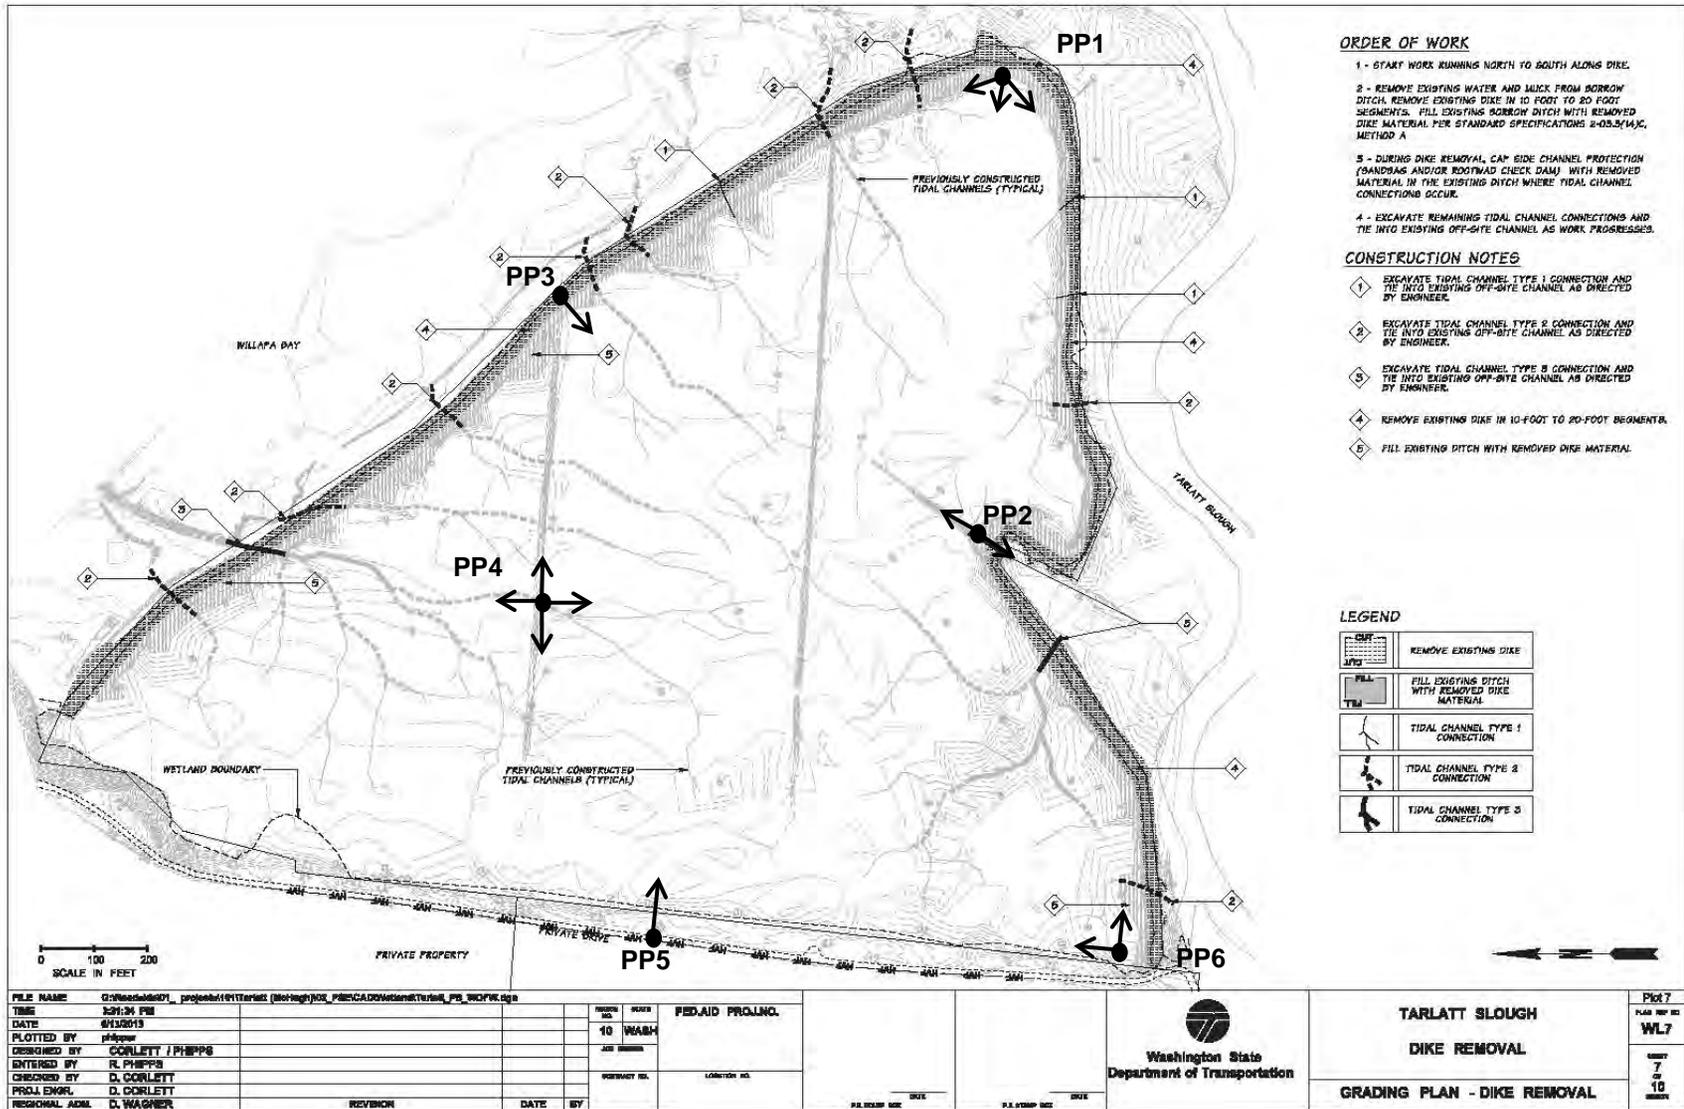
Appendix 1 – As-Built Planting Plan, Grading Plans with Photo Point Locations, and Buffer Planting Areas

Appendix 1 shows the as-built planting plan (WSDOT 2013).

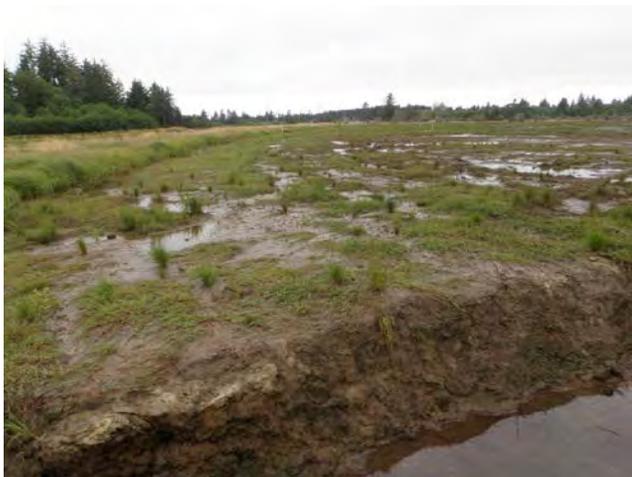
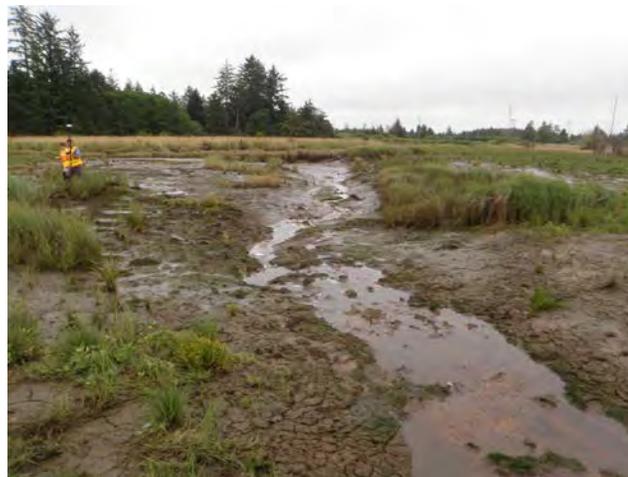
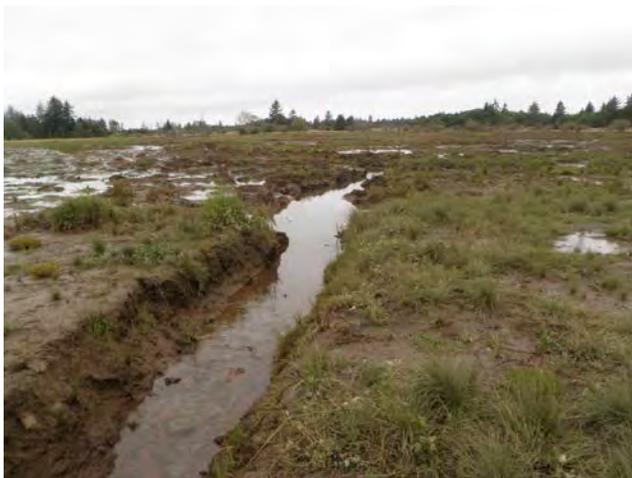
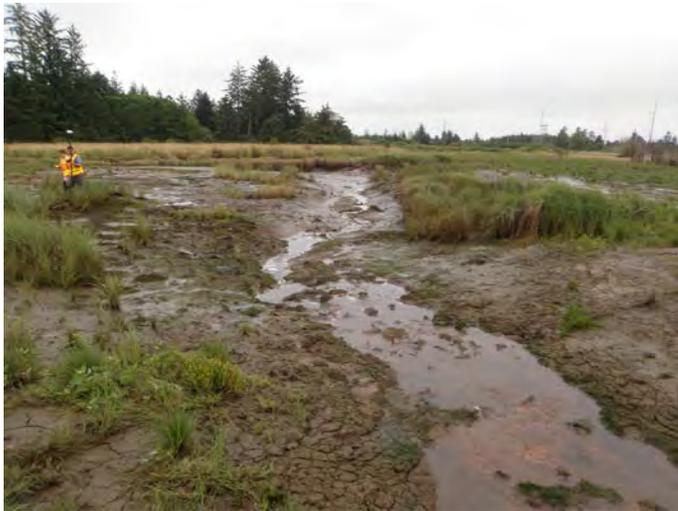
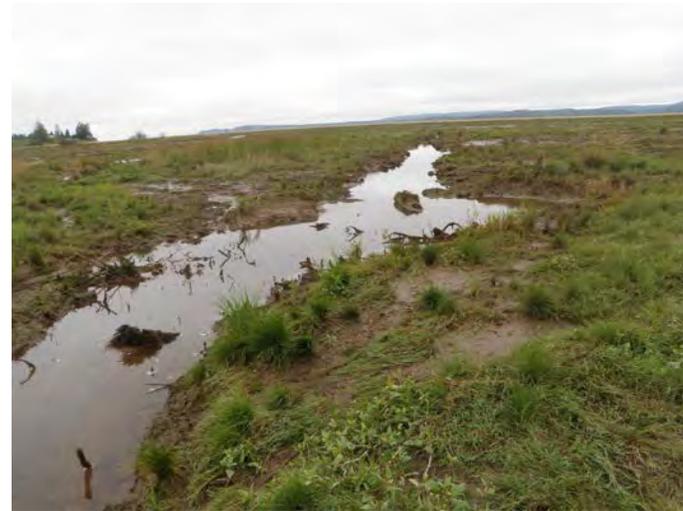
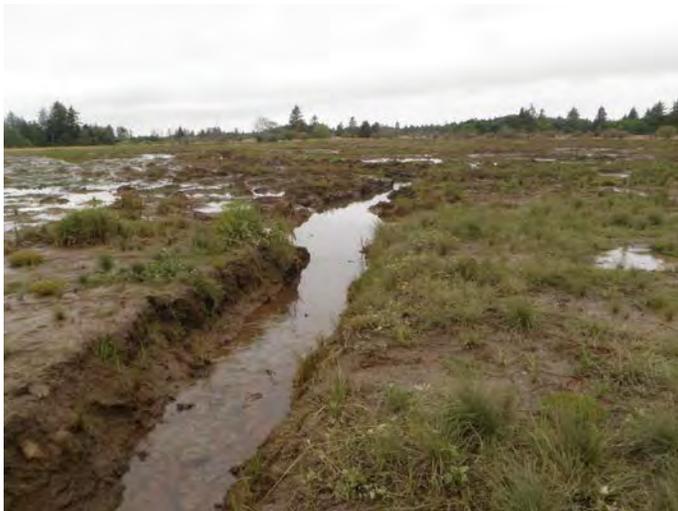
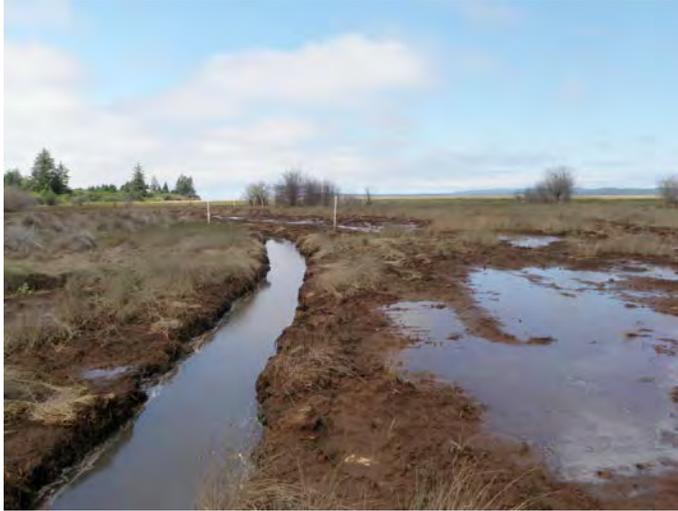
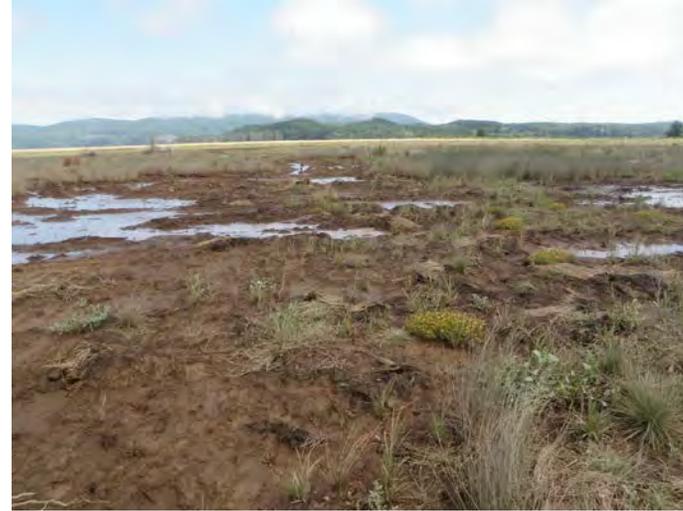
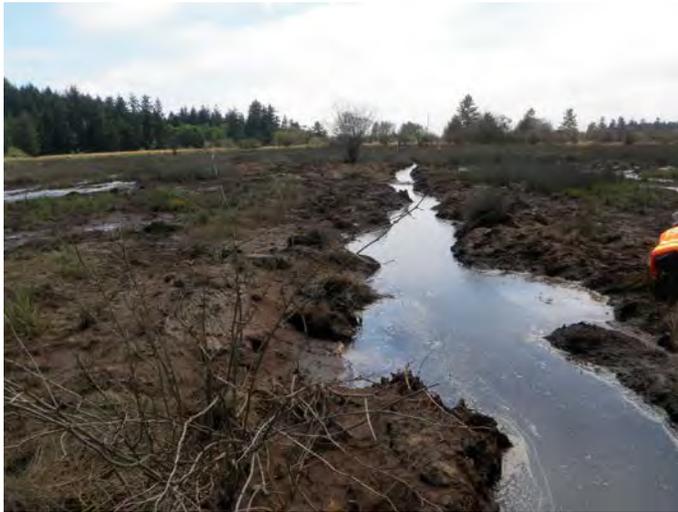
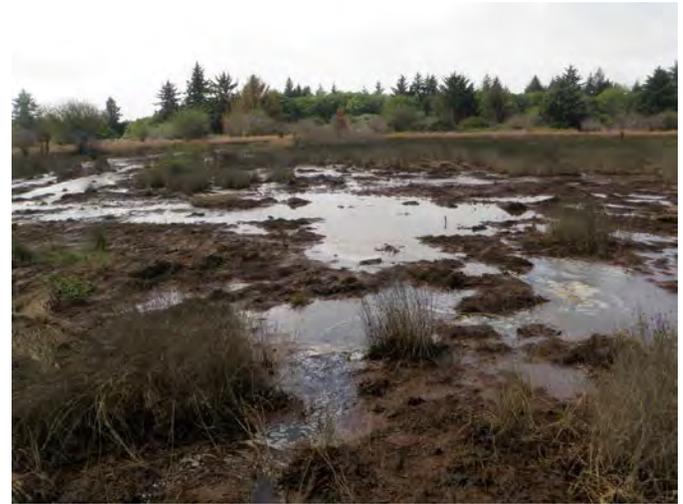
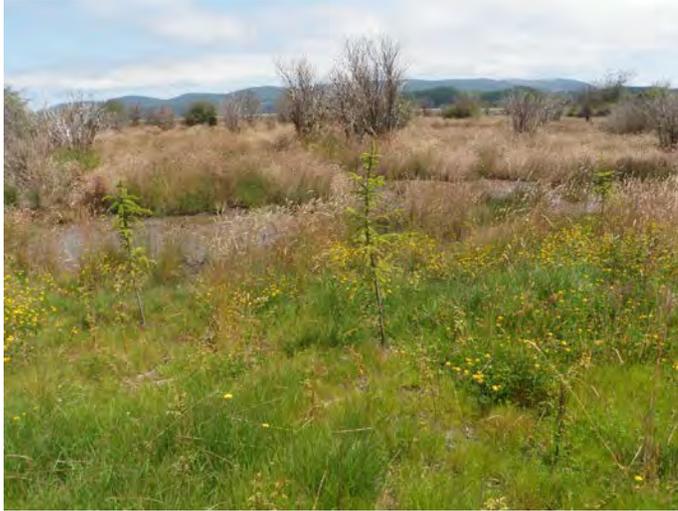
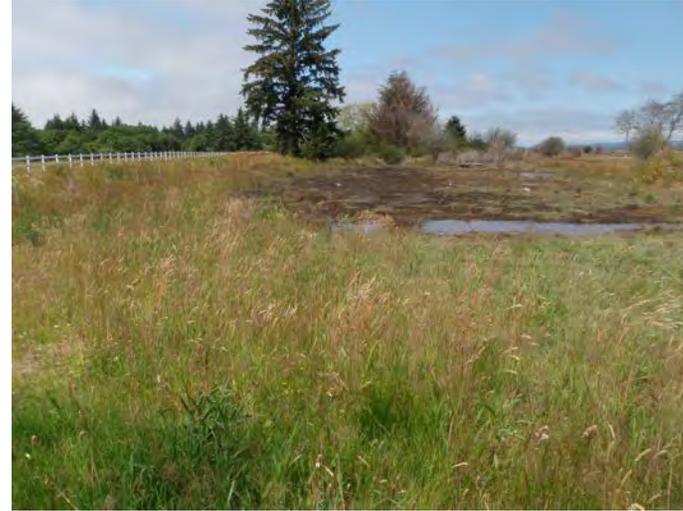
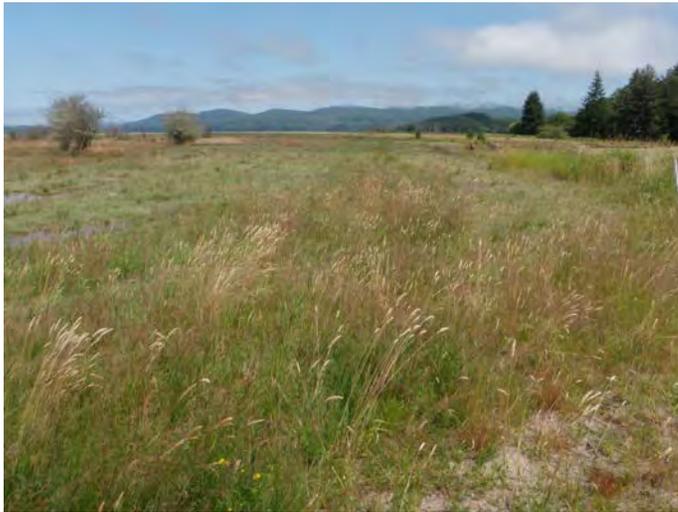
The photographs below were taken from permanent photo-points on July 16, 2014 and document current natural channel processes and development and vegetation re-colonization and establishment across the site.

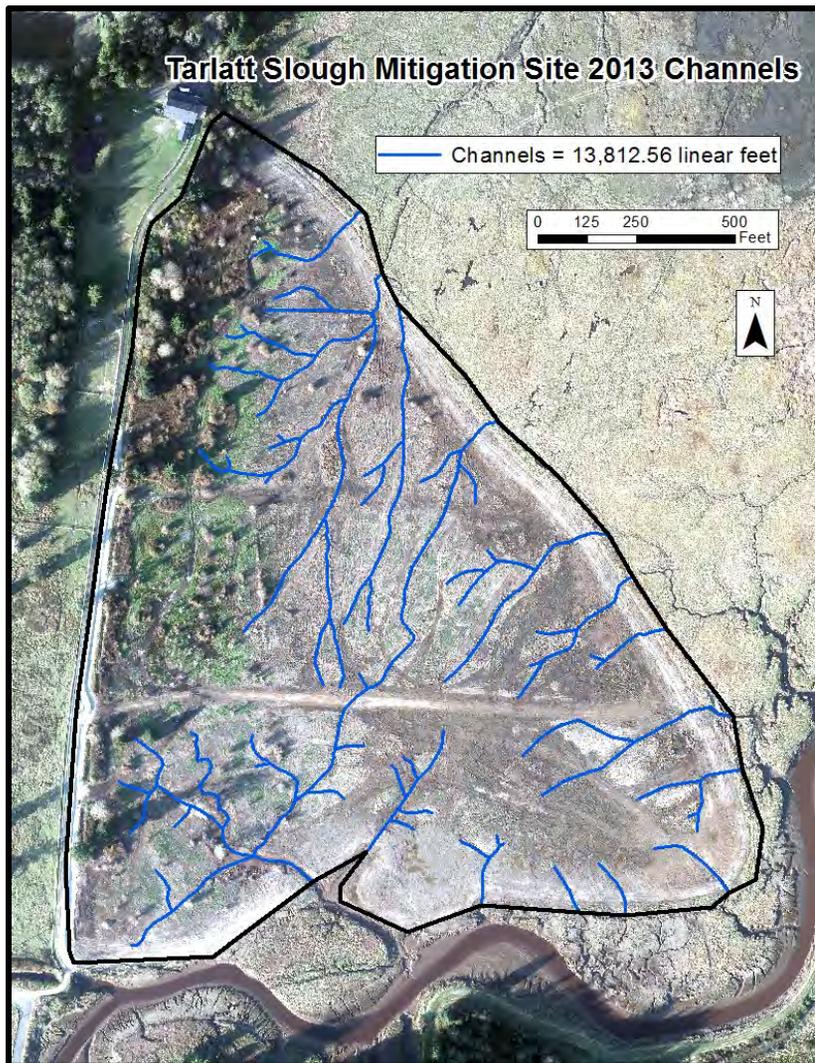
Appendix 3 – Channel Analysis

A total of 13,812 linear feet of restored natural channel was mapped from a 2013 aerial photo of the site (Appendix 3). This exceeds the performance standard target.
