## **APPENDIX B**

### Site Photographs

**Photographic illustrations of unique  
geomorphic processes in the Upper White**

## **Existing Problem Sites**

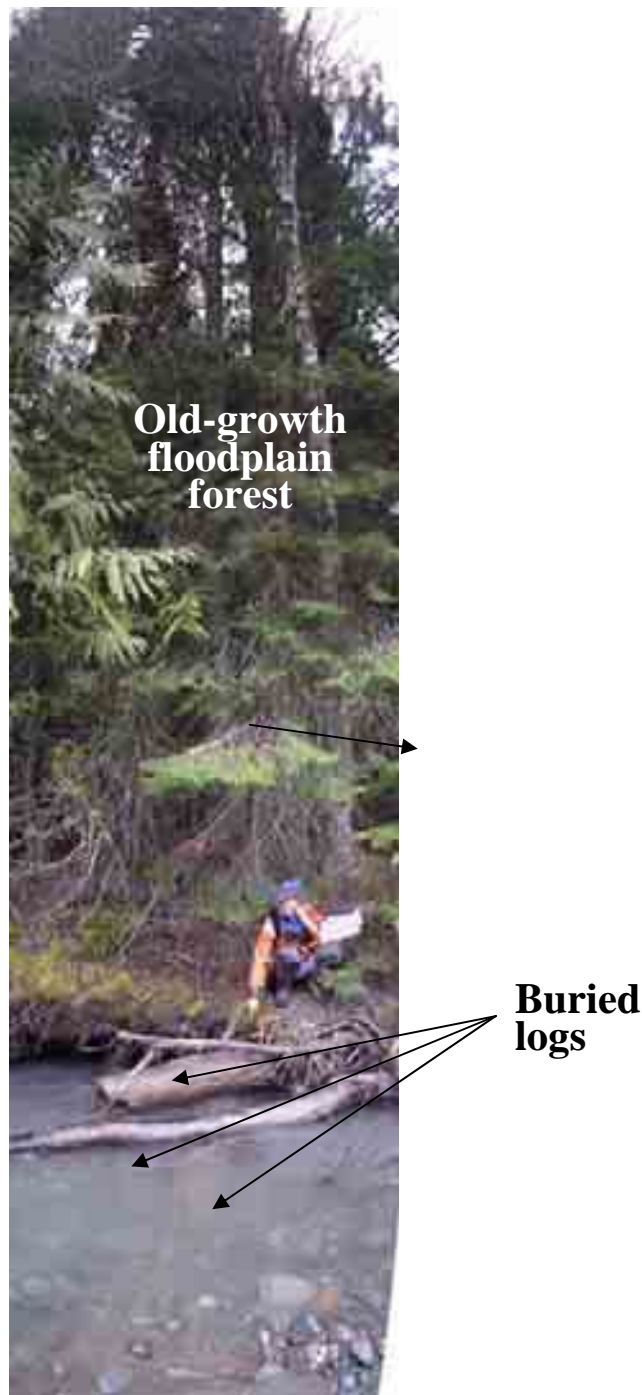
Example of buried logjam matrix situated beneath old-growth floodplains of the Upper White River. This site is located near Site 8 along right bank of mainstem river channel (MP 59.6). These buried logs form a geotechnical matrix that together with the living forest effectively prevents the mainstem river from moving into these floodplain areas even when the river has aggraded well above the floodplain. Side channels are common in these forest floodplains and provide important habitat within the Upper White. Presence of this type of forest has been crucial in preventing the complete loss of SR 410 at site 4 since 2003. April 26, 2005.

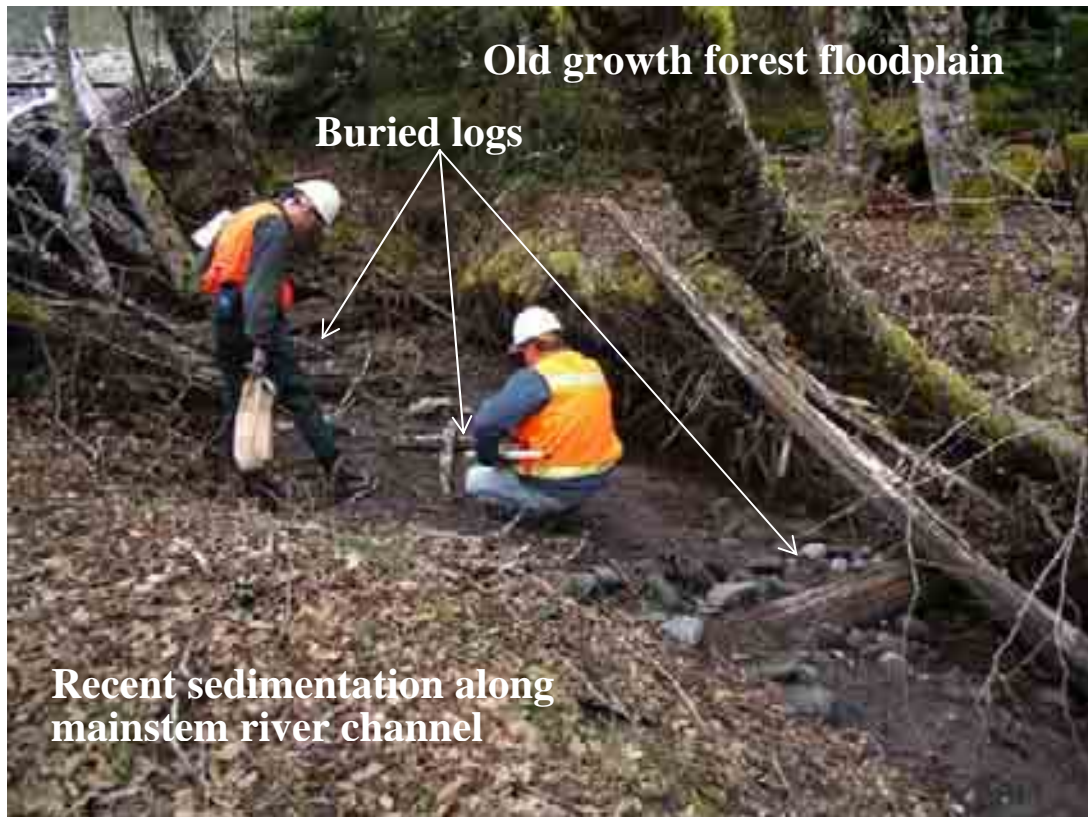
Another example of buried log matrix beneath old growth floodplain forest along right (East) side of river near MP 51. April 25, 2005.

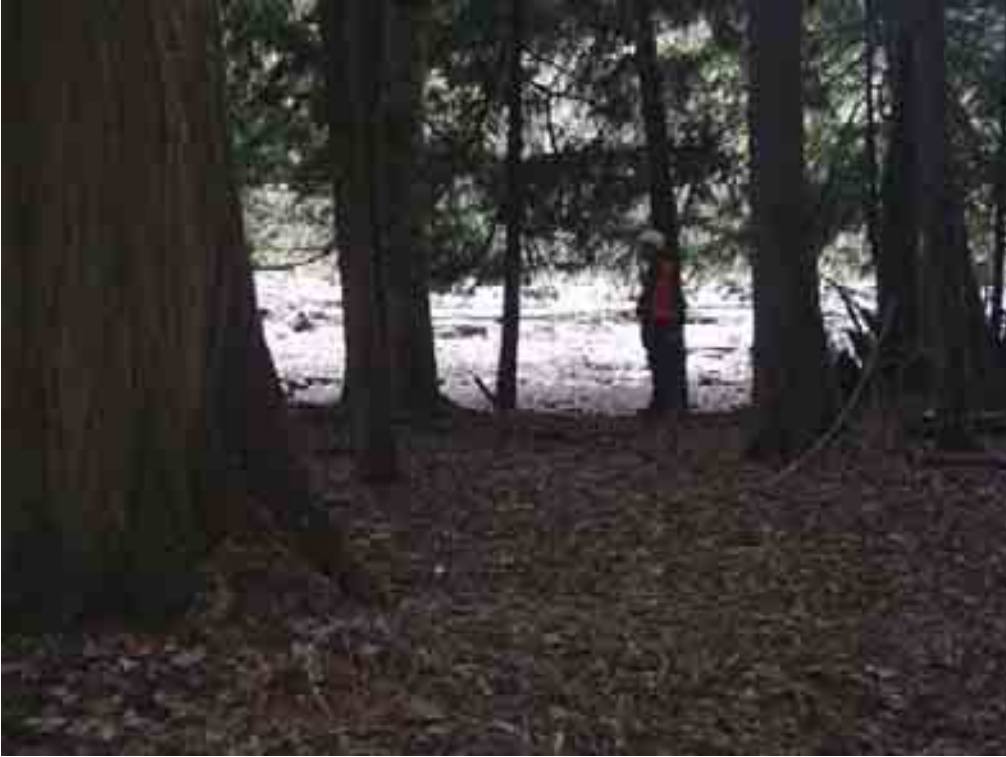
Example of old-growth conifer floodplain forests situated along mainstem channel of the Upper White River (in background), MP 51. Note river bed is at approximately same elevation of floodplain, even though some of the floodplain trees are at least 400 years old. April 25, 2005.

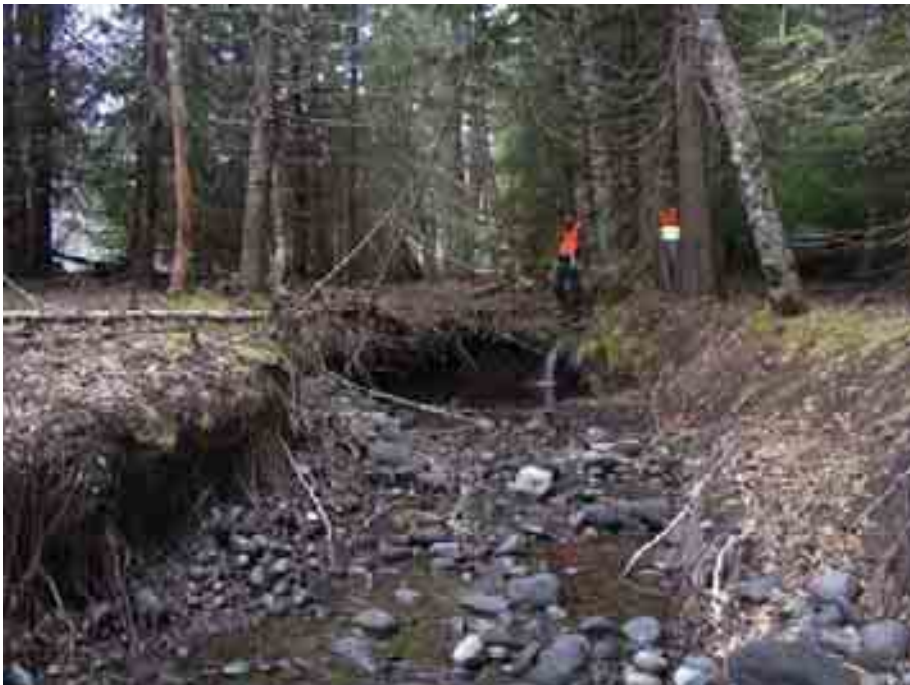
Example of side channel headcut where side channel is actively being cut into mature floodplain forest. Left bank of White River near MP 56 opposite Silver Creek confluence (Mt. Baker-Snoqualmie National Forest).

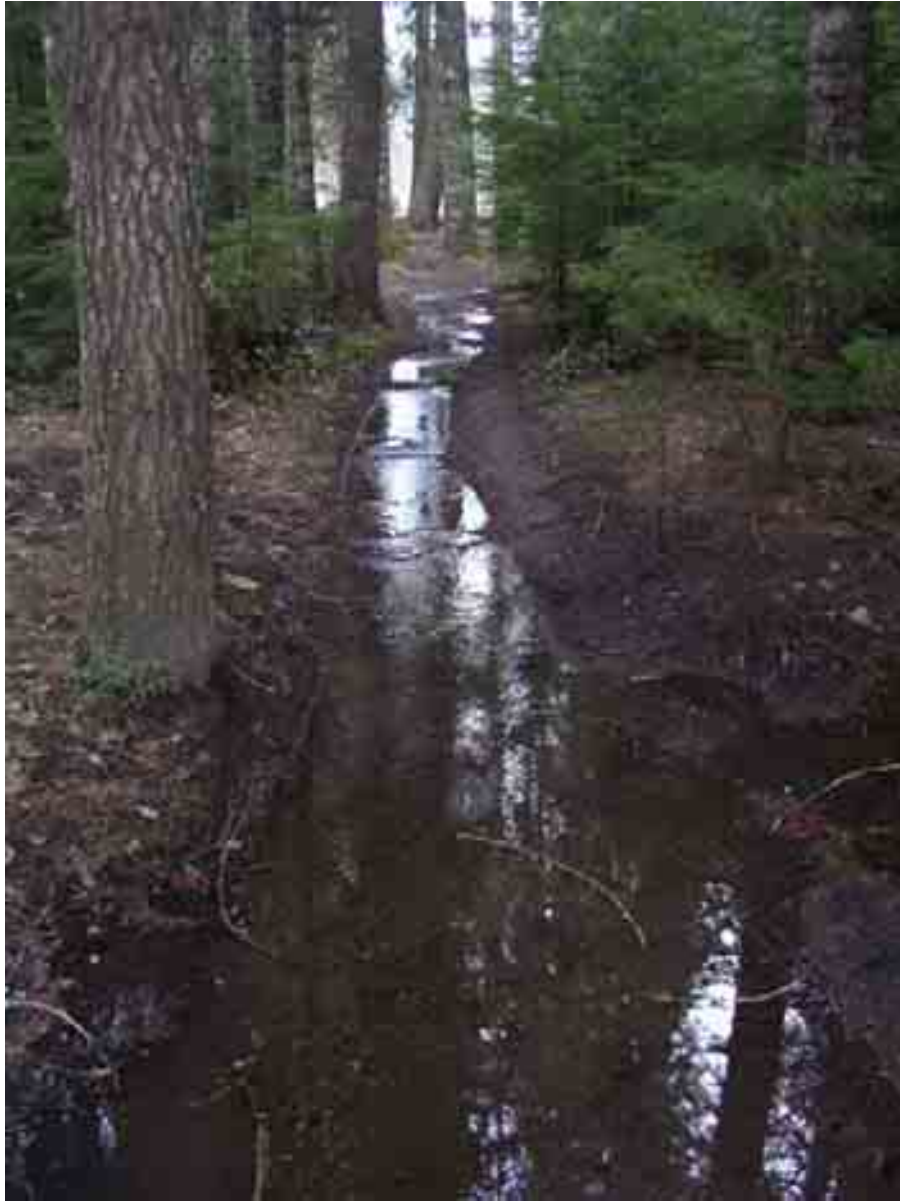
Side channel upstream of headcut illustrated in previous figure. Left bank floodplain of Upper White River near MP 56 (opposite Silver Creek confluence).

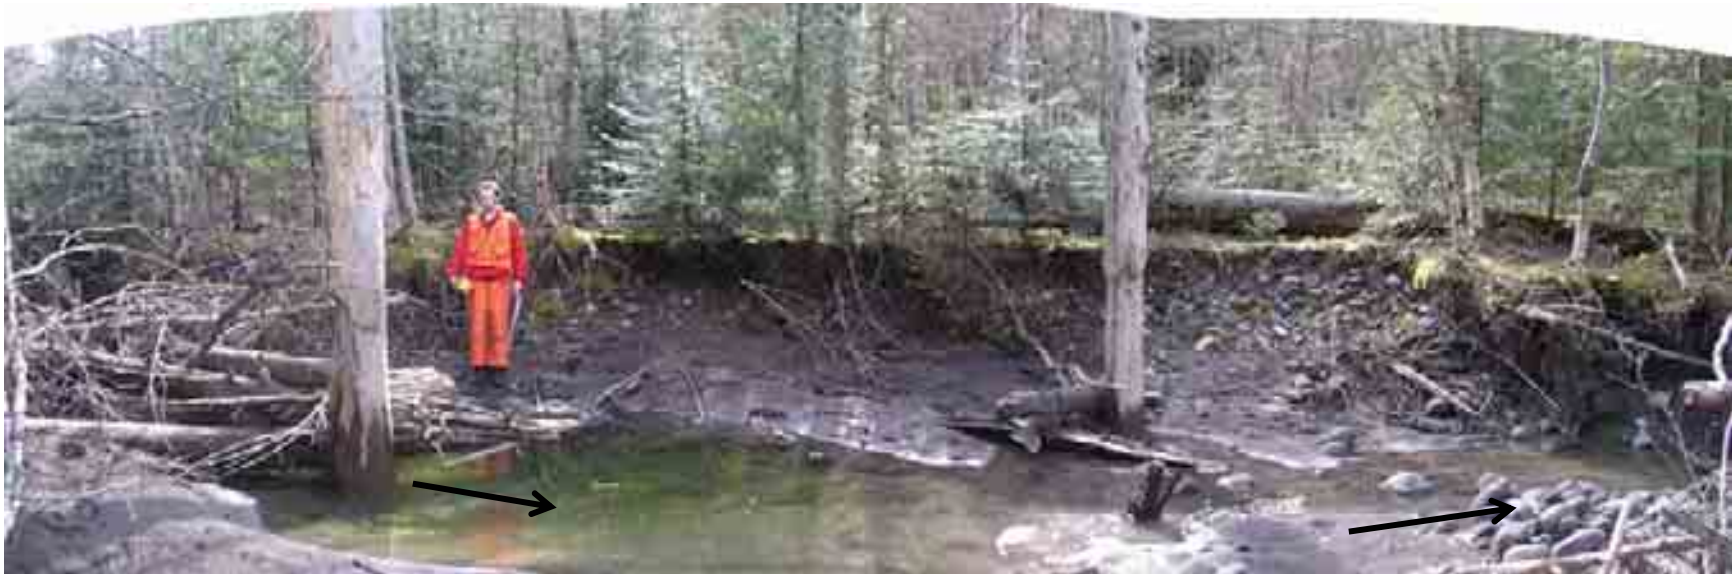
Side channel and buried forest near MP 60.3 (upstream of Site 8). Forest burial began between 1966 and 1979 (see Figure ##). Sedimentation at this site raised the ground surface up to 6 feet. Trees colonizing the site are 5-15 years old, implying that sedimentation didn't occur in a single year but continued several years after 1979. This extended period of landscape adjustment is consistent with current sedimentation at Site 4. April 27, 2005.

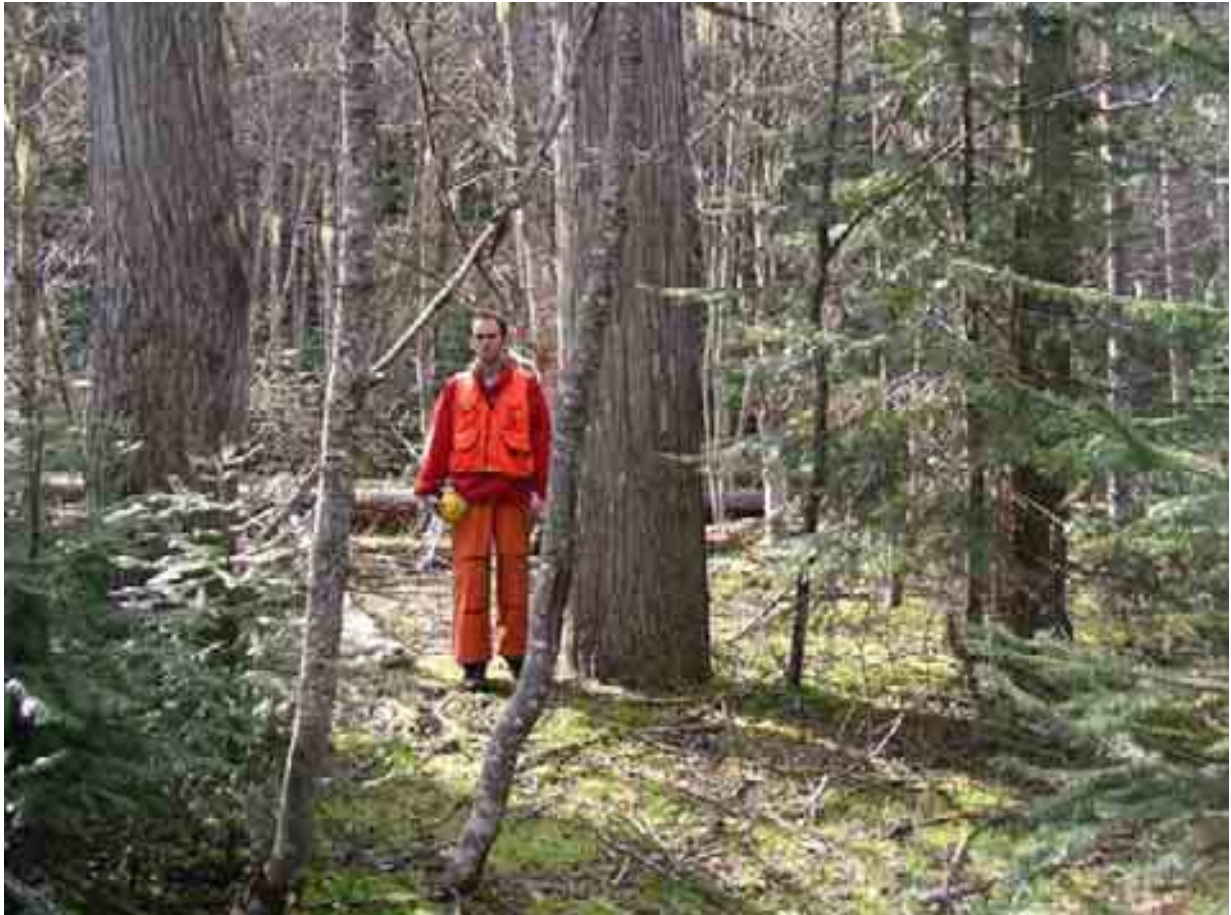
Buried cedar trees near MP 60.3 (upstream of Site 8). Forest burial occurred between 1966 and 1979 (see Figure ##). Trees colonizing the site are 10-15 years old, implying that sedimentation didn't occur in a single year but continued several years after 1979. This extended period of landscape adjustment is consistent with current sedimentation at Site 4. April 27, 2005.

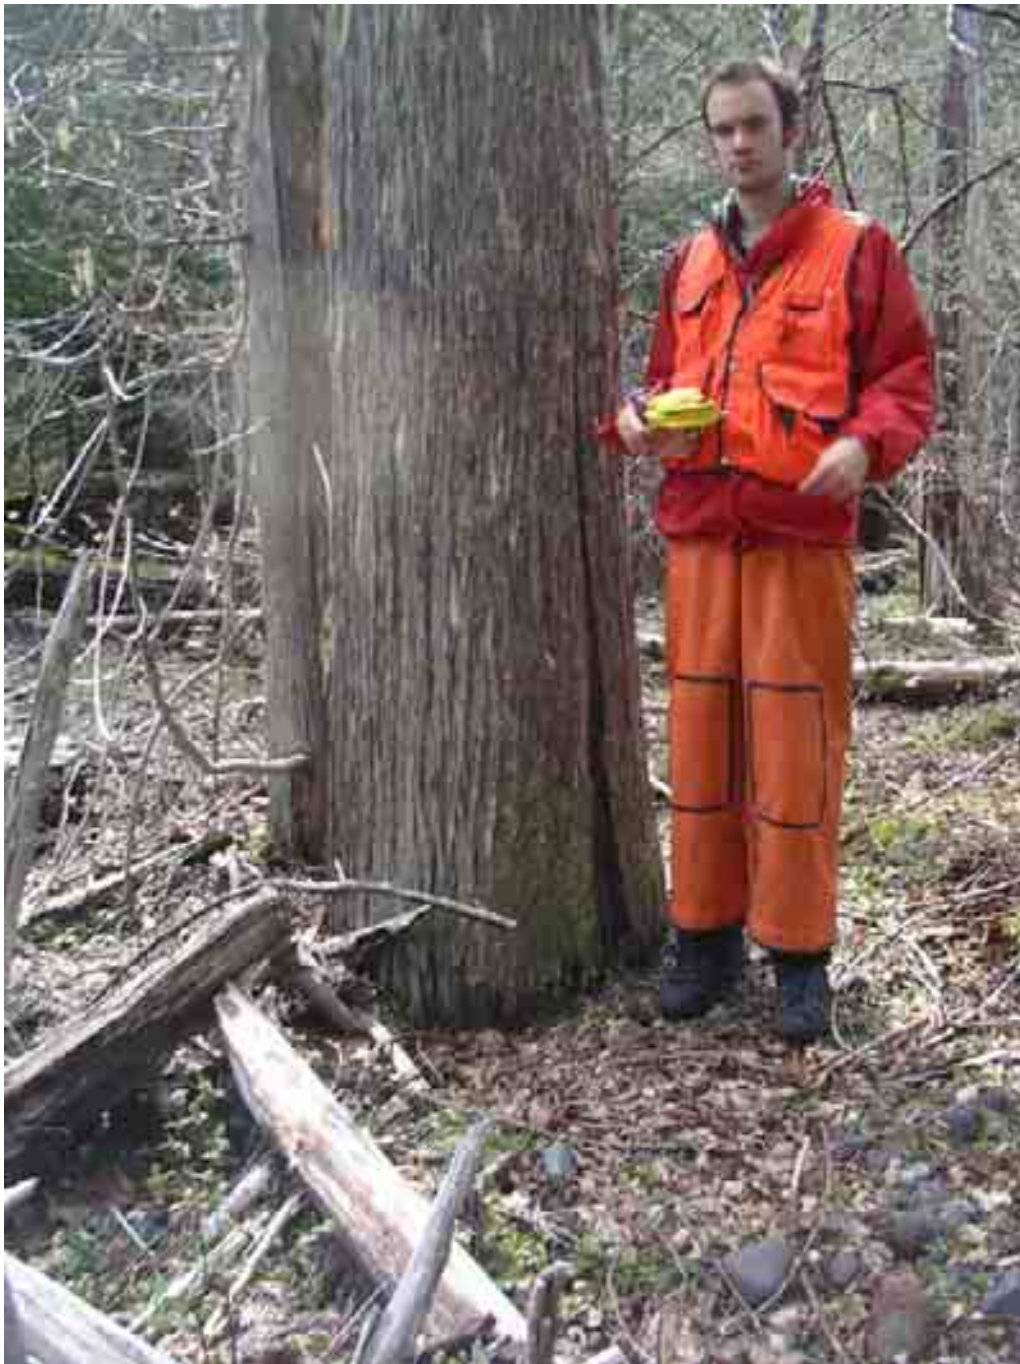
Buried cedar tree at MP 60.3. Note sedimentation is not limited to overbank fine sediment but coarse gravel and cobble (lower right corner in photo). April 27, 2005.

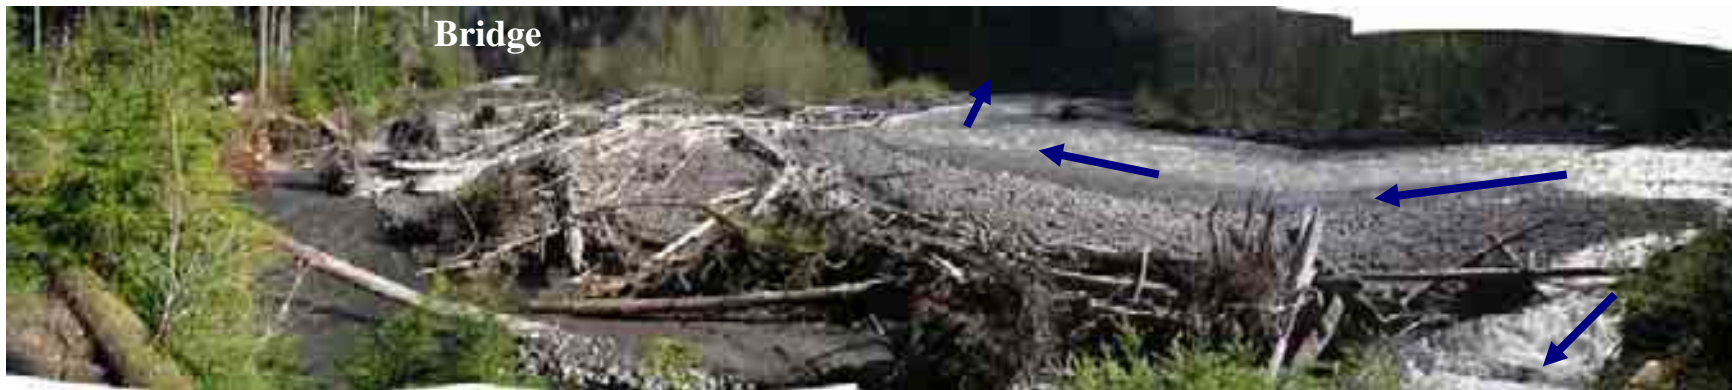
Natural flow deflection jam upstream of Forest Service bridge at SR 410 MP 49.5. If large conifers were not present on left bank the river would be flowing where the jam is located and posed a much more significant threat to the bridge.

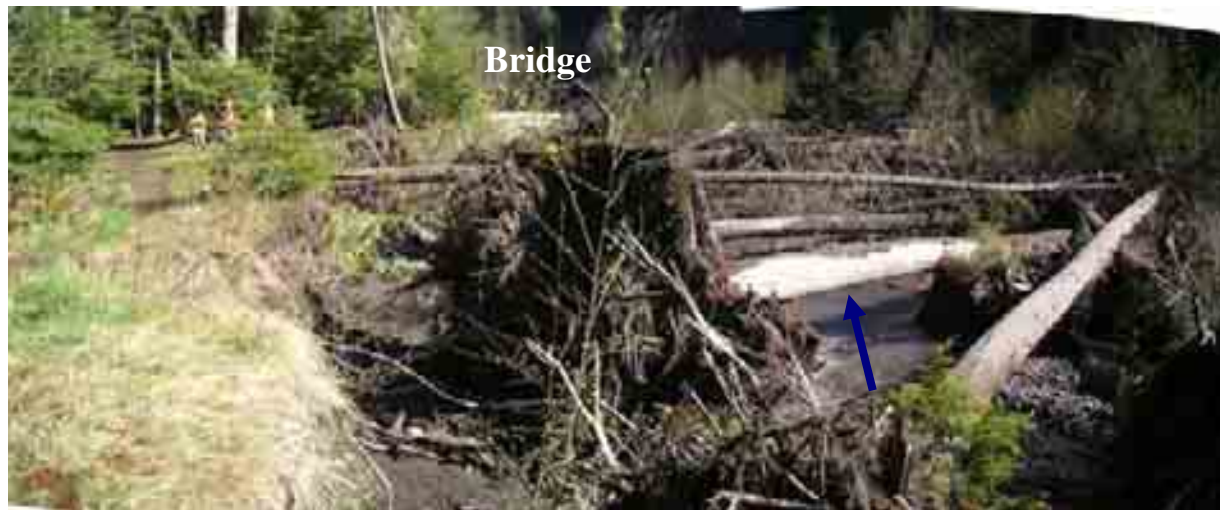
Same site from within flow deflection jam. This natural jam was responsible for preventing river from end cutting left abutment of Forest Service bridge. In addition to protecting bridge, logjam is also creating high quality side channel habitat and cover.

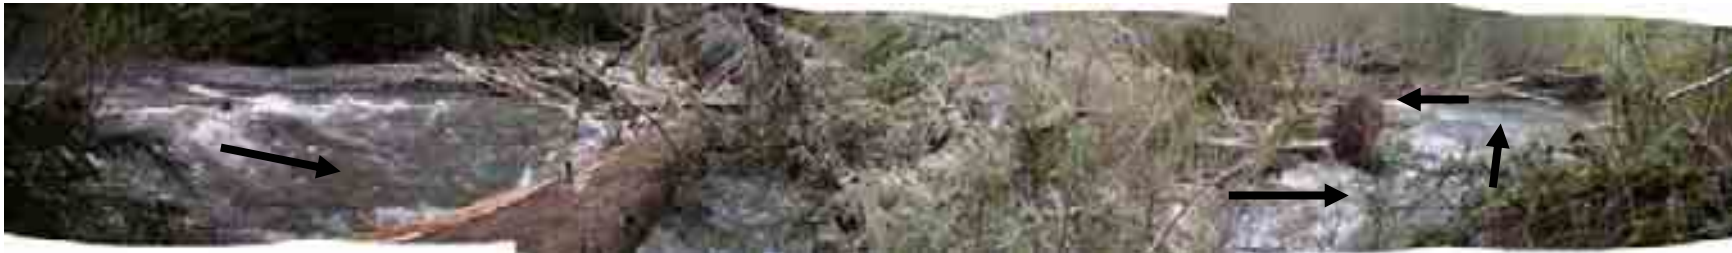
Channel spanning logjam across low flow portion of mainstem channel at MP 50.5. Logjams such as this have formed throughout this reach of the river and directly controlled the river's course and grade. In addition these logjams create the most diverse and highest quality habitat found in the Upper White River. April 25, 2005.

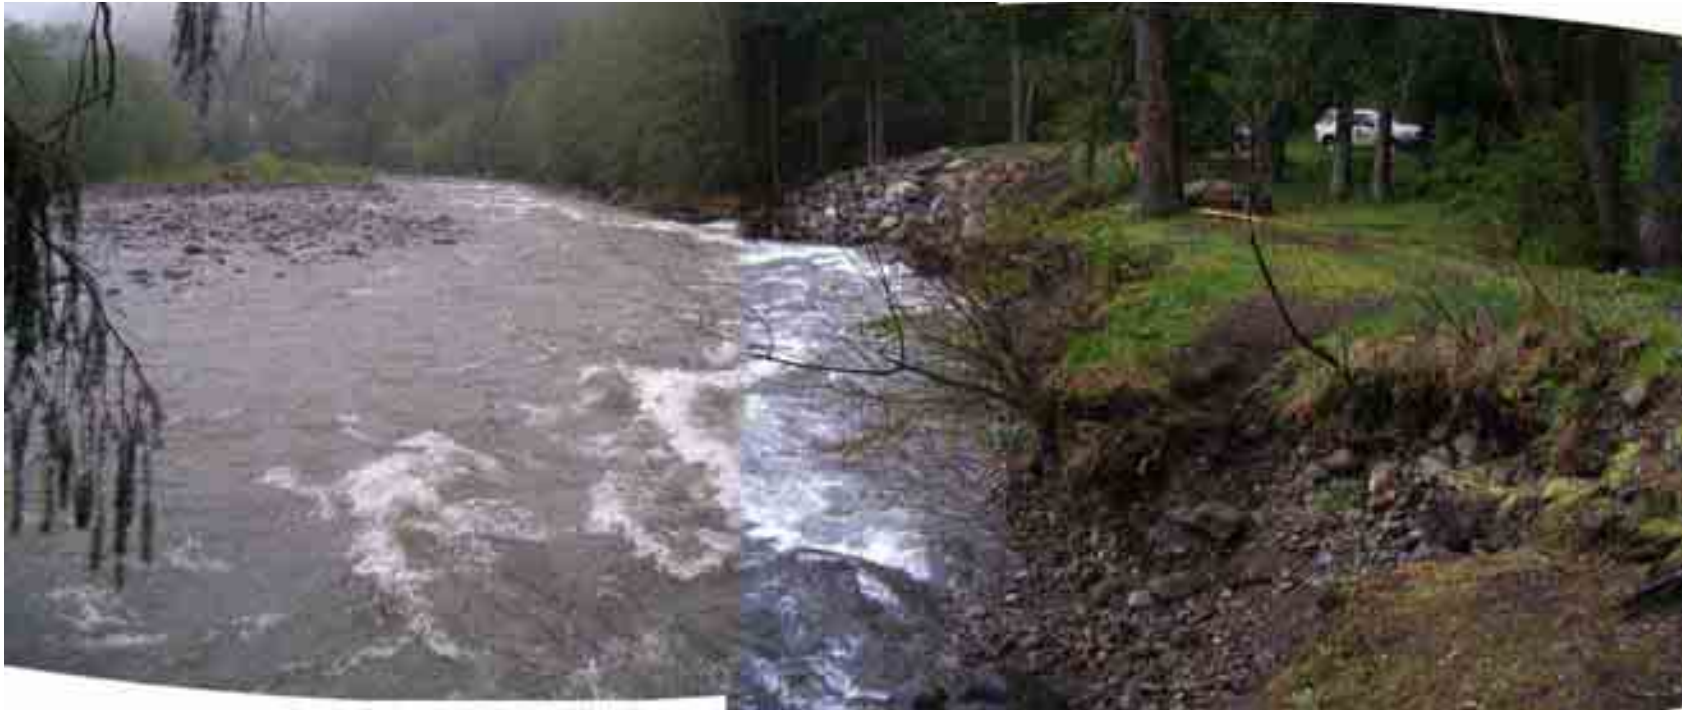
Site 1, Milepost 38 looking downstream at eroding right bank upstream of rock revetment. April 25, 2005.

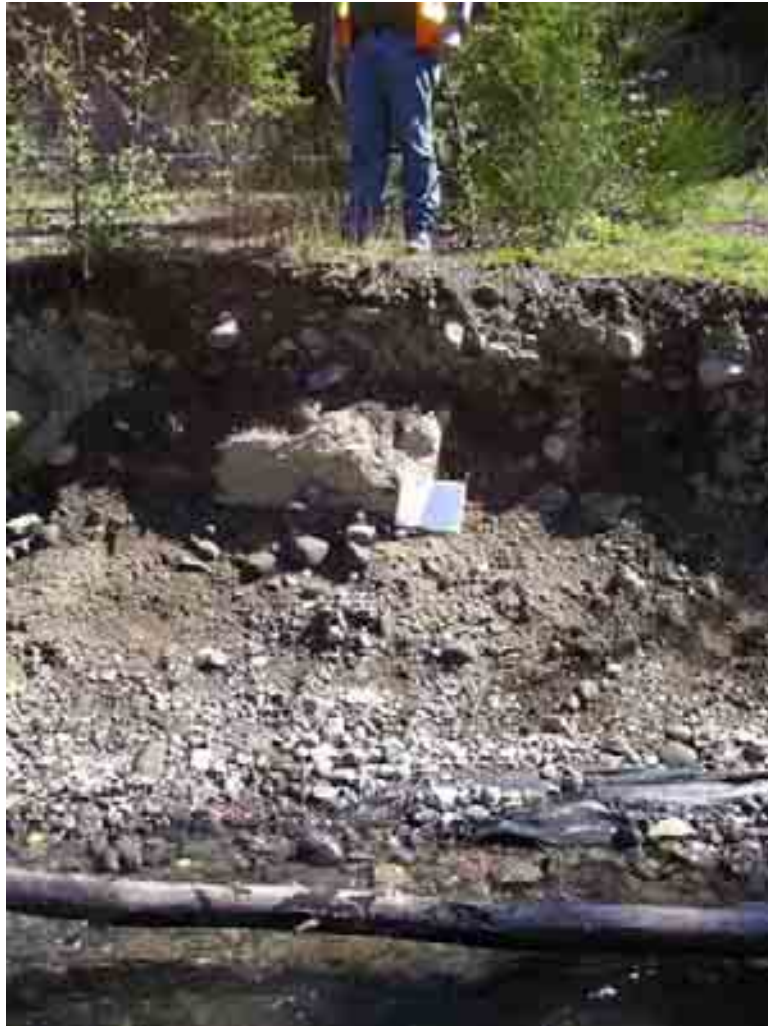
Site 2, Milepost 51.6, Skookum Falls Overlook eroding right bank. Note exposed geotextile at toe of bank installed in previous bank protection measures. April 25, 2005.

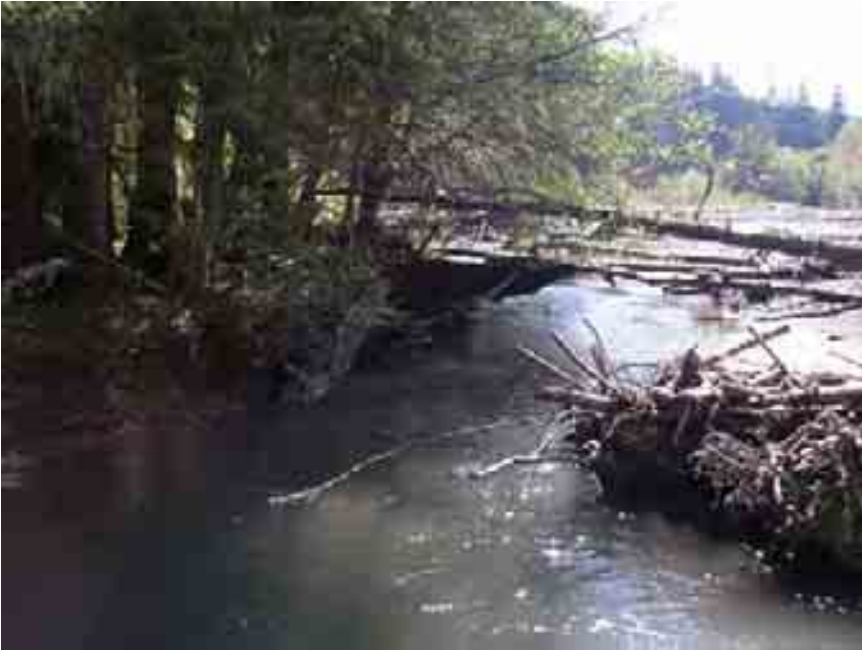
Site 2, Milepost 51.6, Skookum Falls Overlook. Side channel inlet looking upstream. April 25, 2005.

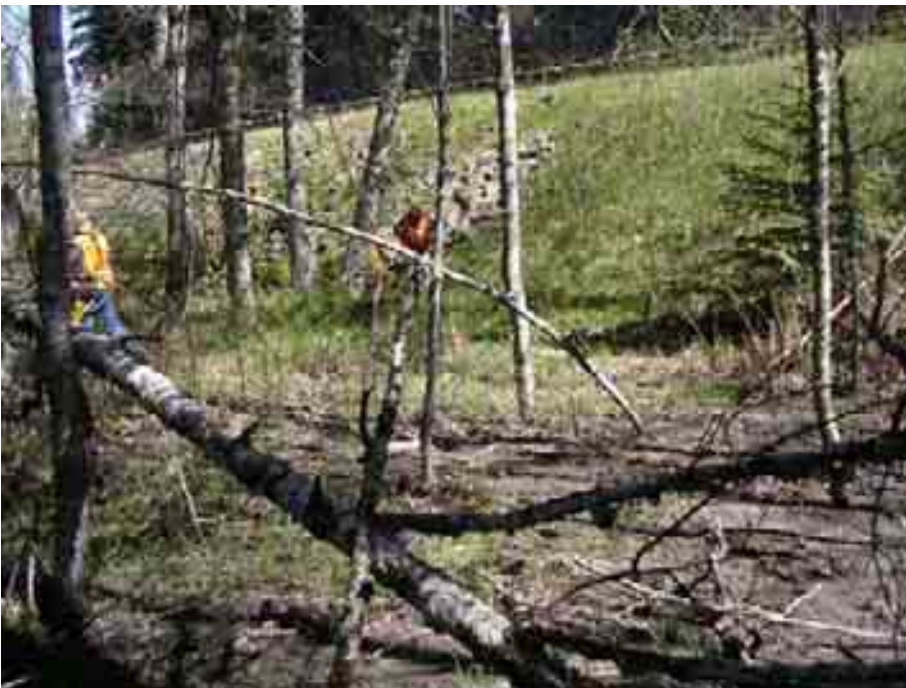
Site 2, Milepost 51.6. Looking downstream from side channel inlet at SR 410 embankment. April 25, 2005.

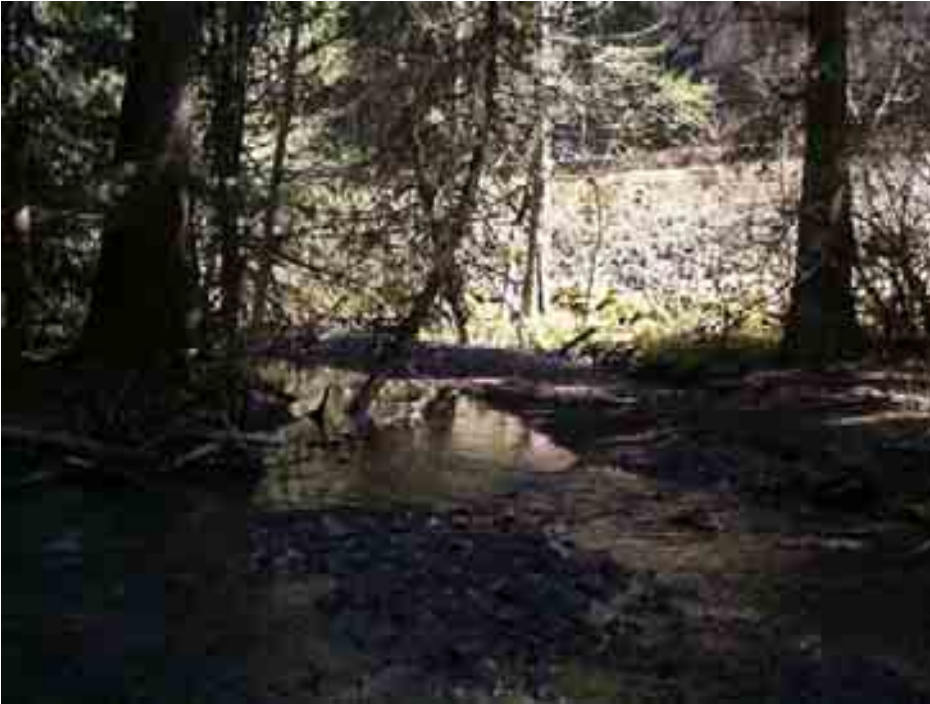
Site 2, MP 51.6. Side channel flowing along SR 410 downstream of Skookum Falls Overlook. April 25, 2005.

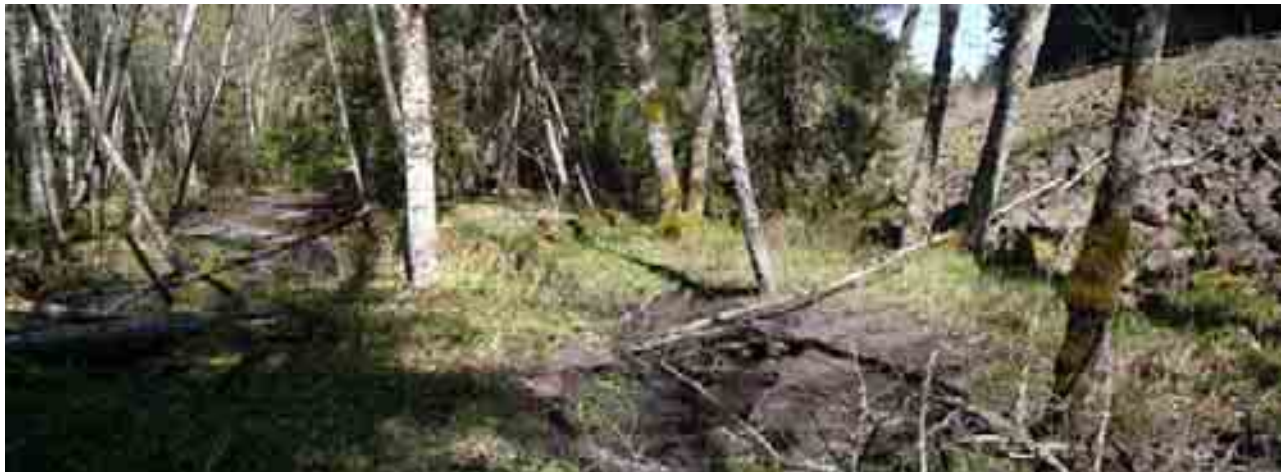
Site 2, MP 51.6. Side channel flowing along SR 410 embankment downstream of Skookum Falls Overlook. Inter-locking large trees should be placed at sites such as this where there are only sparsely spaced small trees to armor highway embankment and trap sediment. April 25, 2005.

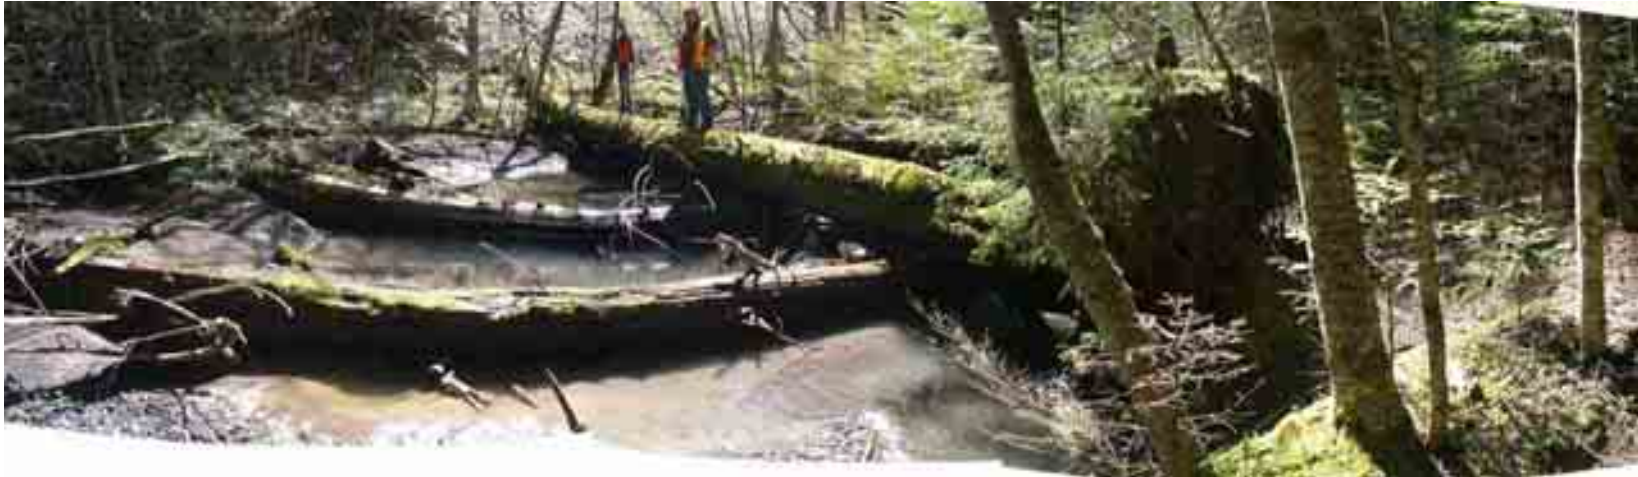
Site 2, MP 51.6. Example of natural LWD armoring at toe of SR 410 embankment, side channel downstream of Skookum Falls Overlook. April 25, 2005.

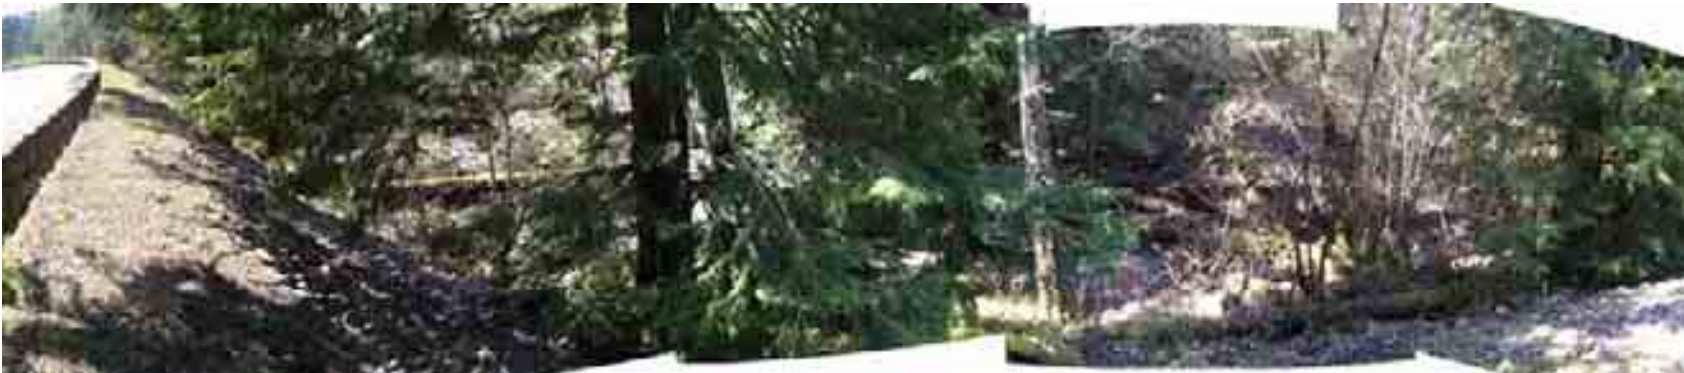
Site 2, MP 51.6. Side channel running along SR 410 embankment downstream of Skookum Falls Overlook. April 25, 2005.

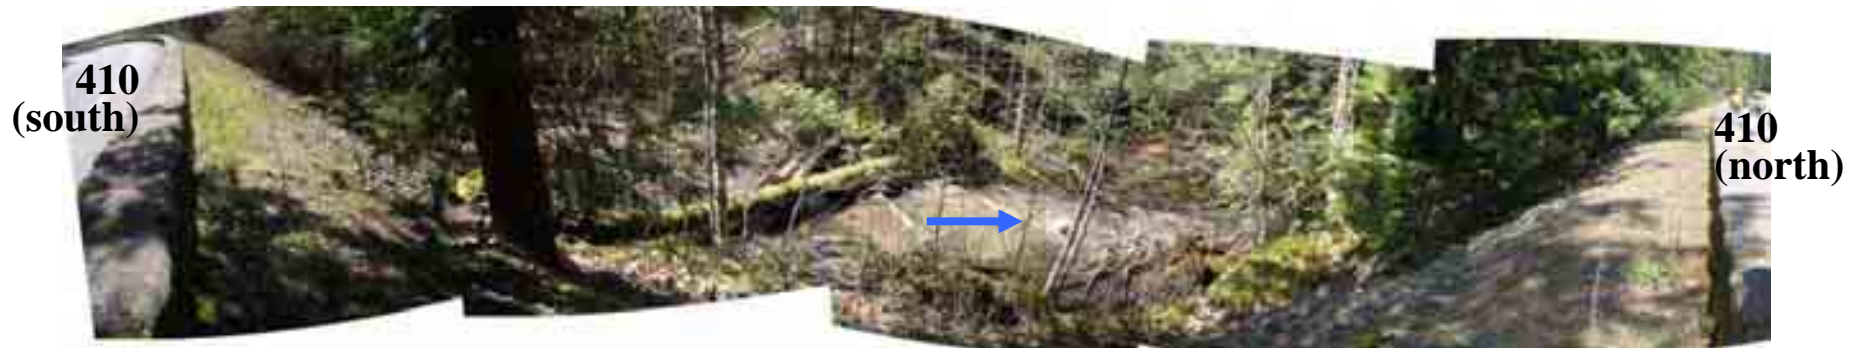
Site 2, MP 51.6. Side channel running along SR 410 embankment downstream of Skookum Falls Overlook. Engineered logjams and LWD armoring is recommended along toe of slope to keep erosive flows away from highway embankment. April 25, 2005.

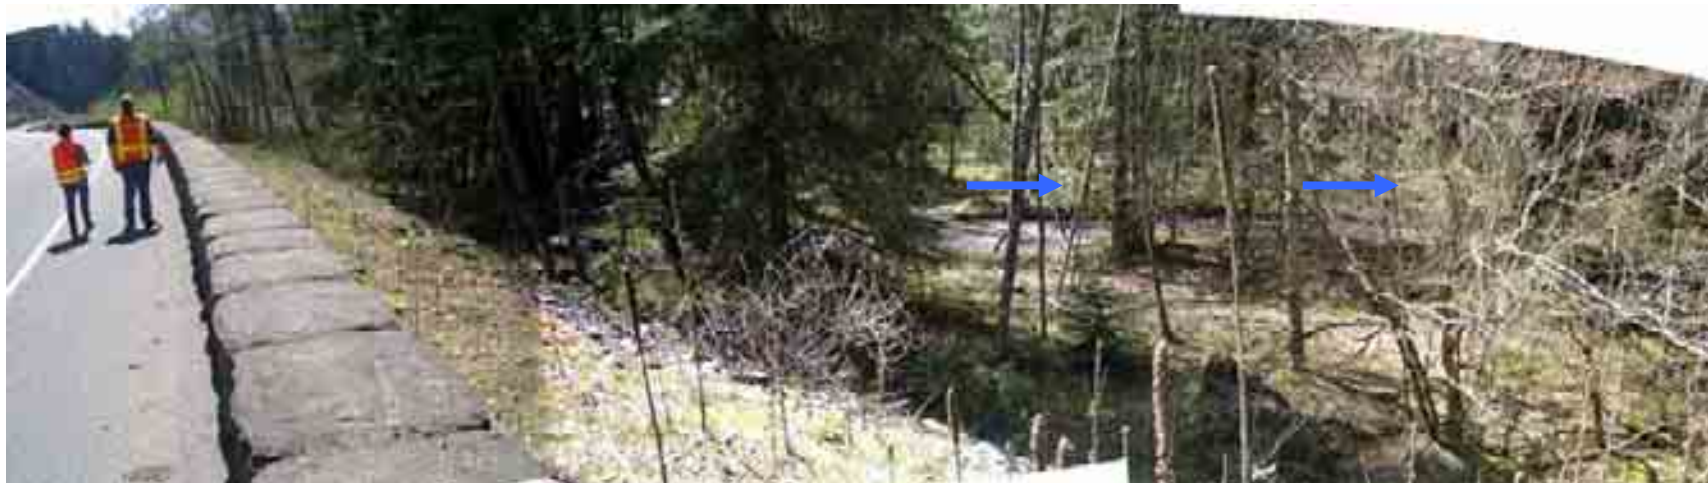
Site 2, MP 51.6. Side channel running along SR 410 embankment downstream of Skookum Falls Overlook. Areas of small deciduous trees such as right side of photo should be supplemented with large trees to prevent side channel from approaching highway embankment. April 25, 2005.

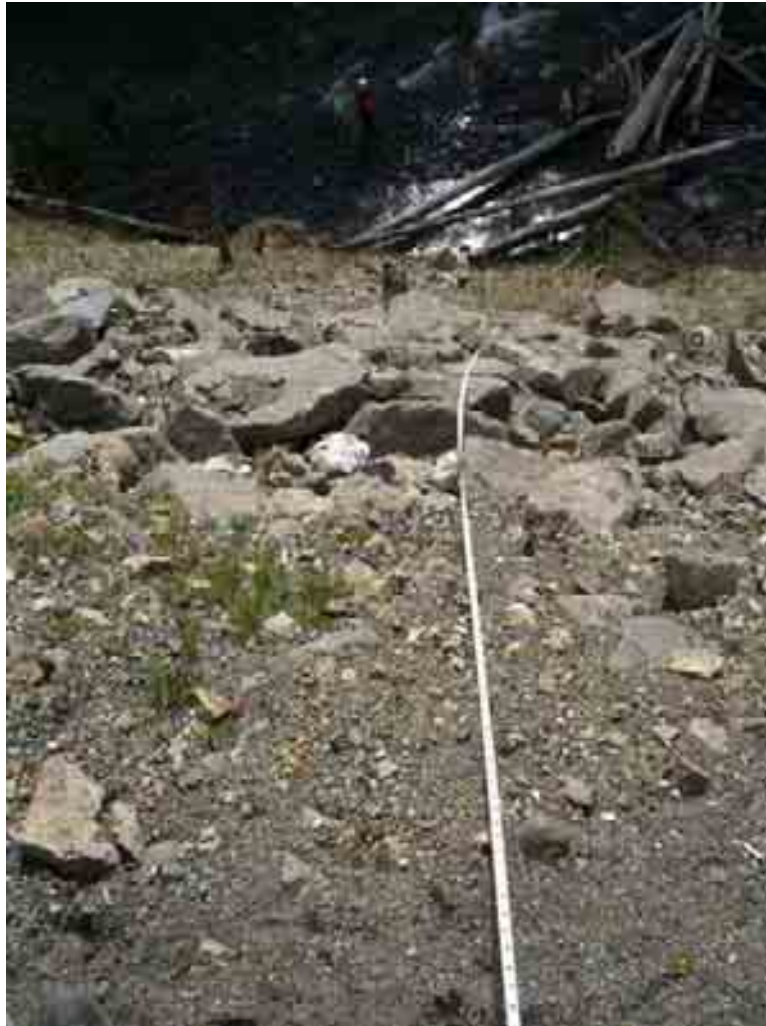
Site 3, MP 55 looking downslope approximately 90 feet from edge of pavement (EOP). Note lack of any woody vegetation on slope and edge of water at toe of slope. Most recent airphoto taken in 1998(?) shows approximately 100 feet of riparian forest between highway and river at this site. Rock riprap covers only upper 20 feet of slope and undercut by eroding slope. April 25, 2005.

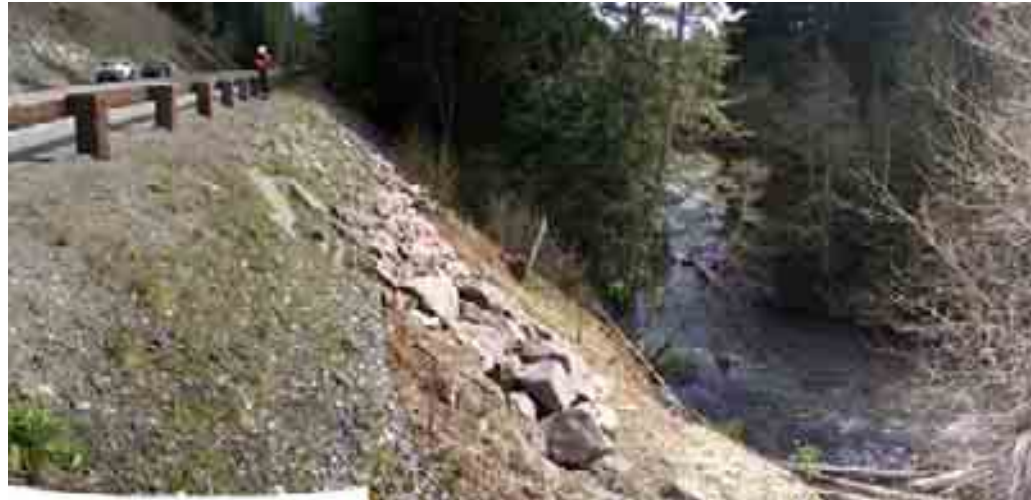
Site 3, MP 55 looking upstream of failing slope. Highway is situated approximately 70 ft above river. River is actively eroding toe of slope. April 25, 2005.

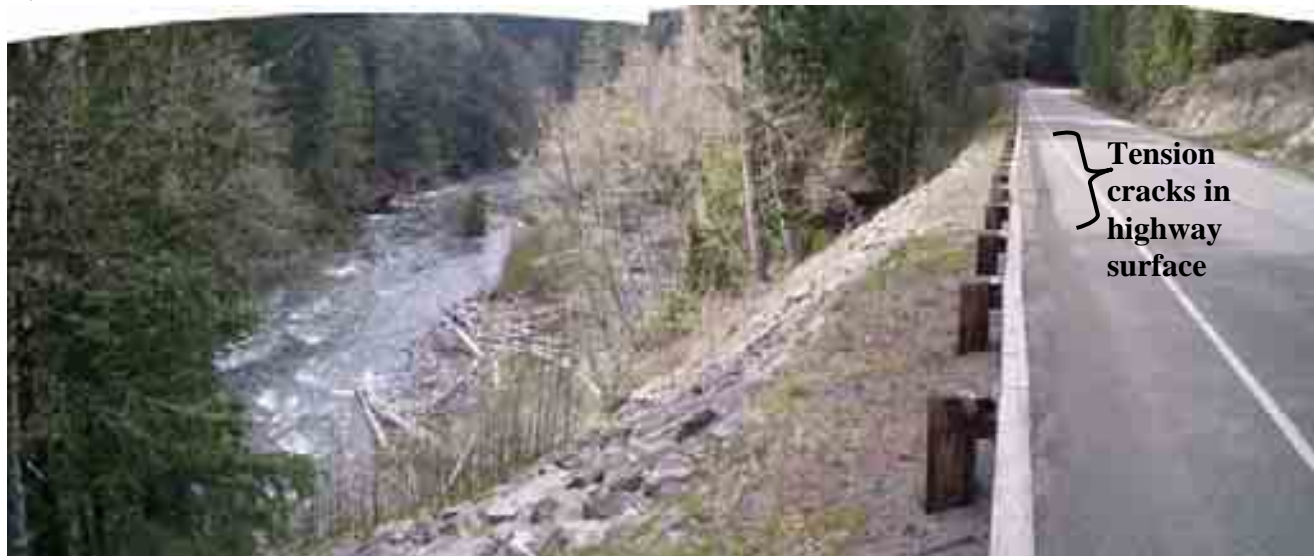
Site 3, MP 55 looking downstream of failing slope. April 25, 2005.

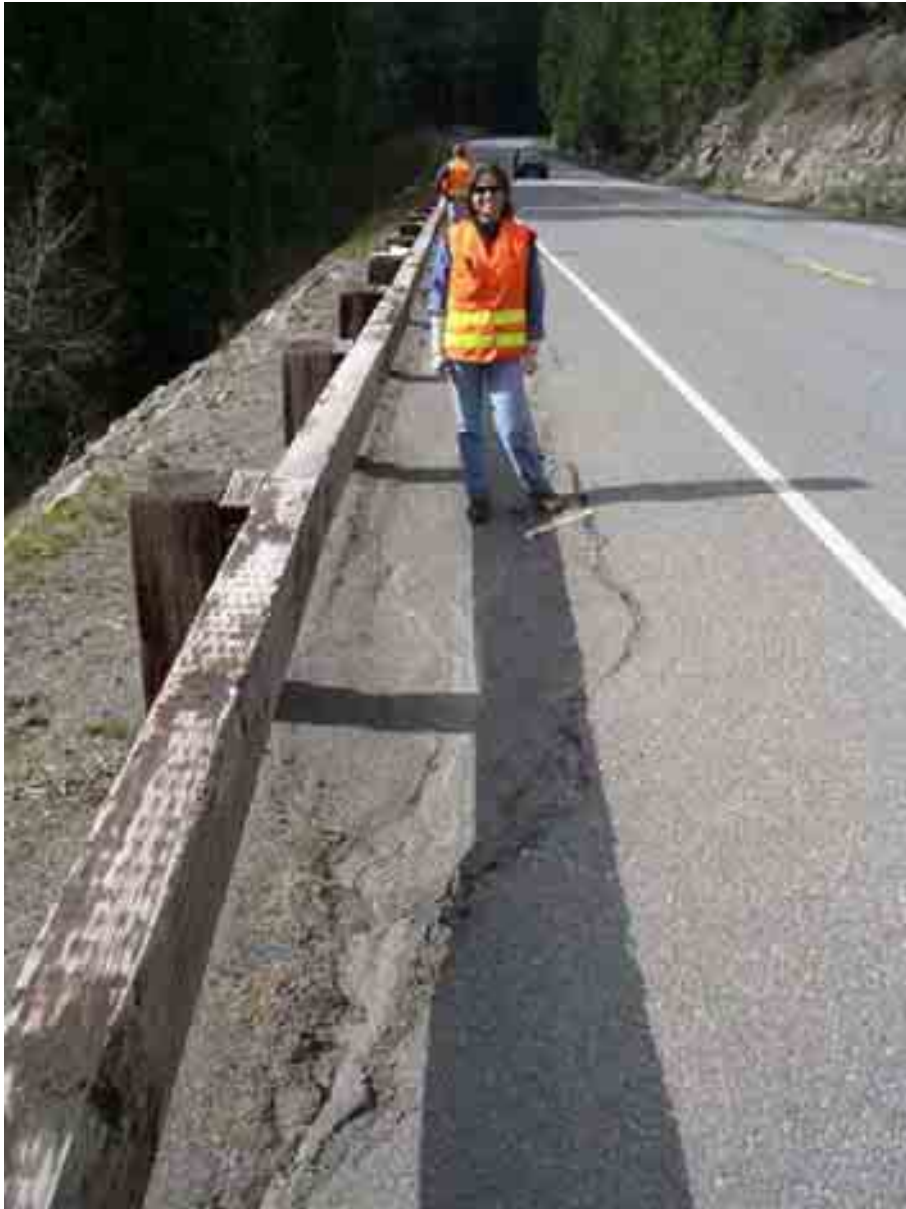
Site 3, MP 55 looking downstream at slope displacement and tension cracks in highway surface. April 25, 2005.

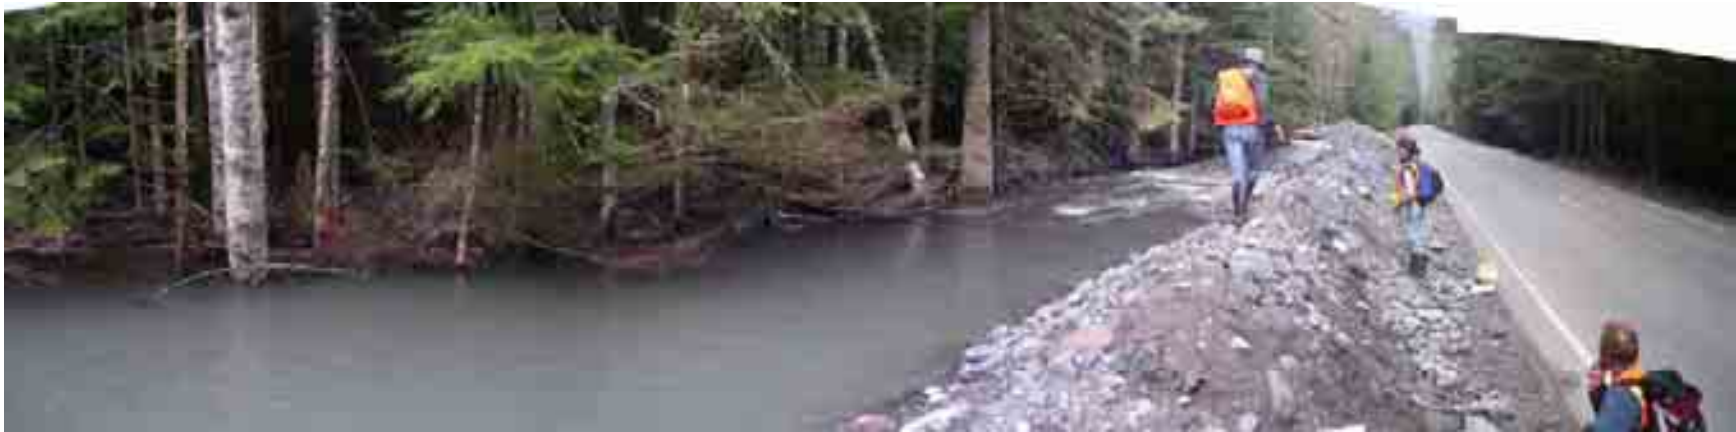
Upstream end of Site 4, MP 58.4. Location where river flow across floodplain currently encounters SR 410. Looking downstream (North) where emergency gravel dike separates side channel flow from highway. Water surface is approximately 1 foot above highway surface during low flow conditions. Note submerged trees to the left. April 27, 2005.

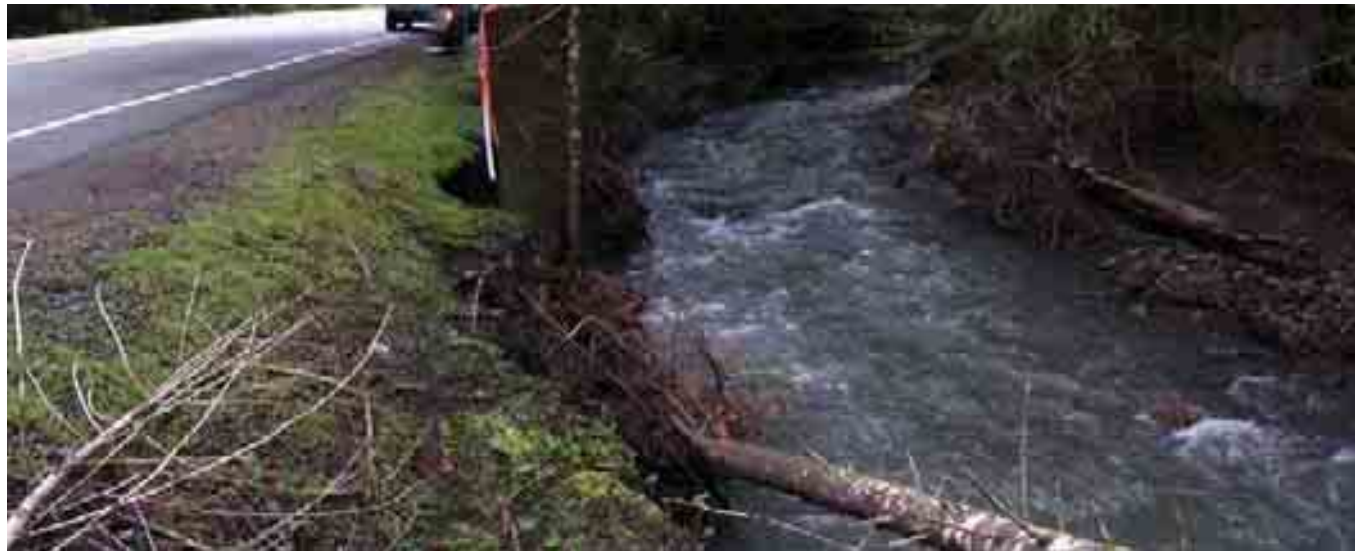
Site 4, MP 58. Looking upstream at side channel along SR 410 where on-going erosion threatens highway embankment. April 27, 2005.
