## **APPENDIX B**

### Site Photographs

**Photographic illustrations of unique  
geomorphic processes in the Upper White**

## **Existing Problem Sites**

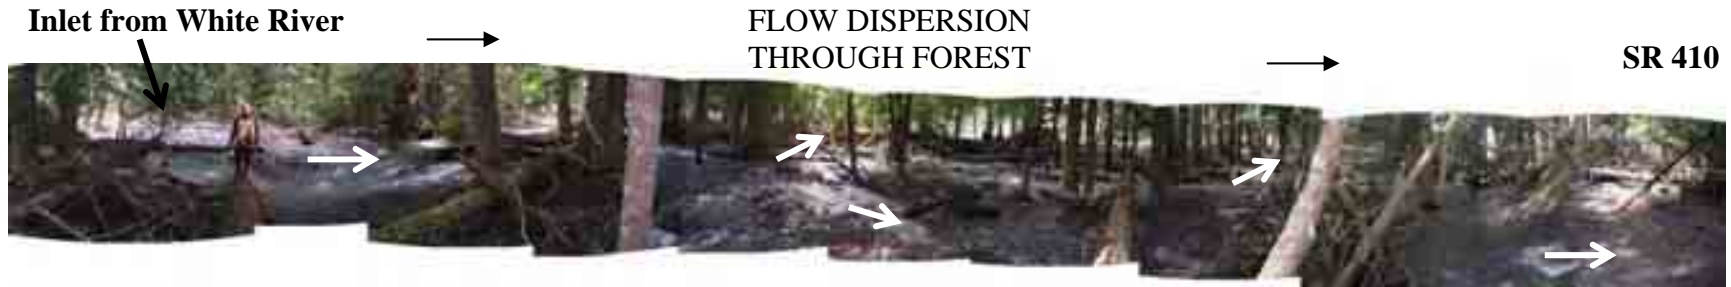
Site 4, MP 58.6 Standing on floodplain east of inlet to side channel where river flow entering forest and flowing down gradient toward SR 410 (flow is left to right). April 27, 2005.

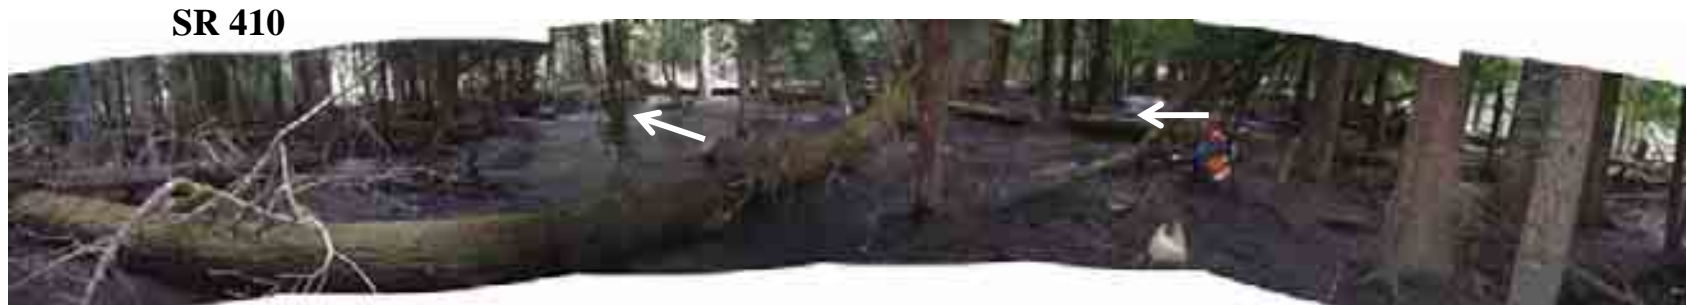
Site 4, MP 58.6 Standing on floodplain north of side channel inlet where river flow entering forest and flowing down gradient toward SR 410 (flow is right to left into photo). April 27, 2005.

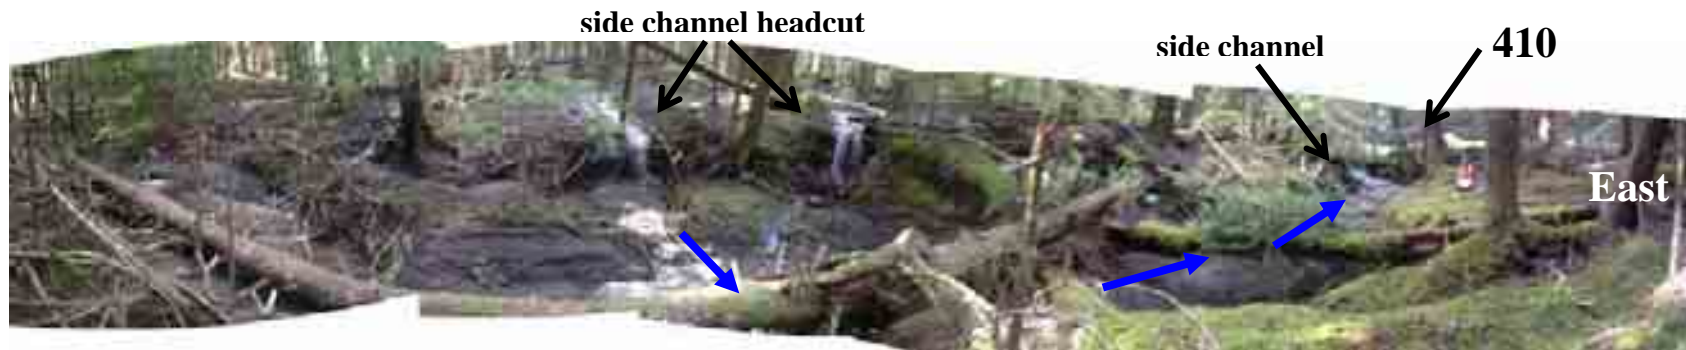
Site 4, MP 58.6 upstream headcut complex downstream of previous two photographs. Looking west from SR 410 near cross-section 7.

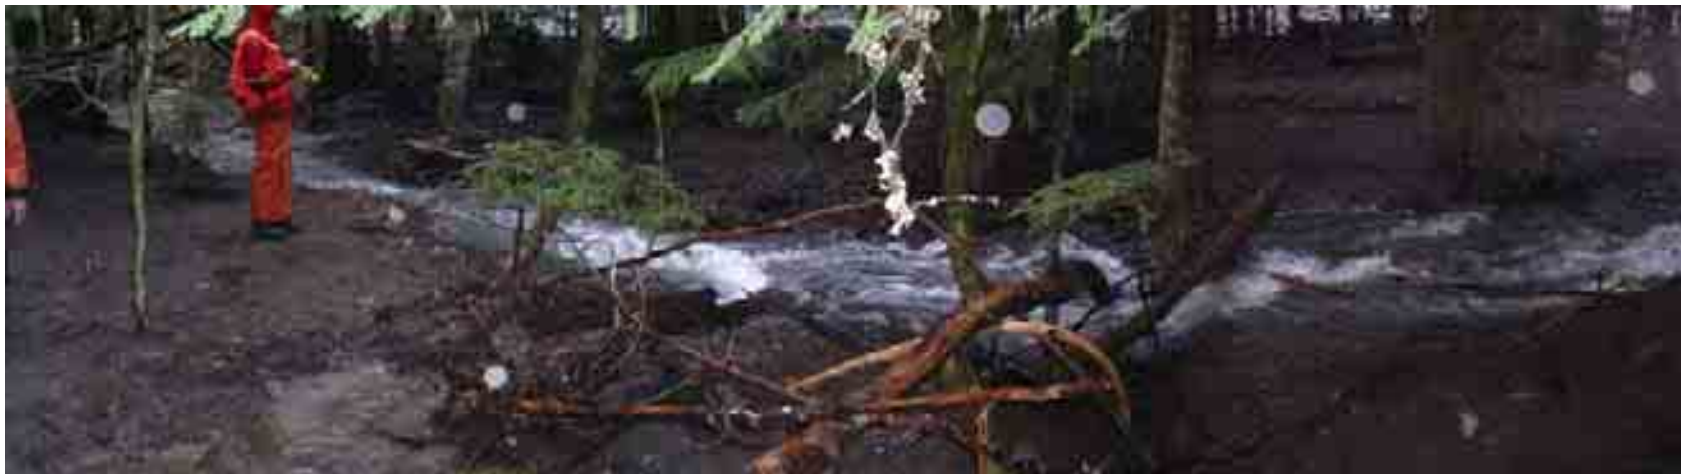
Site 4, MP 58.6 river flow across forested floodplain. Note broad area of sedimentation and tree burial.

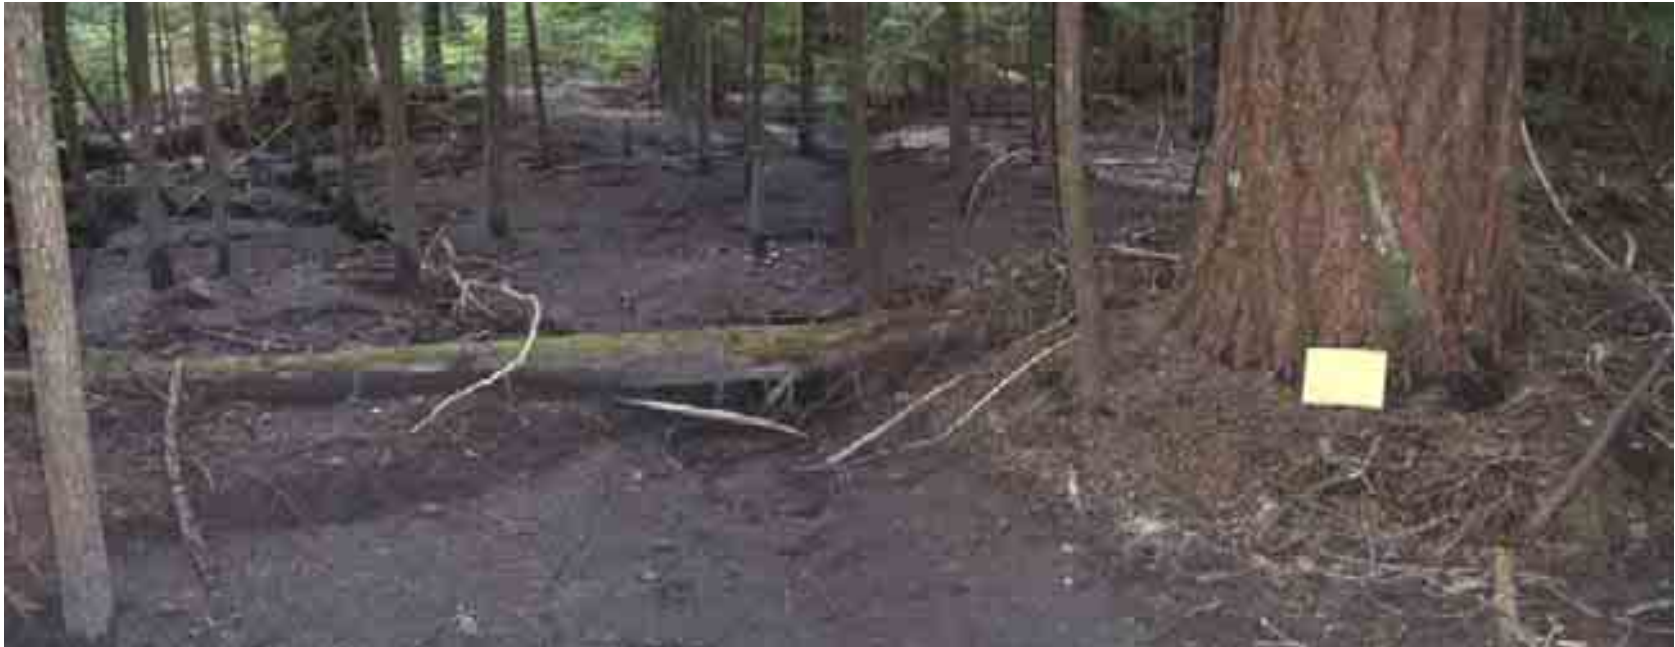
Floodplain sedimentation within downstream portion of Site 4, MP 57.

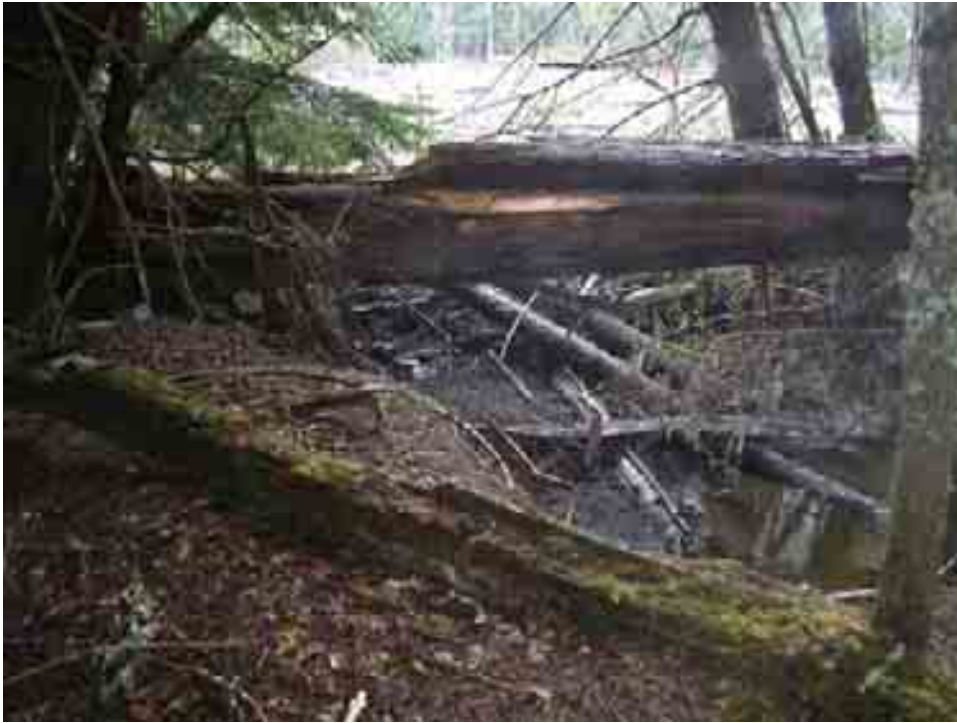
Site 4, MP 58.4. Side channel head cut near right bank of mainstem White River channel. April 26, 2005.

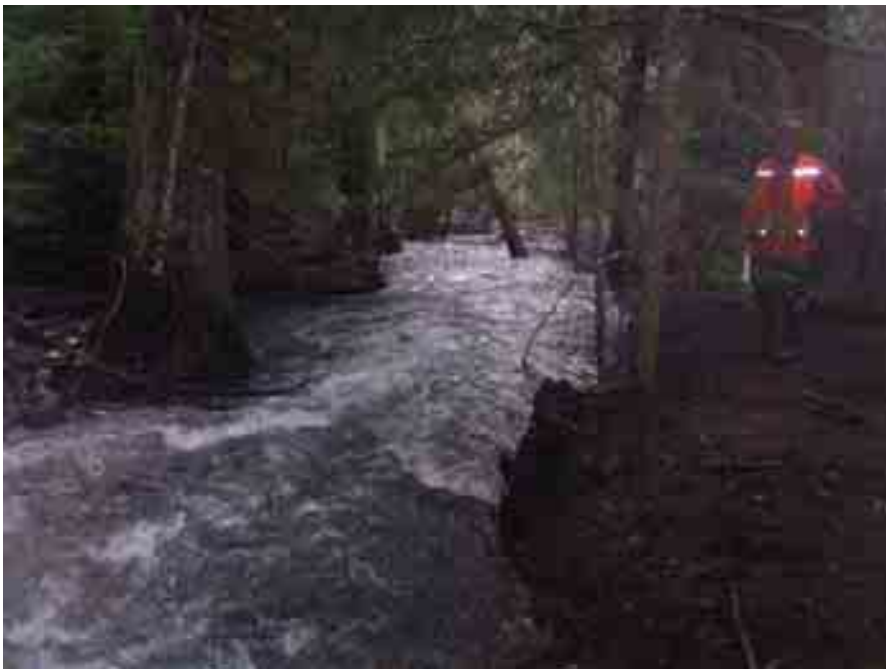
Site 4, MP 58.4 . Side channel flowing through floodplain forest toward SR 410. April 26, 2005.

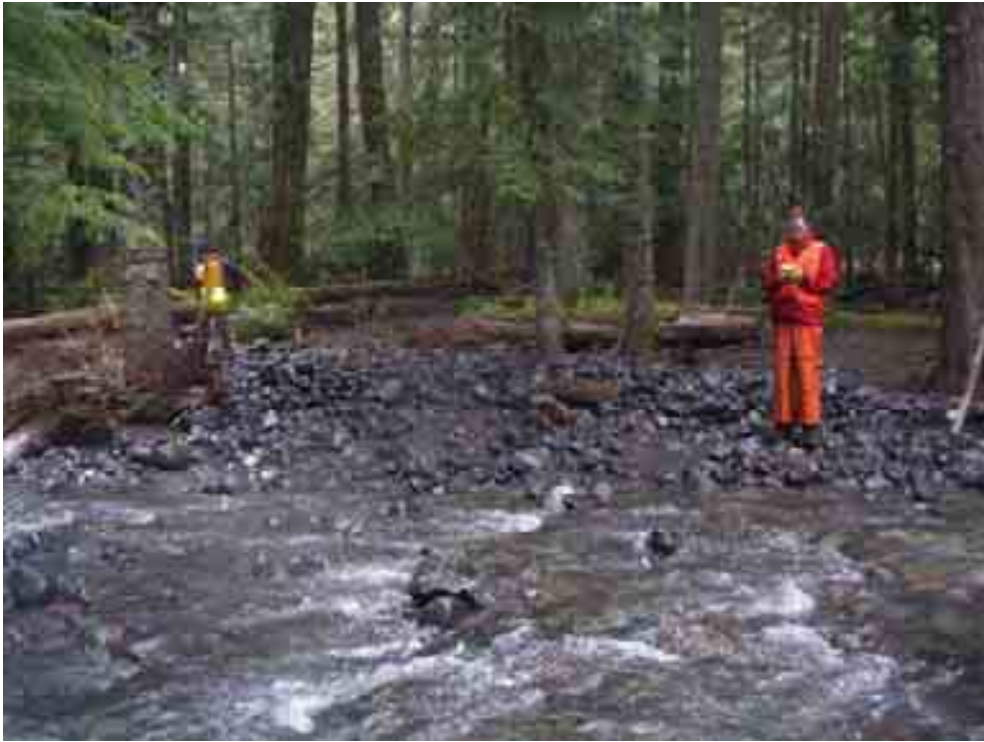
Site 4, MP 58.6. Looking southeast at side channel flow and sedimentation of coarse (cobble) bedload on forested floodplain.

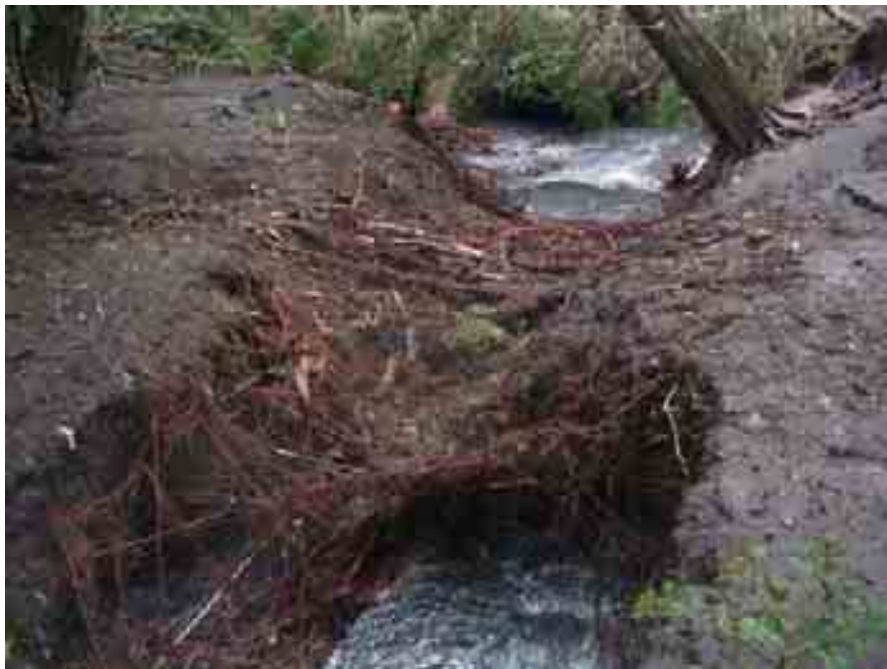
Site 4, MP 58.6. Looking downstream at side channel incision into forested floodplain and example of root cohesion and tree recruitment in preventing entire White River from occupying this low lying area situated up to 15 feet below river bed.

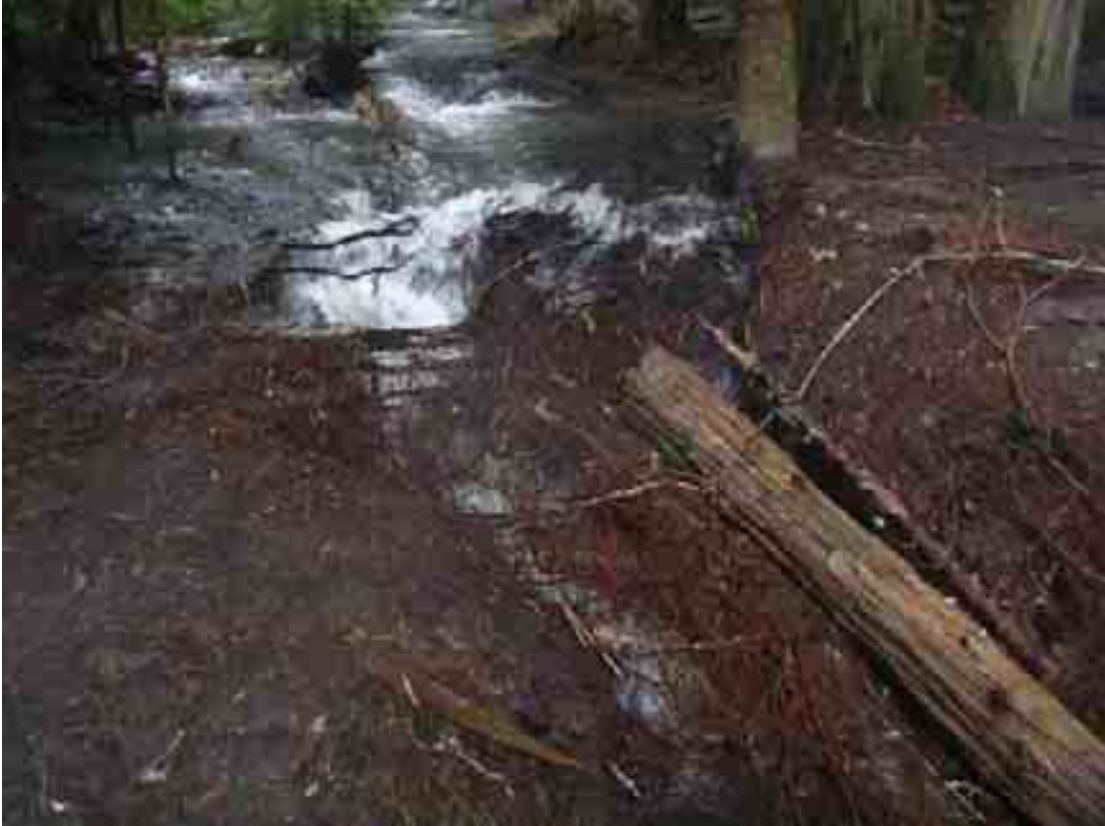
Site 4, MP 58.6. Looking upstream at overbank flow across forest floodplain cutting side channel and resistance presented by root cohesion and woody debris.

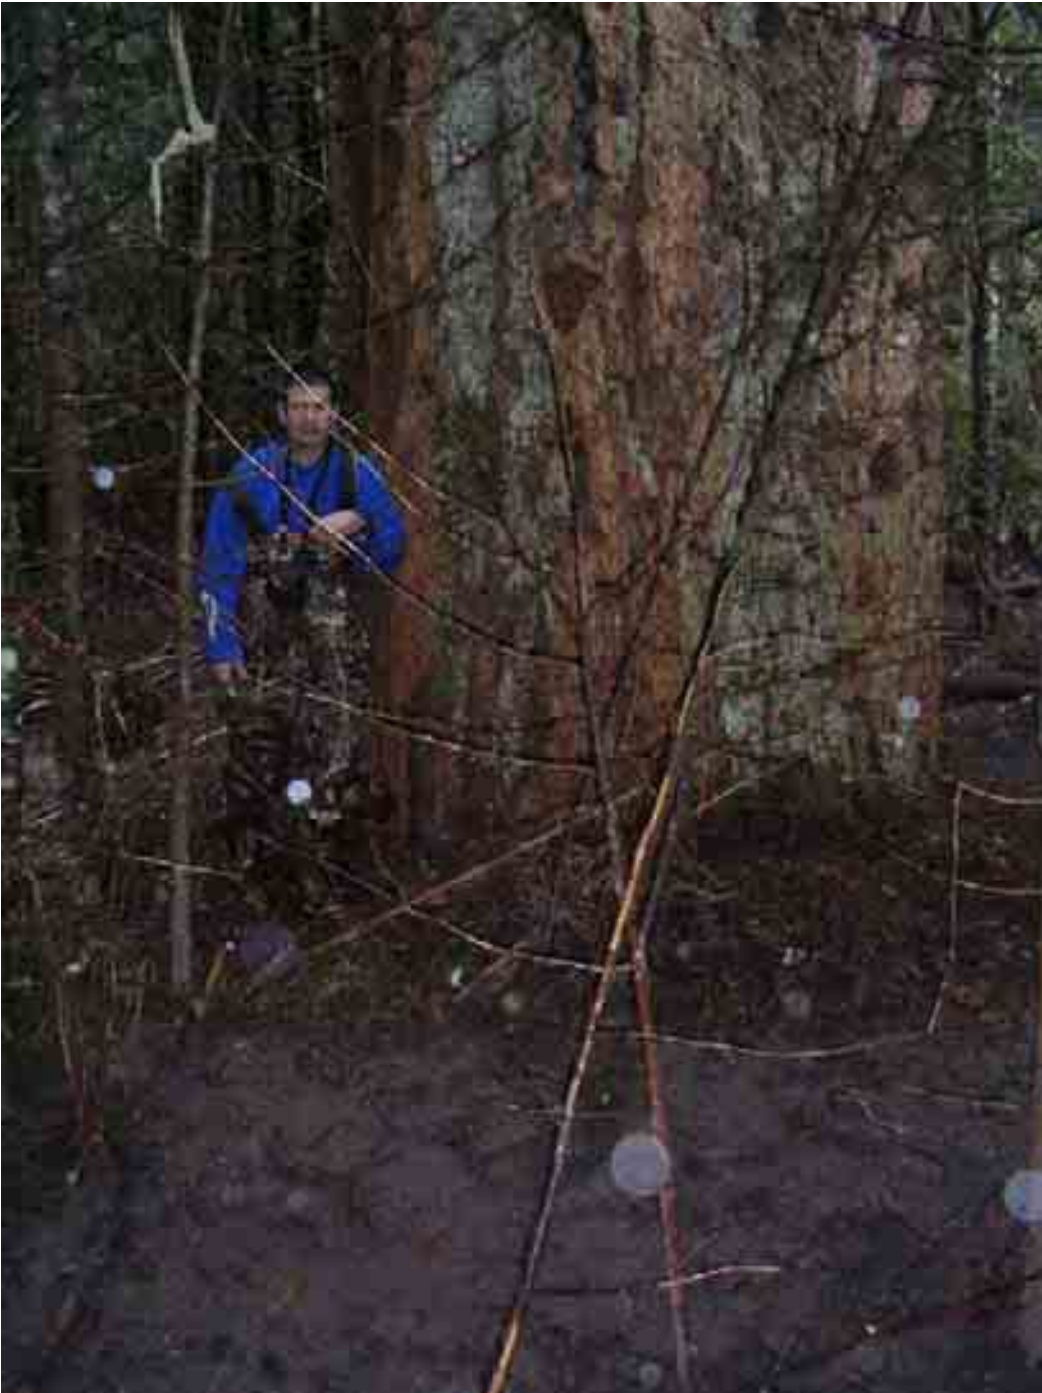
Site 4, MP 57.6. Illustration of old growth trees (>500 years old) being buried in recent sedimentation. April 27, 2005.

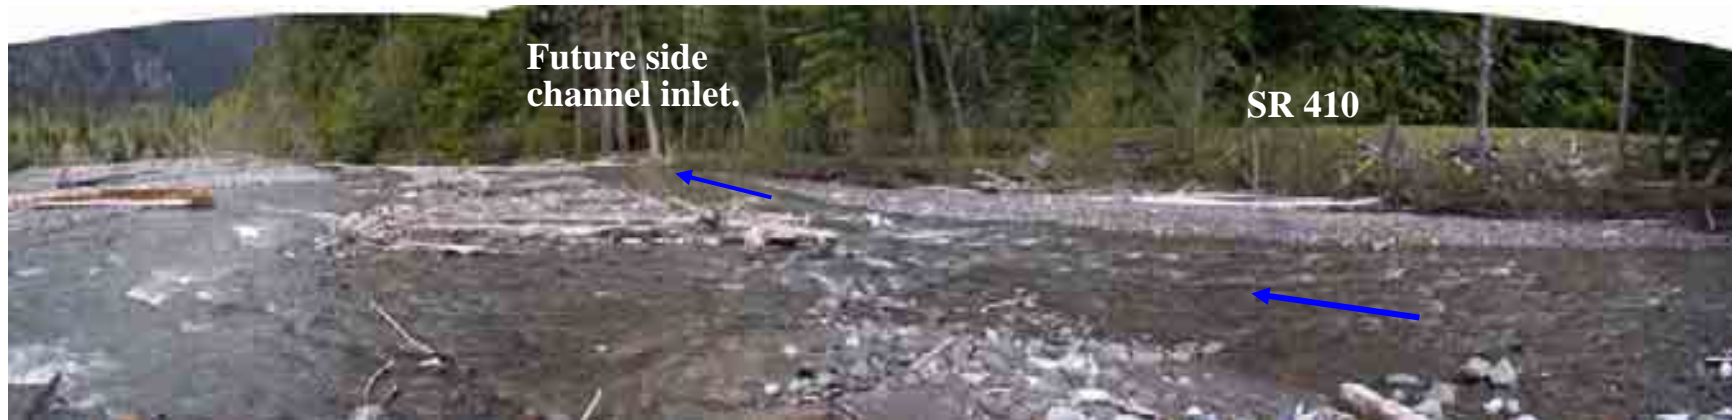
Upstream of site 4 and 5 at future side channel inlet along SR 410, MP 58.8. April 26, 2005.

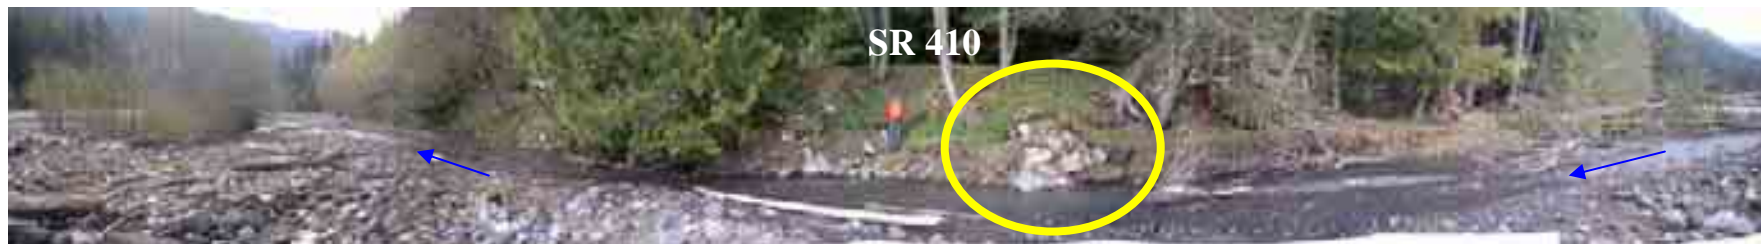
Site 6, MP 59. SR 410 highway embankment along mainstem of White River. Flow is from right to left. Note recent bank failure at center of photo. Recent tree recruitment to river at right may help to deflect flows away from road grade, but a series of ELJ structures is recommended to extend armored riparian forest buffer out from highway approximately 30 feet. April 27, 2005.

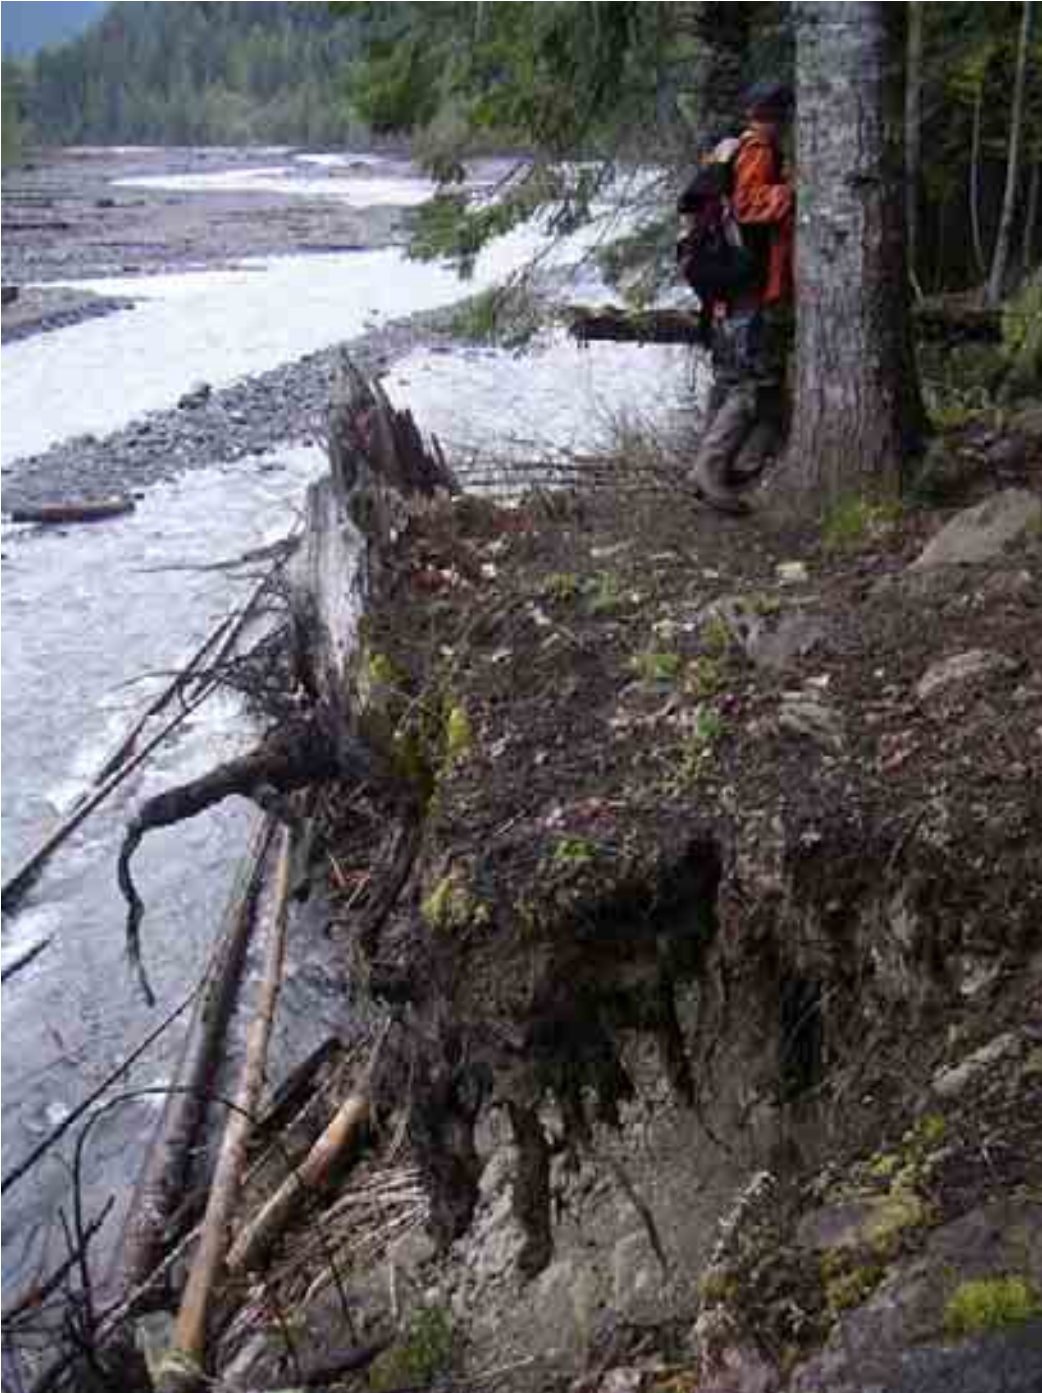
Site 7, MP 59.25. Looking downstream at severely undercut tree on eroding high bank along maintenance yard. April 27, 2005.

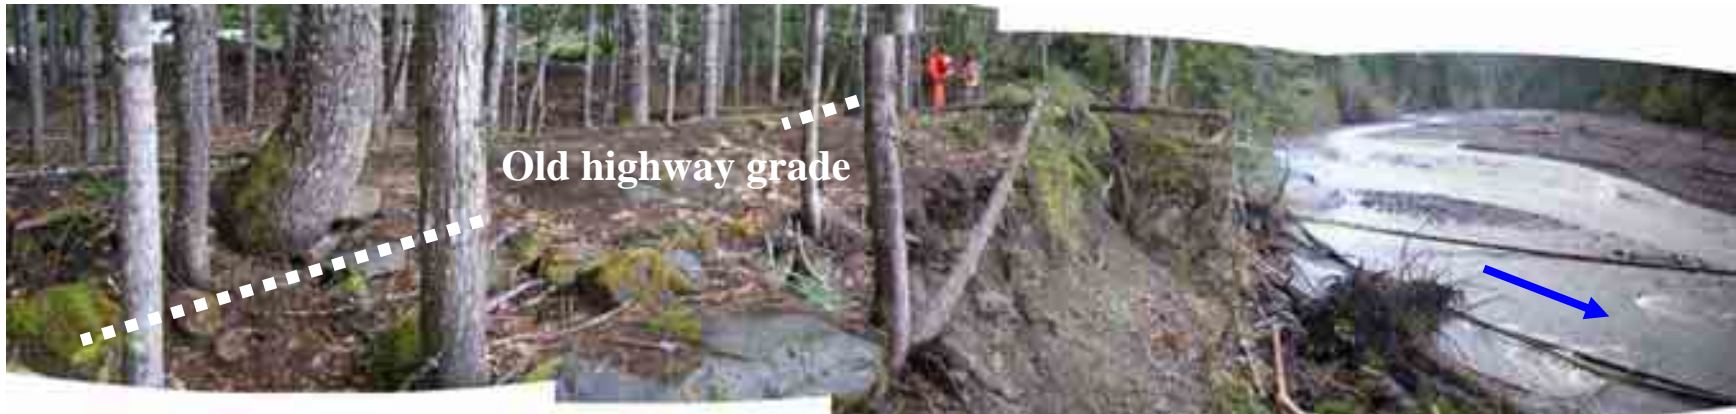
Site 7, MP 59.25. Looking upstream at eroding high bank along maintenance yard. April 27, 2005.

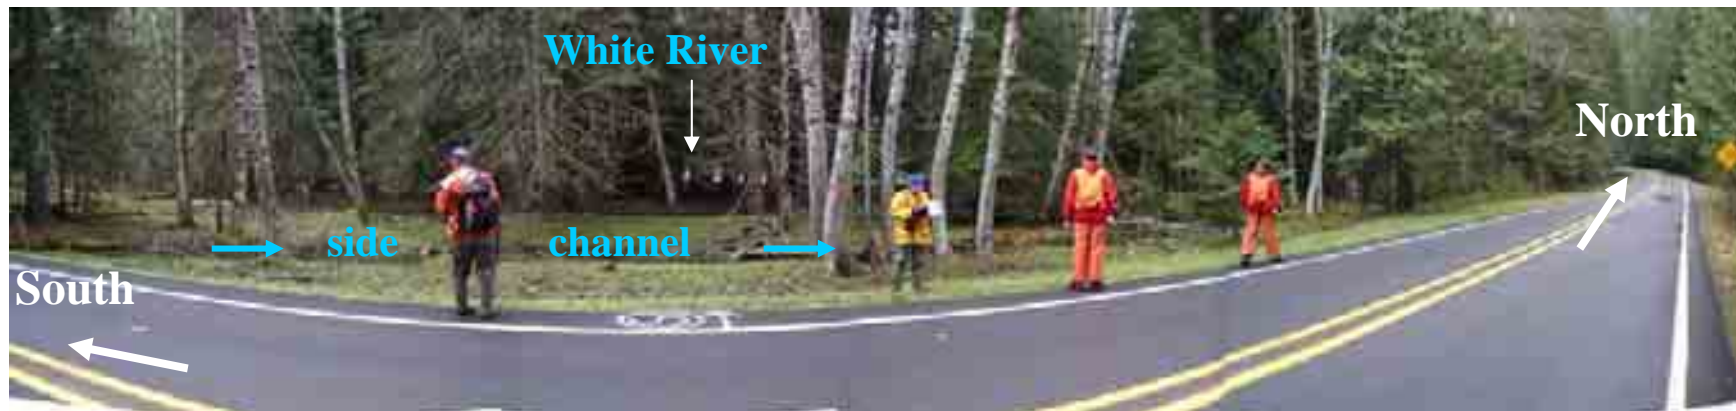
Site 8, MP 59.3. Low lying segment of SR 410 in White River floodplain. Location of WSDOT cross-section (location of cross-section 3, Figure A-5, Appendix A).
