RE: I-5, SR 501 Ridgefield Interchange (McCormick Creek)
Mitigation Site
USACE NWP (23) NWS-2008-1303

The Washington State Department of Transportation completed qualitative monitoring of the I-5 McCormick Creek mitigation site on March 9, March 25, April 6, and September 17, in 2015, to address Year-3 (2016) performance standards. Monitoring activities included hydrology monitoring, vegetation observations, and photo documentation. This Year-2 report is being issued for compliance with the reporting requirements of the US Army Corps of Engineers NWP 23 Number NWS-2008-1303.

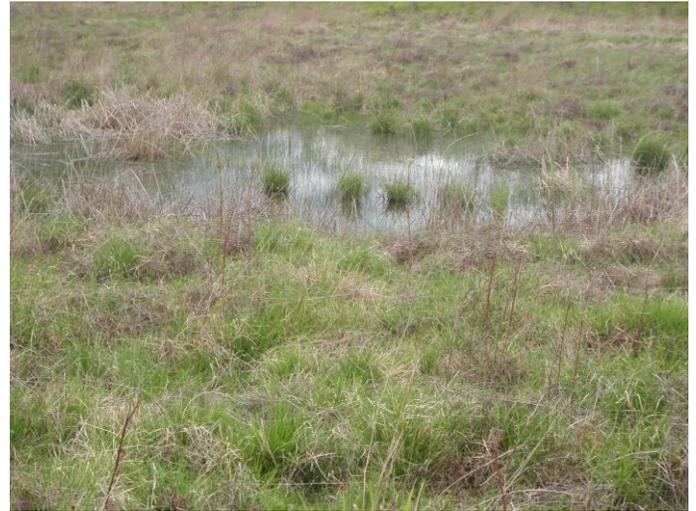
Photo 1 – Inundation at SR 3 McCormick Creek (April 2015)

Water was not present within 12 inches of the soil surface in every well on two of the three visits. On the first visit, March 9, water was present in wells 2 and 4. On the second visit, March 25, water was present in all four wells. On the third visit, April 6, water was present in wells 2-4. (Photo 1)

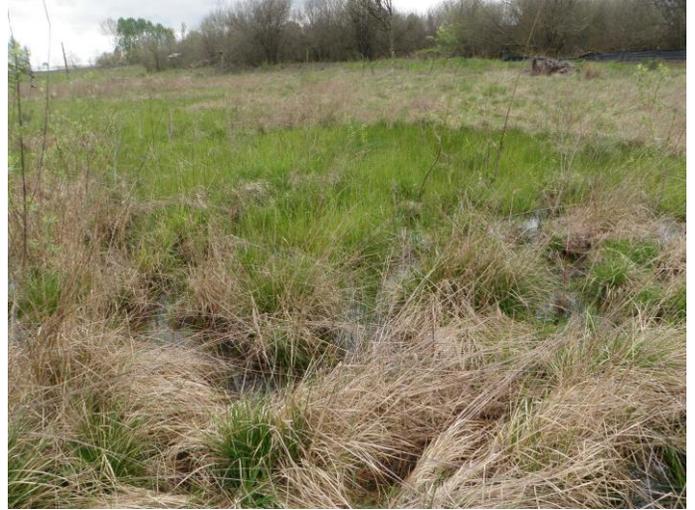
Photo 2 – Cover in the emergent area (April 2015)

Cover of native, facultative wet and wetter species in the emergent wetland is qualitatively estimated at 80 percent. This value exceeds the performance standard target. (Photo 2)
