# **US 101 Bone River Bridge Replacement (Bone River) Mitigation Site**

## **USACE NWP (23) 2009-1152**

**2015 MONITORING REPORT**

# US 101 Bone River Bridge Replacement Mitigation Site

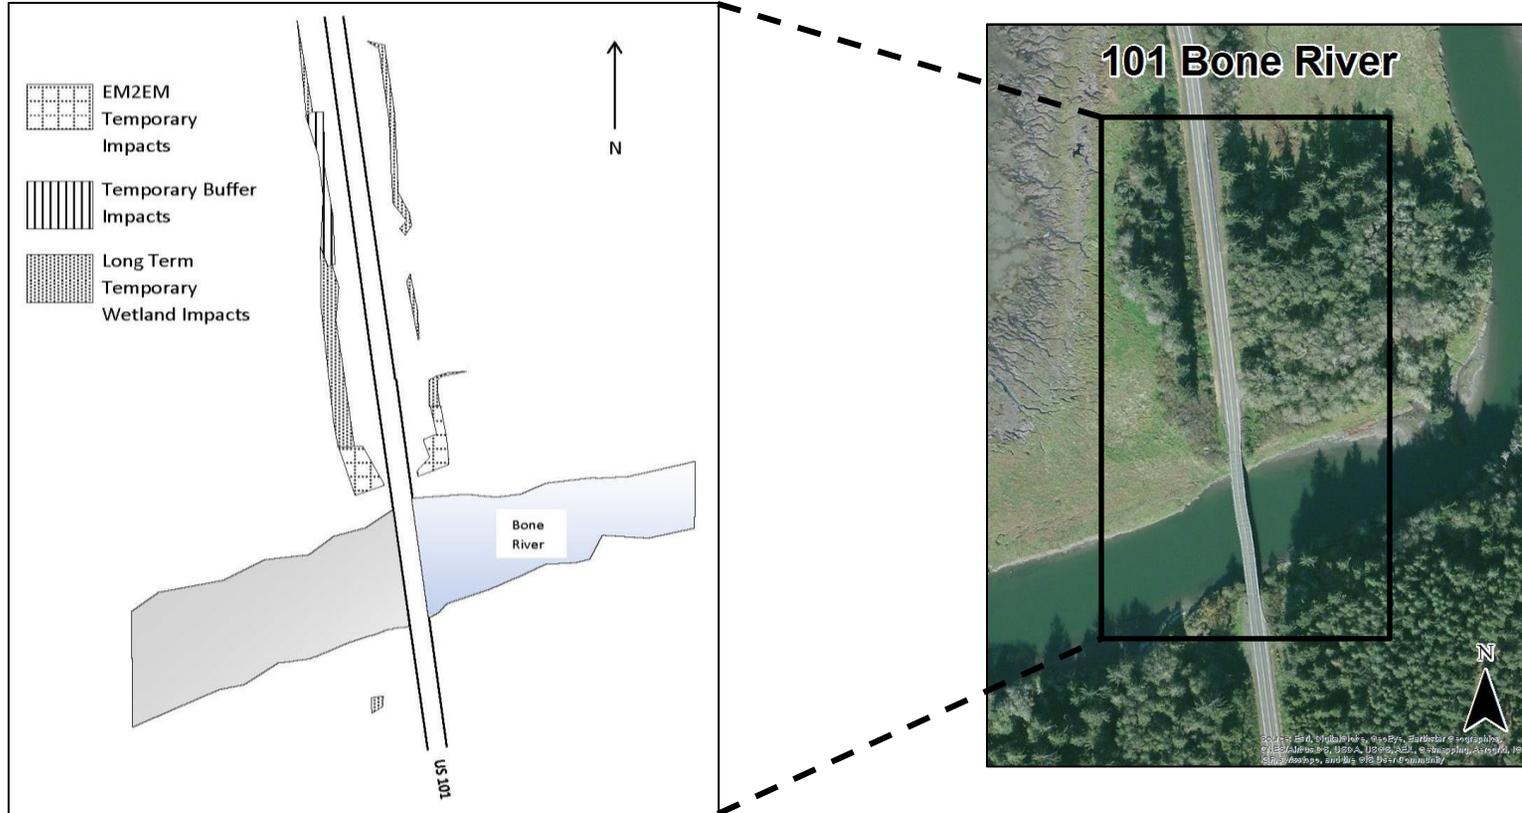
**Figure 1 Site Sketch**

The US 101 Bone River Mitigation Site contains restored emergent and scrub-shrub wetland areas on both sides of US 101 on the north side of Bone River. There is also a restored buffer area to the north along the west side of US 101. Appendix 1 includes site directions.

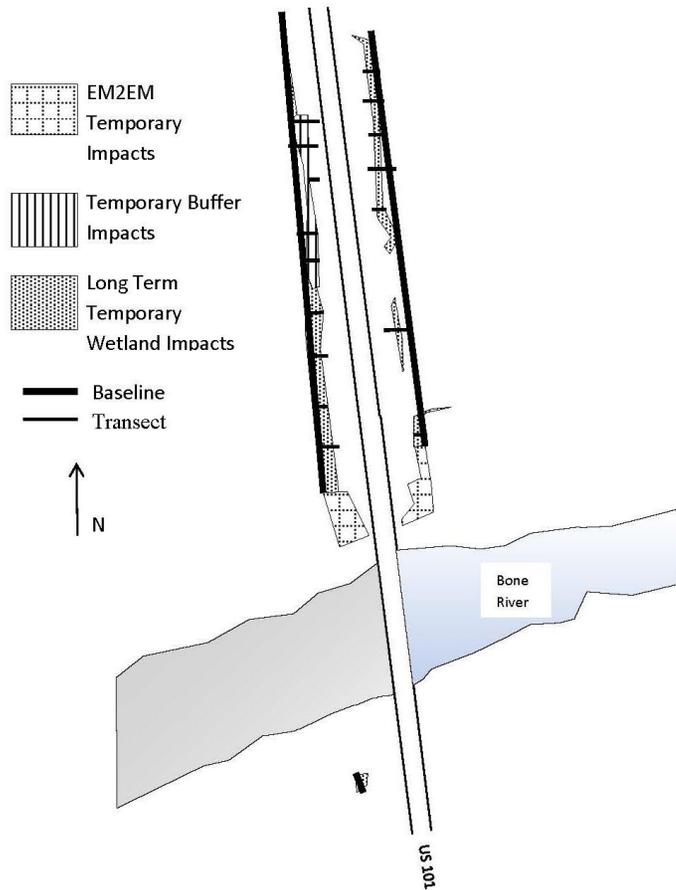
**Figure 2 Site Sampling Design (2015)**

**Placement of Baseline:** Parallel to US 101, through the planting areas.

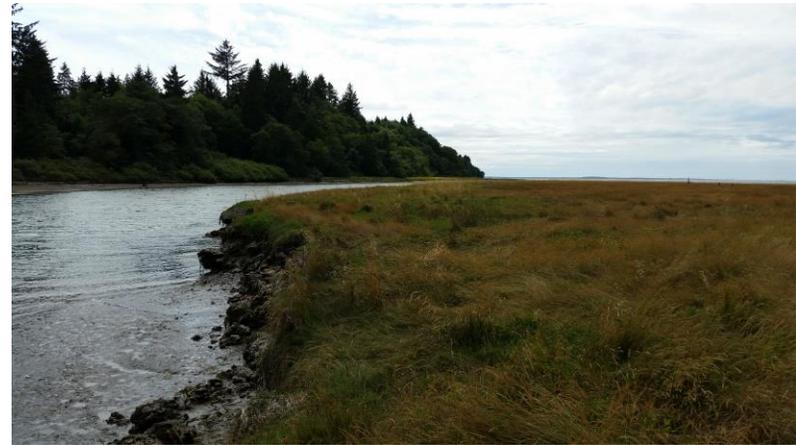
Herbaceous vegetation is the dominant component of the estuarine restoration area; therefore survival is not possible to estimate. Cover of native salt-tolerant herbaceous species was qualitatively estimated at 90 percent. Dominant species observed in this zone included tufted hairgrass (*Deschampsia caespitosa*), and Lyngbye's sedge (*Carex lyngbyei*). (Photo 1)

**Photo 1**  
**Herbaceous cover in the estuarine restoration area**  
**(August 2015)**

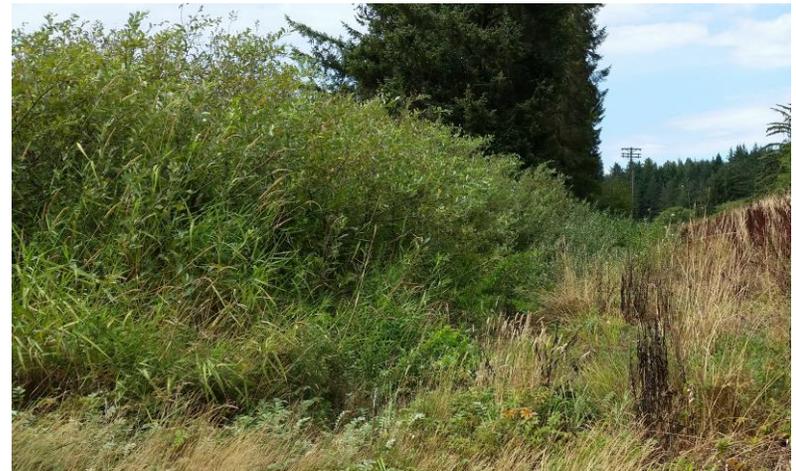
Survival in the palustrine scrub-shrub areas is estimated at 100 percent ( $CI_{80\%} = 100-100\%$ ). No dead plants were observed. This value exceeds the performance standard target. Dominant species include salmonberry (*Rubus spectabilis*), willows (*Salix* species), and red alder (*Alnus rubra*). (Photo 2)

**Photo 2**  
**Survival in the palustrine scrub-shrub areas**  
**(August 2015)**

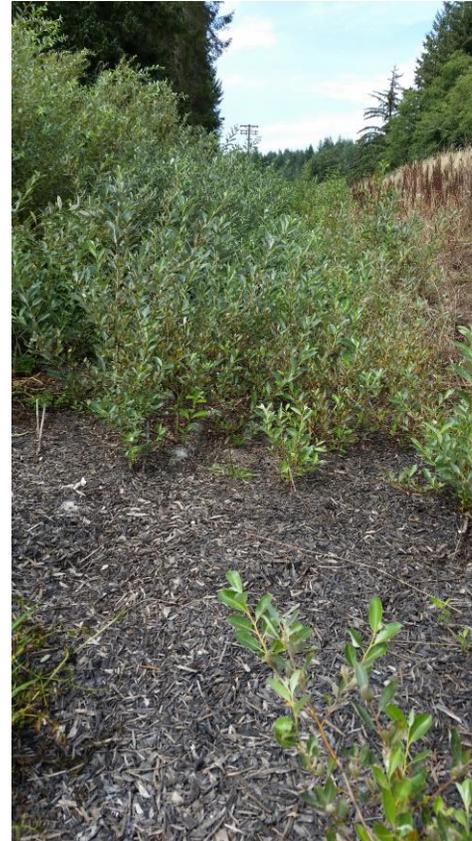
Survival in the buffer restoration areas is estimated at 95 percent. This value exceeds the performance standard target. Dominant species include twinberry honeysuckle (*Lonicera involucrata*) and salmonberry. (Photo 3)

**Photo 3**  
**Survival in the buffer restoration areas**  
**(August 2015)**

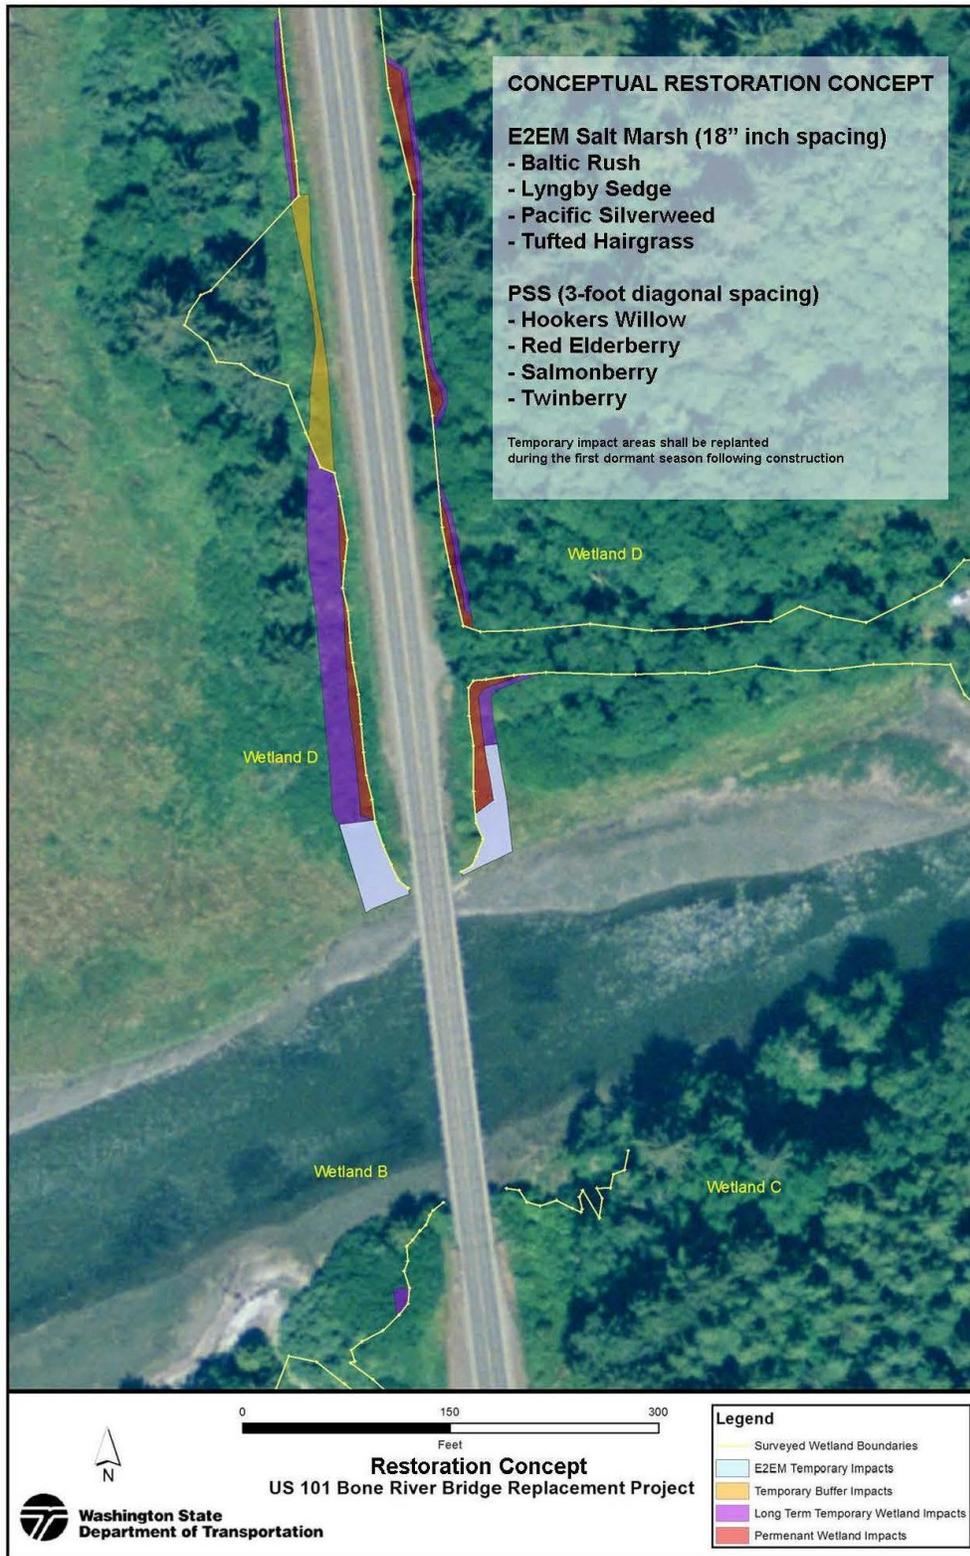
# Appendix 1 – Planting Plan

Appendix 1 shows the planting plan (WSDOT 2012).
