**WSDOT and City of Renton  
Springbrook Creek Wetland and Habitat Mitigation Bank  
Unit C**

**USACE IP 200600100**

**2010 MONITORING REPORT**

**Wetland Assessment and Monitoring Program**

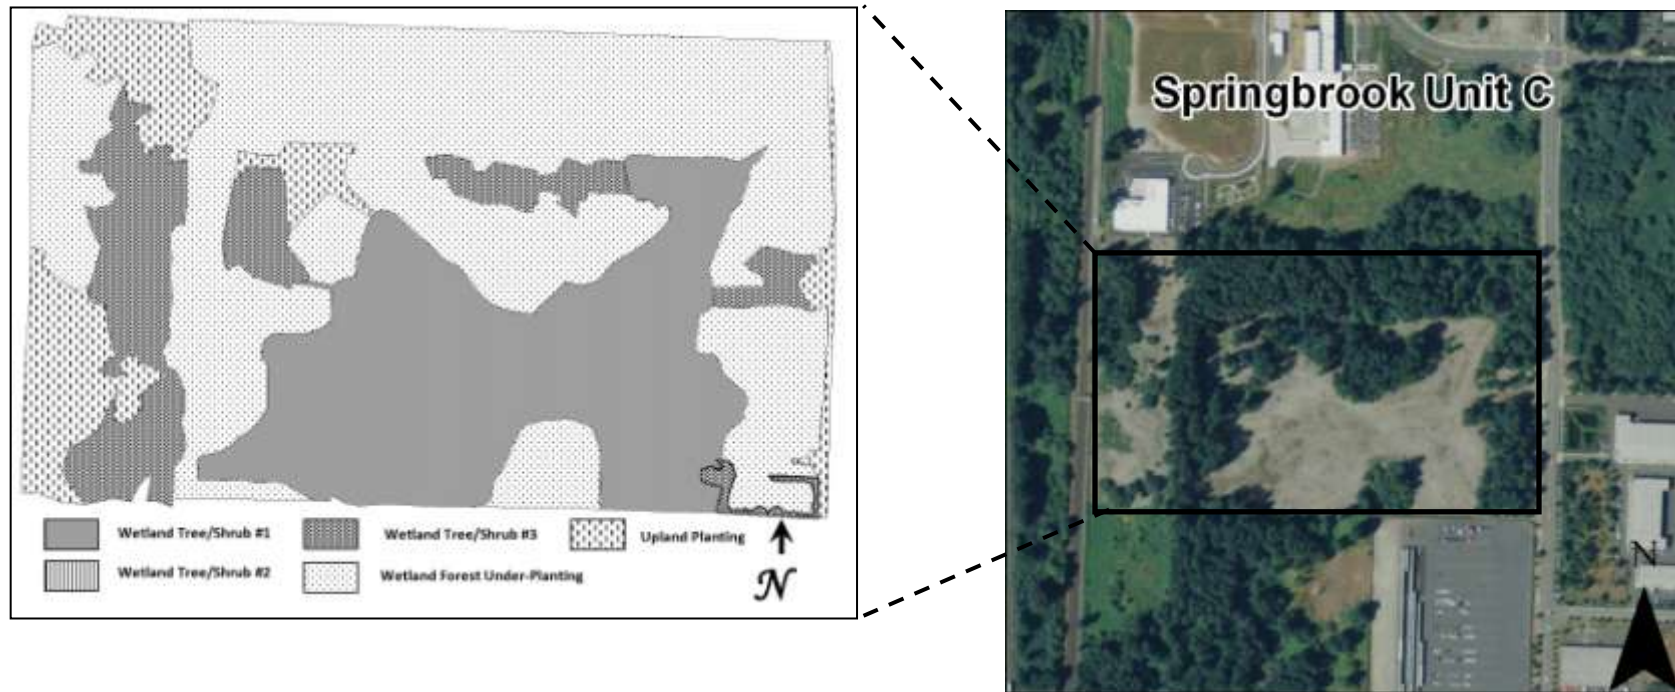
**Figure 1 Site Sketch**

This mitigation bank contains reestablished, rehabilitated, and enhanced wetlands as well as enhanced uplands and riparian areas adjacent to Springbrook Creek. Unit C (Figure 1) is 47.48 acres, of which 27.9 acres are pre-existing wetlands. The bank is operated and managed by WSDOT and the City of Renton. The purpose of the bank is to provide compensation for unavoidable impacts to wetlands and other aquatic resources caused by WSDOT highway construction projects and City of Renton mitigation requirements within the service area.

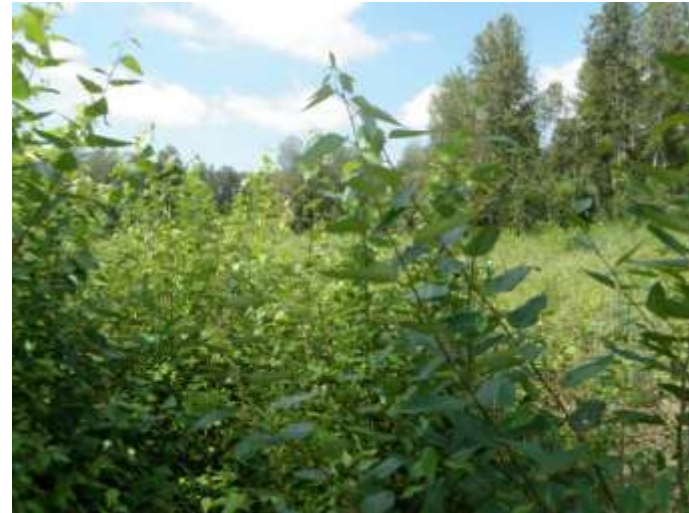
The Wetland Tree/Shrub planting areas have a total of 45,548 living planted stems. The total area of these three wetland planting zones is 19.18 acres. Therefore, the density of live native woody vegetation in this zone is 2,375 plants per acre (Photo 1). This density value exceeds the performance standard target.

**Photo 1 Woody vegetation in the scrub-shrub wetland (August 2010)**

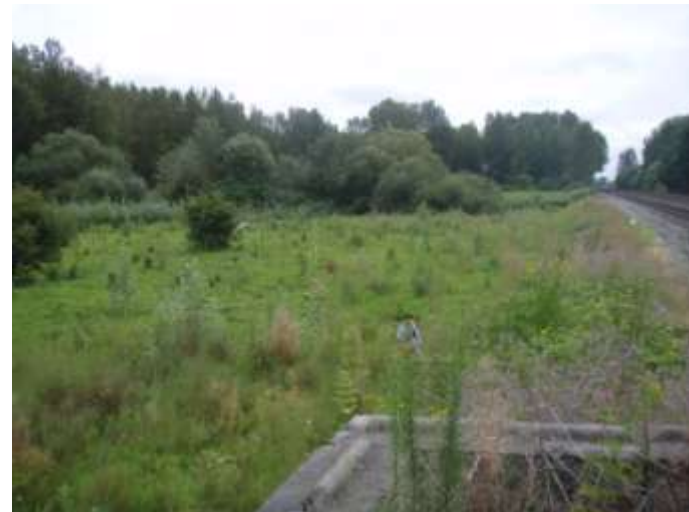
The Upland and Riparian Upland planting areas have a total of 6,381 living native woody plants. The total area of these Upland and Riparian planting zones is 4.86 acres. Therefore, the density of live native woody vegetation in this zone is 1,313 plants per acre (Photo 2). This density value exceeds the performance standard target.

**Photo 2 Woody vegetation in the upland planting zone (August 2010)**
