**Highway 101 Jimmycomelately Estuary (Eng Property)
Mitigation Site**

USACE NWP (27) 200500512

2010 MONITORING REPORT

Wetland Assessment and Monitoring Program

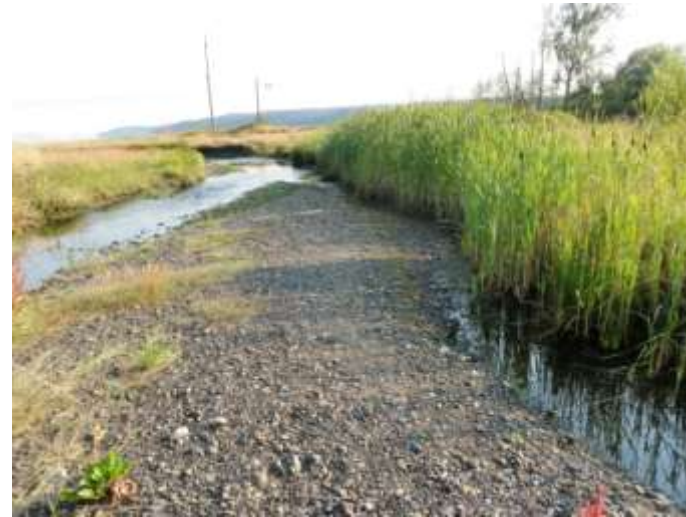
Photo 1
Hydrological connection (August 2010)

A functioning hydrologic connection between Jimmycomelately creek and the adjacent estuary was observed at the time of monitoring (Photo 1). The channels in the estuary were inundated at a depth of approximately twelve to eighteen inches.

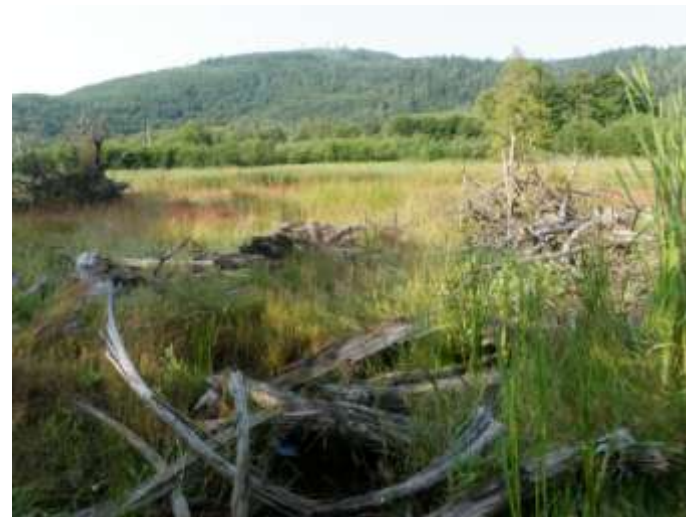
Photo 2
LWD in the wetland (August 2010)

Large woody debris piles were placed on site to provide habitat, cover and foraging sites for wildlife species and it appears that they are performing these functions. The location and cover of the LWD piles were recorded in Year-1 (2006). This baseline data was used to determine percent cover of LWD on-site in Year-5 (2010) (Appendix 3). Cover of large woody debris (measured in square footage) is estimated at 78 percent of the original baseline data (Photo 2), falling just short of the target for Year-5. In 2008, the LWD was estimated at 129 percent of the baseline data. The variation of these data, however, are likely due more to fluctuation in the arrangement of the LWD on the site and the difficulty in establishing an accurate and reliable method for estimating this attribute, than to an actual large change in the amount of LWD on site. Visual observations and photo documentation suggest that the amount of LWD on site has changed very little since it was placed there and is not blocking the waterway nor is it posing any threat to structures.

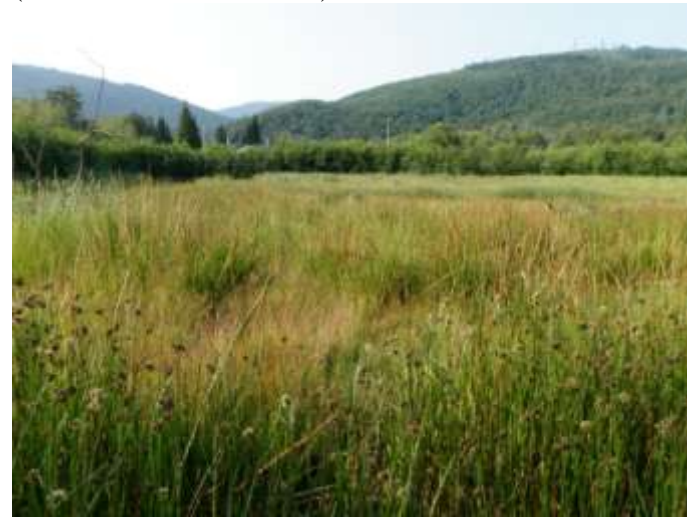
Photo 3
Emergent cover in Wetland 1 (August 2010)

The number of species observed in the tidal flat has increased from previous years. Twenty-five salt and freshwater tolerant plant species provide an estimated 75 percent aerial cover (Photo 3). Twenty of the twenty-five herbaceous species observed are native. Eighteen species are salt-tolerant (Hutchinson 1988). Natural colonization continues to increase species diversity. See Appendix 2 for a list of species recorded, and Appendix 5 for photo points.

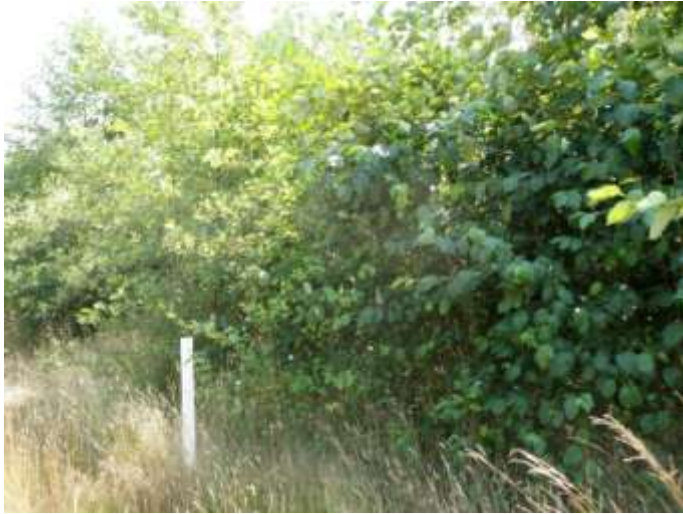
Photo 4
Woody cover in the buffer (August 2010)

The cover of native woody species in the buffer is 77% ($CI_{80\%} = 71-84\%$). Dominant species observed in this area include red alder (*Alnus rubra*) and willows (*Salix* spp.), ranging in height from approximately five to twelve meters (Photo 4 – next page). This estimate does not include the buffer area between the bike trail and US 101, which was originally planted in 2008. At the time of monitoring, this area was dominated by grasses and weedy herbaceous species, but since then, planting and soil amendments have occurred. This cover value does include all of the originally planted buffer areas (the estuary buffer, the riparian banks, and the Smith property).
