**I-5/SR 532 Interchange Improvements Milepost (MP) 212.35
to MP 212.88 (Stanwood) Mitigation Site
WIN A00552R**

USACE NWP (14) 200500845

2014 MONITORING REPORT

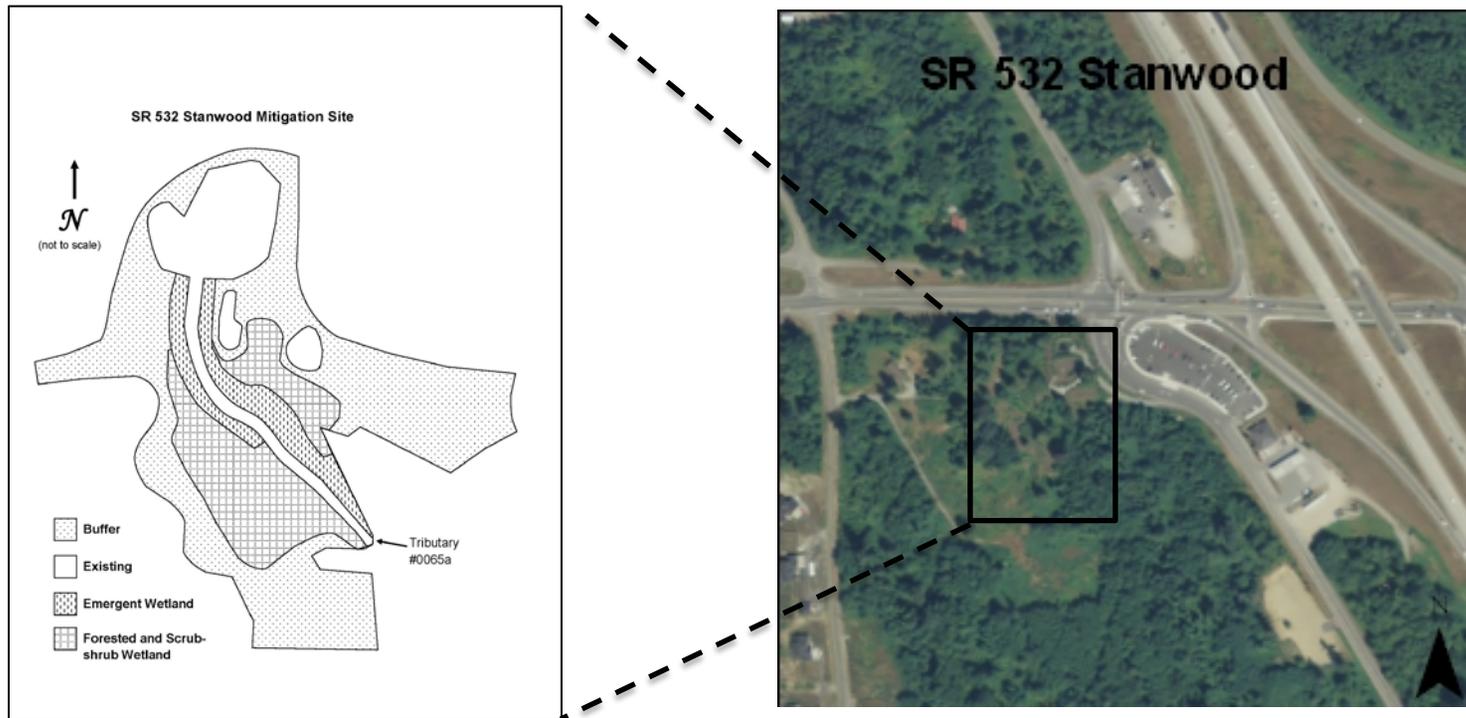
Figure 1 Site Sketch

The SR 532 Stanwood Mitigation Site includes forested, scrub-shrub and emergent wetland areas. Tributary #0065a crosses the established wetland area and connects to adjacent wetlands. Small preserve areas are scattered throughout the buffer. Appendix 2 includes site directions.

This 4.92-acre WSDOT property (Figure 1) contains established and enhanced wetlands, with an enhanced stream channel and its associated buffer. This site is located west of the Pilchuck River, in the Stillaguamish River basin. This site was established to compensate for 0.12 acre of wetland impacts, 0.08 acre of stream buffer impacts, and 0.63 acre of wetland buffer impacts related to improvements along the SR 532 and I-5 interchange. This site connects adjacent wetland complexes and is intended to provide water quality functions and create habitat for fish and amphibians.

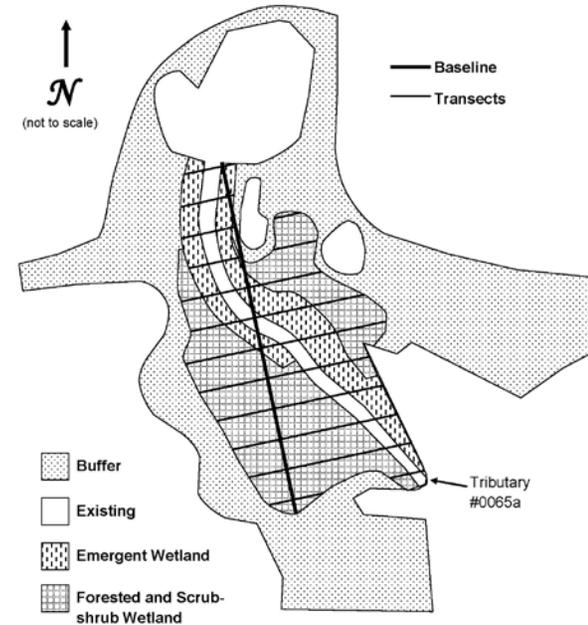
Figure 2 Site Sampling Design (2014)

To evaluate standards for native woody cover in the wetland, a 58-meter baseline was placed roughly north to south through the center of the wetland (Figure 2). Eleven sampling transects were randomly placed perpendicular to the baseline. The line intercept method was used to estimate woody cover (Performance Standard 3, 4, and 5). Twenty-three five-meter long line-segment sample units were randomly positioned along the sampling transects.

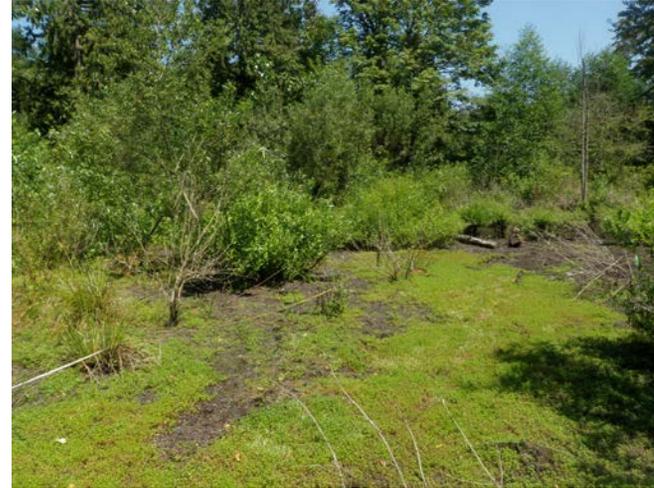
Photo 1
Spatulaleaf loosestrife (*Lythrum portula*) in the wetland (July 2014)

The cover of native FAC or wetter herbs in the emergent wetland is estimated at one percent. The prolonged inundation has virtually purged the emergent zone of native herbs and this area is now dominated by mud flats and spatulaleaf loosestrife (*Lythrum portula*).

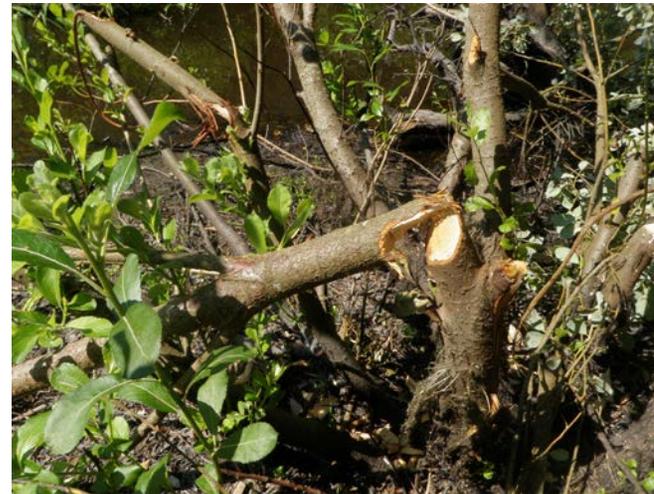
Photo 2
Active beaver herbivory (July 2014)

This site is progressing well despite the continuing setback in native herbaceous cover in the emergent wetland since 2012 due to prolonged deep inundation through the spring, likely caused by beaver activity. Apart from the cover of emergent species, the site is meeting all of its current (year-7) performance standards. The original herbaceous zone no longer exists, due to the beaver dam and the change in hydrology. The prolonged inundation has caused some die of within the scrub-shrub zone and this area is now dominated by an herbaceous layer. However, this area is dominated by spatulaleaf loosestrife (*Lythrum portula*) (Photo 1) which is an introduced species and does not count towards the herbaceous cover performance standard. With the continuing fluctuation of the water levels and the ongoing beaver activity (Photo 2) on the site it may be difficult to meet the emergent performance standard.

Ongoing weed control is planned in 2015. Emergent planting will occur in late spring early summer with a potential planting of an aquatic bed component in the areas that are now permanently inundated. The location will be evaluated at the time of planting due to the existing beaver dam.

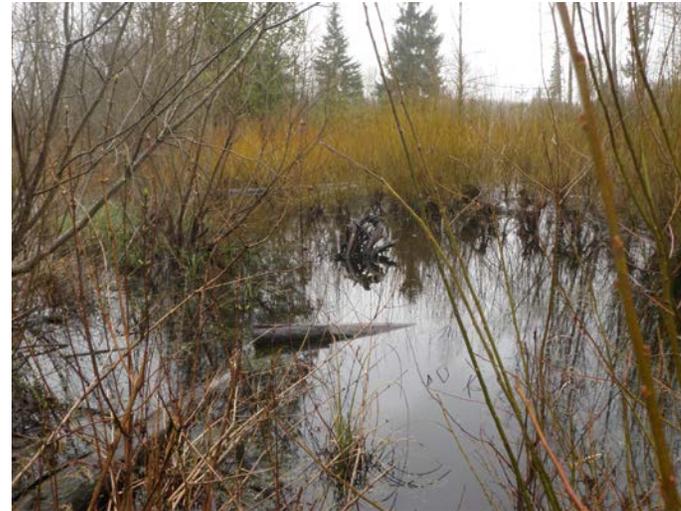
Photo 3
Inundation in the wetland (April 2014)

During three hydrology monitoring visits on March 3, March 18, and April 14 90 percent of the wetland area was inundated and 10% was saturated to the soil surface (Photo 3).

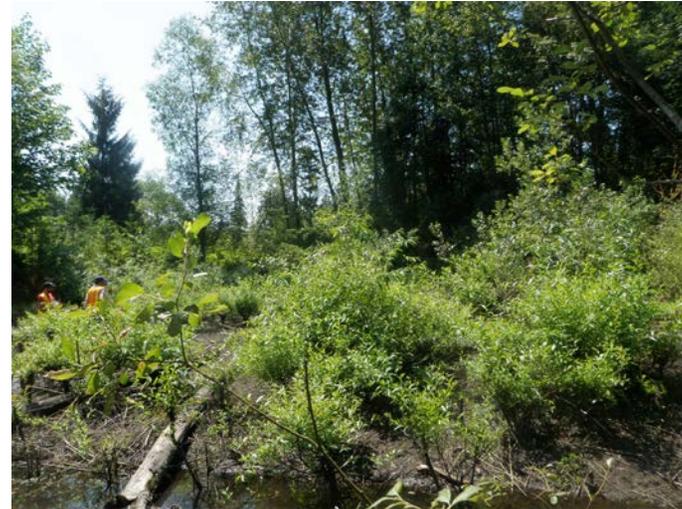
Photo 4
Wetland woody cover (July 2014)

Native facultative or wetter woody species is estimated at 70% cover ($CI_{80\%} = 61-79\%$) (Photo 4). In the PSS/PFO communities red alder (*Alnus rubra*), willows (*Salix spp.*), and salmonberry (*Rubus spectabilis*) each have greater than six percent cover. Red alder (*Alnus rubra*) has a relative cover of 13 percent.

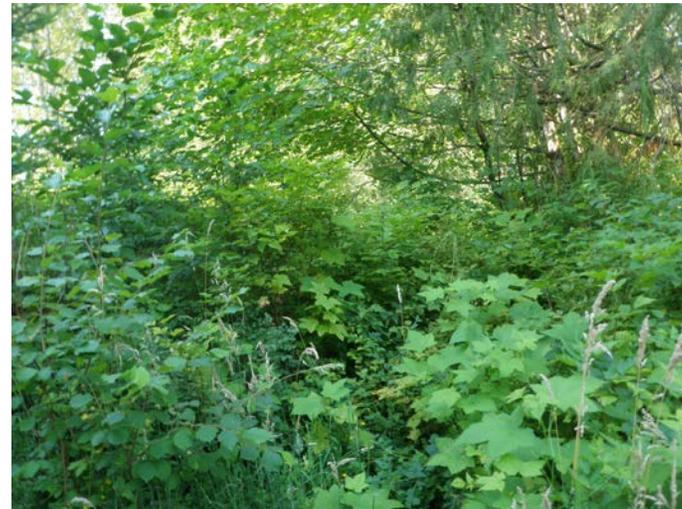
Photo 5
Buffer woody cover (July 2014)

The cover of native woody species in the buffer (Photo 5) is 95%. Salmonberry (*Rubus spectabilis*), snowberry (*Symphoricarpos albus*), and red alder (*Alnus rubra*) achieve at least six percent relative cover in the buffer community. Relative cover of red alder is estimated at 20 percent in the upland buffer community.

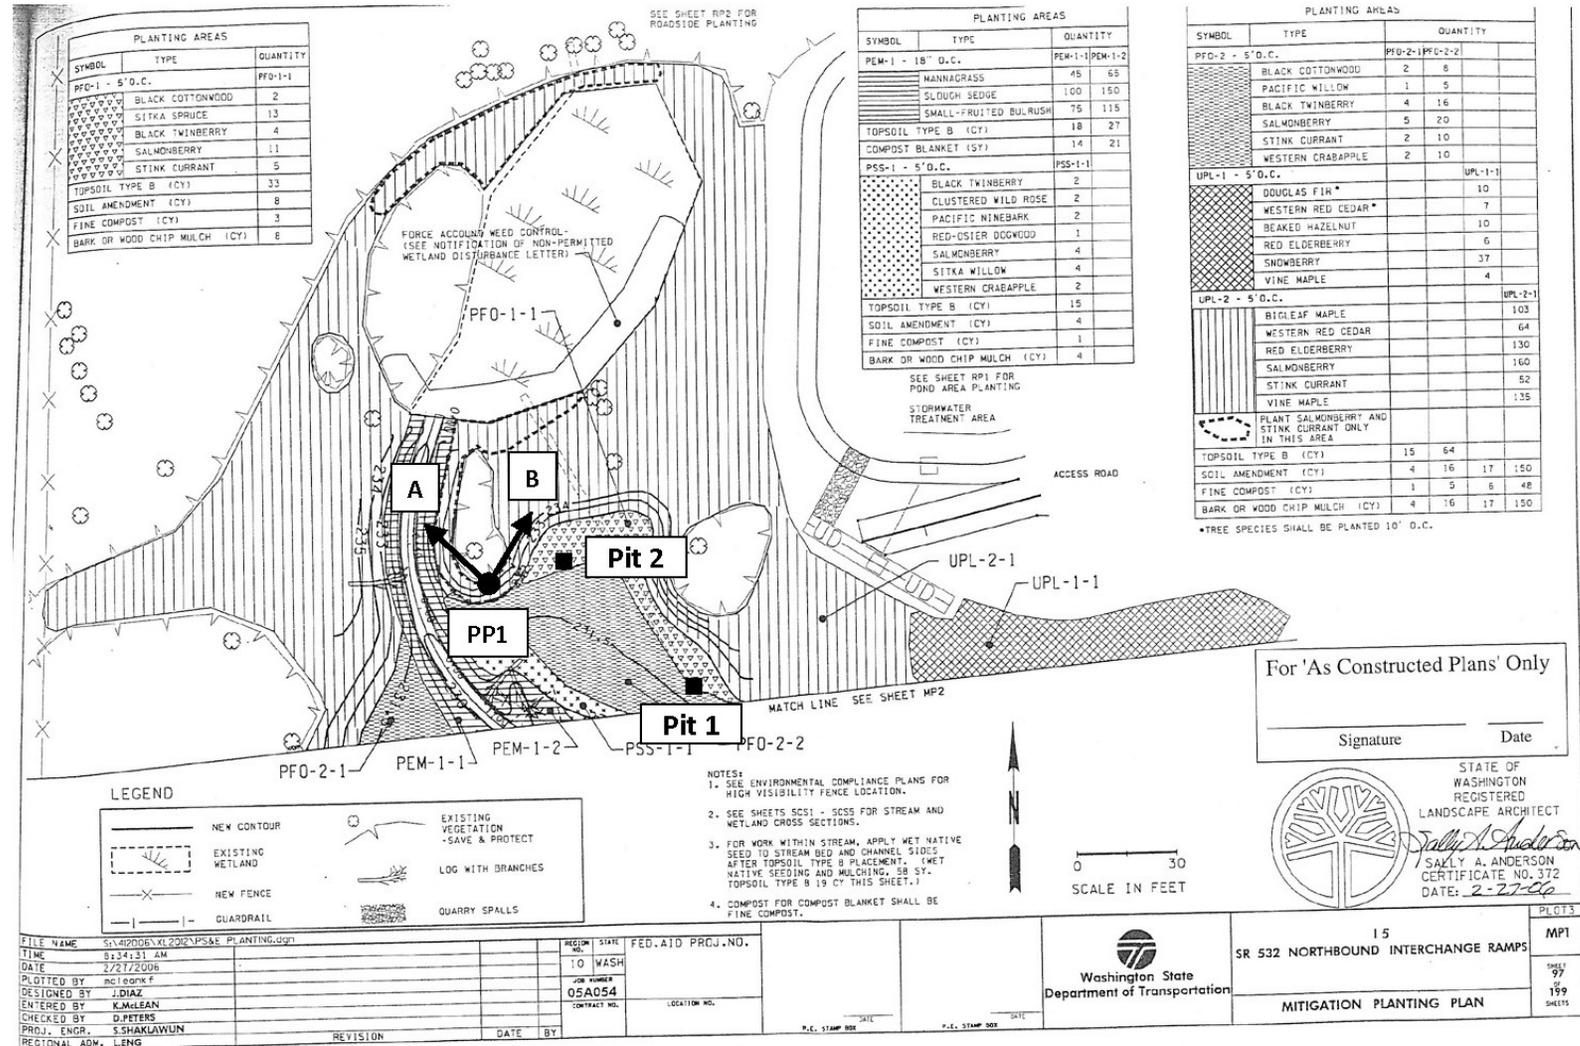
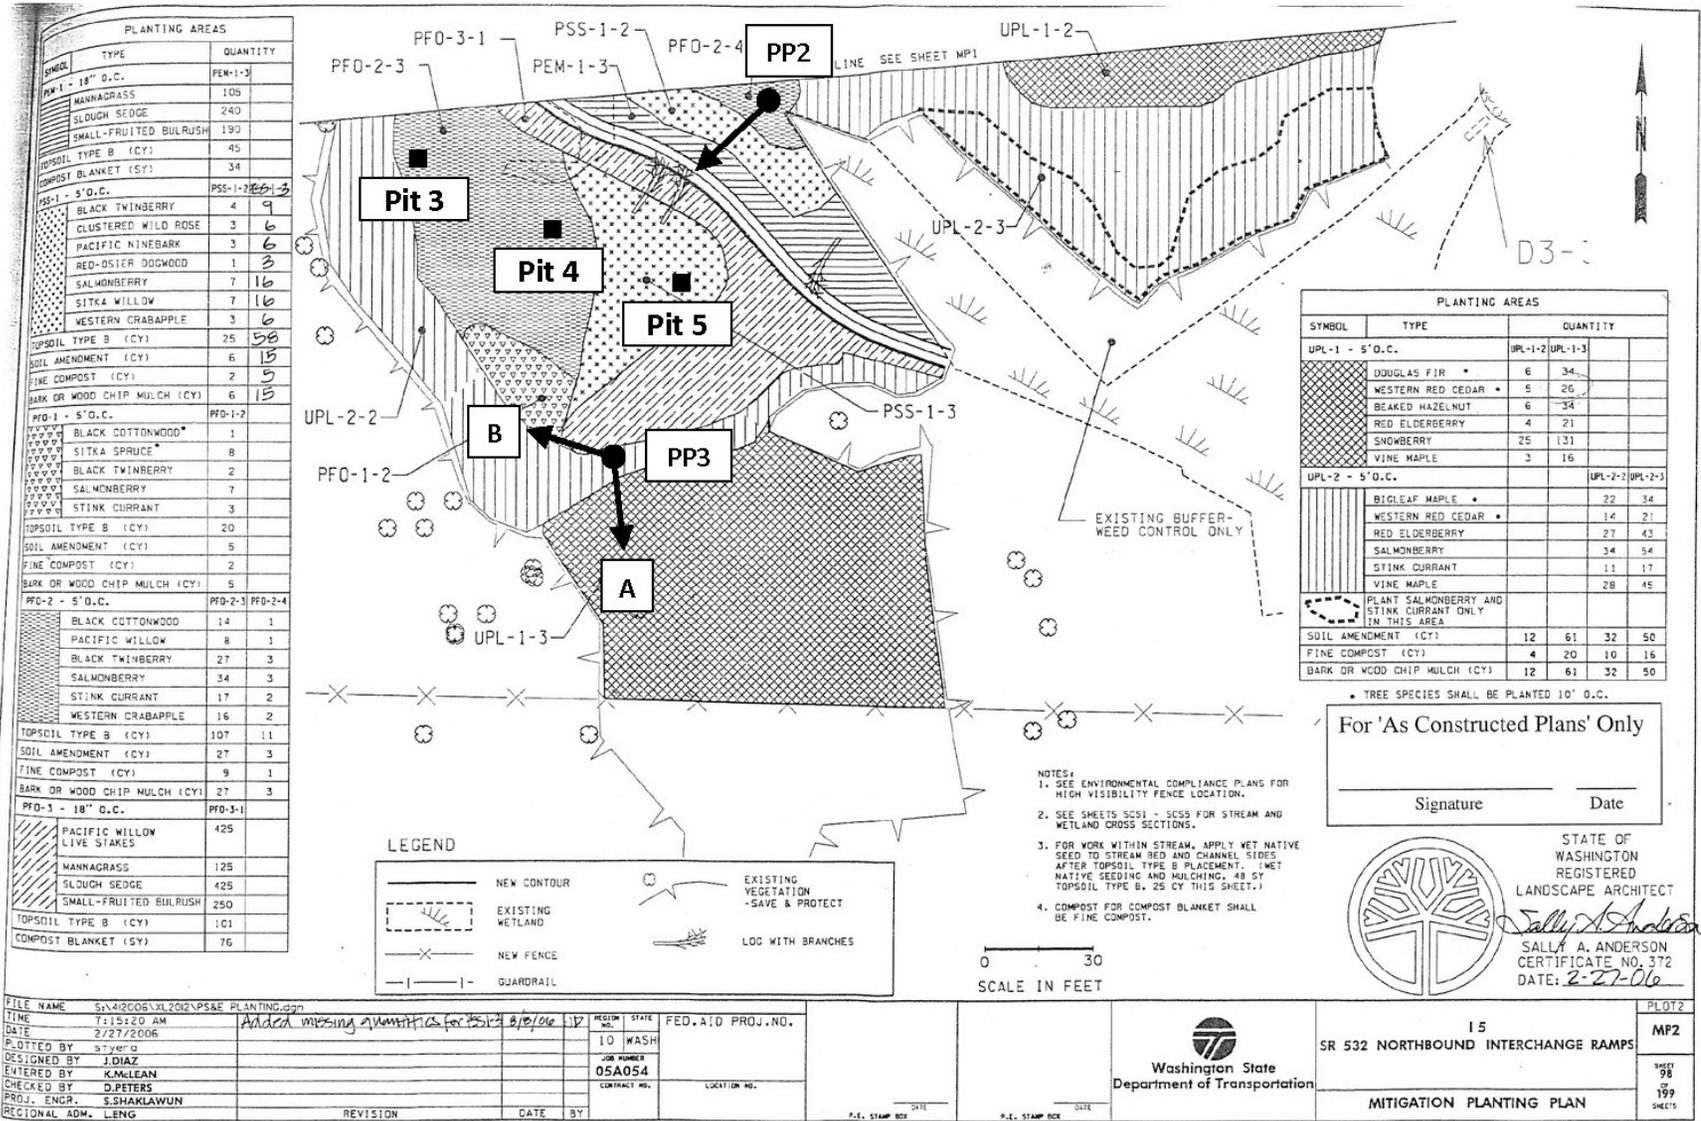
Appendix 1 – Planting Plan (As-Built) with Photo Point Locations and Hydrology Pit or Well Locations

SYMBOL	TYPE	QUANTITY
PF0-1 - 18" O.C.		
	MANNAGRASS	108
	SLOUGH SEDGE	240
	SMALL-FRUITED BULRUSH	190
	TOPSOIL TYPE B (CY)	45
	COMPOST BLANKET (SY)	34
PSS-1 - 5'O.C.		
	BLACK TWINBERRY	4
	CLUSTERED WILD ROSE	3
	PACIFIC NINEBARK	3
	RED-OSIER DOGWOOD	1
	SALMONBERRY	7
	SITKA WILLOW	7
	WESTERN CRABAPPLE	3
	TOPSOIL TYPE B (CY)	25
	SOIL AMENDMENT (CY)	6
	FINE COMPOST (CY)	2
	BARK OR WOOD CHIP MULCH (CY)	6
PF0-1 - 5'O.C.		
	BLACK COTTONWOOD*	1
	SITKA SPRUCE*	8
	BLACK TWINBERRY	2
	SALMONBERRY	7
	STINK CURRANT	3
	TOPSOIL TYPE B (CY)	20
	SOIL AMENDMENT (CY)	5
	FINE COMPOST (CY)	2
	BARK OR WOOD CHIP MULCH (CY)	5
PF0-2 - 5'O.C.		
	BLACK COTTONWOOD	14
	PACIFIC WILLOW	8
	BLACK TWINBERRY	27
	SALMONBERRY	34
	STINK CURRANT	17
	WESTERN CRABAPPLE	16
	TOPSOIL TYPE B (CY)	107
	SOIL AMENDMENT (CY)	27
	FINE COMPOST (CY)	9
	BARK OR WOOD CHIP MULCH (CY)	27
PF0-3 - 18" O.C.		
	PACIFIC WILLOW LIVE STAKES	425
	MANNAGRASS	125
	SLOUGH SEDGE	425
	SMALL-FRUITED BULRUSH	250

SYMBOL	TYPE	QUANTITY
UPL-1 - 5'O.C.		
	DOUGLAS FIR *	6
	WESTERN RED CEDAR *	5
	BEAKED HAZELNUT	6
	RED ELDERBERRY	4
	SNOWBERRY	25
	VINE MAPLE	3
UPL-2 - 5'O.C.		
	BIGLEAF MAPLE *	22
	WESTERN RED CEDAR *	14
	RED ELDERBERRY	27
	SALMONBERRY	34
	STINK CURRANT	11
	VINE MAPLE	28
	PLANT SALMONBERRY AND STINK CURRANT ONLY IN THIS AREA	
	SOIL AMENDMENT (CY)	12
	FINE COMPOST (CY)	4
	BARK OR WOOD CHIP MULCH (CY)	12

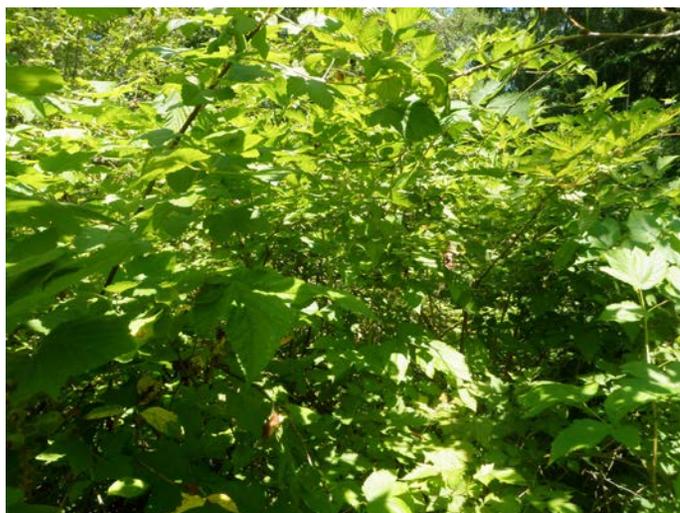
Photo Point 1

The photographs below were taken from permanent photo-points on July 15, 2014 and document current site development.

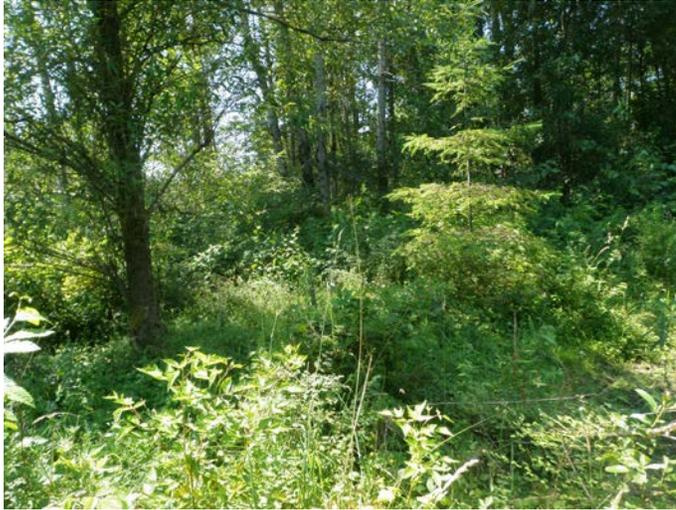
Photo Point 3b

The photographs below were taken from permanent photo-points on July 15, 2014 and document current site development.
