RE: SR 164 - SE 368th Place & 158th Avenue SE (Bass Lake 2) Mitigation Site
USACE NWP 23 Number 2002-4-00231
EPA WQC# ECO-083

The Washington State Department of Transportation completed qualitative monitoring of the SR 164 Bass Lake 2 mitigation site on July 14, 2010. Monitoring was completed to address Year-10 (2012) performance standards. Monitoring activities included an assessment of wetland hydrology, vegetation observations, and photo documentation. This Year-8 report is being issued for compliance with the terms and conditions of the Environmental Protection Agency Water Quality Certification # ECO-083 (200200231) and to document the third year achievement of final year standards (see discussion below).

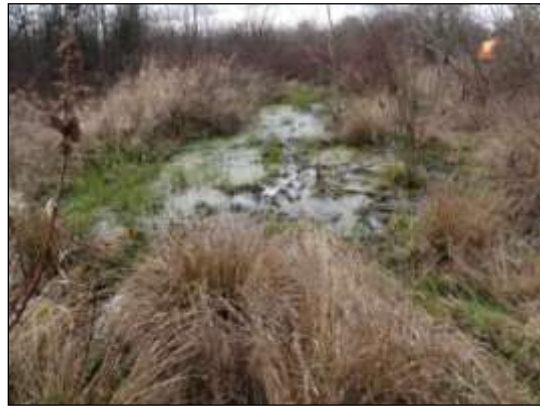
This is the third year in a row that the mitigation site is meeting all of its Year-10 vegetative performance standards and is developing into a functioning wetland. This site has high cover of woody species and few invasive species in both the wetland and upland areas. The native tree and shrub plant community is dominated by redosier dogwood (*Cornus sericea*), roses (*Rosa* spp.), and Sitka willow (*Salix sitchensis*). This community provides the intended wetland functions including habitat complexity, food chain support, opportunities for nesting and perching birds, and fruit, seed, and leaf litter production. Variations in topography result in small depressions. These areas create opportunity for the site to perform hydrologic and water quality functions (Photo 1).

Monitoring records from March and April 2010 indicate wetland hydrology was not present in all of the intended areas. The area that does not appear to be receiving sufficient hydrology is roughly in the center of the site, to the southwest of the access gate. A wetland delineation conducted on the 23rd of March 2010, found 0.47 acre of combined wetland establishment and enhancement. This meets the performance standard.

Photo 1 – Inundated topographical depression (March 2010)

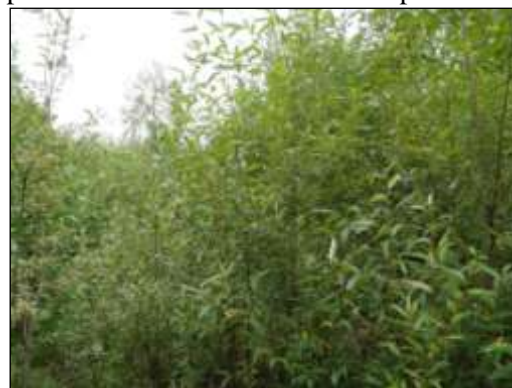
Cover of native FAC or wetter woody species in the forested wetland is visually estimated to be 75 percent and involves at least 11 species (Photo 2).

Photo 2 – Woody cover in the wetland (July 2010)
