SR 20: Quiet Cove to SR 20 Spur Safety Mitigation Site
SR 11: Chuckanut Park and Ride
WIN # A02027C

2010 MONITORING REPORT

Wetland Assessment and Monitoring Program

Issued March 2011

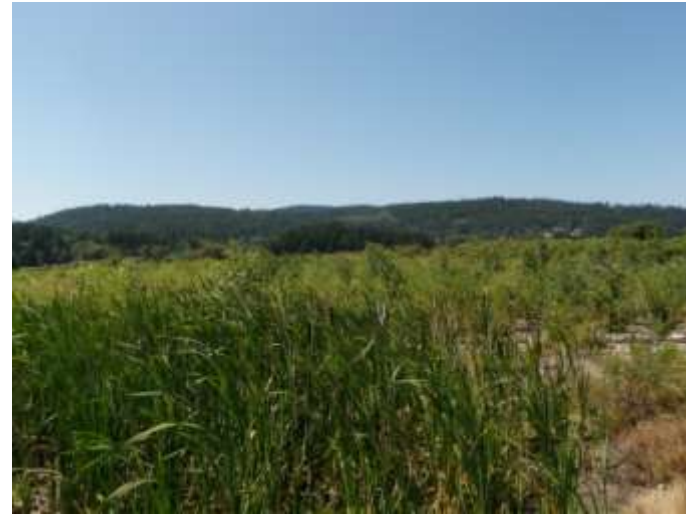
Photo 1
Woody cover in the scrub-shrub wetland (July 2010)

Survival of planted woody species is 91% survival ($CI_{80\%} = 89-94\%$) (Photo 1). The wetland woody species were replanted to 100 percent in the winter of 2009. The performance standard has been met. The site is on a trajectory to meet Year-3 density performance standards. There is moderate mortality of willow (*Salix* spp.) stakes around the three lobes of emergent plantings.

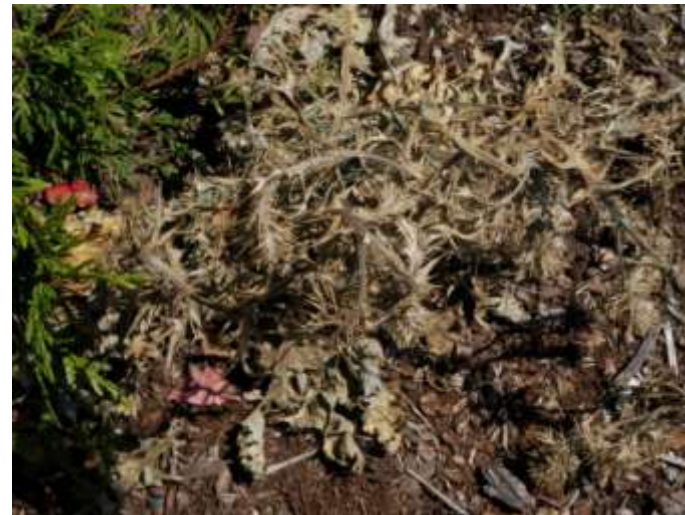
Photo 2
Treated Canada thistle (*Cirsium arvense*) (July 2010)

The cover of non-native invasive species across the entire mitigation site is estimated at five percent. The majority of cover is comprised of reed canarygrass (*Phalaris arundinacea*) and is primarily located in the buffer. Also present on site, but not included in coverage estimates, are Canada thistle (*Cirsium arvense*), and tansy ragwort (*Senecio*

jacobaea). Active weed management was observed on site (Photo 2 – next page).

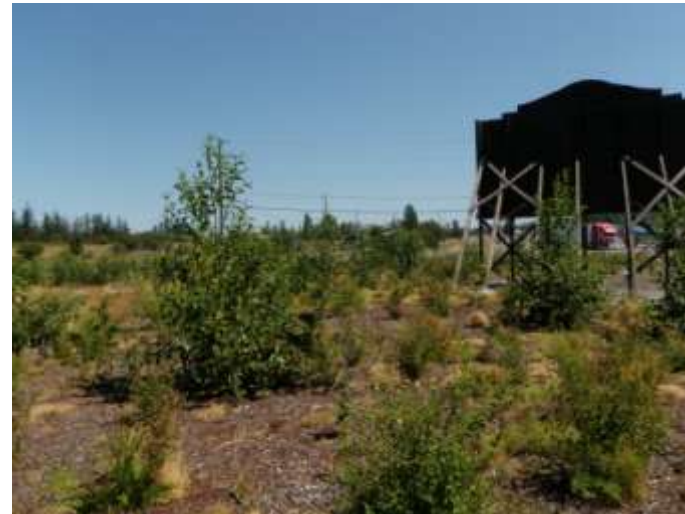
Photo 3
Woody cover in buffer (July 2010)

Survival of planted woody species is 93% survival (CI_{80%} = 92-95%) (Photo 3). Garden vetch (*Vicia sativa*) was observed growing in dense mats over a number of woody species in the buffer; its removal may benefit the establishment of plantings. The majority of the western serviceberry (*Amelanchier alnifolia*) on site exhibited signs of severe herbivory. The upland woody species were replanted to 100 percent in the winter of 2009. The performance standard has been met. The site is on a trajectory to meet Year-3 density performance standards.

Replacement plant material is scheduled to be installed in the mitigation site upland buffer during the 2011/2012 planting window. Weed control shall continue in 2011 as necessary.

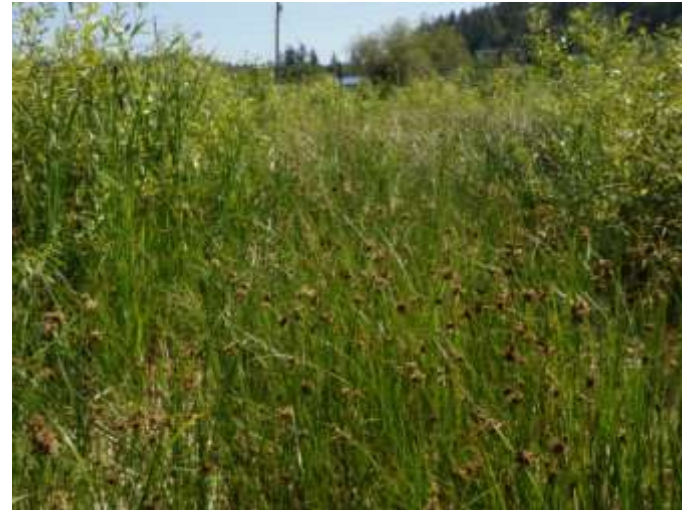
Photo 4
Emergent cover in finger-like depressions (July 2010)

The three emergent “fingers” are beginning to be colonized by Seacoast bulrush (*Schoenoplectus maritimus*) and there has been a considerable increase in cover (Photo 4 – p. 9).
