APPENDIX B
NACHES RIVER BASIN REGIONAL SETTING

NACHES RIVER BASIN REGIONAL SETTING

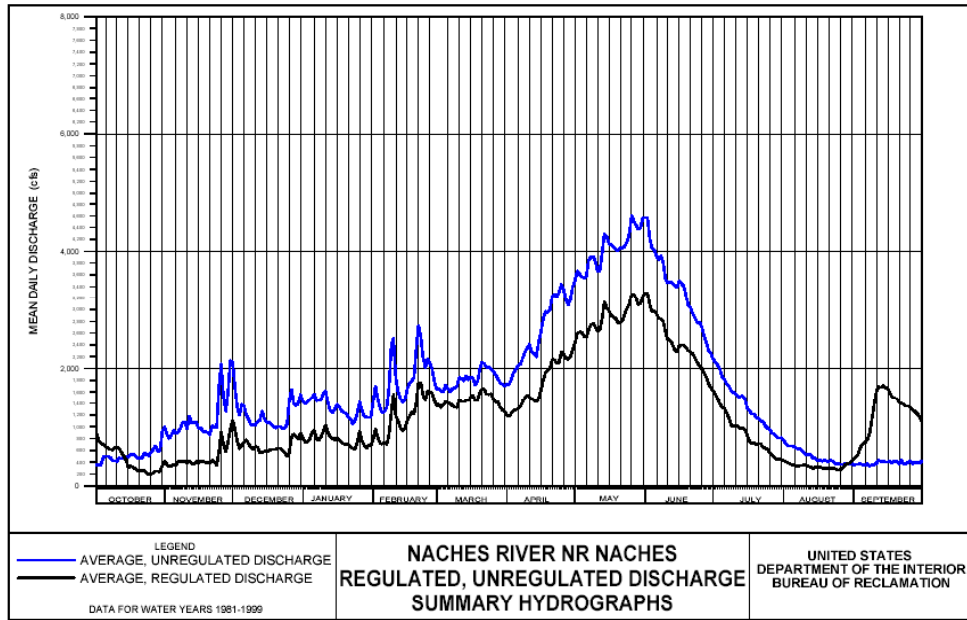
Figure C-1: Regulated and Unregulated Summary Hydrographs for the Naches River. Blue line represents average, unregulated hydrograph; black line represents average, regulated hydrograph. Adapted from the USBR DRAFT IOP, page 6-48 (USDI, 2002 DRAFT).

The flip-flop period occurs when unregulated flows would typically be at their annual low (see Figure C-1). Instead, Tieton River flows are up to five times higher than would occur naturally (USDI, 2002 DRAFT). Operation of Rimrock Dam during the flip-flop in early September increases releases from about 650 cfs to over 2,000 cfs. These releases then drop abruptly in mid-October, when the irrigation season ends. Daily mean winter releases from Rimrock Dam rarely exceed 250 cfs from the end of the flip-flop through mid-February. Even then, daily mean releases from the reservoir do not exceed 500 cfs until approximately the first week in May, when snowmelt runoff is beginning to increase and the reservoir is approaching capacity. Under pre-dam conditions flows reached a summer maximum (approximately 850 cfs) during late-June. Discharge then declines through the summer into fall.

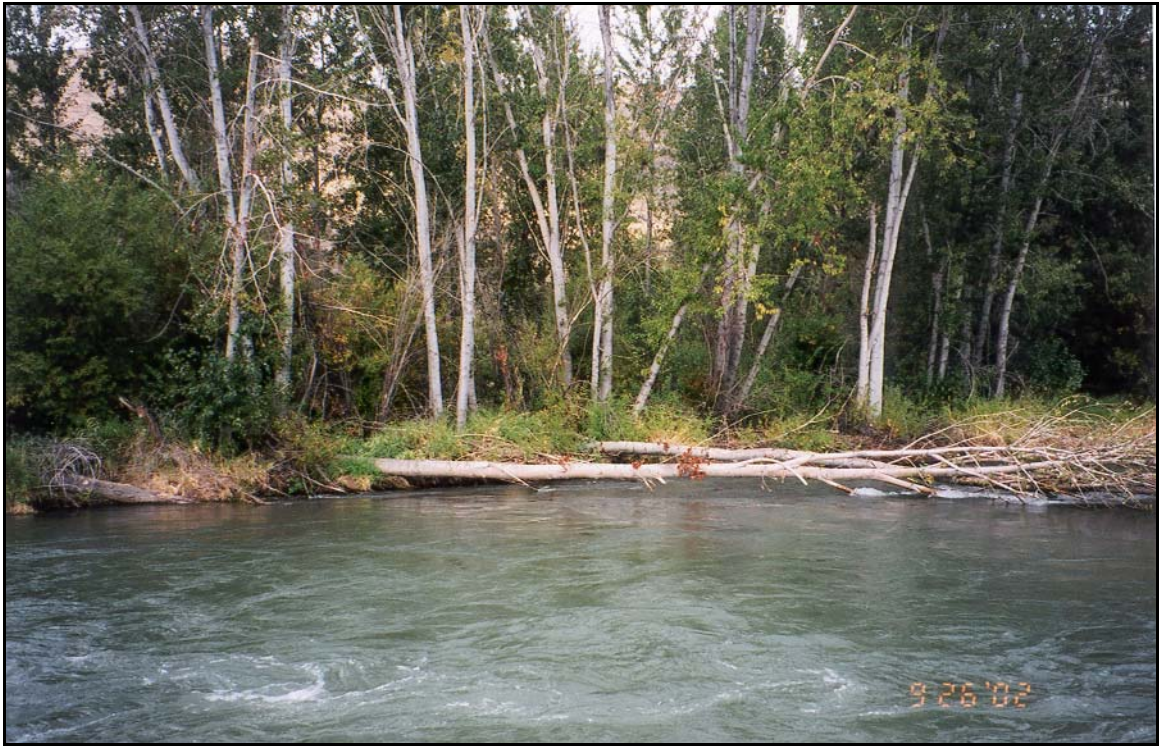
Figure E-2: Photograph of floodplain saturation of a cottonwood stand during flip-flop flow conditions and recently fallen trees at edge of bank.

From our field observations during the flip-flop and subsequently from cursory surveys within the forest in the study area, it appears that the trees along the Naches River are very susceptible to inundation during the growing season. During our observations we found few

viable cottonwood seedlings, and only small areas of emergent-sized trees (up to $\frac{3}{4}$ inch diameter). In addition, there were numerous dead mature-sized (18-30 inches diameter at breast height [dbh]) trees along the river. Our observations during the flip-flop (discharge approximately 2,000 cfs) indicate that the discharge increase inundates entirely or thoroughly saturates the roots of many trees directly adjacent to and nearby the edge of the active channel (Figure E-2). At some locations within the project area, the entire available floodplain was either inundated or saturated to a level above the root structure of the riparian vegetation.

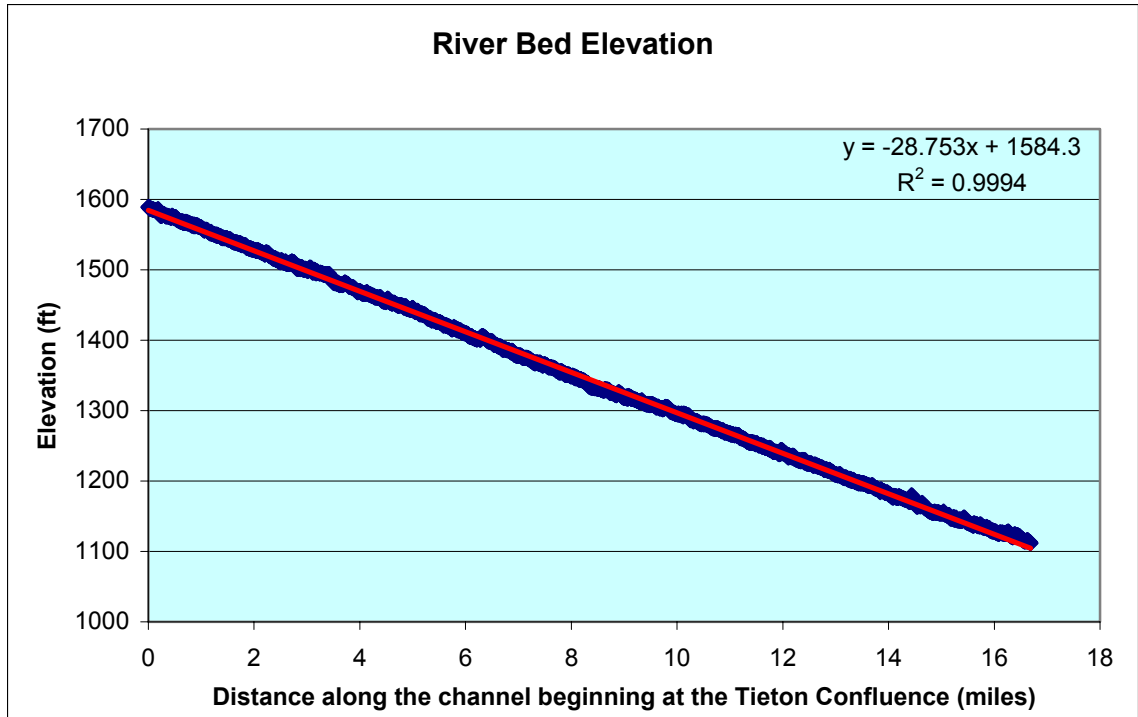
Figure H-1: Riverbed elevation for the Naches River running downstream from the Tieton River confluence.

The project reach is in the lower Naches Valley. While it is clear that headwater channels in the Naches are steeper than the project reach, LiDAR data available to us indicate that the gradient through the study reach is not appreciably less than the reach from the Naches Gap upstream to the confluence with the Tieton River (Figure H-1). The best-fit line and R^2 value displayed in Figure H-1 highlight that the elevation drop per mile from the confluence of the Tieton to the Yakima River is essentially equivalent. Based on the similarities in gradient and lack of tributary inputs, we surmise that sediment flux and thereby natural channel characteristics and processes in the project reach were similar to those of the reach from the Tieton River to the Naches Gap.

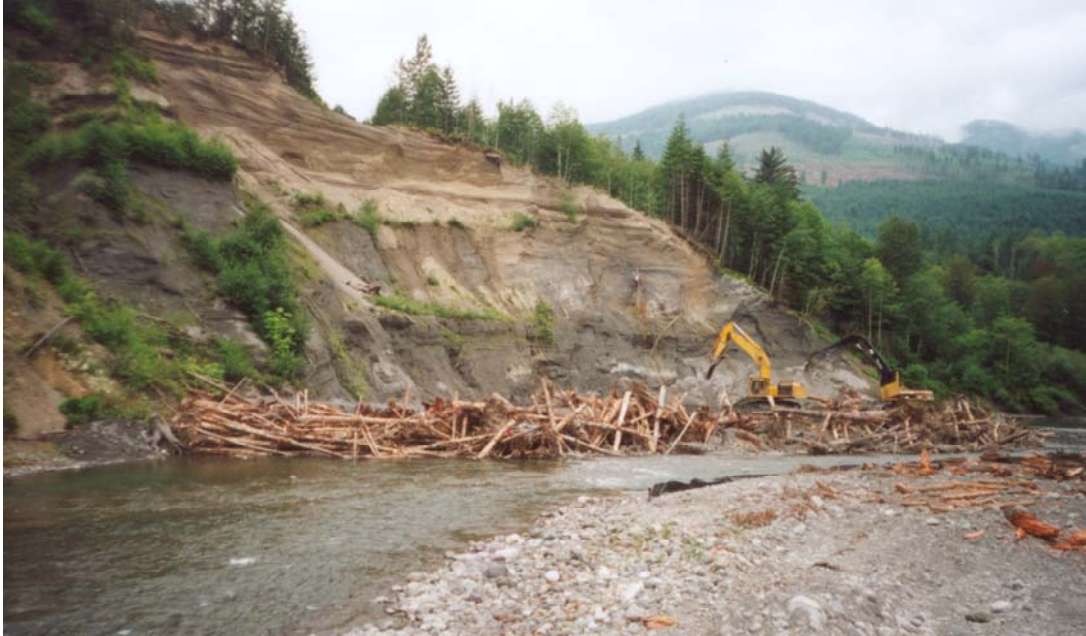
Figure I-5: LWD revetment constructed as part of the South Fork Nooksack, Larson’s Bridge Project, approximately RM 20.

Isolating the river from the roadway can also be accomplished using a revetment or cribwall constructed primarily with large woody debris. An example of this type of application is shown in Figure I-5.

This structure was constructed as part of the South Fork Nooksack, Larson’s Bridge Engineered Log Jam Project (GeoEngineers 2001). The objective of this structure was to isolate the river from the landslide to prevent toe erosion and provide an area for the slide to fail into and establish an angle of repose. Halting this failure will also protect a road located just off the top of the bluff. This type of structure is constructed by interlocking large trees together to form a stable configuration. The result of this approach is a more natural looking structure that creates instream habitat while providing protection of human infrastructure. Conceptual profile view is shown in Figure I-6.

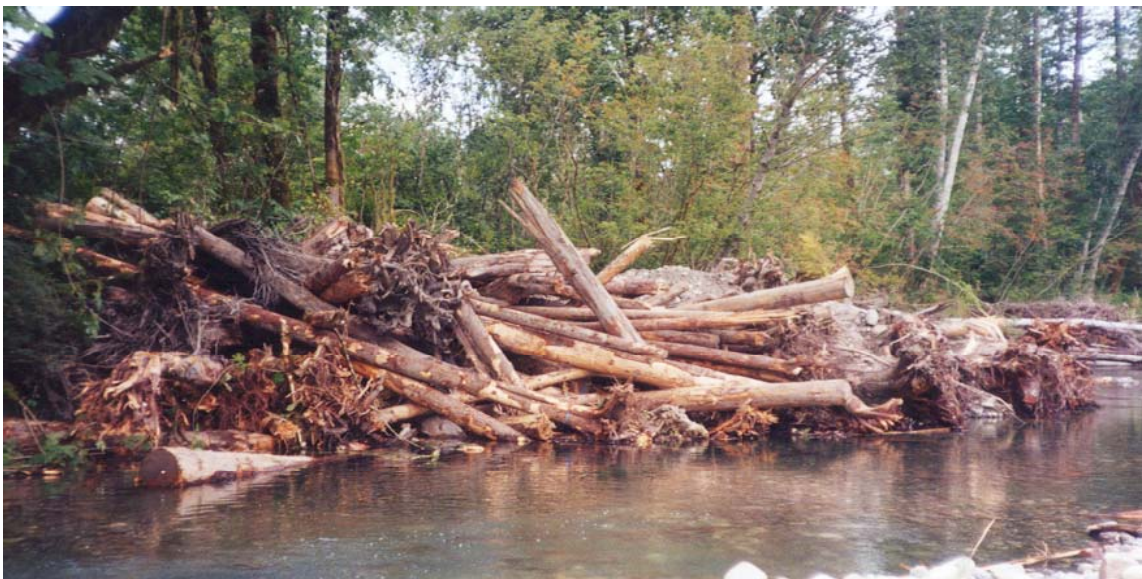
Figure I-7: ELJ constructed as part of the North Fork Stillaguamish, ELJ project.

Engineered Log Jams (ELJs) are instream hydraulic structures comprised primarily with LWD that can be used to solve common river engineering problems involving grade control, flow manipulation, and channel training (Figure I-7).

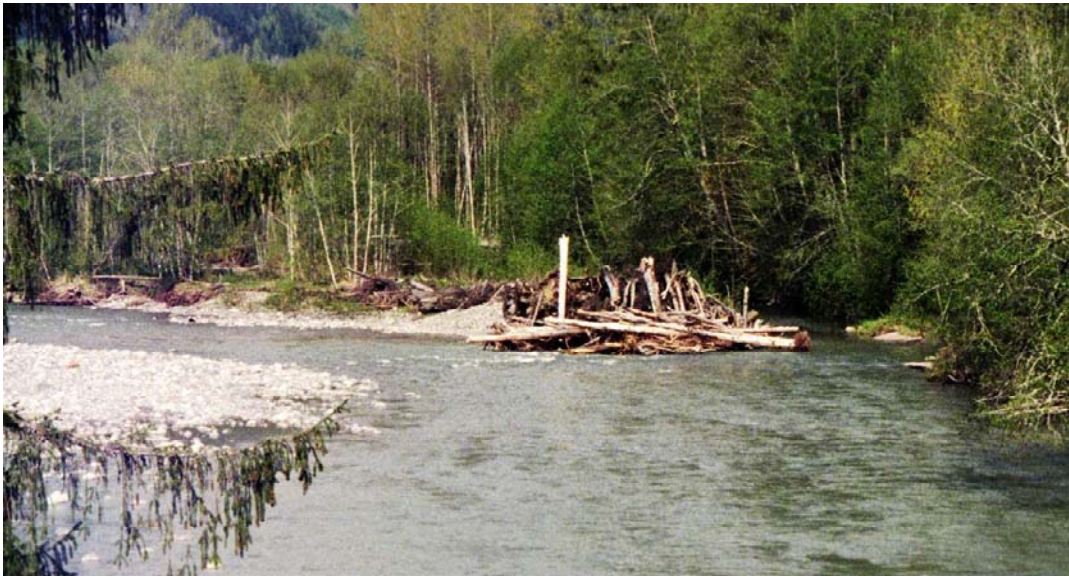
Figure I-9: ELJ constructed as part of the South Fork Nooksack, Larson’s Bridge Project.

Log Jams have been used primarily for the creation of fish habitat for pool creation and for the diversification of channel networks by splitting flows and creating secondary channels Figure I-9.
