**I-405/NE 8th St to SR 520 Braided Ramps (Sturtevant Creek)
Mitigation Site**

USACE NWP (14) NWS-2008-504

2014 MONITORING REPORT

Issued March 2015

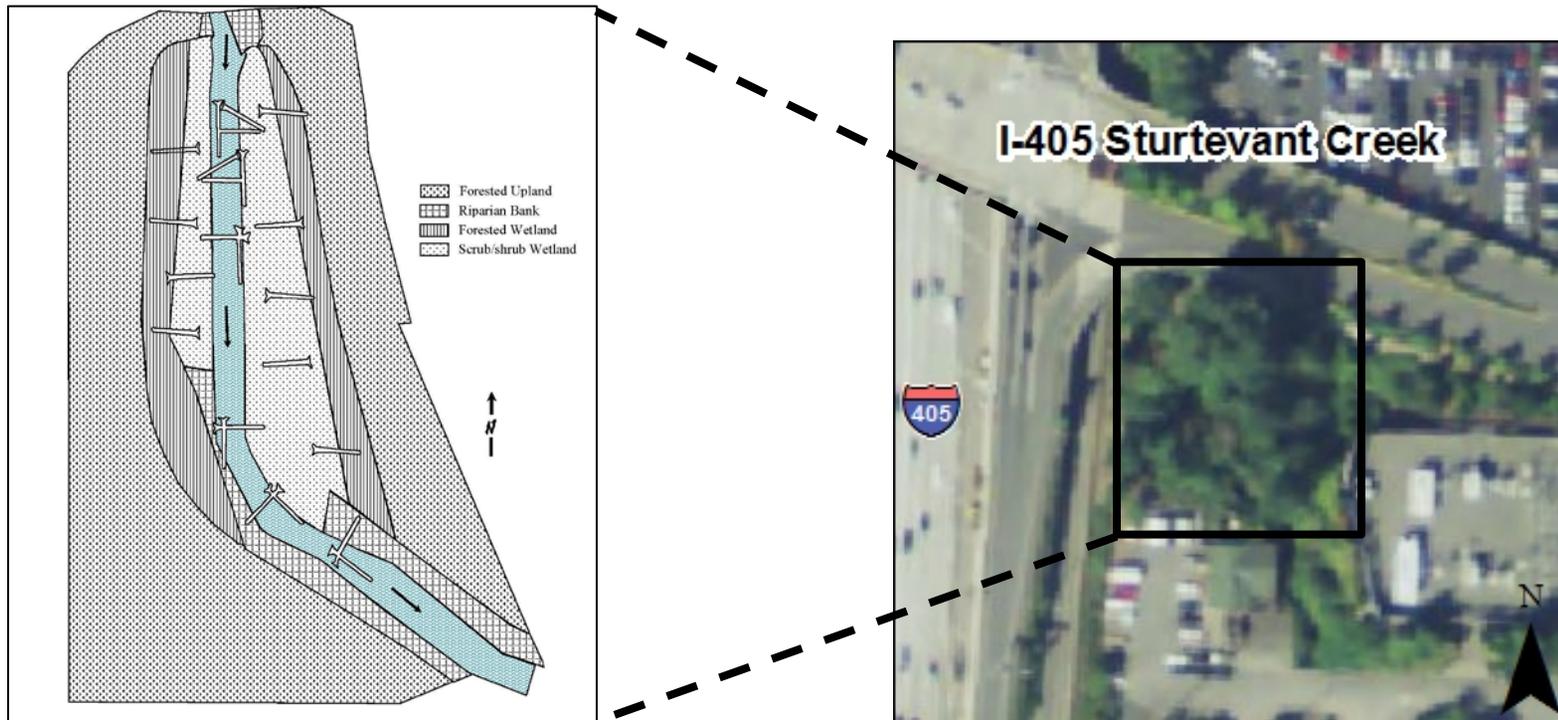
Figure 1 Site Sketch

This mitigation site (Figure 1) consists of 200 ft. of relocated stream channel and 0.34-acre of riparian buffer established adjacent to the exit 13B off ramp in downtown Bellevue. This site was created to compensate for the loss of 0.04-acre of stream channel and 0.15-acre of riparian buffer due to road improvements at the I-405 and SR 520 interchange. The addition of large woody debris structures and riparian plantings are designed to provide mitigation for lost stream functions including organic input, in-stream primary productivity, channel complexity and roughness.

The I-405 Sturtevant Creek (Bellevue Braids) Stream Mitigation Site contains enhanced forested and scrub-shrub wetland areas on both sides of Sturtevant Creek. Forested uplands flank the wetland areas. Appendix 1 includes site directions.

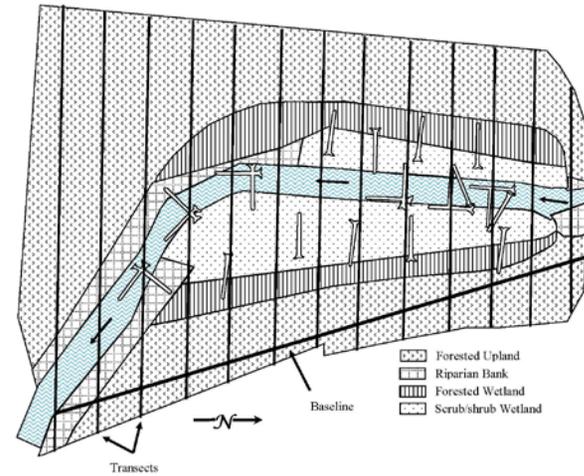
Figure 2 Site Sampling Design (2014)

To evaluate standards for vegetative cover, a baseline was established more or less parallel to the eastern site border (Figure 2). Ten sampling transects were randomly placed perpendicular to the baseline. The unequal belt transect method was used to determine woody density (Performance Standard 1). Ten one-meter wide belt transects were sampled. Invasive species cover was completed qualitatively with visual estimates (Performance Standard 2).

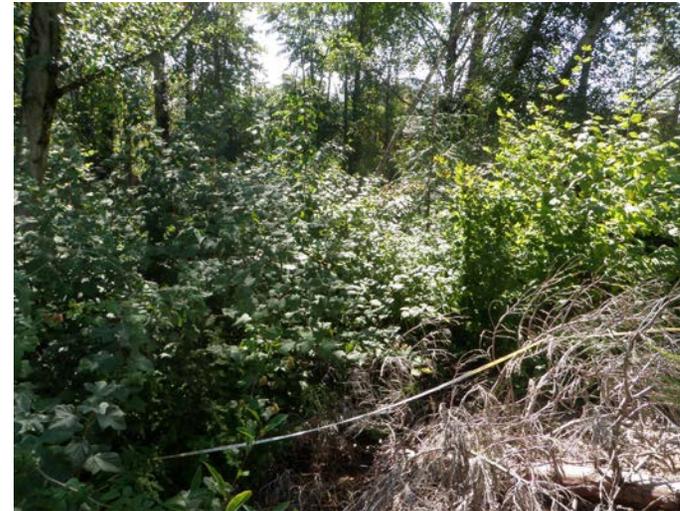
Photo 1
Woody density (August 2014)

The density of native woody species is estimated at 5.8 plants/100ft² (CI_{80%} = 5.3-6.2) (Photo 1). A diverse assemblage of species is present on site with over thirty separate species documented. Dominant species include western red cedar (*Thuja plicata*), Indian plum (*Oemleria cerasiformis*), and salmonberry (*Rubus spectabilis*).

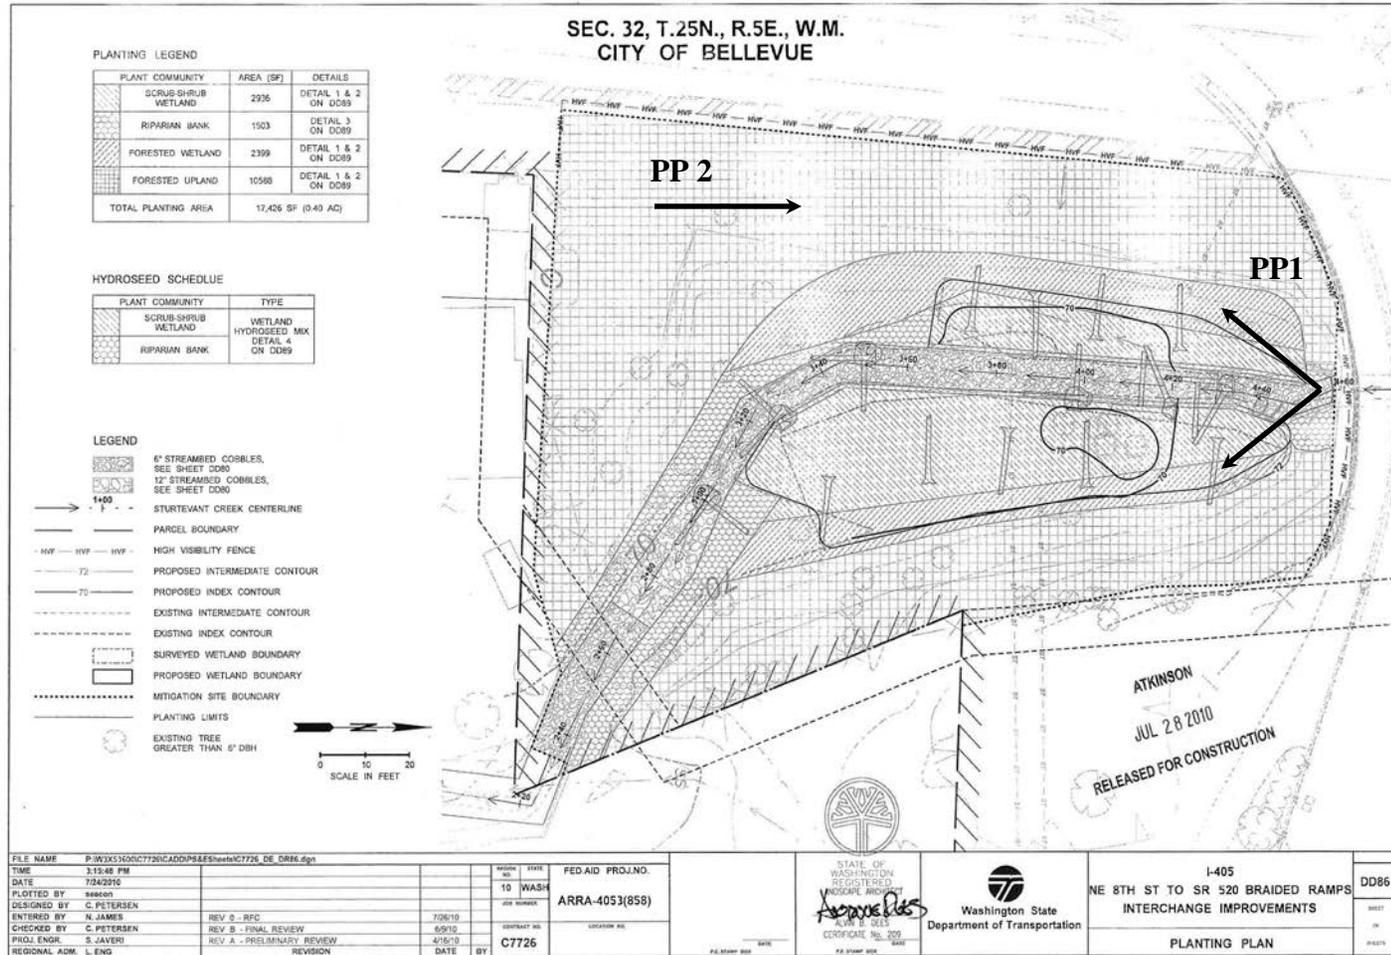
Appendix 1 – Planting Plan and Photopoint Map

Appendix 1 shows the planting plan (Small 2010).

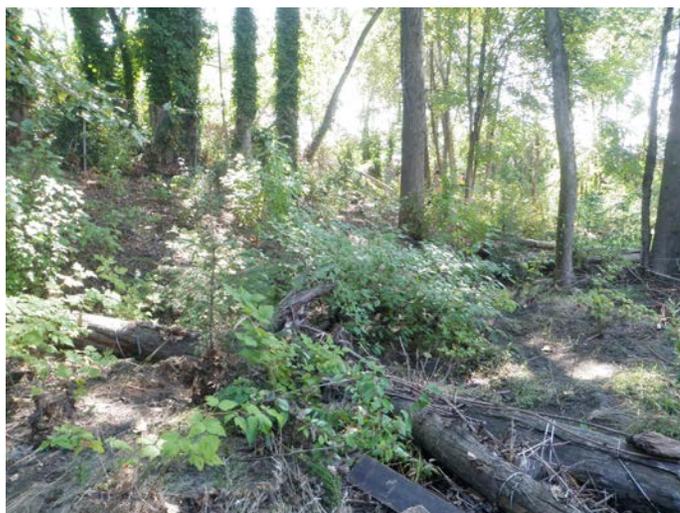
Photo Point 1a

The photographs below were taken from permanent photo-points on August 19, 2014 and document current site development.
