SR 167 North Sumner Interchange Wetland Mitigation Site

2010 MONITORING REPORT

Wetland Assessment and Monitoring Program

Issued March 2011

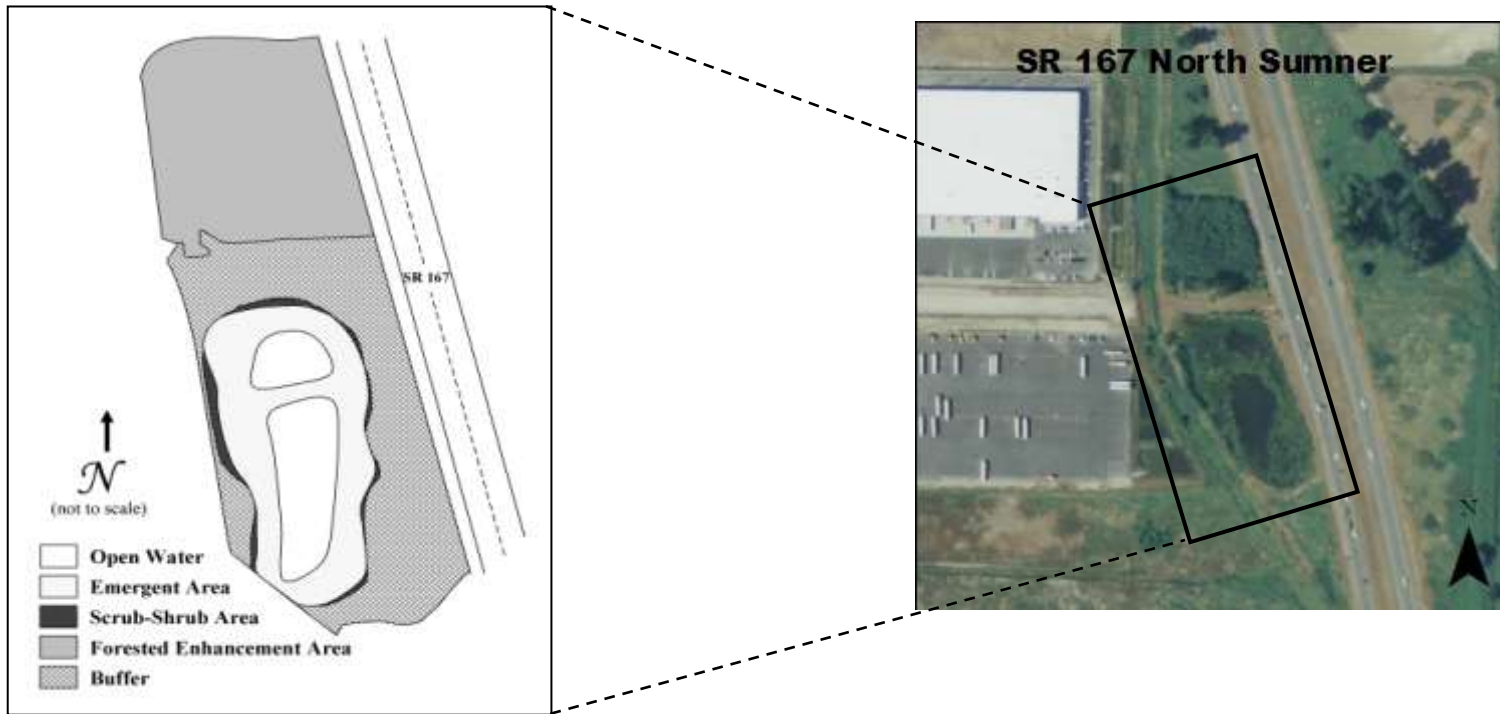
Figure 1 Site Sketch

The SR 167 North Sumner Mitigation Site consists of an established emergent wetland bordered by scrub-shrub wetland and buffer with a connection to Soaton Creek. An emergent wetland north of the established wetland was enhanced with native woody vegetation. A stream buffer was planted west of the wetland on both sides of Soaton Creek (not visible in sketch).

This 8.6-acre mitigation site (Figure 1) was created to compensate for the loss of 1.42 acres of Category II and III wetlands due to the construction of a new split diamond interchange and road expansions along SR 167. The site consists of wetland establishment (formerly called creation), wetland enhancement, riparian enhancement, and buffer. The site is designed to provide lost wetland functions including wildlife habitat, storm and floodwater storage, and water quality improvement.

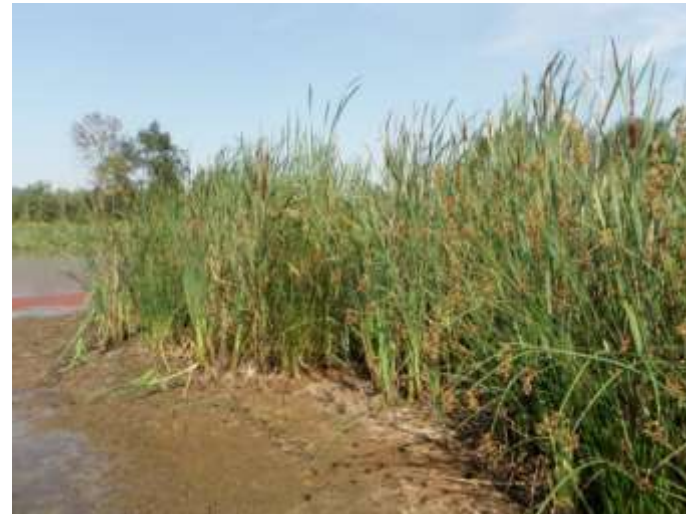
Photo 1 Herbaceous cover in the emergent wetland (August 2010)

Aerial cover of native herbaceous vegetation in the emergent wetland is qualitatively estimated to be 75 percent (Photo 1). This estimate is slightly less than the 80 percent target. Two species, broadleaf cattail (*Typha latifolia*), and soft-stem bulrush (*Schoenoplectus tabernaemontani*), each provide at least 10 percent cover. Broadleaf cattail is very dominant in this community and provides an estimated 55 percent aerial cover. Soft-stem bulrush is estimated to provide 10 percent aerial cover; soft rush (*Juncus effusus*) and woolgrass (*Scirpus cyperinus*) each provide five percent cover.

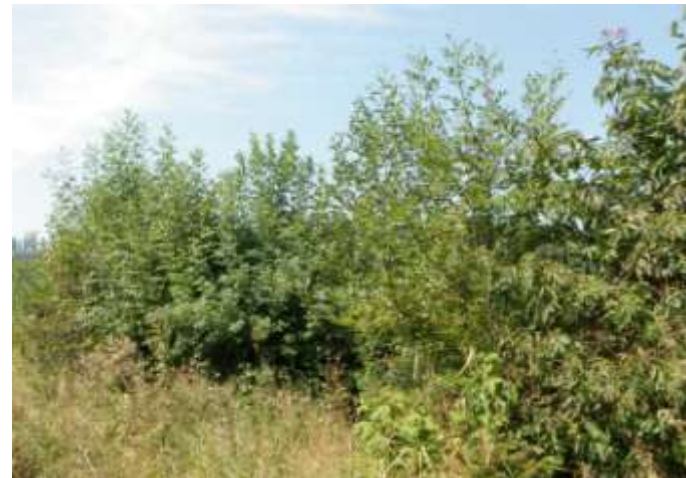
Photo 2 Woody cover in the scrub-shrub wetland (August 2010)

The aerial cover of native woody vegetation in the scrub-shrub wetland is 80% ($CI_{80\%} = 64-96\%$) (Photo 2), and 97% ($CI_{90\%} = 97-100\%$) in the enhanced forested wetland. Both of these mean values achieve the over-all cover target. In the scrub-shrub wetland, five tree species were estimated to provide greater than five percent cover, and two shrub species provide greater than ten percent cover. In the forested wetland, five trees were estimated to provide greater than five percent cover and two shrubs were estimated to provide greater than ten percent cover. See Tables 1 and 2 in Appendix 3 for detailed cover data.

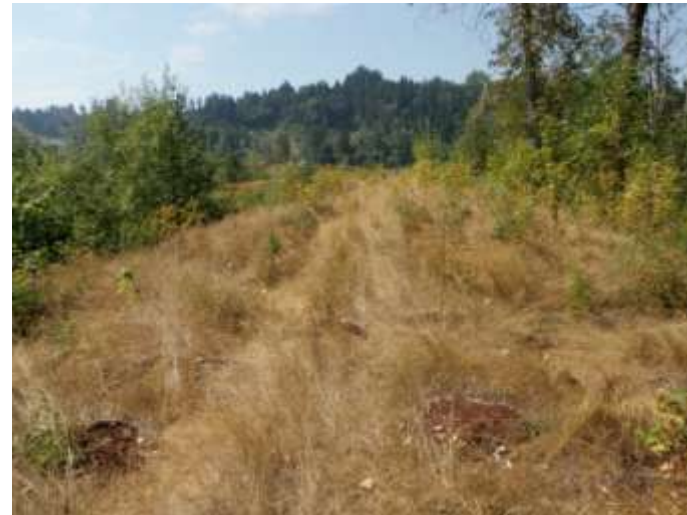
Photo 3
Woody cover in upland buffer (August 2010)

The aerial cover of native woody vegetation in the upland buffer is 37% (CI_{80%} = 28-45%). Generally, cover in the buffer is most lacking in the area between the upland buffer and scrub-shrub wetland (Photo 3). Native cover is greater in the southern area of the upland buffer. Dominant species present in the buffer include snowberry (*Symphoricarpos albus*), Douglas-fir (*Pseudotsuga menziesii*), and roses (*Rosa* spp.) approximately one to two meters in height. No species in the upland buffer provide greater than ten percent cover.

Site managers will continue with ongoing weed control and watering as needed. The buffer area around the pond and the riparian area have been recently replanted and mulch rings have been installed around the new buffer plantings. The riparian area has recently been replanted.

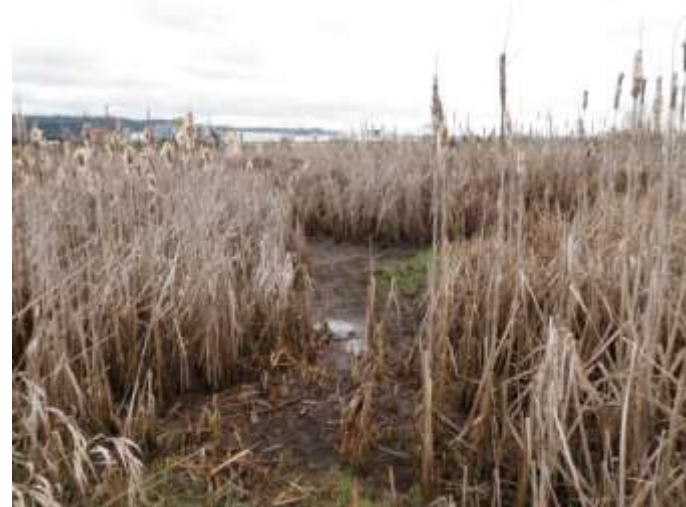
Photo 4
Inundation in the emergent wetland (March 2010)

Monitoring records from February and March 2010 indicate wetland hydrology is present in all intended areas (See results in Appendix 3, Table 3). Surface saturation or inundation (Photo 4) was observed across the entire wetland establishment area during all hydrology monitoring visits.
