RE: SR 539 Widening Project: Horton Road to Tenmile Road (MP 1.64 to MP 6.26) (Larson Road)
 Mitigation Site
 WDFW HPA Permit **104032-2**

The Washington State Department of Transportation completed monitoring of the site on July 19th 2010 to determine survival of planted species for compliance with the above-listed HPA.

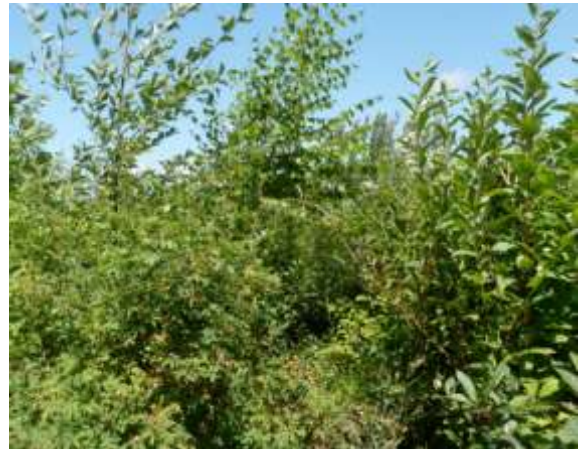
Photo 1
Woody cover in the stream buffer
(July 2010)

Based on the total count completed by the region, survival of the planted woody species across the site is 96 percent (Photo

1). The dominant species observed in the buffer include red alder (*Alnus rubra*), salmonberry (*Rubus spectabilis*), and black

cottonwood (*Populus balsamifera* ssp. *Trichocarpa*) and in the wetland include redosier dogwood (*Cornus sericea*), willows (*Salix* spp.), salmonberry (*Rubus spectabilis*), and twinberry honeysuckle (*Lonicera involucrata*). Overall, the planted native species are robust and thriving (Photo 2).

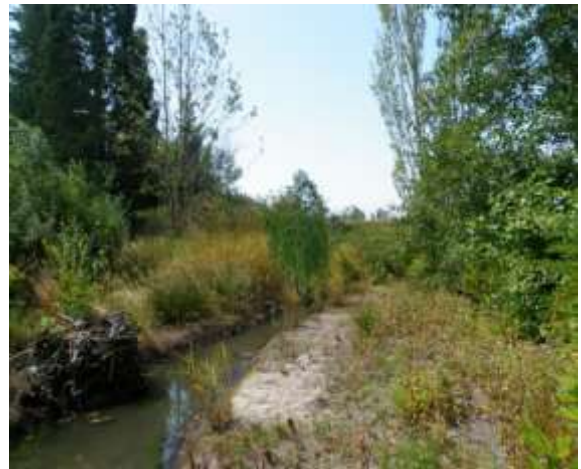
Photo 2
Stream Channel (July 2010)

The riparian zone has a continuously thick growth of willows (*Salix* spp.) along each bank of the stream. The banks are relatively steep, however, with the installation of the erosion control fabric and live stakes, the stream banks have remained stable. An additional 1,211 redosier dogwood (*Cornus sericea*) and willow (*Salix* spp.) live stakes were planted along the creek in November, 2010. The stream channels were shallowly inundated at the time of summer vegetation monitoring (Photo 2). The stream channels meander, slowing water and providing storage for flood flow.
