Washington State Department of Transportation North Fork Newaukum Mitigation Bank

2010 MONITORING REPORT

Wetland Assessment and Monitoring Program

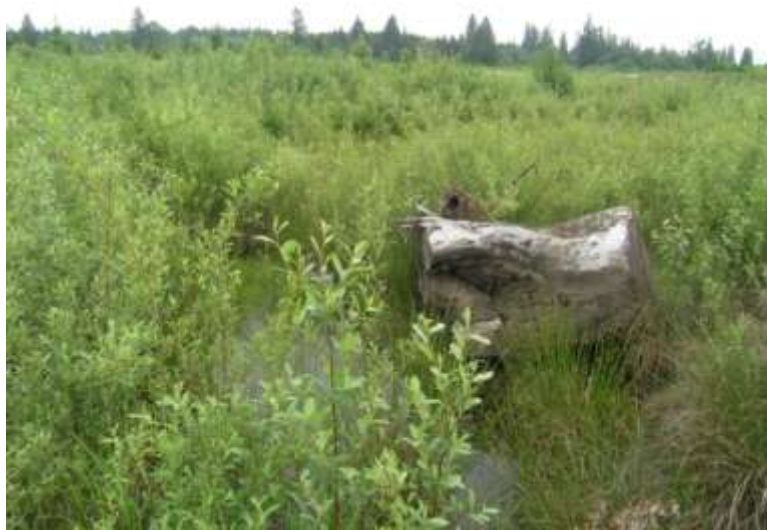
Pond C2 in 2008

Ponds dominated by willows (*Salix* sp.) significantly increased in cover over past two years (2008 -2010).

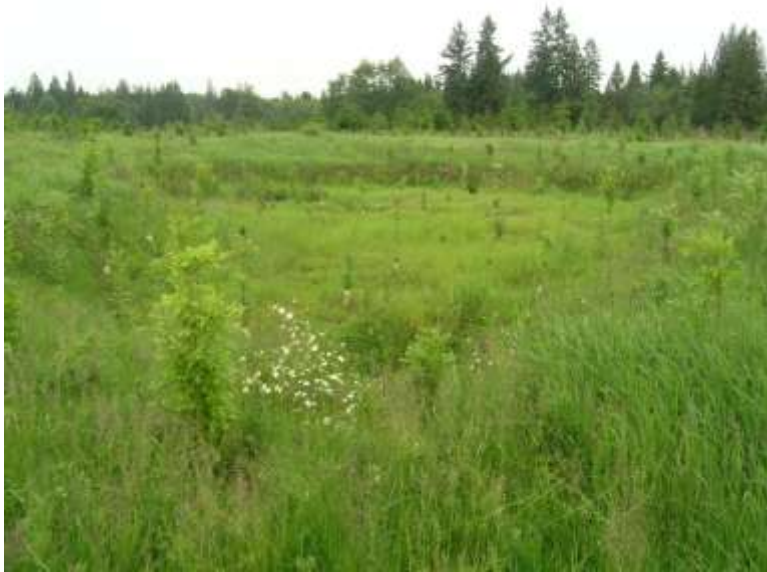
Pond C3 in 2008

Ponds dominated by Oregon ash (*Fraxinus latifolia*) and sub-dominated by quaking aspen (*Populus tremuloides*) seemed to remain similar in cover.

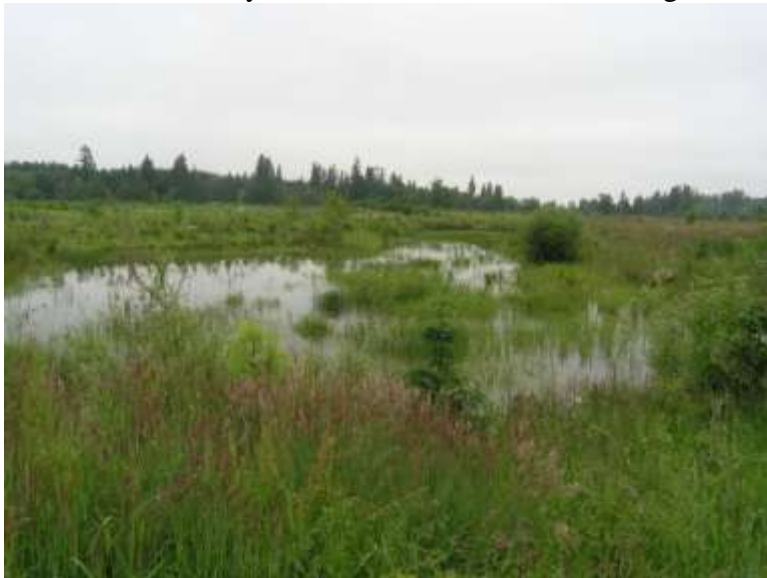
Pond C1 in 2008

Ponds dominated by herbaceous FAC and wetter vegetation had relatively high cover in 2008 and remain in a similar state.
