SR 20 Fredonia to I-5 Mitigation Site
USACE NWS-98-2005-1406-SOD WIN # A02039B

(SR 20 Fredonia Stage 1 Mitigation Site)

2010 MONITORING REPORT

Wetland Assessment and Monitoring Program

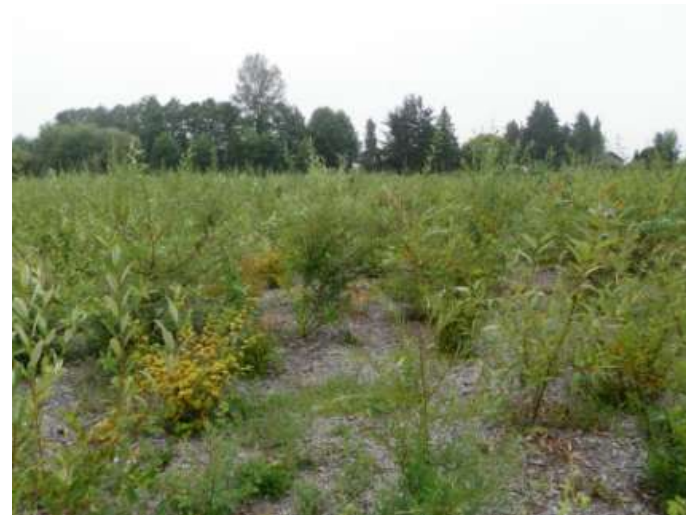
The survival of woody species in the wetland is 88% ($CI_{80\%} = 85-91\%$ s). The wetland is dominated by willows (sandbar willow (*Salix exigua*), Pacific willow (*Salix lucida* ssp. *lasiandra*), and Sitka willow (*Salix sitchensis*)) (Photo 1). The wetland woody species were replanted to 100 percent in the winter of 2009. The performance standard has been met. The site is on a trajectory to meet Year-3 density performance standards.

Photo 1
Woody survival in the wetland (July 2010)

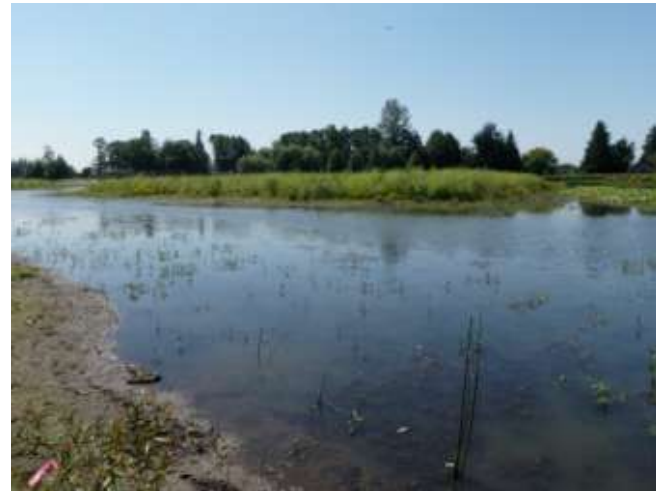
Cover of native FAC or wetter herbaceous vegetation in the emergent/aquatic areas together was visually estimated at less than five percent (Photo 2). This is well below the performance standard of 40 percent. The majority of this area was intended as aquatic bed and planted with Rocky Mountain pond-lily (*Nuphar lutea* ssp. *polysepala*). Only a few individual pond-lilies were observed despite an original planting number (from the as-built) of 1,961. The intended emergent area was sampled for cover and the preliminary data indicate about 35 percent cover in this area. However, few of the plantings seem to have survived in this zone either. The majority of the cover in this zone is from volunteer two-headed water-starwort (on the wetter side of this zone), and Idaho bentgrass (*Agrostis idahoensis*) (on the drier side of this zone). Overall, including the aquatic bed and the emergent zones the cover was qualitatively estimated at less than five percent. Gauges slough is an overwintering site for mallards and pintails which number in the thousands. There is a resident population of Canadian Geese as well. Any new plantings will be grazed by waterfowl and the use of goose excluder netting is not recommend at this site. Future management activities are under evaluation. We do expect natural recruitment of emergent vegetation to take place.

Photo 2
Aquatic bed cover in channel (July 2010)

Ongoing weed control is planned through the 2011 growing season. New emergent vegetation plantings are a concern which will need to be addressed but planting is not recommended at this time due to waterfowl grazing. Future management activities are under evaluation.

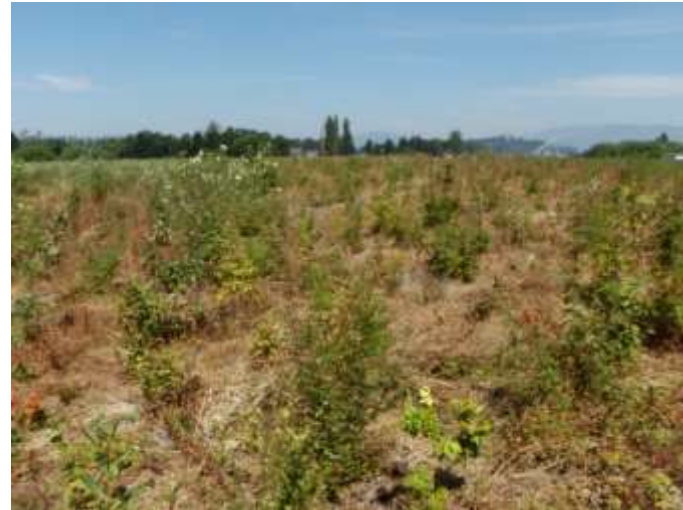
Data indicate a survival rate of 83% ($CI_{80\%} = 78-87\%$ survival) (Photo 3). Dominant species include Nootka rose (*Rosa nutkana*), snowberry (*Symphoricarpos albus*), and tall oregongrape (*Mahonia aquifolium*). The upland woody species were replanted to 100 percent in the winter of 2009. The performance standard has been met. The site is on a trajectory to meet Year-3 density performance standards.

Photo 3
Woody survival in the buffer (July 2010)

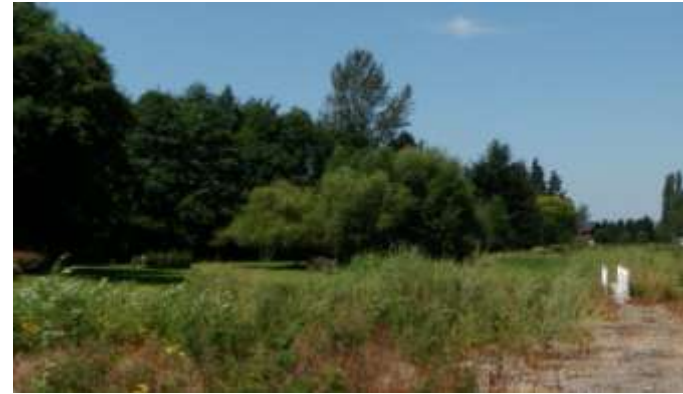
Data indicate 95% (CI_{80%} = 93-97% survival) in the riparian planting areas (Photo 4). This satisfies the permit requirement. Dominant species include willows (*Salix* spp.), red alder (*Alnus rubra*), and redosier dogwood (*Cornus sericea*).

Photo 4
Woody survival in the riparian planting area (July 2010)
