I-5/SR 502 Interchange Mitigation Site

2010 MONITORING REPORT

Wetland Assessment and Monitoring Program

Issued March 2011

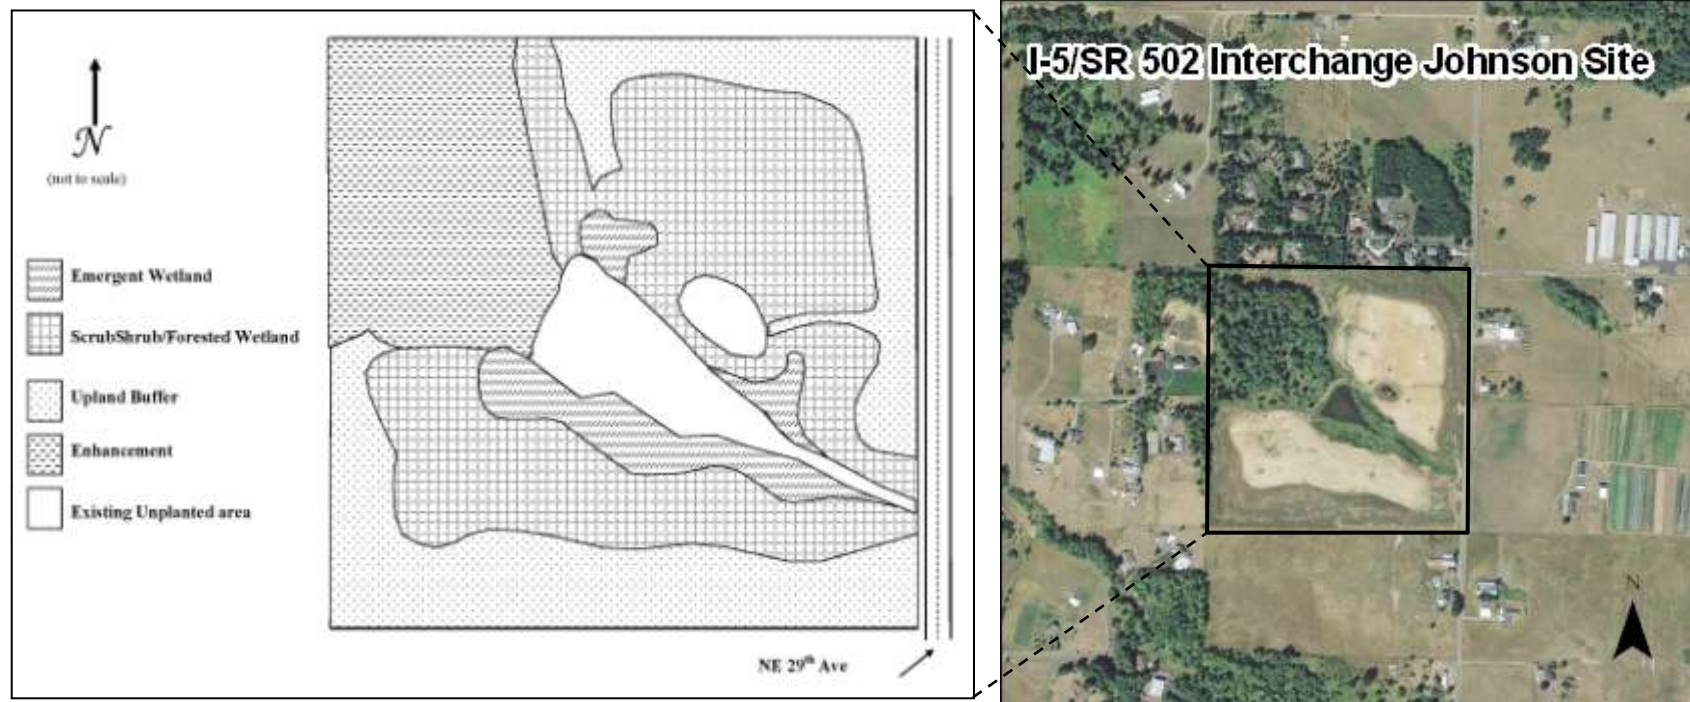
Figure 1 Johnson Site Sketch

This 39.8-acre mitigation site (Figure 1) consists of establishment, enhancement, and preservation areas. This site was created to compensate for the loss of 6.42 acres of wetlands due to the construction of new Interstate (I) 5 on and off ramps and a bridge that spans I-5 to connect to SR 502. This large and diverse mitigation site is designed to provide a variety of functions including wildlife habitat, water quality improvement, nutrient and sediment retention, groundwater recharge, base flow contributions to Gee Creek, and flood flow attenuation.

The Johnson Mitigation Site contains an existing pond surrounded by a mosaic of emergent, scrub-shrub, and forested wetland communities. The existing forested area in the northwestern corner of the site is underplanted with western red cedar. Appendix 4 includes a vicinity map and description of the Gee Creek riparian mitigation area.

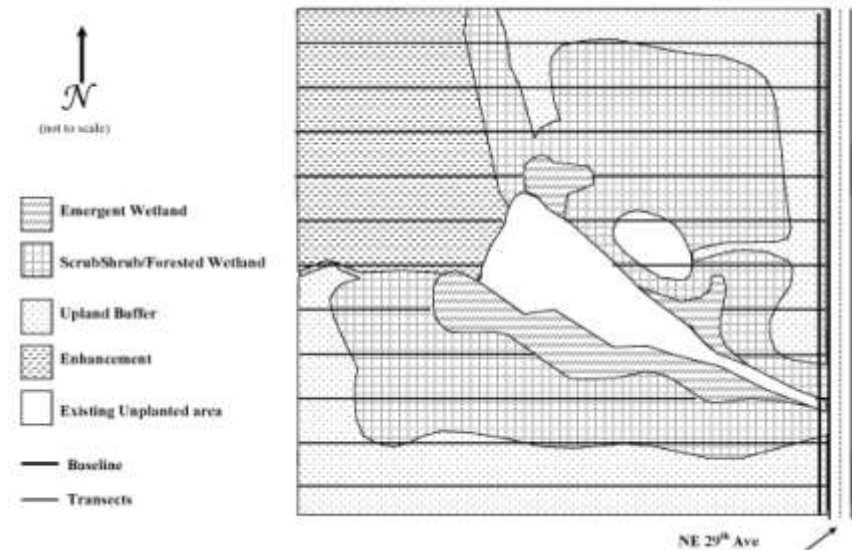
Figure 2 Johnson Site Sampling Design (2010)

The unequal-area belt transect method was used to evaluate standards for vegetative survival at the Johnson site and at the Gee Creek riparian site (Performance Standards 2 and 3). At the Johnson site, a baseline was established parallel to NE 29th Ave (Figure 2). Twenty-five transects were randomly placed perpendicular to the baseline. One-meter wide belt transects were positioned along the length of each transect. For the Gee Creek Riparian area, a segmented baseline was established parallel to the south and northbound lanes of Interstate 5 (Figure 3). Twenty-five transects were randomly placed perpendicular to the baseline. Two-meter wide belt transects were positioned along the length of each transect.

At the Johnson site, to assess vegetation standards, a 400-meter baseline was established parallel to NE 29th Ave on the east side of the site. Twenty-five temporary sampling transects were placed perpendicular to the baseline using a systematic random sampling method (Figure 2). Survival of woody species in the buffer, and scrub-shrub and forested wetland zones (Performance Standard 2) was assessed using the unequal belt transect method. Twenty-five one-meter wide unequal sample units were placed along the sampling transects.

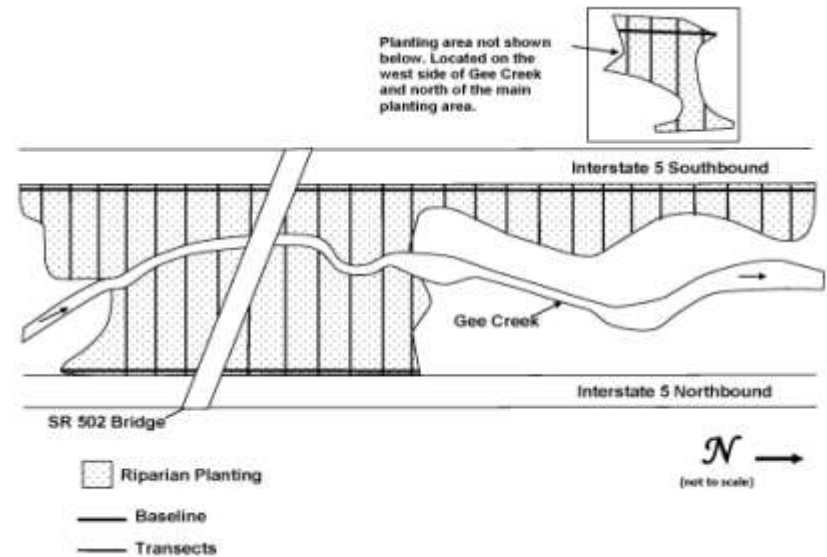
Figure 3 Gee Creek Site Sampling Design (2010)

At the Gee Creek riparian area, to assess vegetation standards, a 761-meter baseline was established in three segments parallel to Interstate 5 north and south bound lanes on each side of the creek. Twenty-five temporary sampling transects were placed perpendicular to the baseline using a systematic random sampling method (Figure 3). Survival of woody species in the riparian planting zones (Performance Standard 3) was assessed using the unequal belt transect method. Twenty-five two-meter wide unequal sample units were placed along the sampling transects.

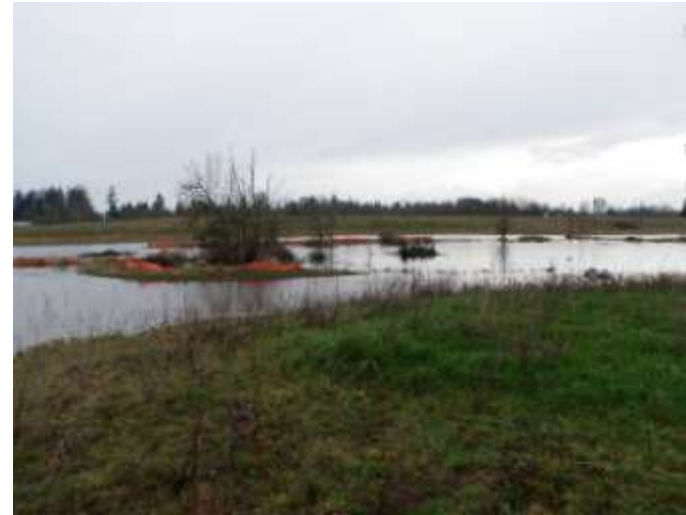
The growing season as defined in the Soil Survey of Clark County, WA (USDA, 1972) is from April 1st to November 4th, 217 days, ten percent of which is 21.7 days. The months of March and April, 2010 were within the 30 year average range for rainfall (See Appendix 3, Table 2). The second and third monitoring visits, March 11, 2010 and April 5, 2010 are 28 days apart and demonstrated inundation or saturation in the top 12 inches of the soil. The visit in March is not within the growing season range specified by the Soil Survey. However, the observations made at the time of monitoring indicate hydrology is present on site. The soils observed on site are fine and clayey and are slightly compacted due to the site's recent construction (2008) (see results in Appendix 3, Table 1). This could possibly be the cause of some of the varied results observed at the time of monitoring including surface inundation (Photo 1).

Photo 1 Surface water (March 2010)

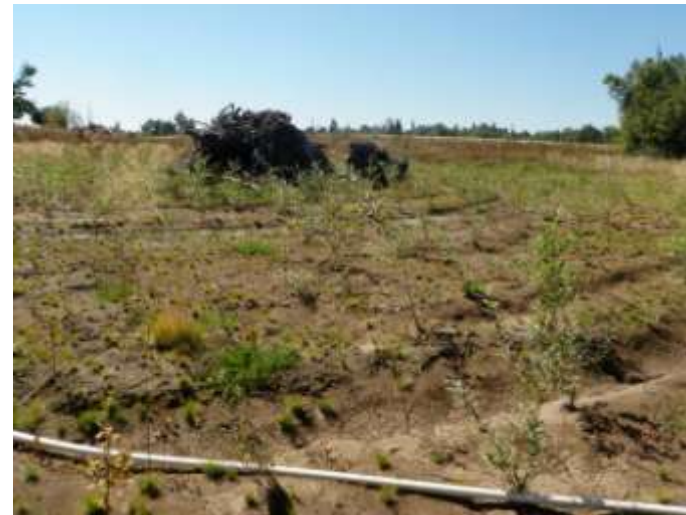
The survival of planted woody species in the forested, scrub-shrub, and buffer areas is 89% (CI_{80%} = 87-91%). This is just under the value required for the standard but; the confidence interval includes values above the standard. The buffer zone appeared more stressed than other areas on site. This could possibly be attributed to previous issues with irrigation in the buffer as well as competition from grasses. The scrub-shrub and forested zones appear to have higher survival in most areas (Photo 2). Plant height across the site ranges from 0.5

Photo 2 Woody cover in the scrub-shrub wetland (August 2010)

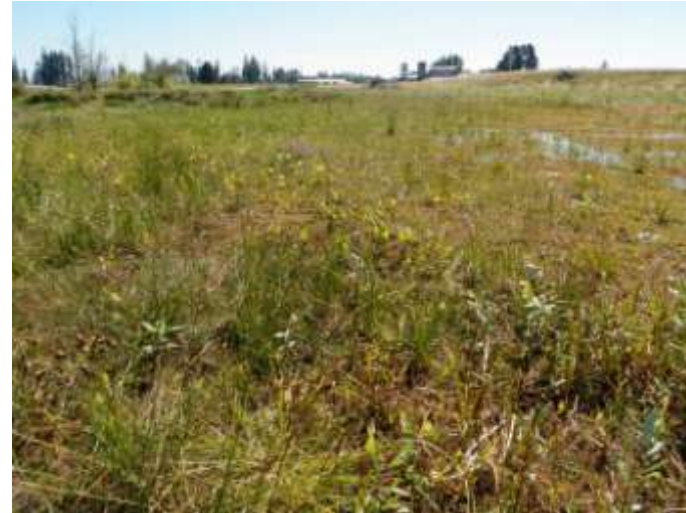
The emergent zone was addressed qualitatively with cover estimates for each planting area labeled on the planting plan. Overall, approximately half of the planting areas are thriving (Photo 3). The results are listed in a table located in Appendix 3, Table 3.

Photo 3 Herbaceous cover in the emergent zone (August 2010)

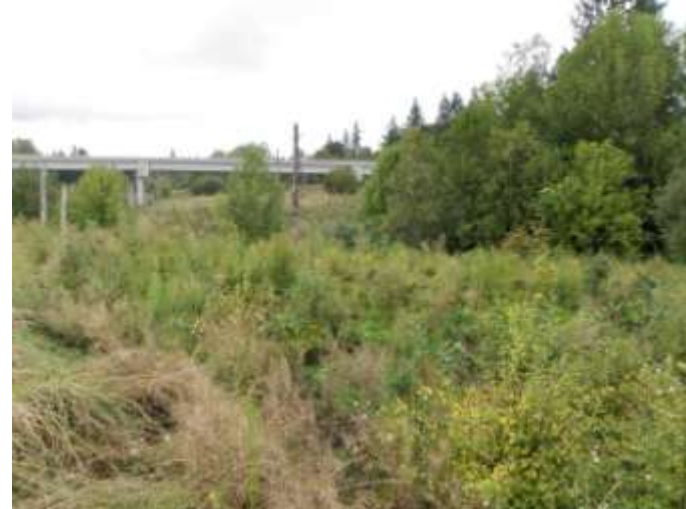
Survival in the riparian area is 96% ($CI_{80\%} = 96-97\%$). Most species planted in mulched area have high survival (Photo 4). The northwestern corner of the site appears to have the highest mortality. Dominant species in this area include western serviceberry (*Amelanchier alnifolia*) and snowberry (*Symphoricarpos albus*). Sub-dominants include western red cedar (*Thuja plicata*), tall oregongrape (*Mahonia aquifolium*), and Oregon white oak (*Quercus garryana*).

Photo 4 Woody cover in Gee Creek riparian area (September 2010)
