**Site and Reach Assessment
Yakima River at SR 224 (Van Giesen Road)**

Work Order MT0100

WSDOT Environmental Services

Site and Reach Assessment, Yakima River at SR 224, Van Giesen Road

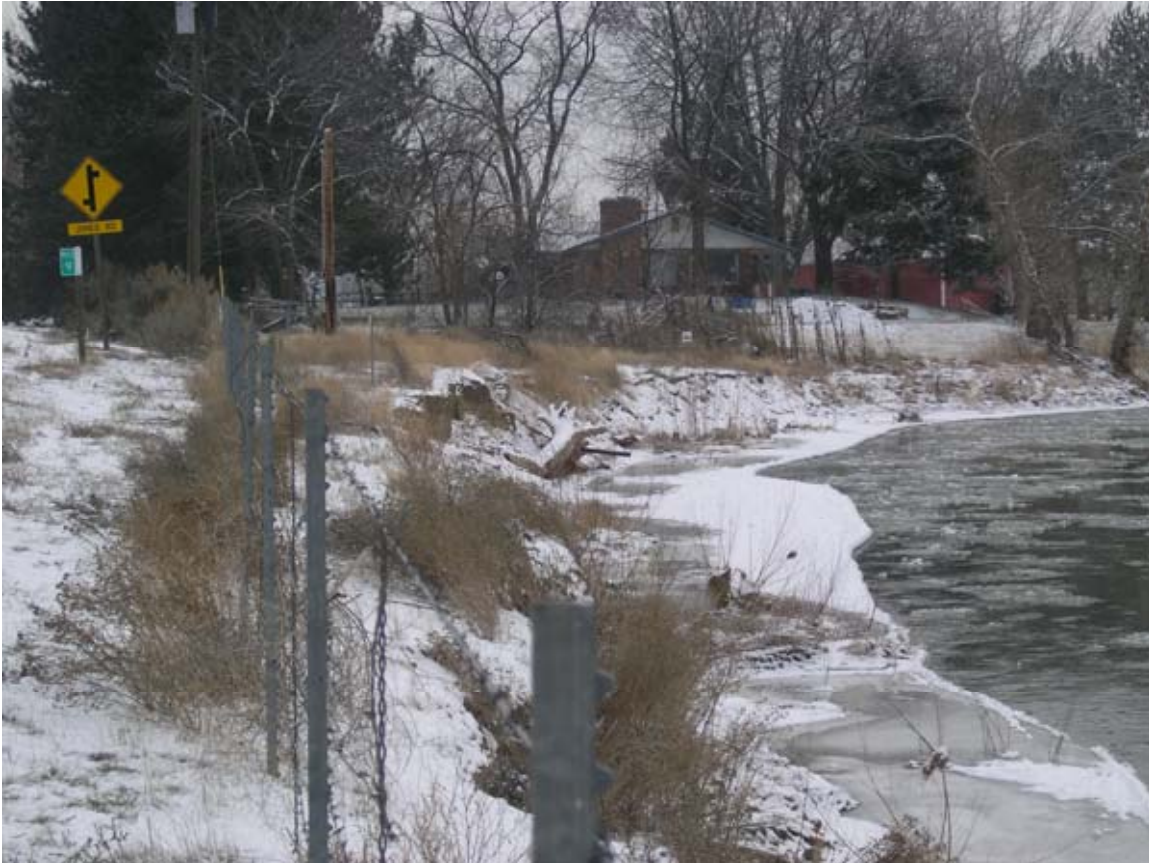
Figure 1. Left bank erosion on the Yakima River at SR 224/Van Giesen Road.

The problem is concentrated on the left bank of the Yakima River near Milepost 9 on SR 224 in West Richland, Benton County Washington. The Yakima River at the project reach has a gradient of 0.1 percent and has a meandering planiform with a tortuosity of 1.8. The reach is an alluvial floodplain; however, the right bank is protected by a certified Army Corps of Engineers (COE) levee that diverts the river's thalweg to the left bank, where SR 224 is located.

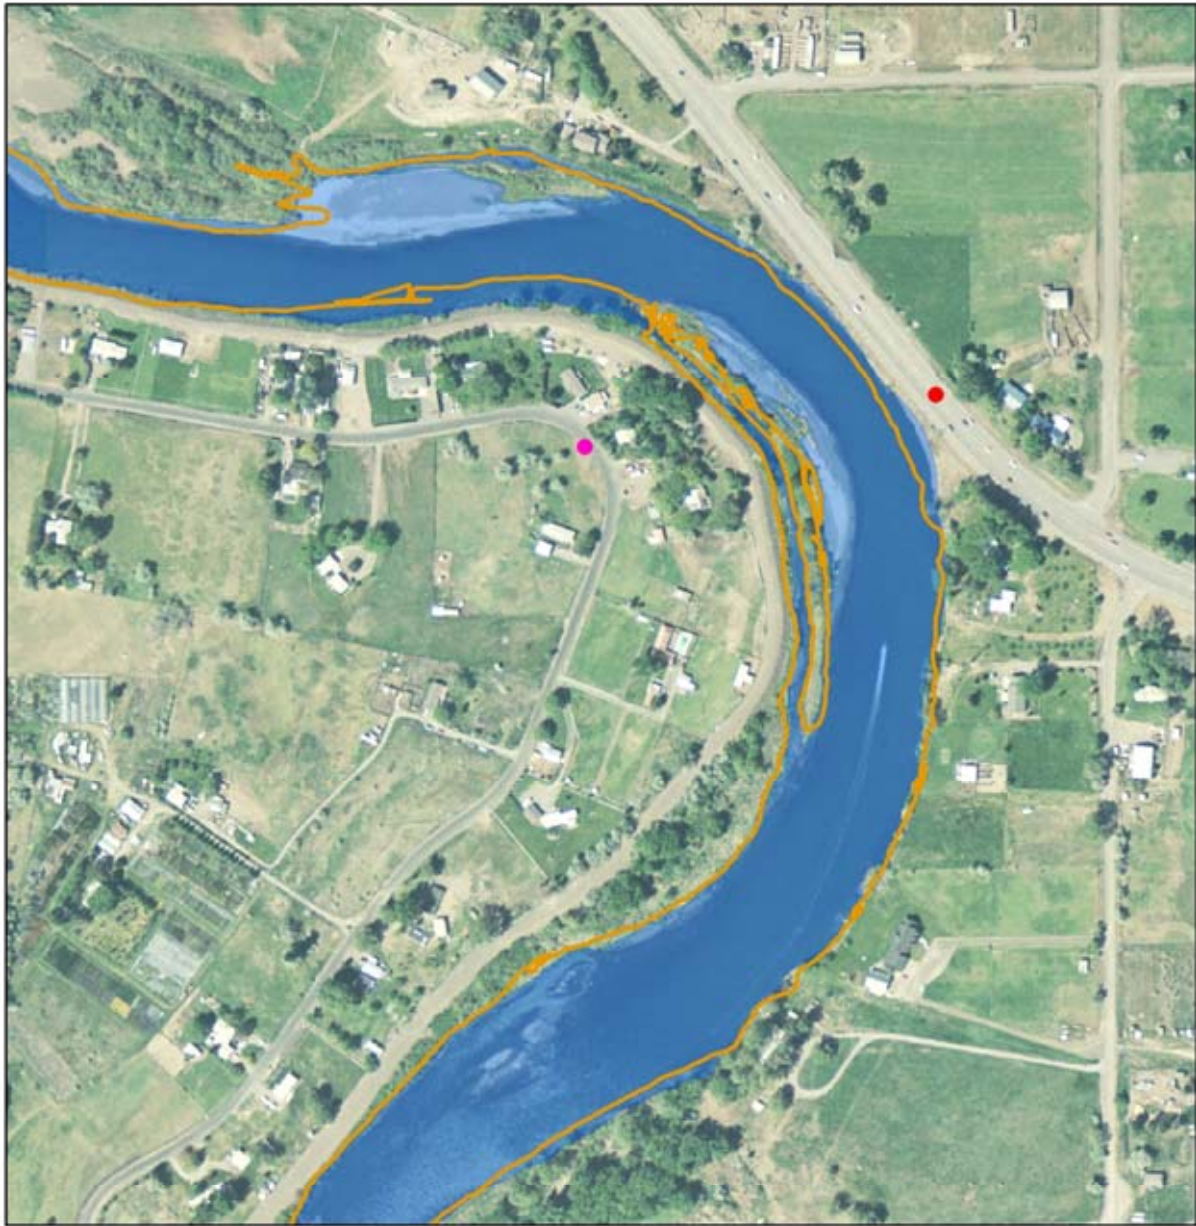
Figure 5. Yakima River Migration.

The dominant landforms in the project reach have been defined by three major geologic events, the Miocene Columbia Basin flood basalt deposits, the Miocene Yakima Fold Belt, and the Pleistocene Lake Missoula glacial breach floods (Orr and Orr, 2002). In the project reach, the broad, low gradient Yakima floodplain is the dominant feature. The floodplain in the project area has been truncated by a large COE levee, which eliminates the possibility of channel migration, side-channel formation, and other geomorphic / floodplain functions (see Figure 5).

SR 224 MP 9 Yakima River Historical Migration

Channel migration and avulsion risk: Channel migration at the project site is currently rotating clockwise through the meander and is moving east and southeast through the alluvial floodplain that extends well to the east of the current position of the Yakima and SR 224. Historic aerial photos (see Figure 5) do not show rapid migration, but due to the close proximity of the Yakima River to SR 224 (in places, less than eight feet), any future eastward migration may affect SR 224 operations. Any chance of an avulsion occurring is precluded by the COE levee that protects the right bank.

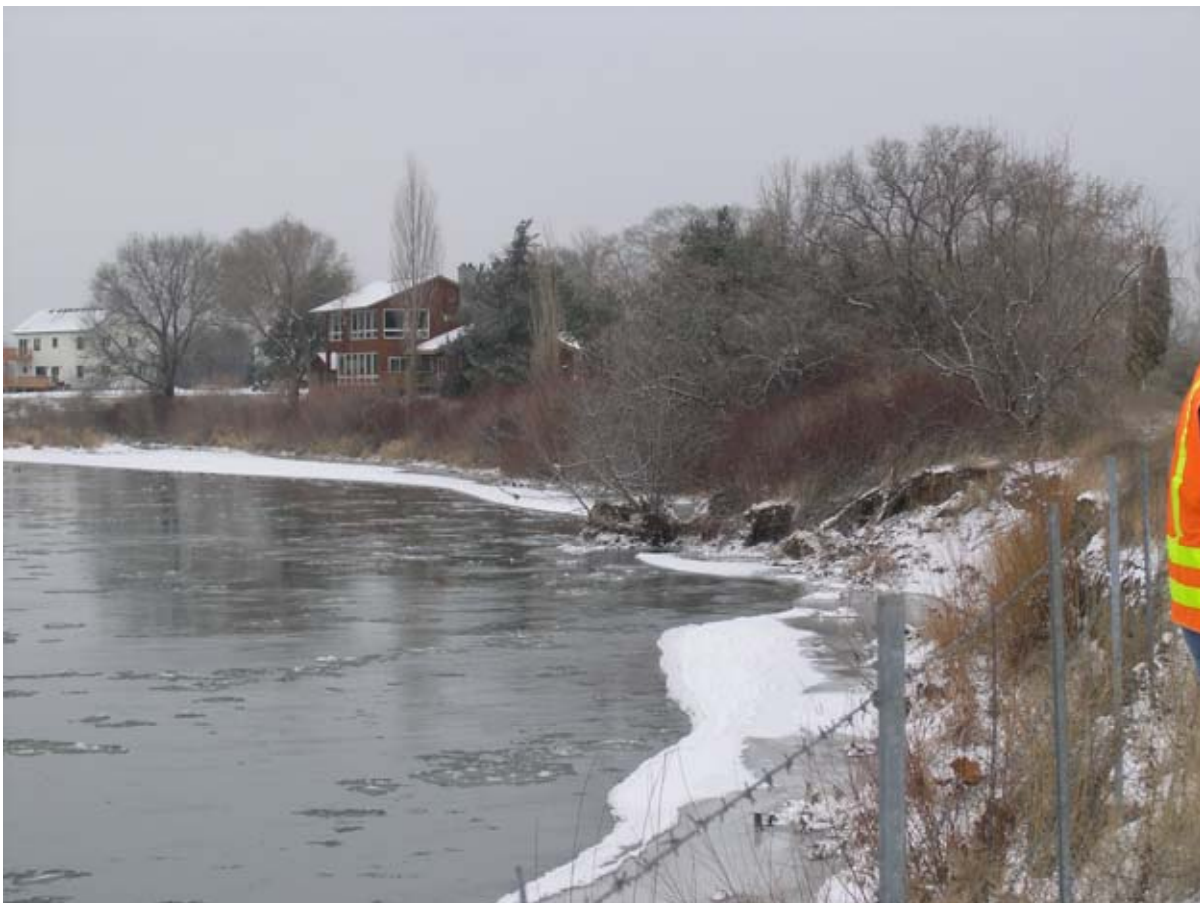
Figure 8. Near-bank Back Eddies and Resulting Scallop-Shaped Erosion Features.

Back eddies: As the thalweg has moved into the left bank along SR 224, localized near-bank obstructions have developed from sloughing at the meander's cut bank. This results in localized near-bank back eddies that result in strong downwelling and upwelling currents, high boundary stress, and high velocity gradients in the near-bank region (see Figure 7).

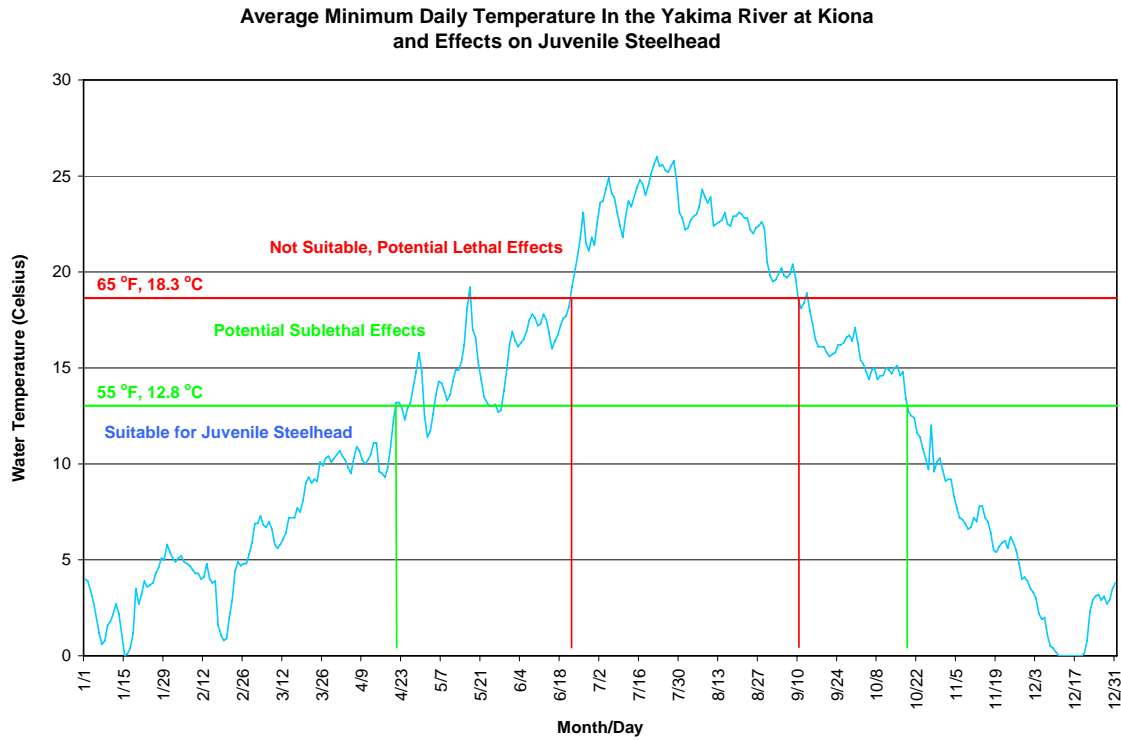
Figure 9. Effects of Mean Lower Yakima Water Temperatures on Juvenile Steelhead.

Water quality in the lower Yakima basin is highly impaired by high seasonal temperatures, alkaline conditions, and turbidity as indicated by water quality data collected at the USGS gage at Kiona. Mid-summer temperatures are high enough to impair all fish species that may inhabit the river.
