**SR 518 Sea Tac Airport to I-5/I-405 Interchange Stream
Mitigation Site**

USACE # 200600651

2010 MONITORING REPORT

Wetland Assessment and Monitoring Program

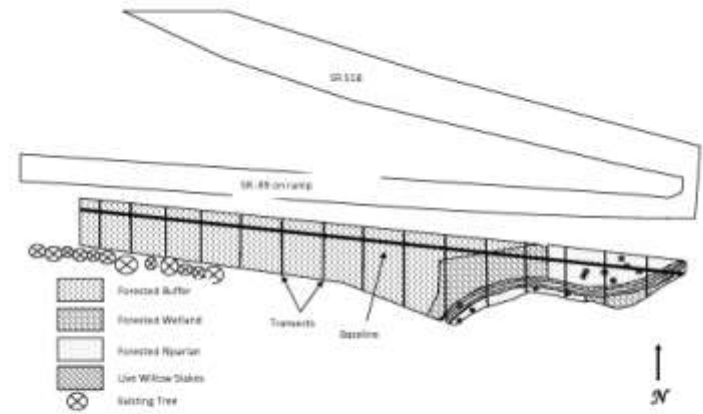
Figure 2 Site Sampling Design (2010)

To evaluate standards for vegetative cover, a baseline was established parallel to the SR 99 on ramp (southwest tributary to Gilliam Creek) (Figure 2). Twenty sampling transects were randomly placed perpendicular to the baseline. The unequal belt transect method was used to estimate woody survival. Total counts were conducted at the unnamed tributaries 1 and 2 (Performance Standard 1, Permit Requirement 3 and 4). The southwest tributary was visually inspected (Performance Standards 2, 3 and 4). Invasive cover was qualitatively assessed (Permit Requirement 1 and 2).

To evaluate standards for vegetative cover, a baseline was established parallel to the SR 99 on ramp (southwest tributary to Gilliam Creek) (Figure 2). Twenty one-meter wide sampling transects were randomly placed perpendicular to the baseline. The unequal belt transect method was used to estimate woody survival. Total counts were conducted at the unnamed tributaries 1 and 2 (Performance Standard 1, Permit Requirement 3 and 4)). The southwest tributary was visually inspected (Performance Standards 2, 3 and 4). Invasive cover was qualitatively assessed (Permit Requirement 1 and 2).

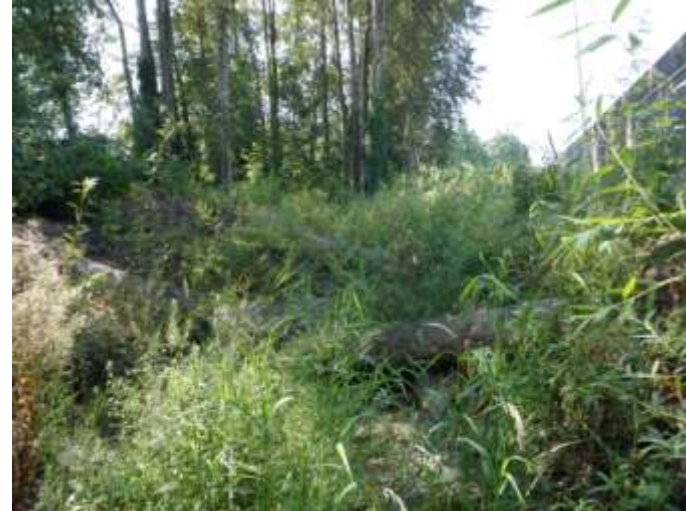
Photo 1
Woody survival at southwest tributary (July 2010)

Survival of woody species at the southwest tributary is estimated to be 99% (CI_{80%} = 98-100%) (Photo 1). Dominant species include roses (*Rosa* spp.) and vine maple (*Acer circinatum*). Survival of woody species is estimated to be 98 percent and 97 percent, respectively, for unnamed tributary 1 and 2. Additional planting is planned for 2011.

Survival of woody species at the southwest tributary is determined to be 99% ($CI_{80\%} = 98-100\%$). Dominant species include roses (*Rosa* spp.) and vine maple (*Acer circinatum*).

The southwest tributary is currently in the process of remediation. The site is in the process of being permitted for a design fix on the weirs. Due to repairs to the weir configurations a number of the plantings will be temporarily removed to provide access for heavy equipment during the summer of 2011.

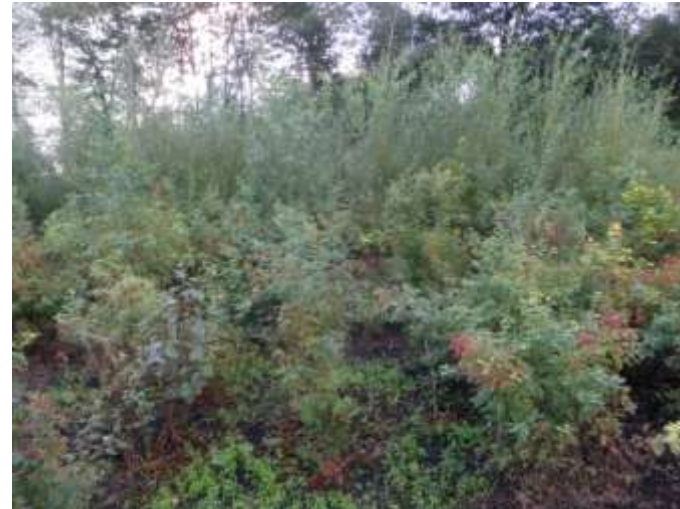
Photo 2
Woody survival at Tributary 1 (August 2010)

Tributary 1 is beginning to develop quite well. There is high survival and the plantings for the most part appear healthy and vigorous. Willow (*Salix* spp.) fascines along the realigned tributary are flourishing, reaching heights of 3-meters. A few bigleaf maples (*Acer macrophyllum*) appear stressed and a number of Oregon ash (*Fraxinus latifolia*) have what appear to be aphids. The invasive cover was exceedingly low.

Survival of woody species is estimated to be 98% and 97%, respectively for unnamed tributary 1 and 2 (Photos 2 and 3). This exceeds the permit requirement.

The southwest tributary is currently in the process of remediation. The unnamed tributaries will be replanted during the winter of 2011 and continued invasive control is planned through the 2011 growing season.

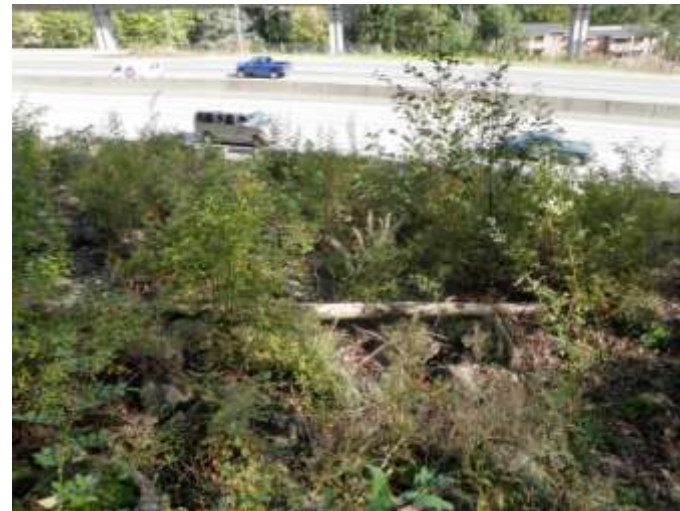
Photo 3
Woody survival at Tributary 2 (August 2010)

Tributary 2 is also beginning to develop quite well. Overall, the woody plantings appear healthy and vigorous. A few stressed western red cedars (*Thuja plicata*) and vine maple (*Acer circinatum*) were observed on site. The invasive cover is exceedingly low and there is extensive evidence of Himalayan blackberry (*Rubus armeniacus*) control.

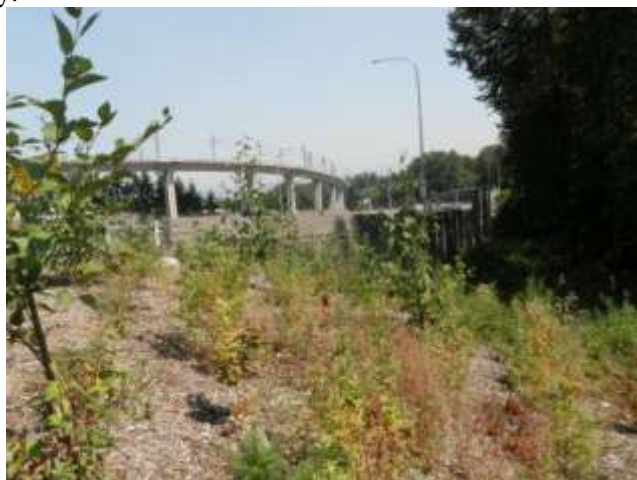
Photo Point 1a

The photographs below were taken from permanent photo-points on August 16th, 2010 and document current site development at the southwest tributary.
