# WSDOT SR520 PROGRAM Pontoon Construction Project Expert Panel Report, Phase 2

Submitted to WSDOT by the Expert Panel February 18<sup>th</sup> 2013

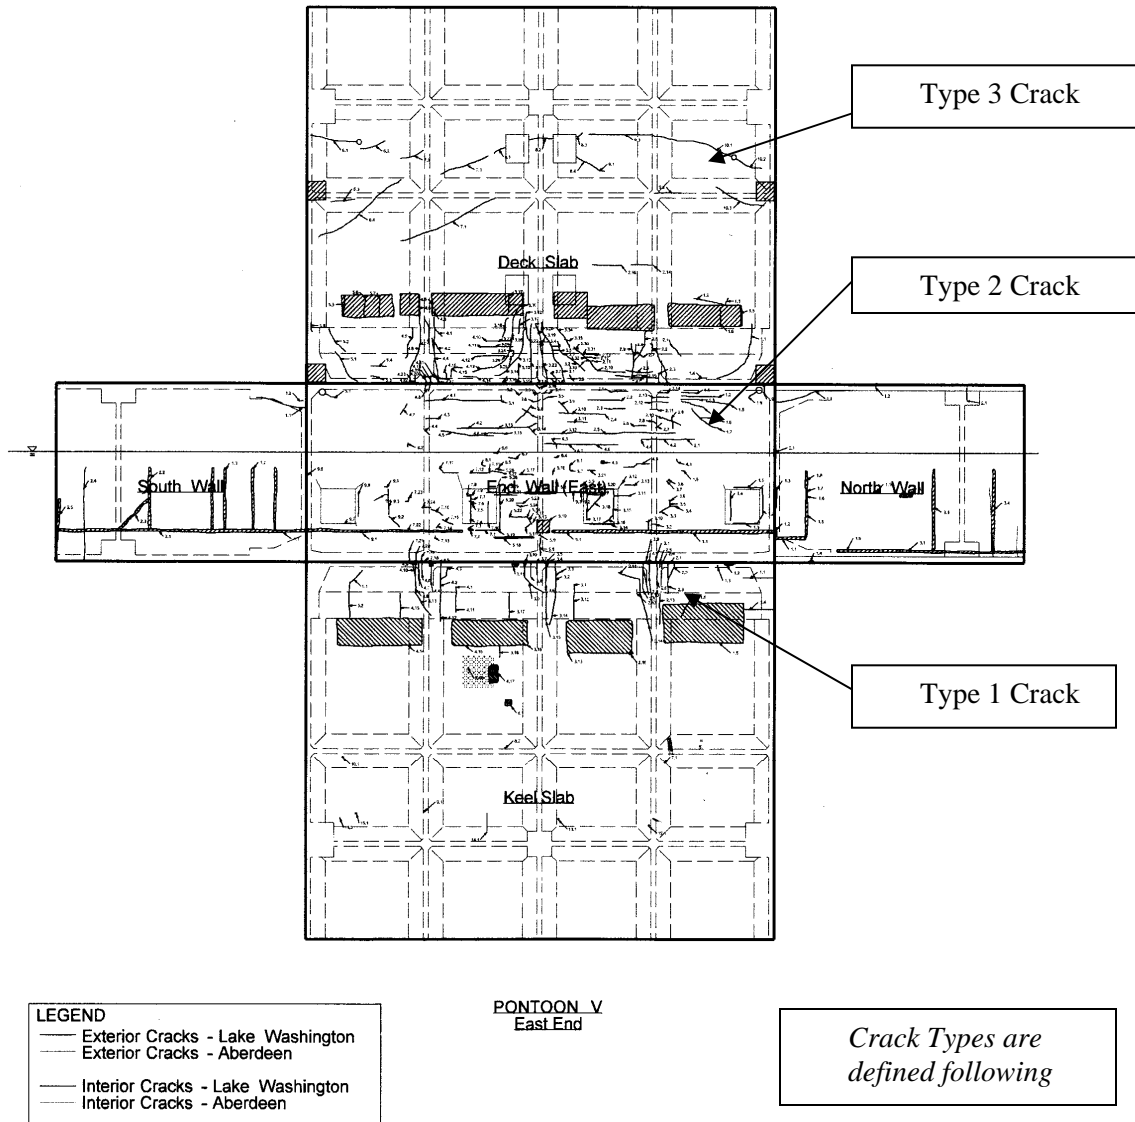
Figure 1, Crack Maps for Pontoon V

Shown in the figure below is a composite developed scale drawing of the cracking extent on the east end of cycle 1 Pontoon V. Both interior and exterior crack locations are noted. Where concrete was removed to permit the insertion of PT deviation reinforcement, and then replaced, it is indicated by hatching. The central portion of the diagram is the east end wall and the line of the top of the bolt-beam is clearly indicated by hatching.. To each side of that diagram and on the same horizontal line are diagrams for the adjoining east ends of the north and south longitudinal walls. Above the central diagram is the diagram for the adjoining east end of the deck slab and below is the diagram for the adjoining east end of the keel slab. The different cracks are identified as either Type 1, Type 2, and Type 3 cracks.

The post-tensioning induced cracks occur at the ends of the completed post-tensioned pontoons. The cause, location, consequence, and repairs of these cracks are detailed in Section 3 and 5 of this report. Transverse post-tensioning modifications and WSDOT/contractor designed repairs, discussed in sections 3 and 5, have and are being designed to provide cycle 1 and 2 pontoons with similar, or better, durability than other existing WSDOT pontoons. Transverse post-tensioning modifications are also being designed to reduce existing cracks and to prevent or minimize future cracks.
