# IN-SERVICE PERFORMANCE OF GUARDRAIL TERMINALS IN WASHINGTON STATE

WA-RD 580.1

Research Report  
June 2004

**In-Service Performance of Guardrail Terminals  
In Washington State**

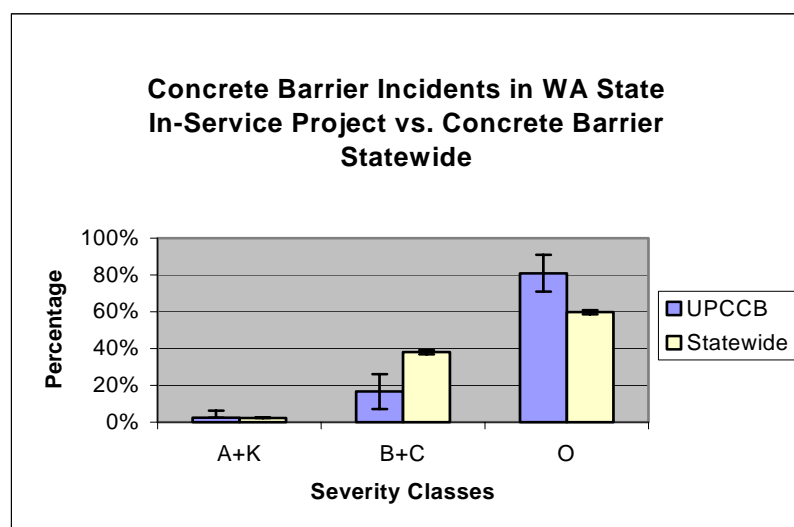
**Figure 6-In-Service Project vs. Concrete Barrier Statewide**

Examining the confidence intervals in Figure 6 for the UPCCB study sample and the statewide concrete barrier collisions shows that they overlap in the (A+K) injury category, which implies similar performance for the two groups. However, the confidence intervals do not overlap in either the (B+C) injury category or the property damage only (O) category, which would imply that the performances may significantly differ in these two categories. Thus, single vehicle collisions with the UPCCB would be expected to result in a lower proportion of (B+C) injuries and a higher proportion of property damage only collisions than the performance shown for statewide concrete barriers collisions.

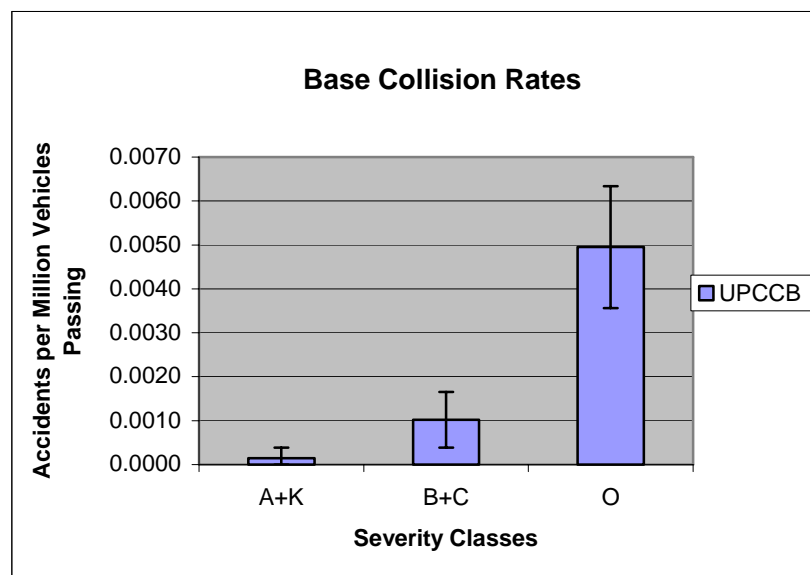
**Figure 8-Base Collision Rates for UPCCB**

As was done earlier for guardrail terminals, base collision rates were calculated for the UPCCB in the study area. This was done by adjusting the observed collision and injury rates using Accident Modification Factors. The geometric features employed were shoulder width and curve length. The resulting base collision rates for the UPCCB are tabulated in Table 33 and plotted in Table 8.
