SR 142 Bowman Creek Fish Passage Barrier Removal Mitigation Site

2010 MONITORING REPORT

Wetland Assessment and Monitoring Program

Issued March 2011

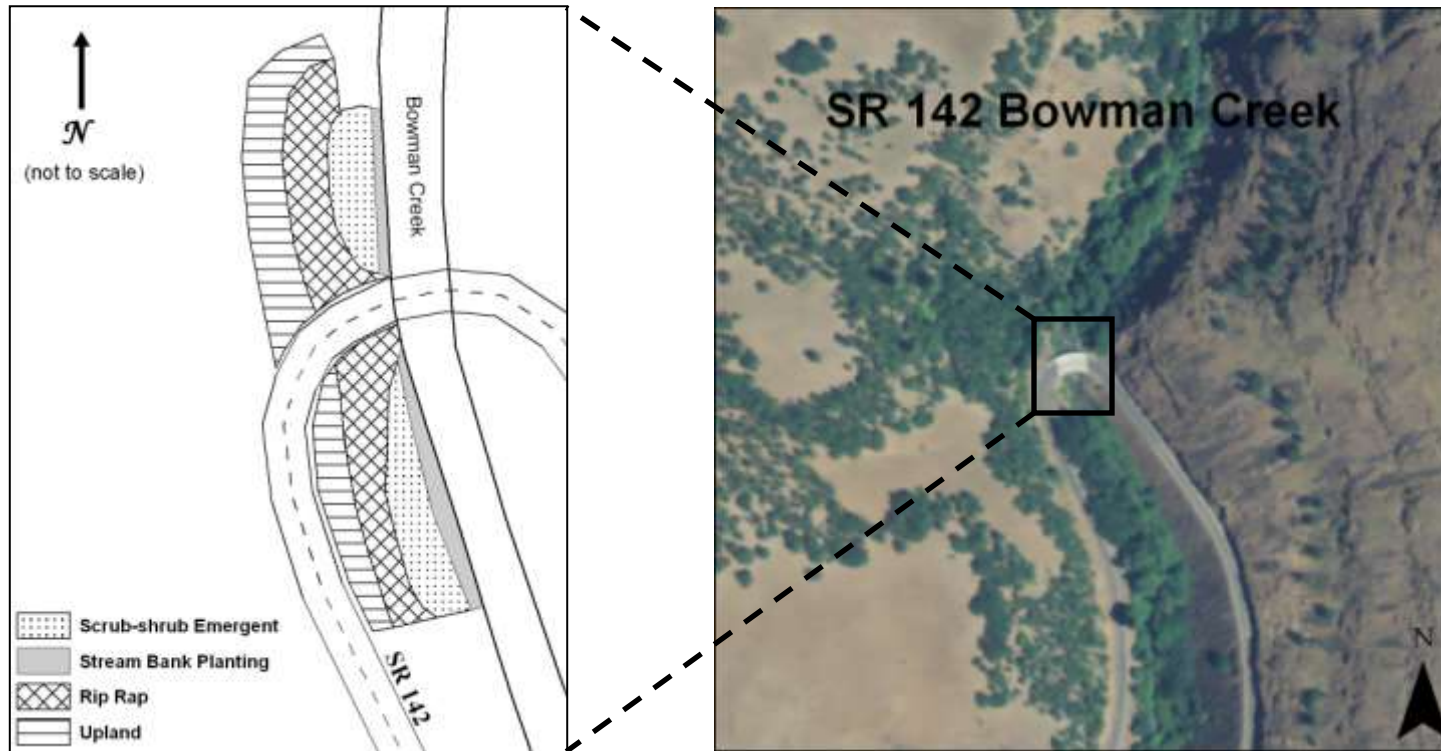
Figure 1 Site Sketch

The SR 142 Bowman Creek Mitigation Site consists of two floodplain planting benches along one side of Bowman Creek, one on each side of the bridge.

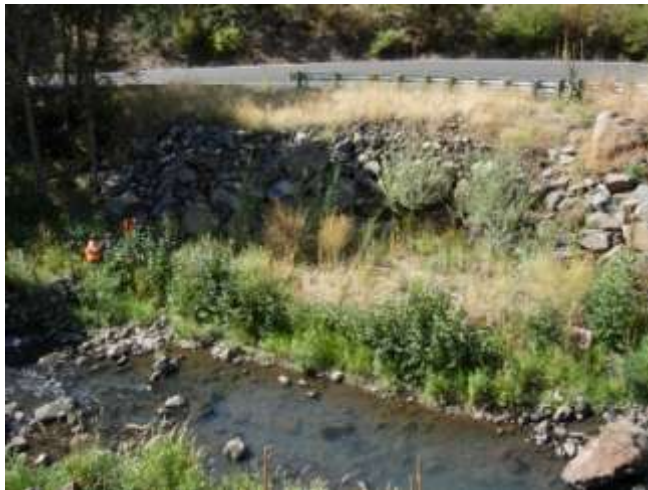
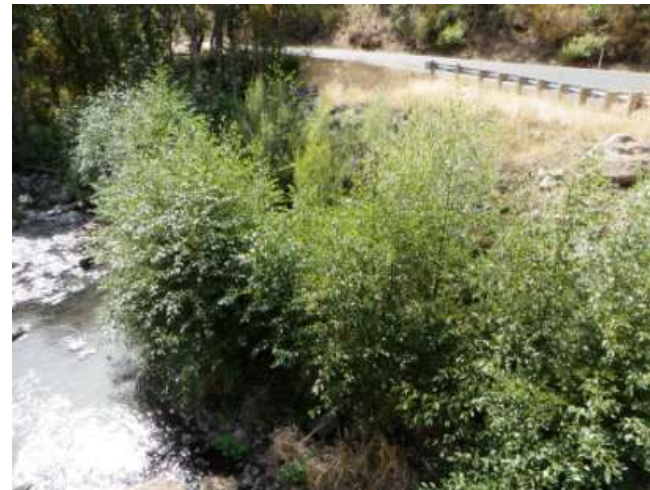
Photo 1 Woody cover comparison (southwest floodplain bench) 2008 to 2010.

In general, the west benches have developed to a greater extent and display higher aerial native woody coverage and survival. The northeast bench has been the slowest to develop with a native woody aerial coverage of 20 percent. As the site has developed the distinction between an emergent and a scrub/shrub zone has decreased to a point of no distinguishable separation, which has resulted in the inability to address Performance Standards 1 and 2 separately. Invasive aerial cover is qualitatively assessed at 25 percent. *Phalaris arundinacea* (reed canarygrass) is the dominant invasive with *Solanum dulcamara* (climbing nightshade) and burning bush (*Bassia scoparia*) present in small numbers. On the whole the site has shown substantial progress since 2008 (Photo 1).

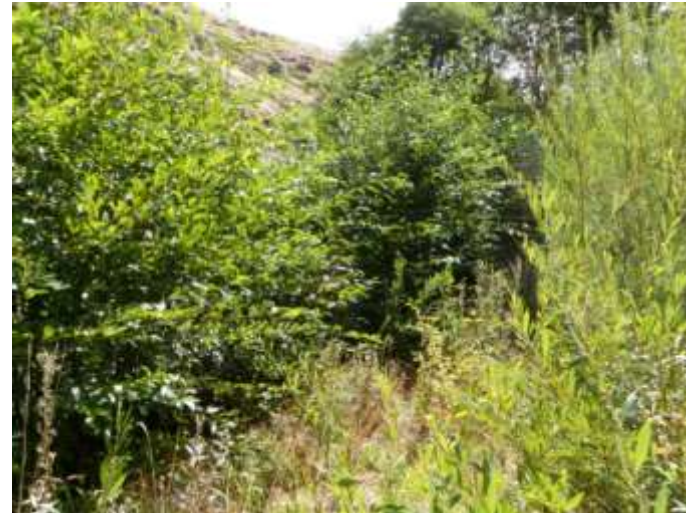
Photo 2
Woody cover southwest floodplain bench
(September 2010)

Cover was assessed across the site rather than by zone. The result of this qualitative estimate is 60 percent overall. Cover varied by location onsite. The northeast side had twenty percent cover, northwest had sixty percent, southwest had eighty-five percent (Photo 2), and the southeast side had sixty percent cover. Sitka alder (*Alnus viridis ssp. Sinuate*), bigleaf maple (*Acer macrophyllum*), and willows (*Salix spp.*) are some of the species present.

The cumulative area of the planted bank that is established with native woody vegetation is qualitatively estimated at slightly less than two-thirds of the total area. A number of volunteer Sitka alder provide a share of the established woody vegetation.

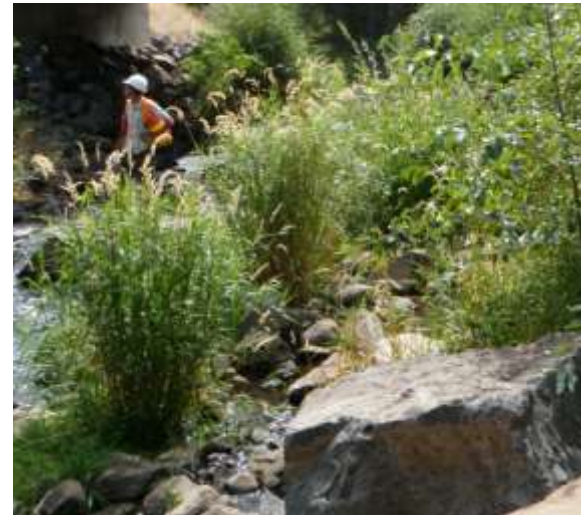
Photo 3
Reed canarygrass cover northwest floodplain bench (September 2010)

Invasive species cover across the site is estimated at twenty-five percent. This cover is made up predominantly of reed canarygrass (*Phalaris arundinacea*). Other species present include climbing nightshade (*Solanum dulcamara*) and burning bush (*Bassia scoparia*) (Photo 3). Invasive control was not conducted during the 2010 growing season.

Targeted replanting will occur during the Fall of 2011. Continued vegetation management activities focusing on Reed canarygrass control and other invasive species will continue throughout the summer months.

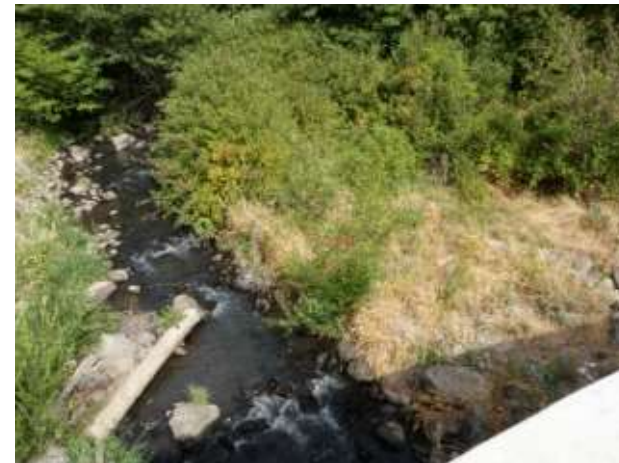
Photo 4
Woody establishment northeast floodplain bench (September 2010)

The survival of native woody vegetation is qualitatively estimated at 60 percent. Native woody plant establishment has been less successful on the northeast bench (Photo 4).

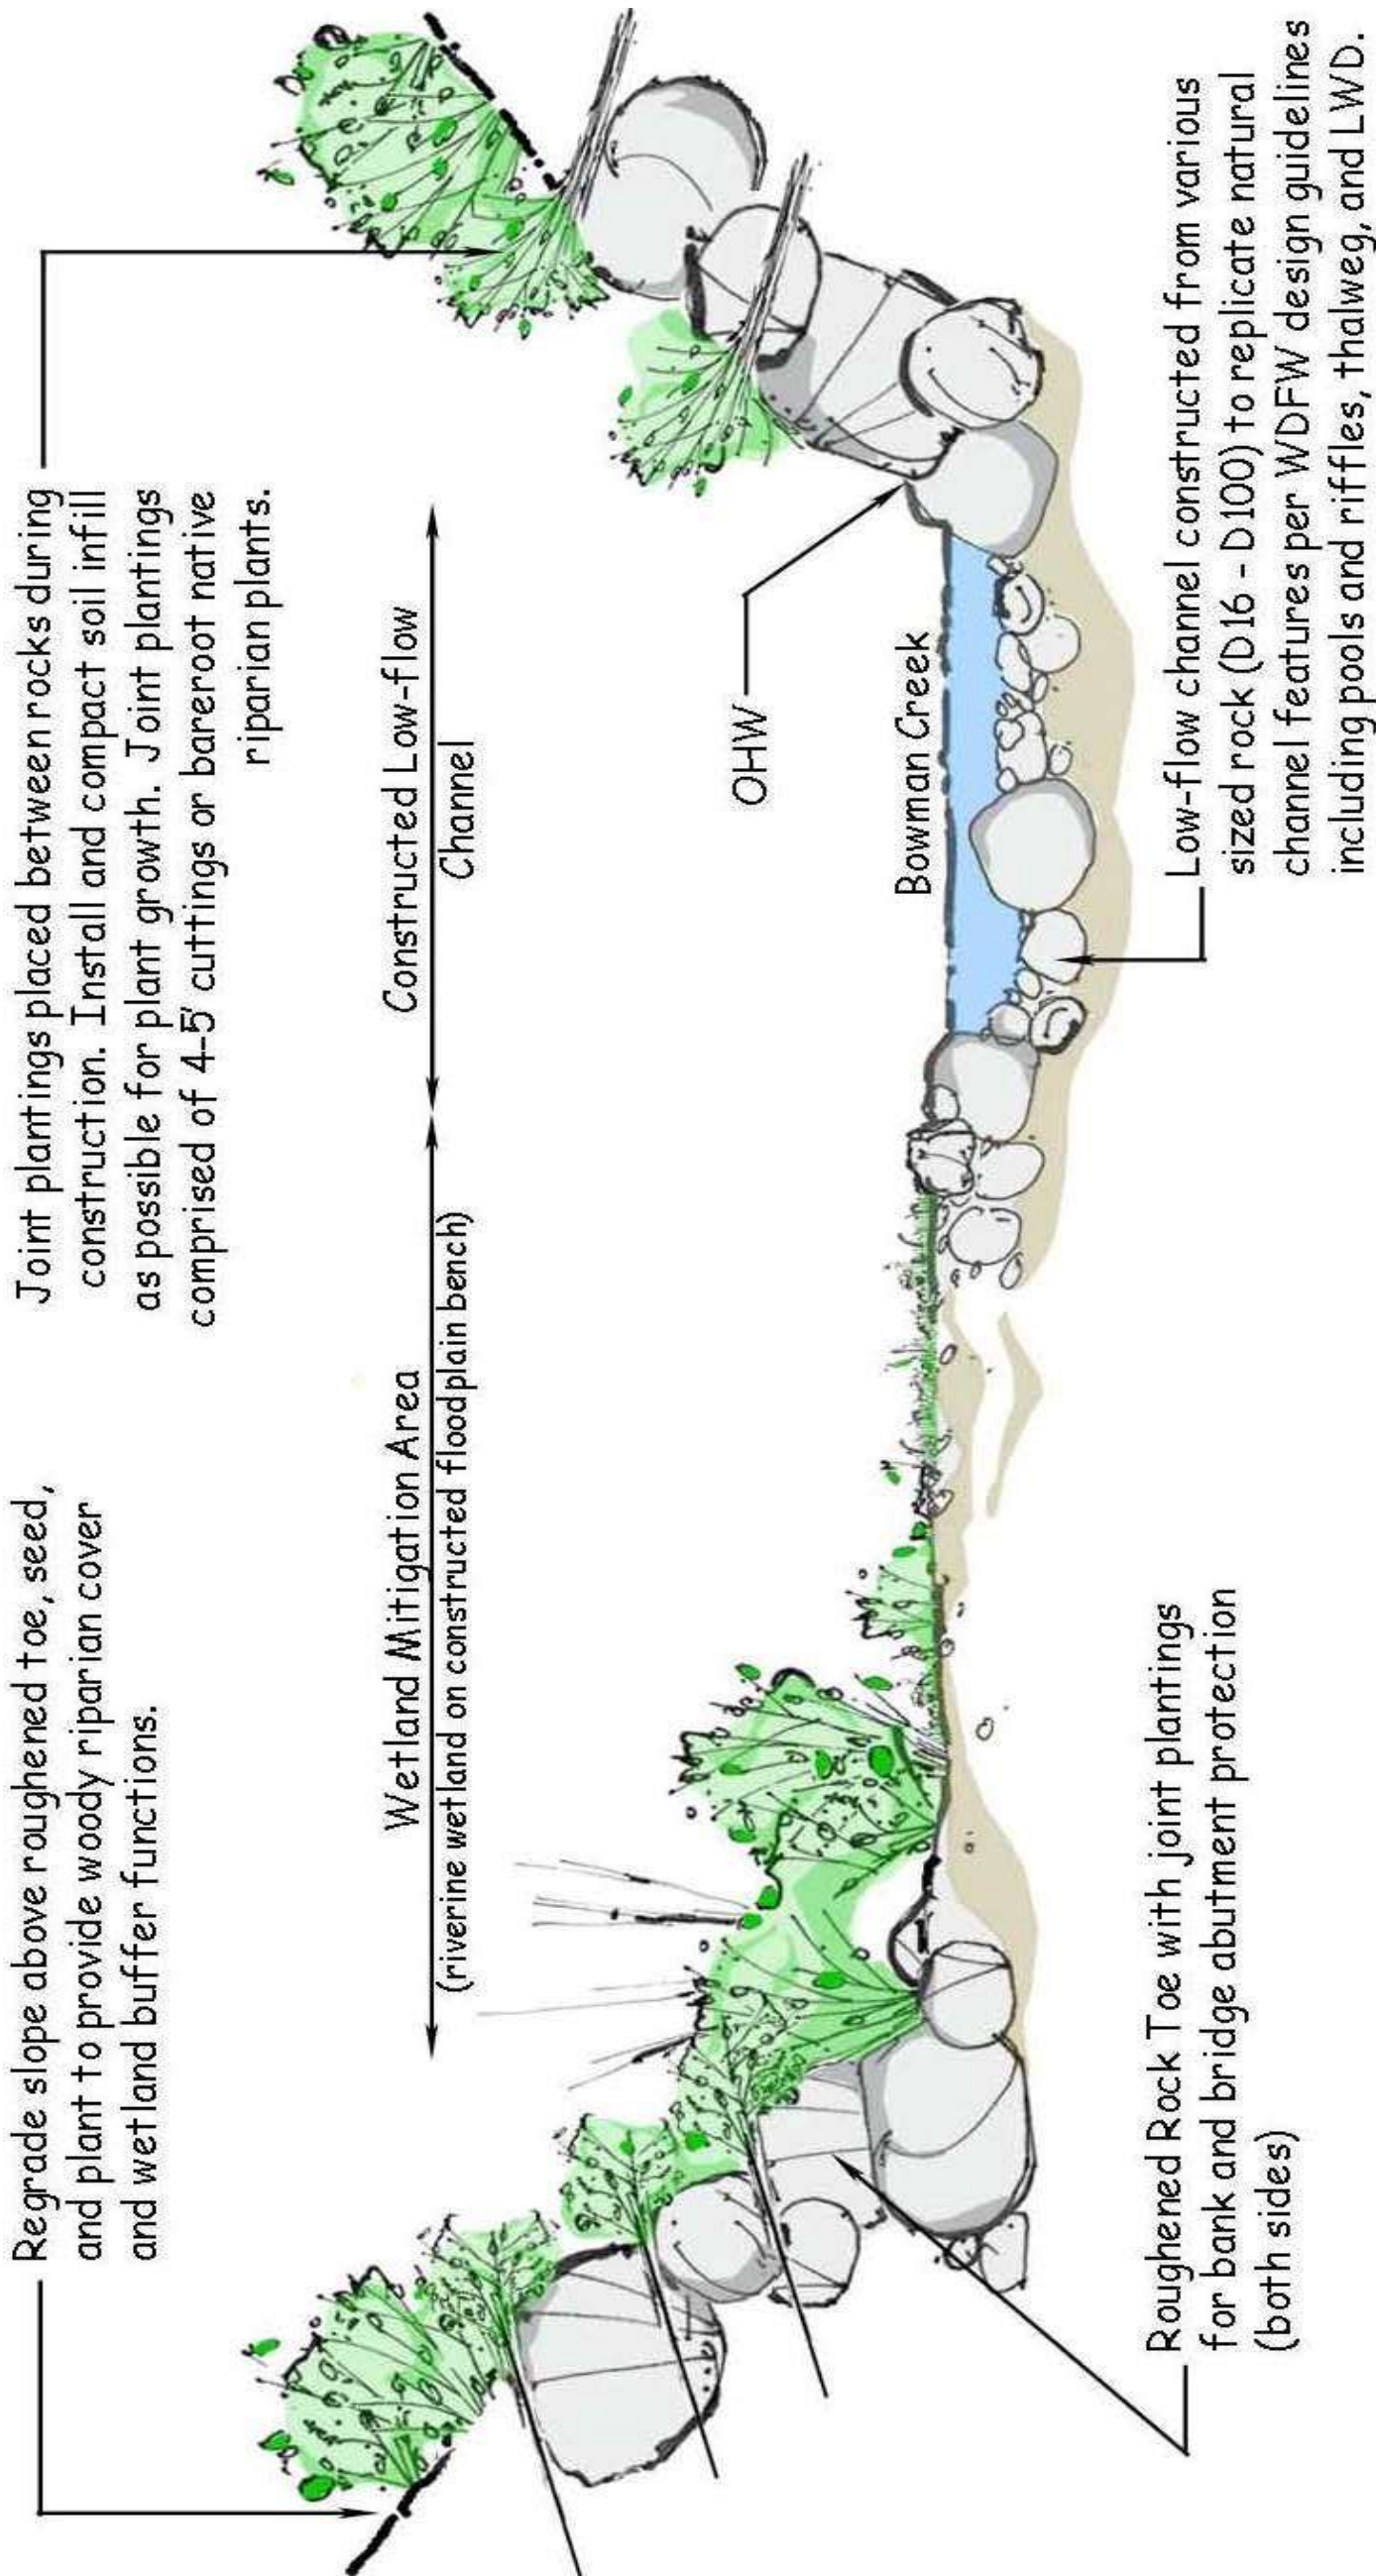
SR-142/ Bowman Creek Fish Barrier Removal Project Proposed Channel Treatment and Wetland Mitigation Concept

idealized section looking upstream, BC Station 12+60

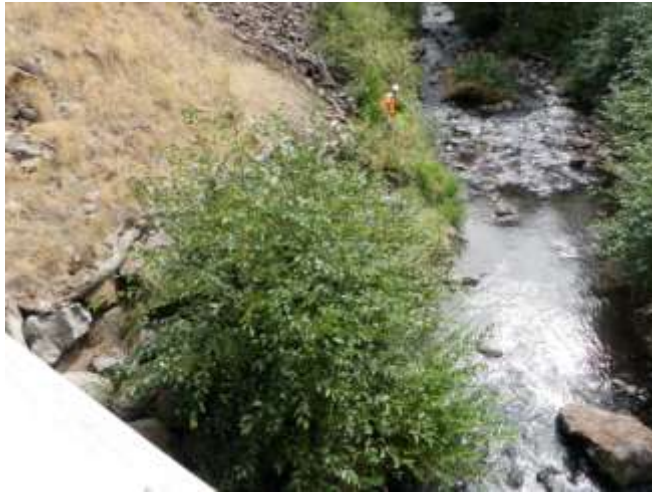
Photo Point 1 (southeast bench)

The photographs below were taken from permanent photo-points on September 13th, 2010 and document current site development.
