3. Why is the Corridor So Congested?

- Constraints in Study Area
- Obsolete Overpasses
- Regional Growth
- Collision Data

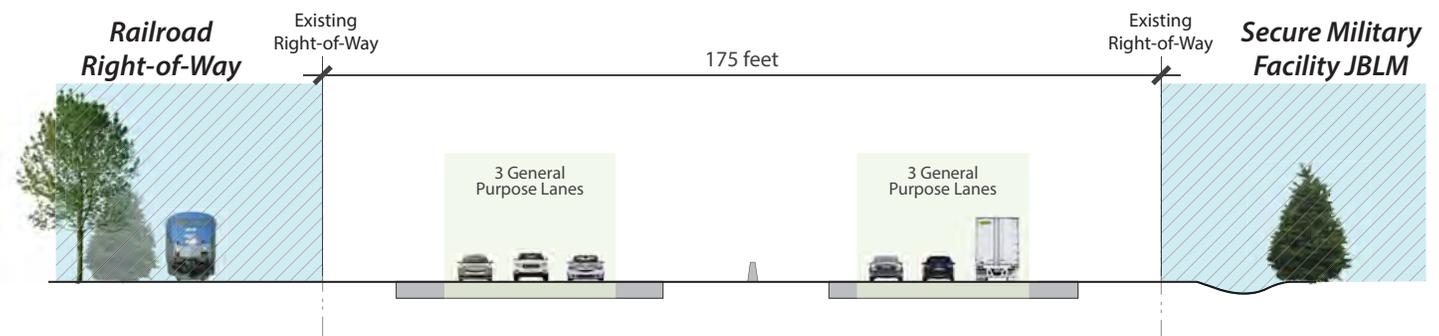
Typical I-5 Cross Section in Study Area

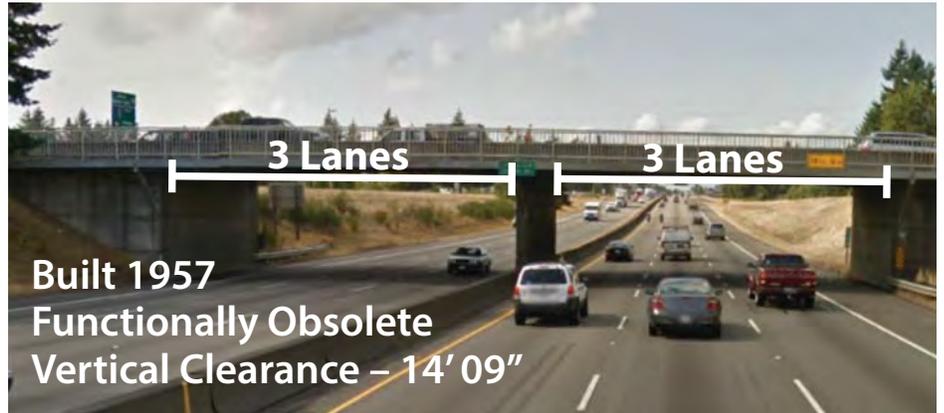
EXIT 119

Obsolete Overpasses in Study Area

Steilacoom
DuPont Rd ↗

Interstate requirement is 16.5 feet of vertical clearance

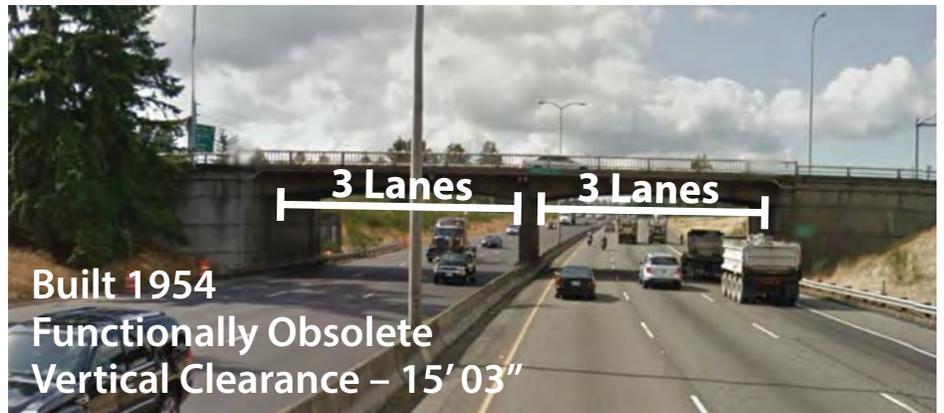
EXIT 122

Berkeley St
↗

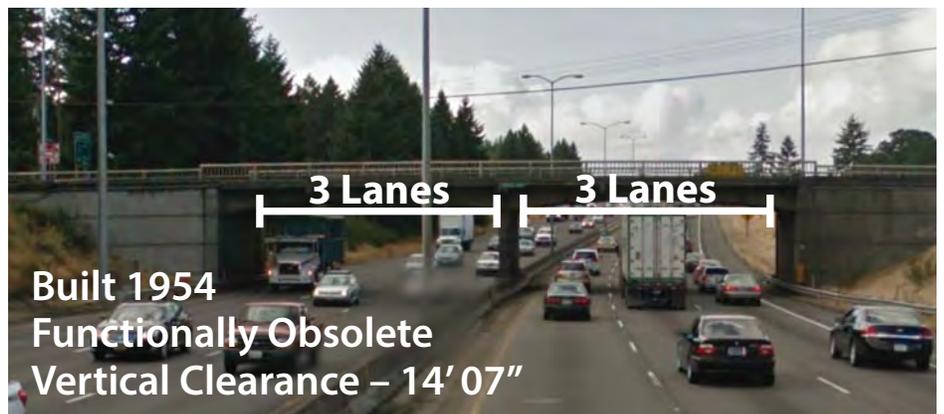
EXIT 123

Thorne
Lane ↗

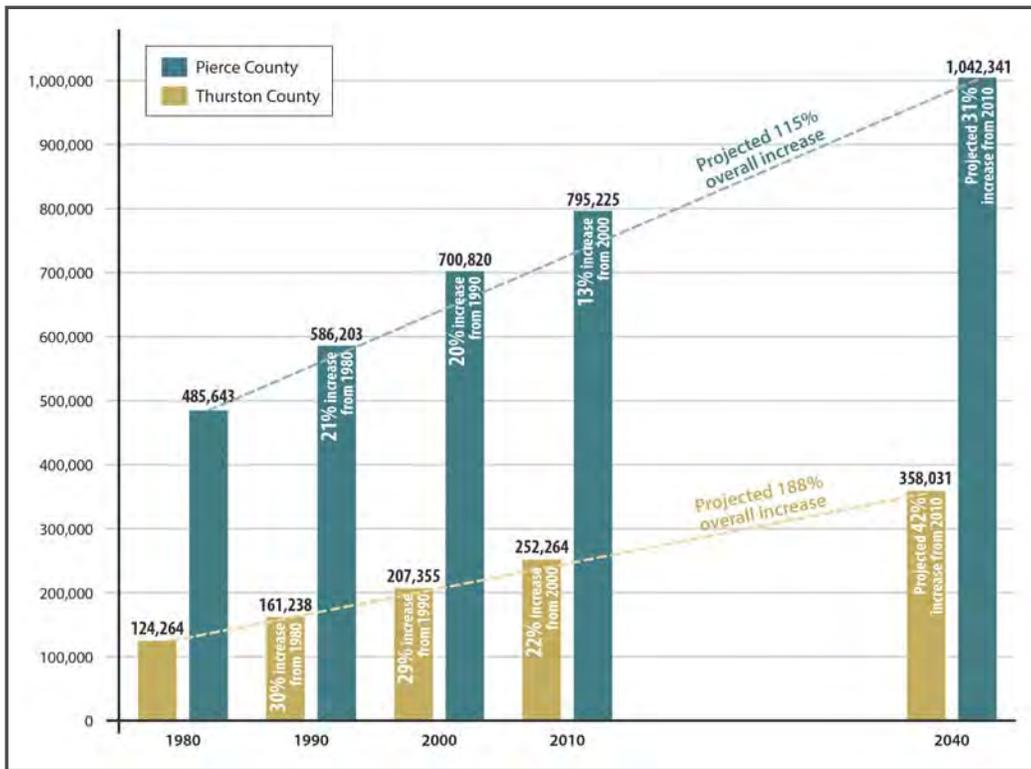
Population Growth Trends
Pierce and Thurston Counties, 1980-2040

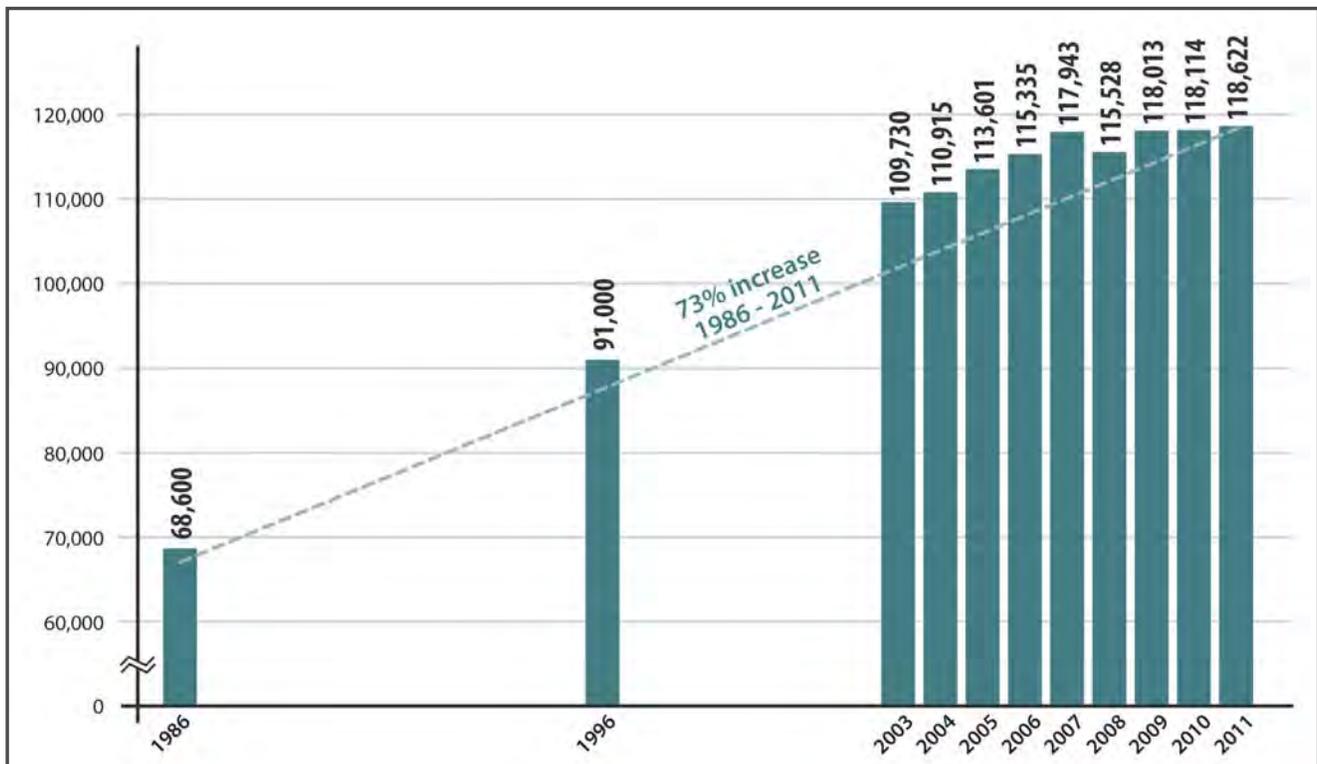
Average Annual Daily Traffic Volume
1986-2011, I-5 at DuPont

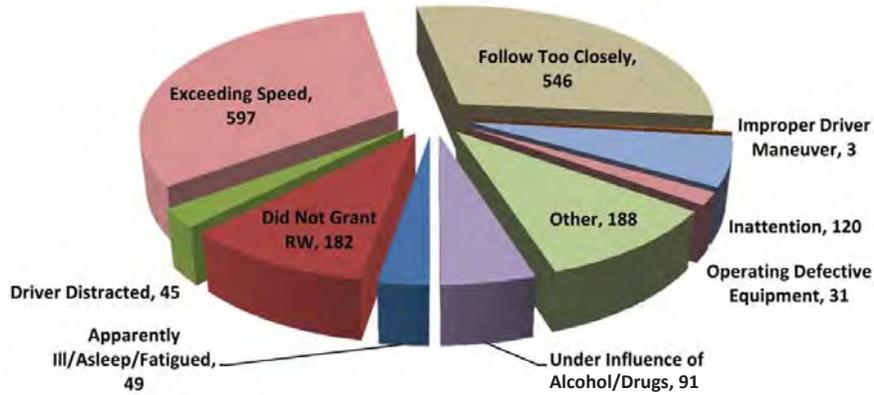
Contributing Circumstance for I-5 Collisions, 2007-2011 Milepost 116 to Milepost 126.2

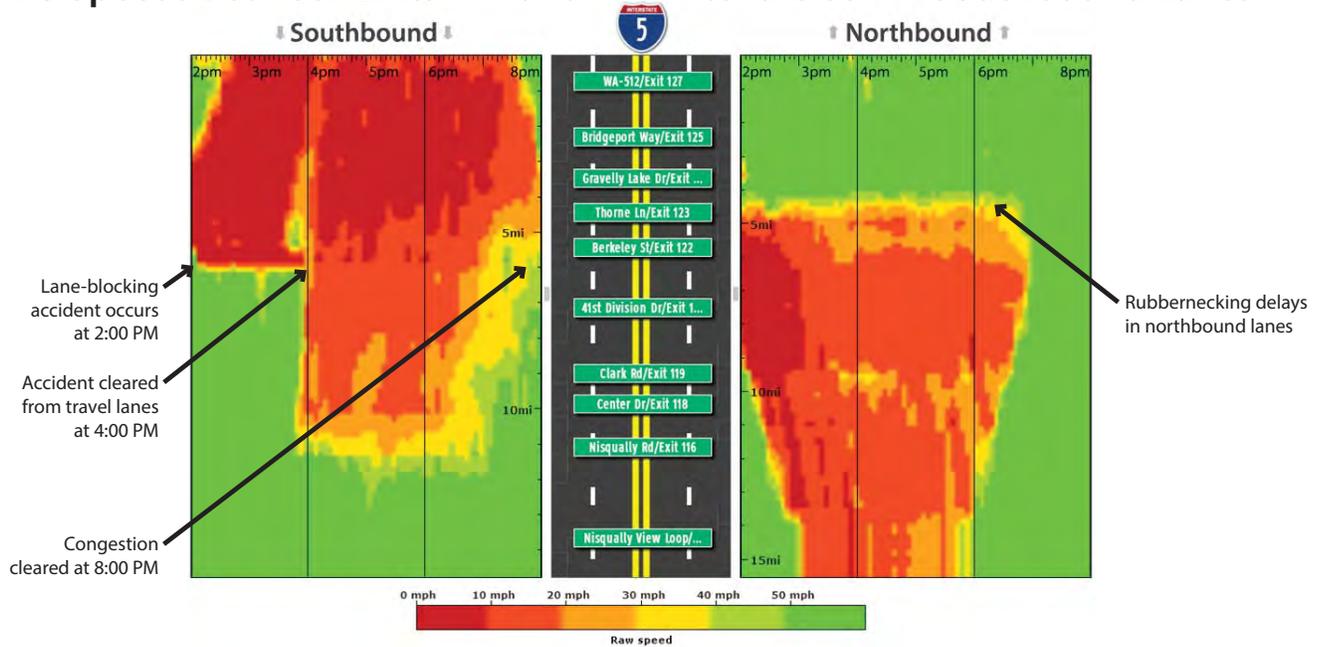
I-5 Speeds Between Exits 114 and 127 After a Crash in Southbound Lanes

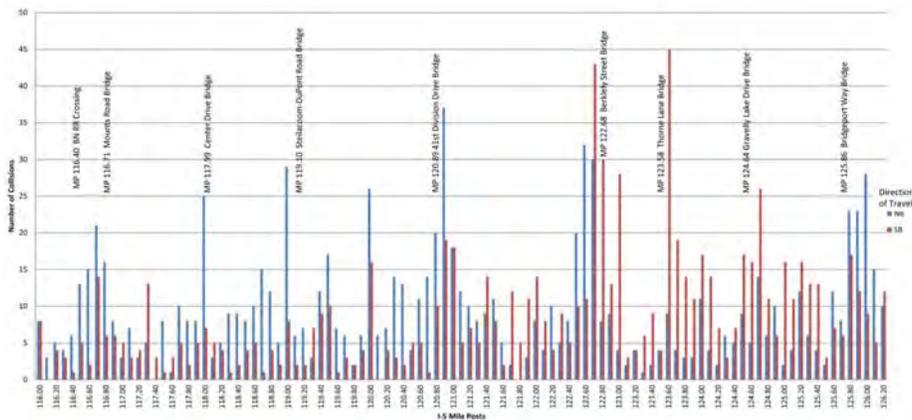
I-5 Collision Summary by Milepost, 2007-2011 Milepost 116 to Milepost 126.2
