## **Fidalgo Bay Mitigation Site**

**SR 20: Quiet Cove to SR 20 Spur Safety Improvements (MP 44.65 to MP 47.87) WIN # A02027C USACE NWP (23) 200601135**

**2014 MONITORING REPORT**

**Wetlands Program**

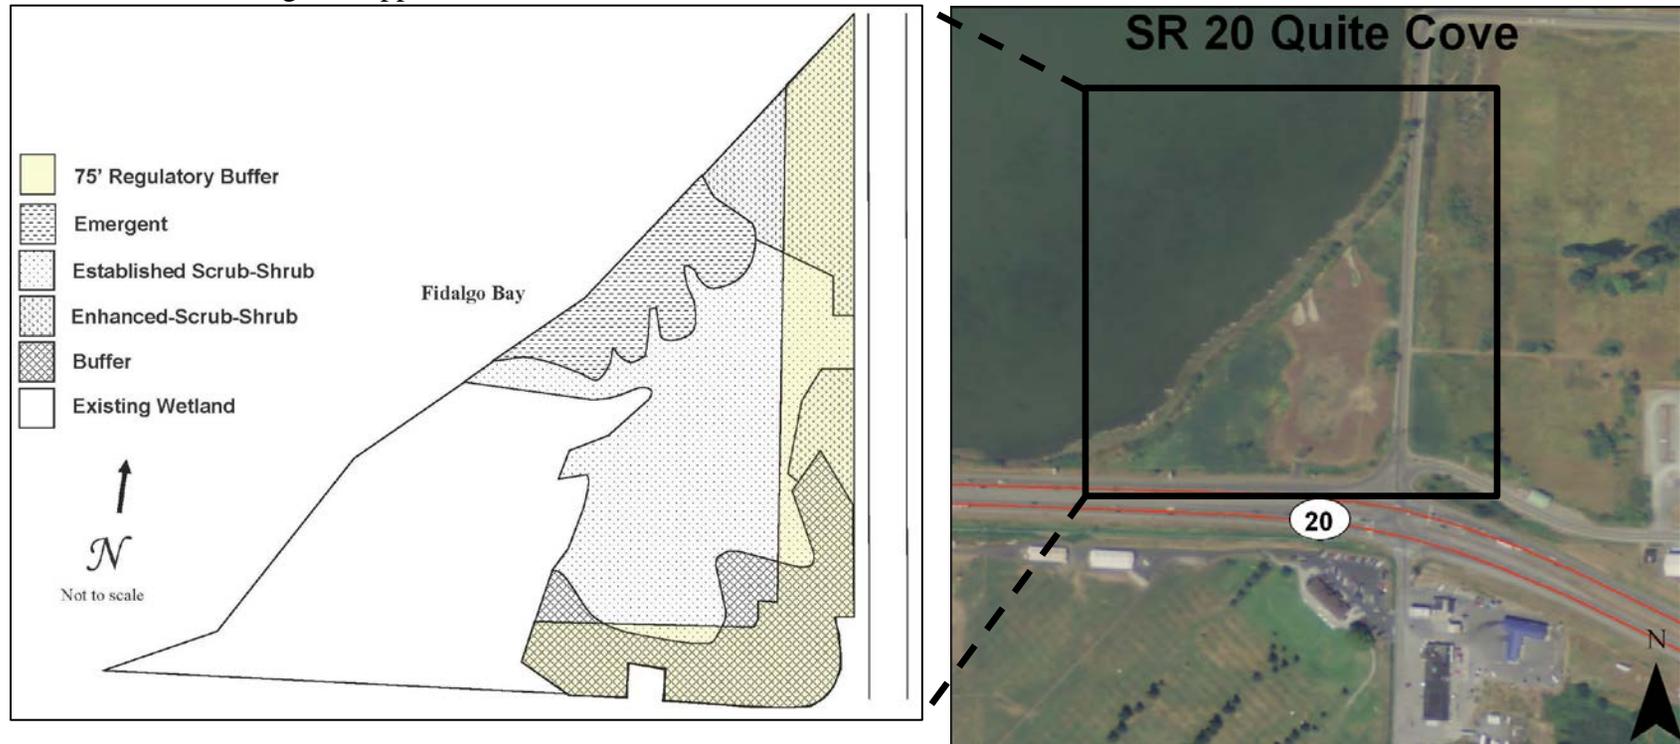
**Figure 1 Site Sketch**

This 5.95-acre mitigation site (Figure 1) is a combination of wetland enhancement, establishment, and existing wetland located southeast of Fidalgo Bay at the corner of SR 20 and March Point Road in the city of Anacortes. This site was created to compensate for the loss of 0.70 acre of wetlands due to road improvements along State Routes 9, 11, and 20. The seasonally ponded depressions and surrounding scrub-shrub areas are designed to provide mitigation for lost wetland functions including wildlife habitat, biological support, and storm water control.

The SR 20 Fidalgo Bay (Quiet Cove) Mitigation Site contains three established emergent finger-like depressions that are tidally influenced from Fidalgo Bay. Scrub-shrub areas flank the finger-like depressions and buffer enhancement borders the site to the east and south. Appendix 2 includes site directions.

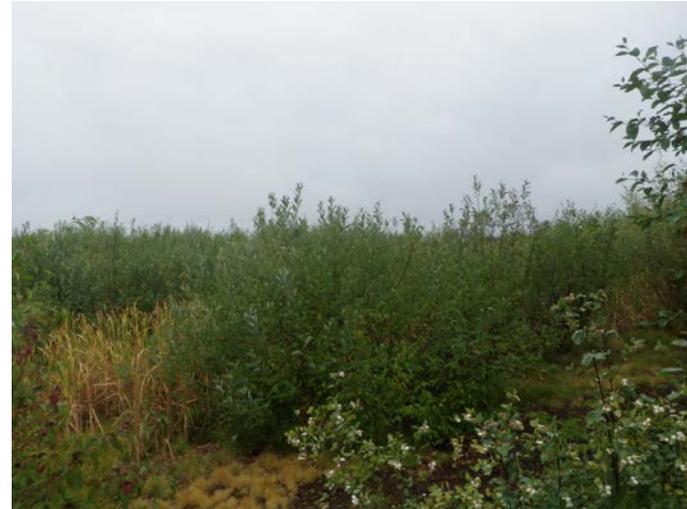
Wetland woody cover is qualitatively estimated at 80 percent (Photo 1). The scrub/shrub is dominated by willows (*Salix spp.*) with an understory of twinberry honeysuckle (*Lonicera involucrata*) and redosier dogwood (*Cornus alba*). The percent cover continues to slowly increase over time.

**Photo 1**  
**Woody cover in the scrub-shrub wetland (August 2014)**

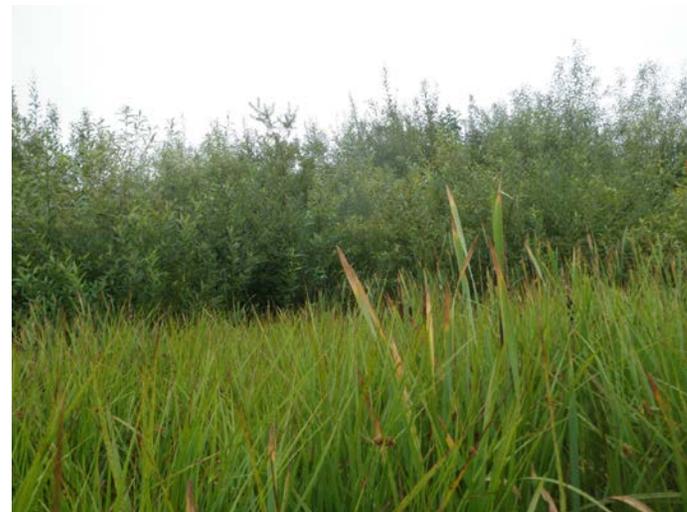
Herbaceous cover is qualitatively estimated at 90 percent (Photo 2). There is a diverse community of both salt water tolerant and freshwater species differentiated in area by slight changes in elevation.

**Photo 2**  
**Emergent cover in Wetland 1 (August 2014)**

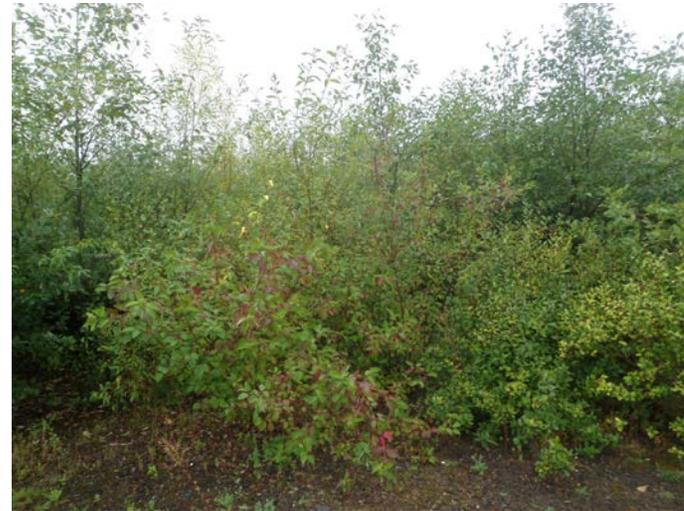
Native woody cover in the buffer is qualitatively estimated at 70 percent. This greatly exceeds the final year performance standard. The dominant species include a red alder (*Alnus rubra*) over story and a snowberry (*Symphoricarpos albus*) understory (Photo 3).

**Photo 3**  
**Woody cover in the buffer (August 2014)**

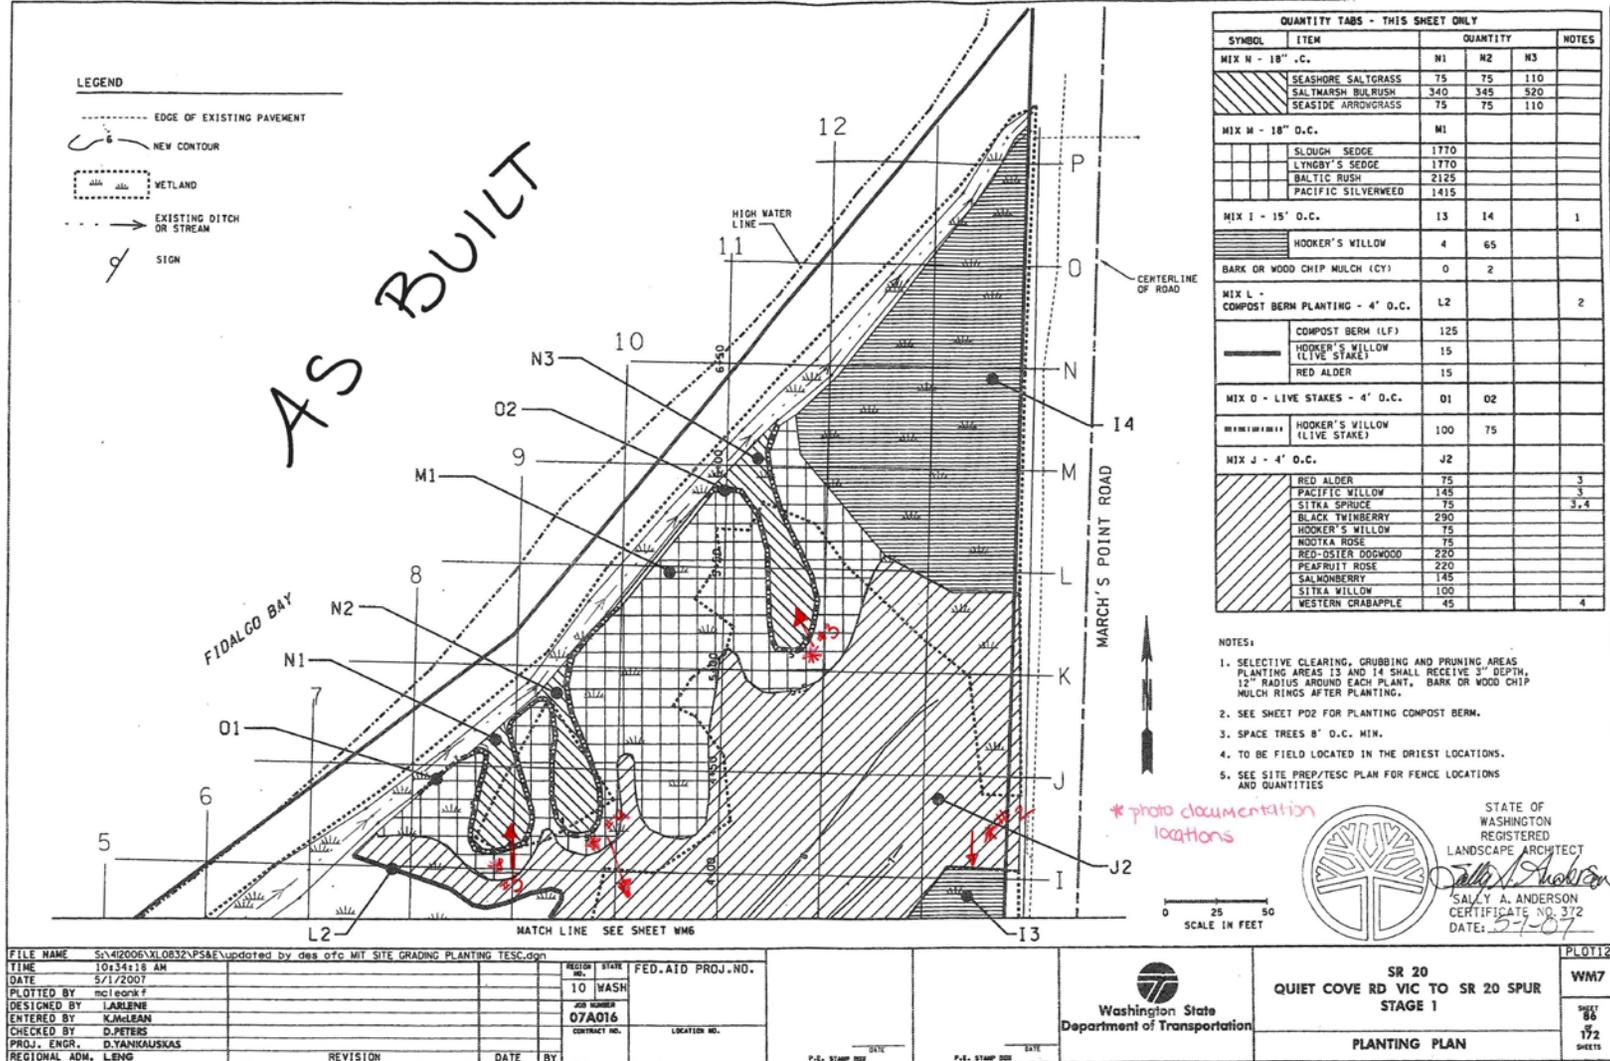
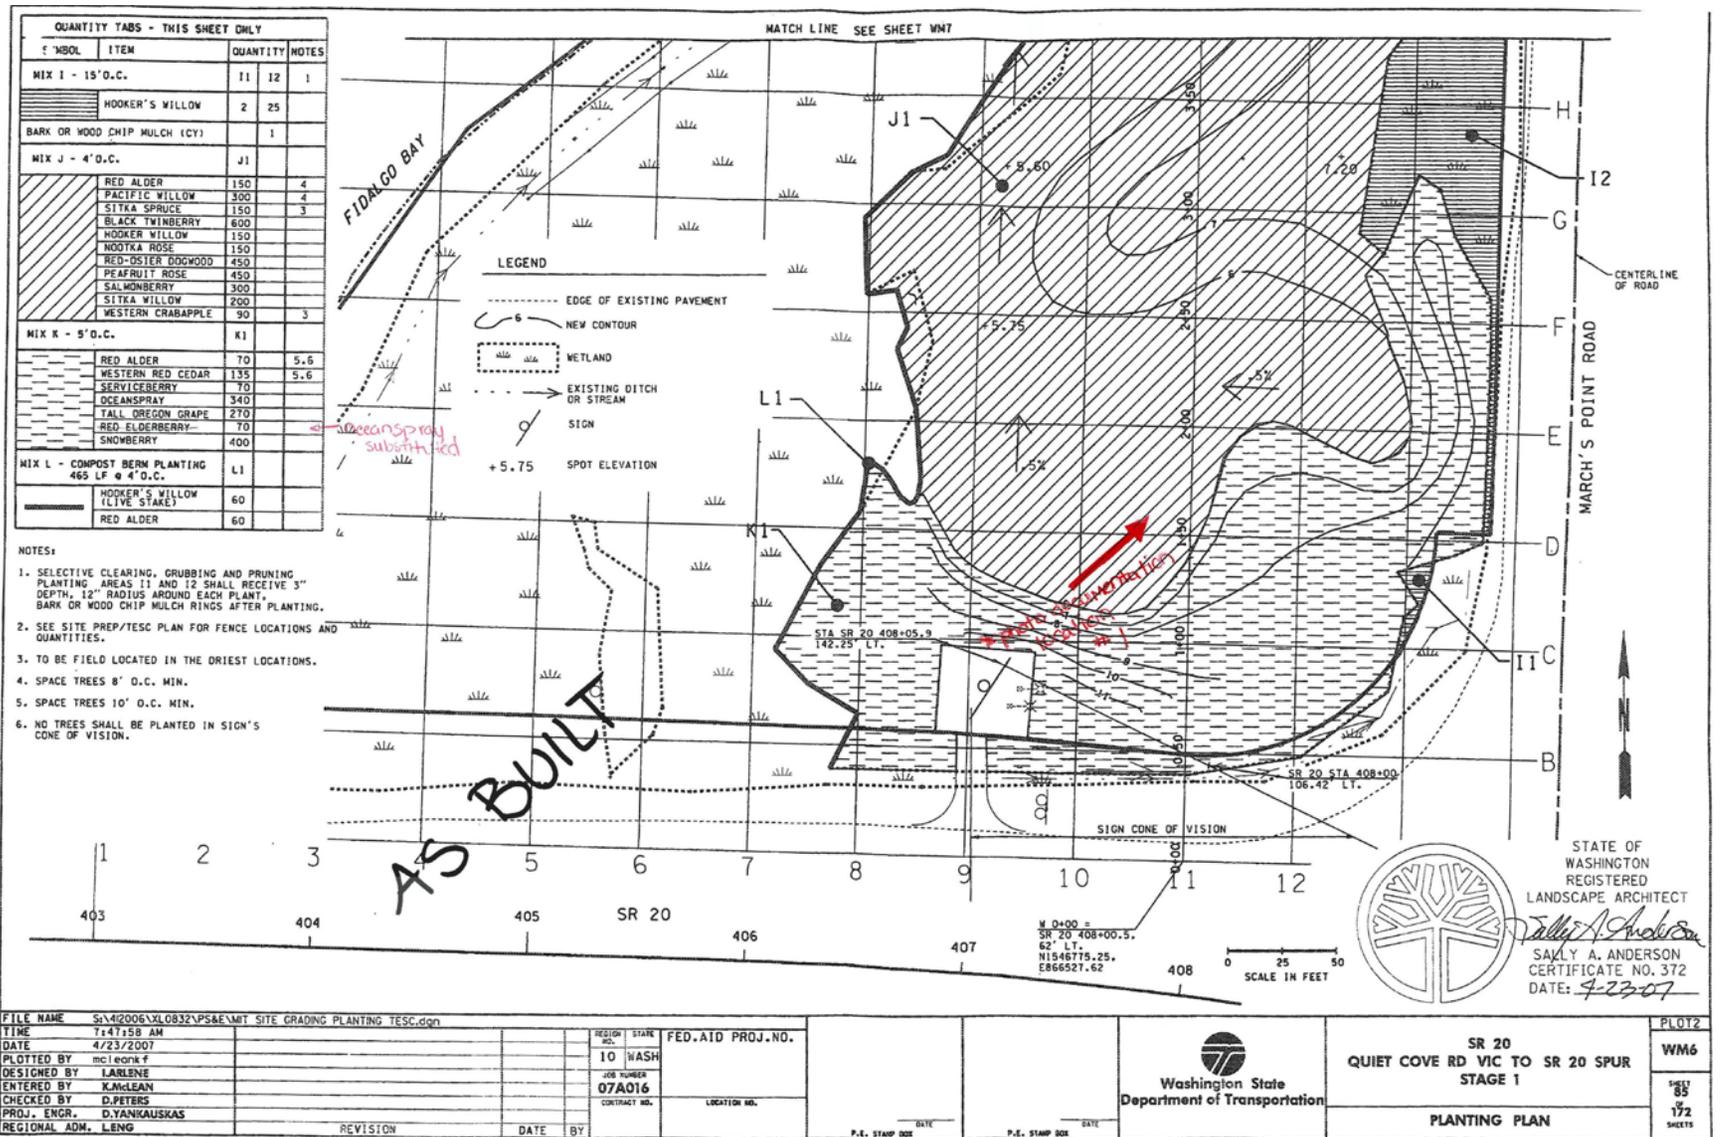
# Appendix 1 – Planting Plan (As built) With Photopoint Locations

- NOTES:
1. SELECTIVE CLEARING, GRUBBING AND PRUNING PLANTING AREAS I1 AND I2 SHALL RECEIVE 3" DEPTH, 12" RADIUS AROUND EACH PLANT, BARK OR WOOD CHIP MULCH RINGS AFTER PLANTING.
  2. SEE SITE PREP/TEST PLAN FOR FENCE LOCATIONS AND QUANTITIES.
  3. TO BE FIELD LOCATED IN THE DRIEST LOCATIONS.
  4. SPACE TREES 8' O.C. MIN.
  5. SPACE TREES 10' O.C. MIN.
  6. NO TREES SHALL BE PLANTED IN SIGN'S CONE OF VISION.

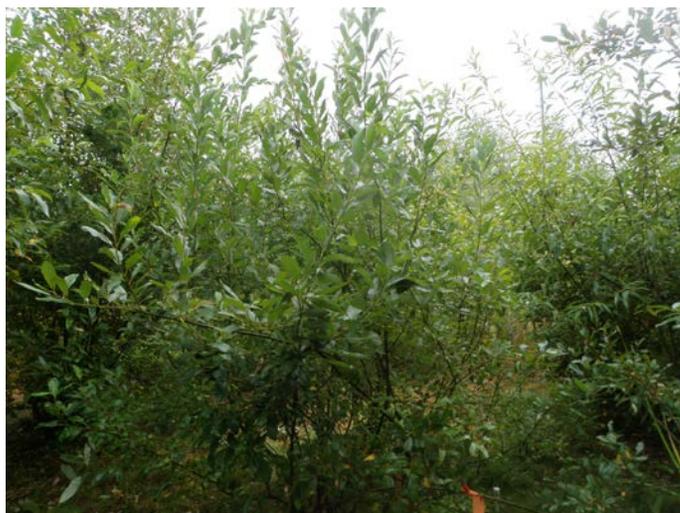
**Photo Point 1**

The photographs below were taken from permanent photo-points on August 13, 2014 and document current site development.

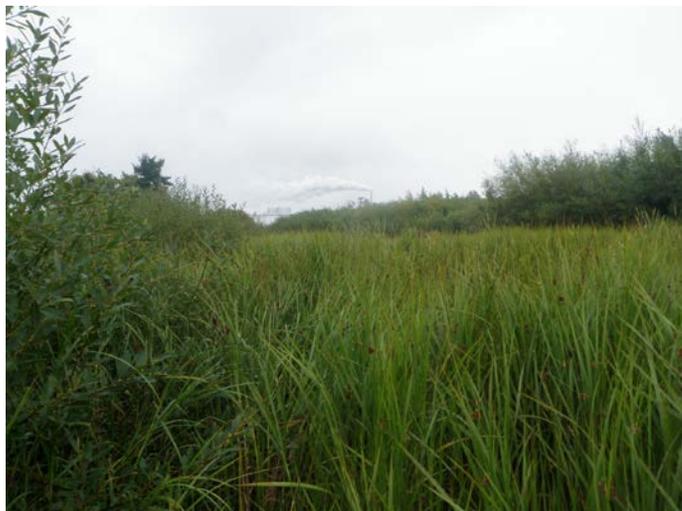
**Photo Point 5**

The photographs below were taken from permanent photo-points on August 13, 2014 and document current site development.

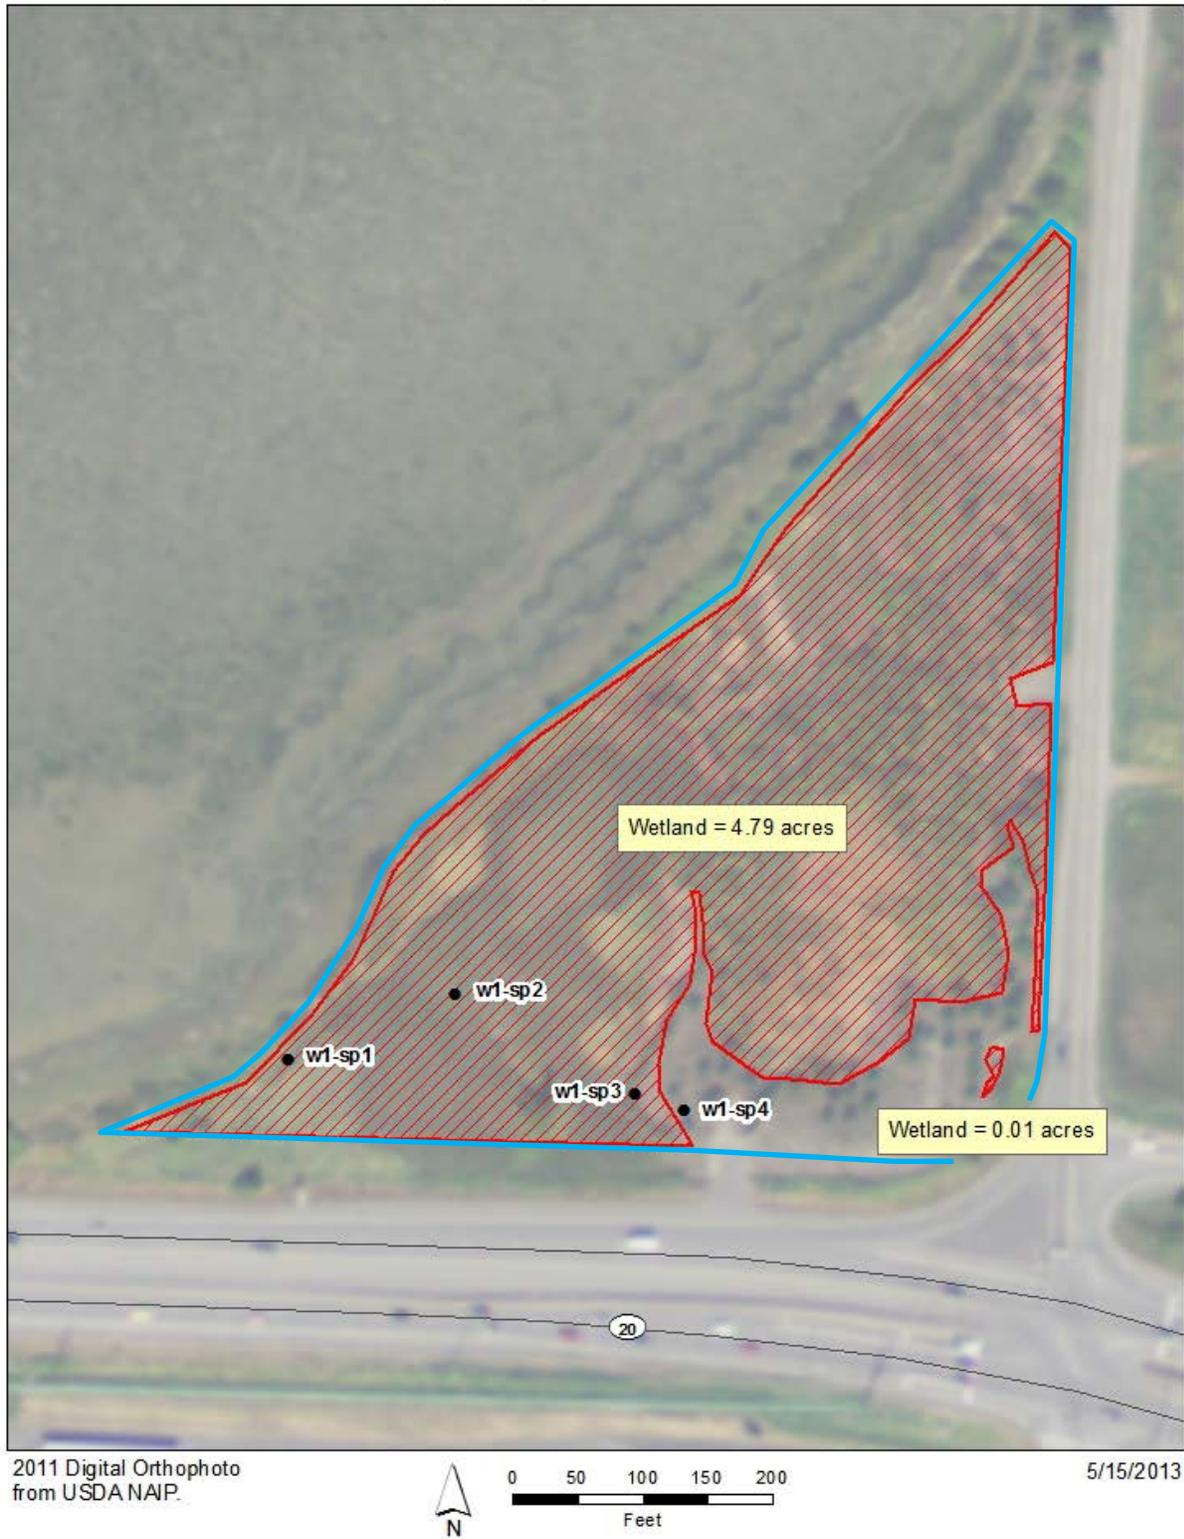
A Global Positioning System (GPS) Trimble GeoXT mapping grade unit was used to record the wetland boundaries and sampling point locations (Figure 2). Wetland boundary points were recorded at regular intervals and at any change in direction along the boundary.

Wetlands described in this report were assessed only within the wetland mitigation site boundary (Figure 2). Wetland preservation areas and wetland areas that are considered regulatory buffers are present within the mitigation site boundary and are included in this delineation.

**Figure 2. Study area in blue, wetland boundary in red, and sampling point locations in black.**
