**Interstate 90 Seismic Retrofit**  
WIN A09051N  
**NWP (25) 200300122**

**2010 MONITORING REPORT**

**Wetland Assessment and Monitoring Program**

# I-90 Seismic Retrofit Mitigation Site

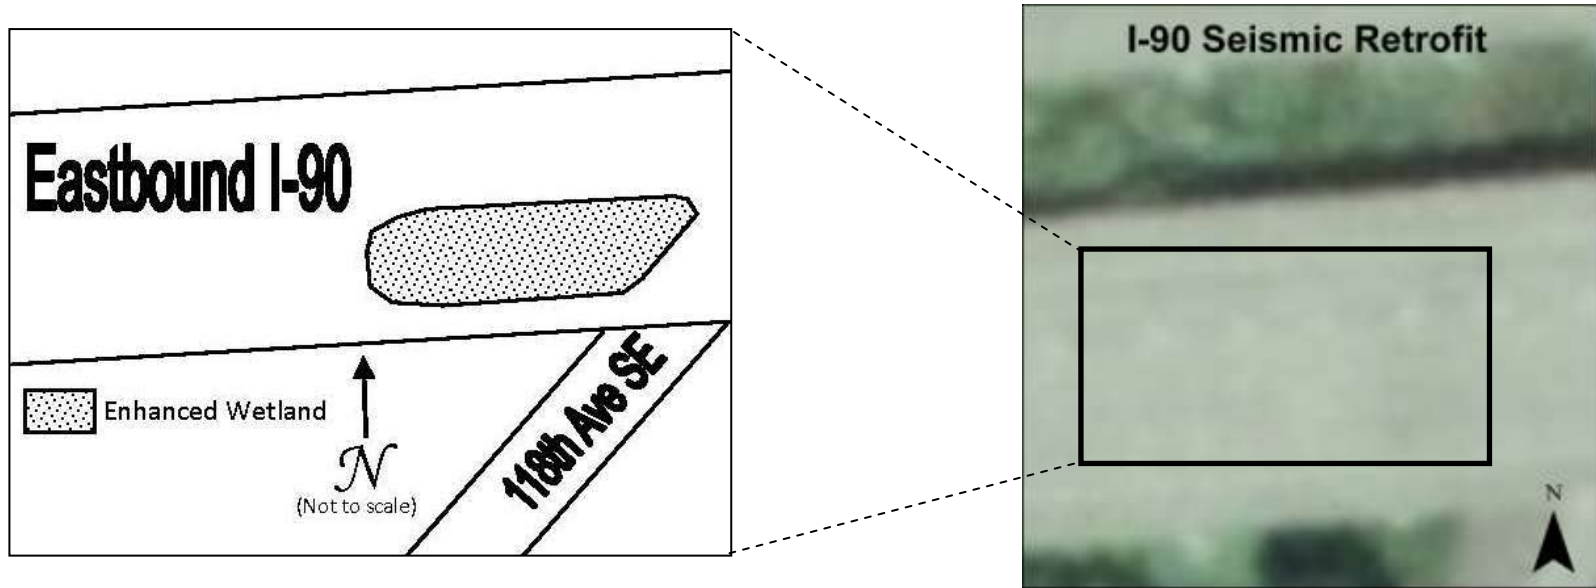
**Figure 1** Site Sketch

This 0.25-acre mitigation site (Figure 1) is located directly underneath I-90 and consists of a scrub-shrub planting area with an herbaceous understory of colonizing emergent vegetation. The purpose of the project was to reduce the potential for earthquake damage to the bridge by installing steel jackets around the bridge piers. Thirty-six of these piers were located in wetland areas.

The I-90 Seismic Retrofit Wetland Mitigation Site occupies a small area of a large wetland complex associated with Mercer Slough and Lake Washington. The site is underneath the westbound I-90 bridge and not visible in the low quality aerial photo.

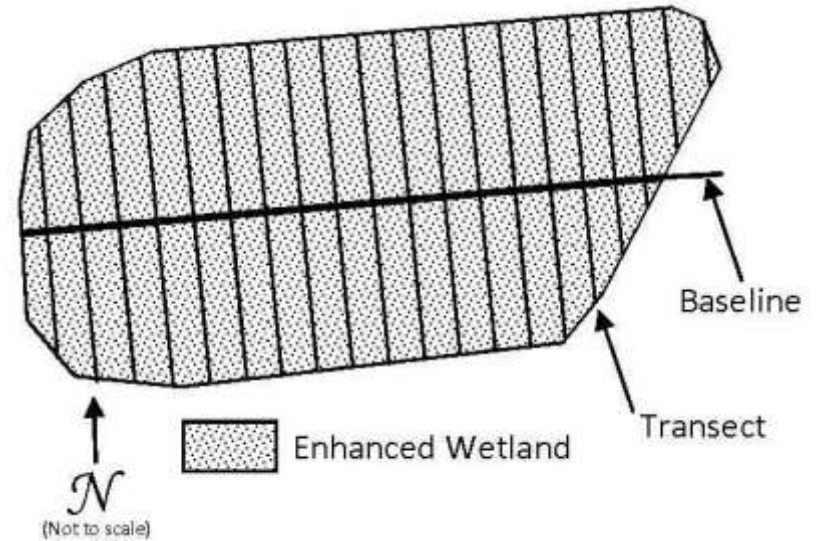
Figure 2 Site Sampling Design (2010)

To evaluate standards for vegetative cover, a baseline was established through the center of the site (Figure 2). Thirteen sampling transects were randomly placed perpendicular to the baseline using a restricted random sampling method. The point intercept method was used to determine native (Performance Standard 1) as well as invasive cover (Performance Standard 2). For both data sets, 13 randomly positioned 8-meter point-line sample units (32 points each) were placed along sampling transects across the site.

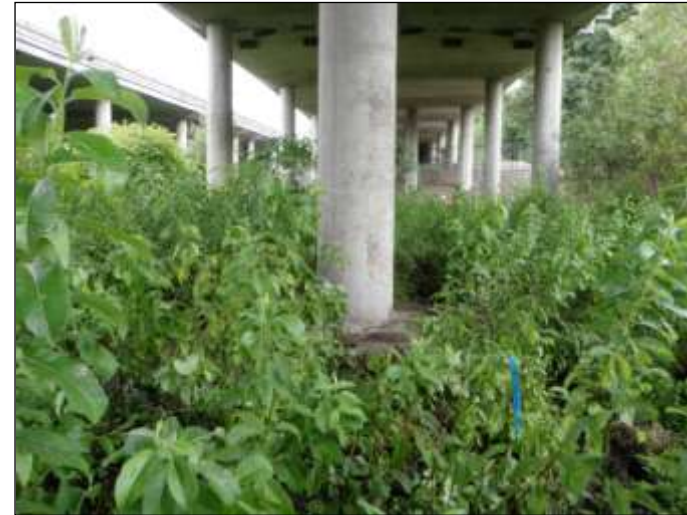
**Photo 1**  
**Native cover in the enhanced wetland (August 2010)**

Aerial cover of native species in the enhanced wetland is estimated to be 72% (CI<sub>90%</sub> = 58-87%) (Photo 1). This estimate exceeds the performance standard target. Dominant woody species observed included Sitka willow (*Salix sitchensis*), Pacific willow (*Salix lucida* ssp. *lasiandra*) and redosier dogwood (*Cornus sericea*). These plants are generally between 1.5 to 2 meters in height. Dominant native herbaceous plants observed included small-fruited bulrush (*Scirpus microcarpus*), soft rush (*Juncus effusus*), fringed willowherb (*Epilobium ciliatum*), and common ladyfern (*Athyrium filix-femina*).

The climbing non-native invasive species are well established in adjacent areas and will likely continue to present an ongoing challenge to control throughout this site. Weed control is planned through the 2011 growing season to minimize the competition and provide a better establishment period for the wood species recently planted. Weed control focusing on eradicating the remaining invasive species will continue in 2011.

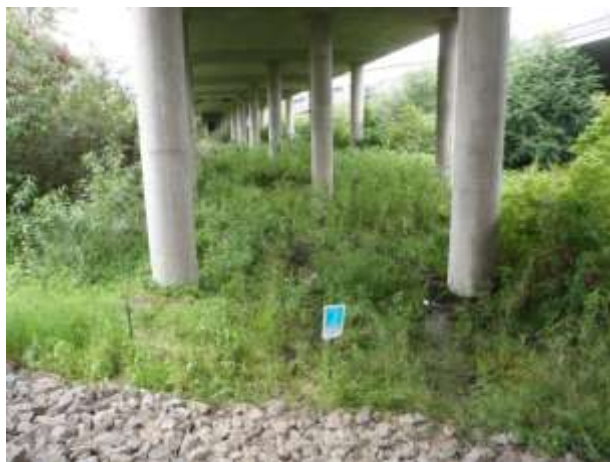
**Photo Point 1**

The photographs below were taken from permanent photo-points on August 10<sup>th</sup>, 2010 and document current site development.
