**DRAFT ENVIRONMENTAL IMPACT STATEMENT
SR 520 BRIDGE REPLACEMENT AND HOV PROGRAM**

SR 520 Pontoon Construction Project

Hazardous Materials Technical Memorandum

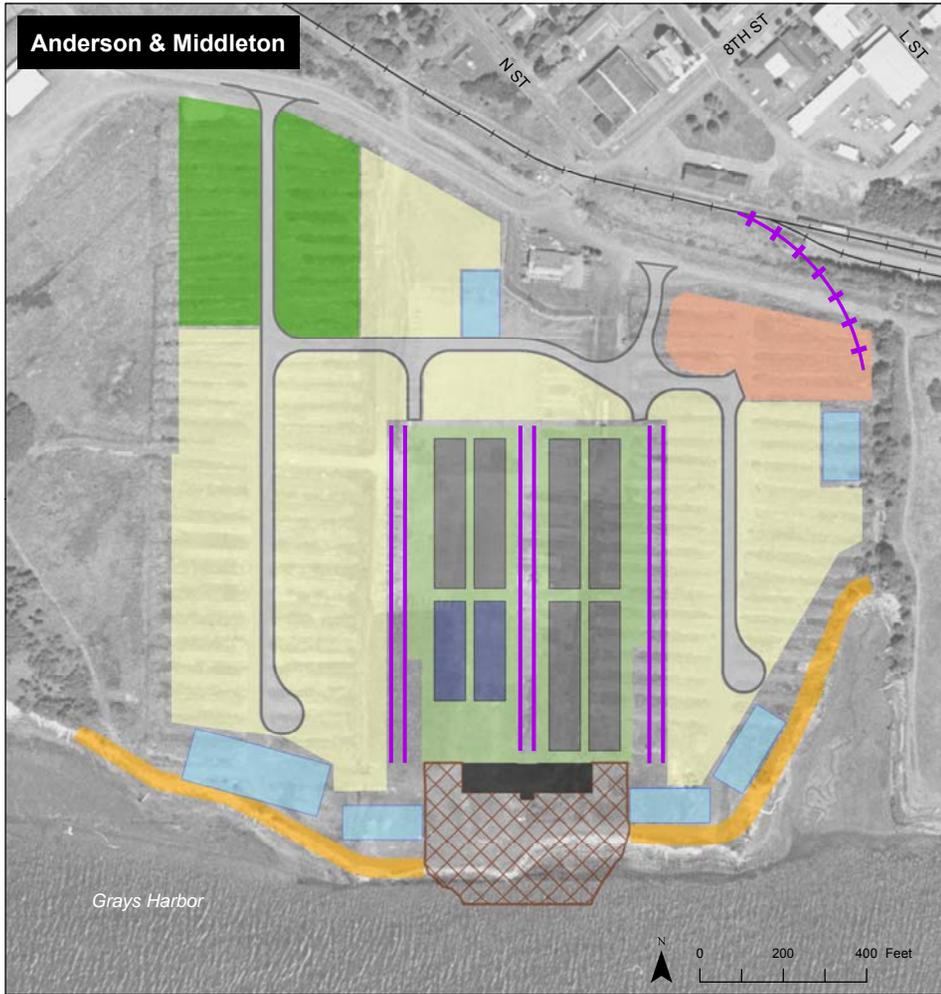
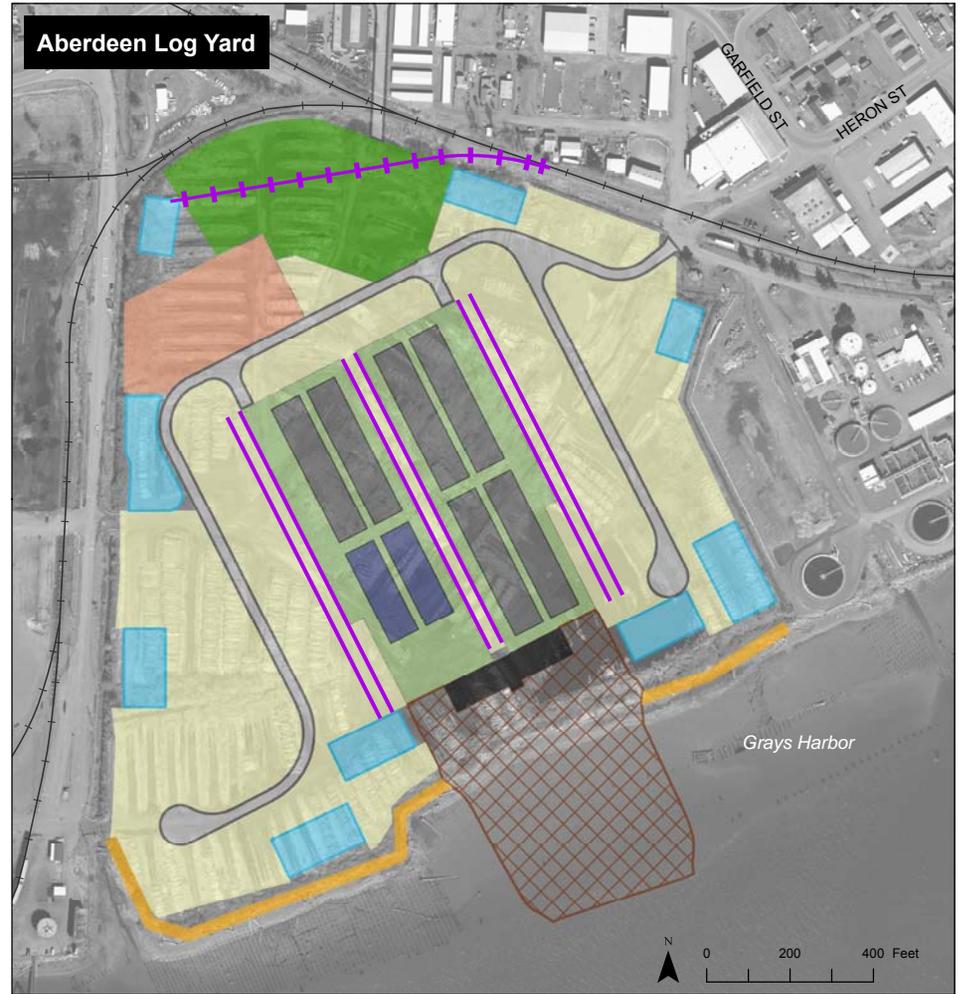
- Crane rail
- Proposed rail spur
- Existing railroad
- CTC facility limits
- Cross pontoon
- Longitudinal pontoon
- Water treatment area
- Access road
- Batch plant
- Berm
- Casting basin
- Dry storage and laydown area
- Gate
- Launch channel
- Office and parking

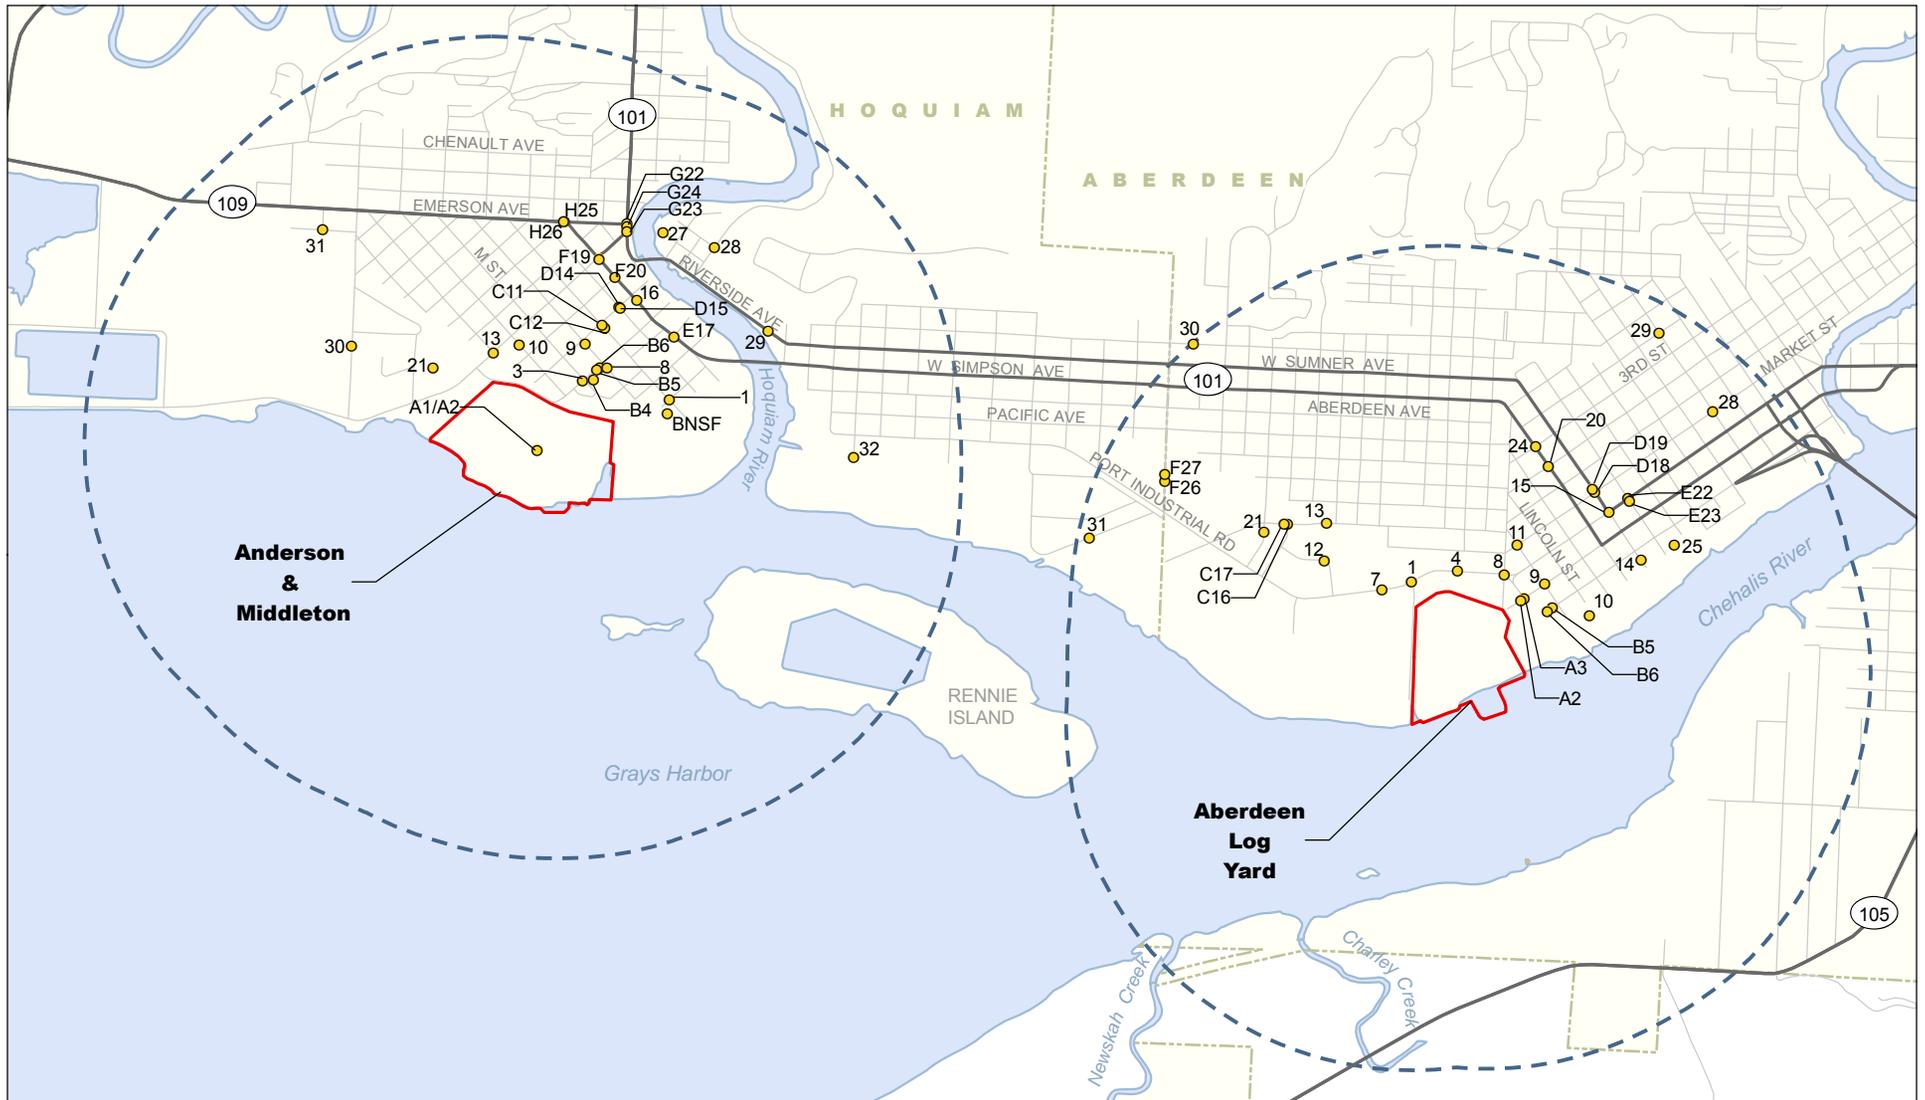
- Listed site in study area
- 1-mile buffer
- Build Alternative Site
- City limits

Methodology used to evaluate hazardous materials included reviewing local, state, and federal regulatory databases to identify potential contamination sources within 1 mile of the property centerline. Information on sites with known or suspected environmental concerns within the project vicinity was also obtained from Environmental Data Resources, Inc. (EDR), a commercial database service that searches EPA and Ecology databases. This 2008 EDR database search report is included as a compact disc in Attachment D.

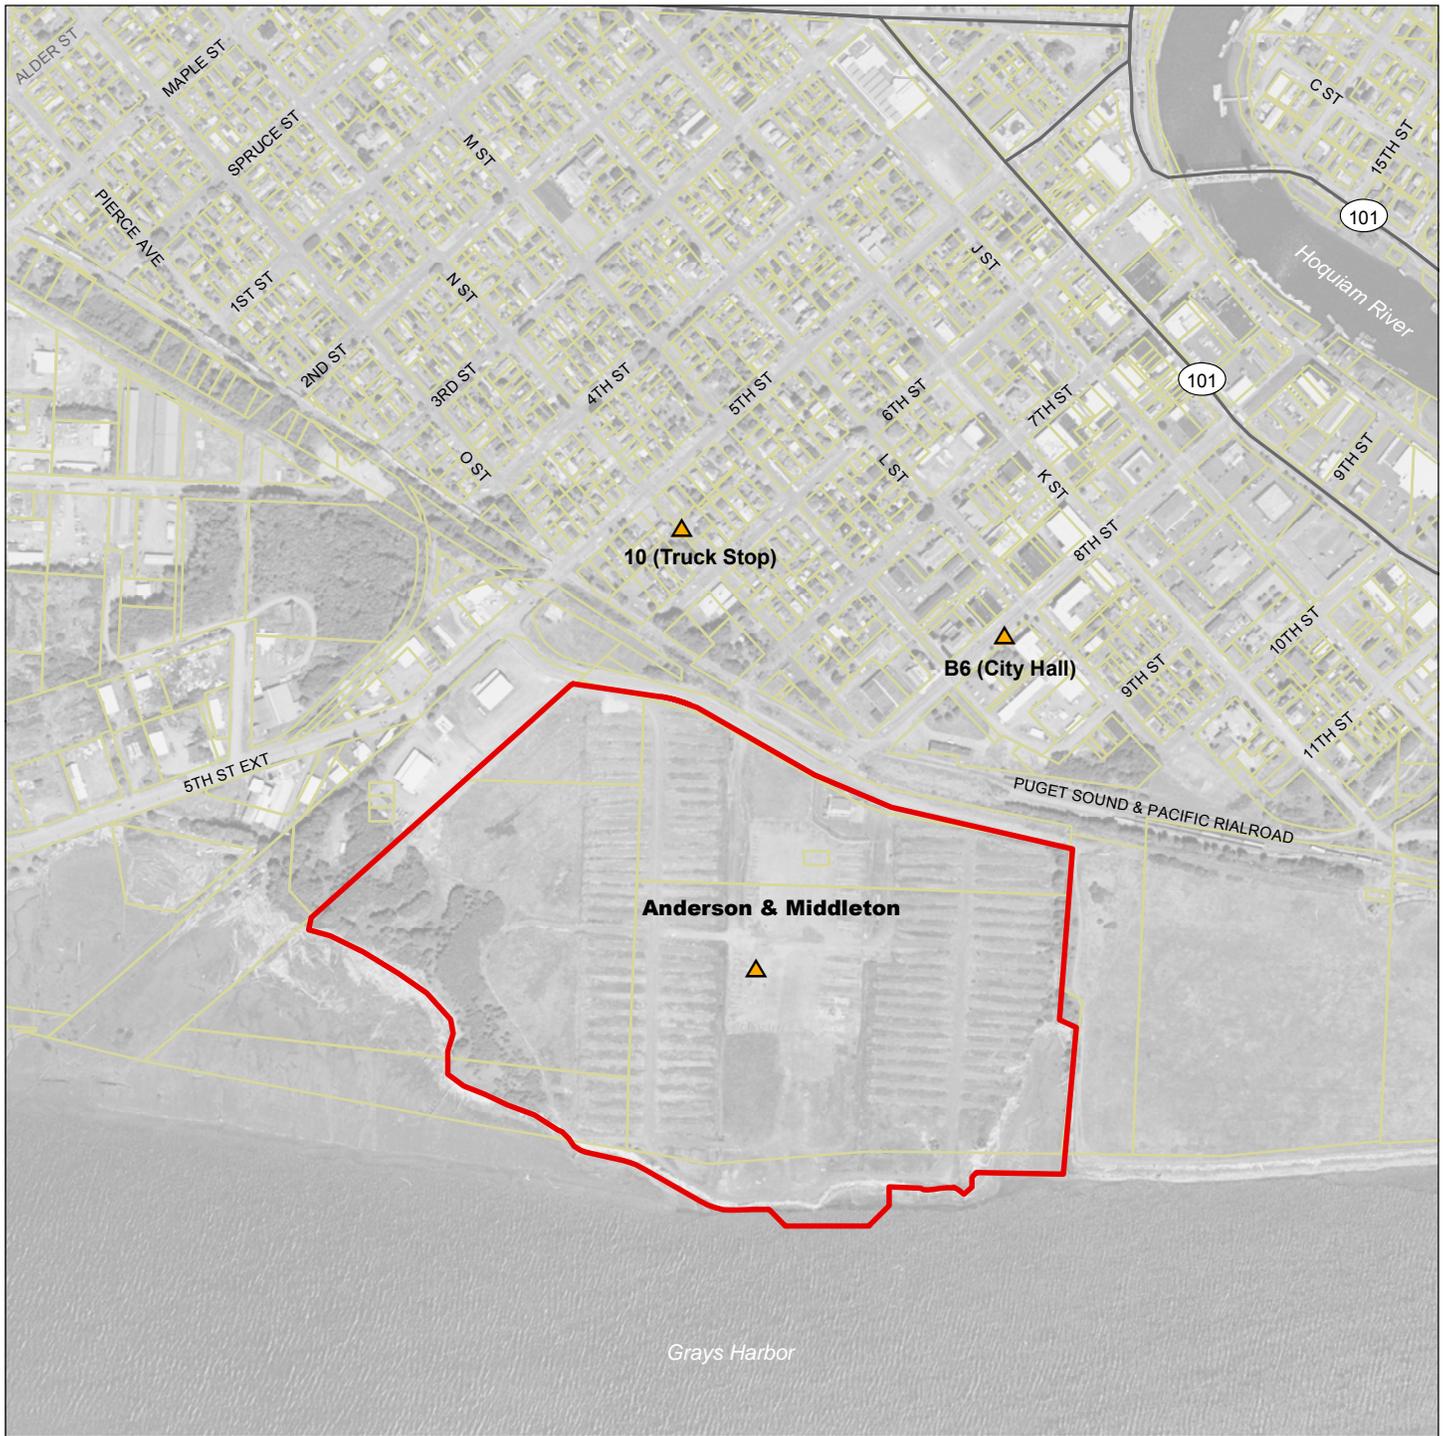
Sites with USTs Within One-Quarter Mile of the Anderson & Middleton Alternative Site

- ▲ Low- to moderate-impact site
- Build Alternative Site
- Parcel

Anderson & Middleton (Map ID-A1, A2). The address listed for Anderson & Middleton property is 815 Eighth Street. Reviews of previous reports and documents conducted as part of environmental site assessments indicated that due to past wood-burning activities and wood preservative use at or near the site, the potential exists for RECs at the site.

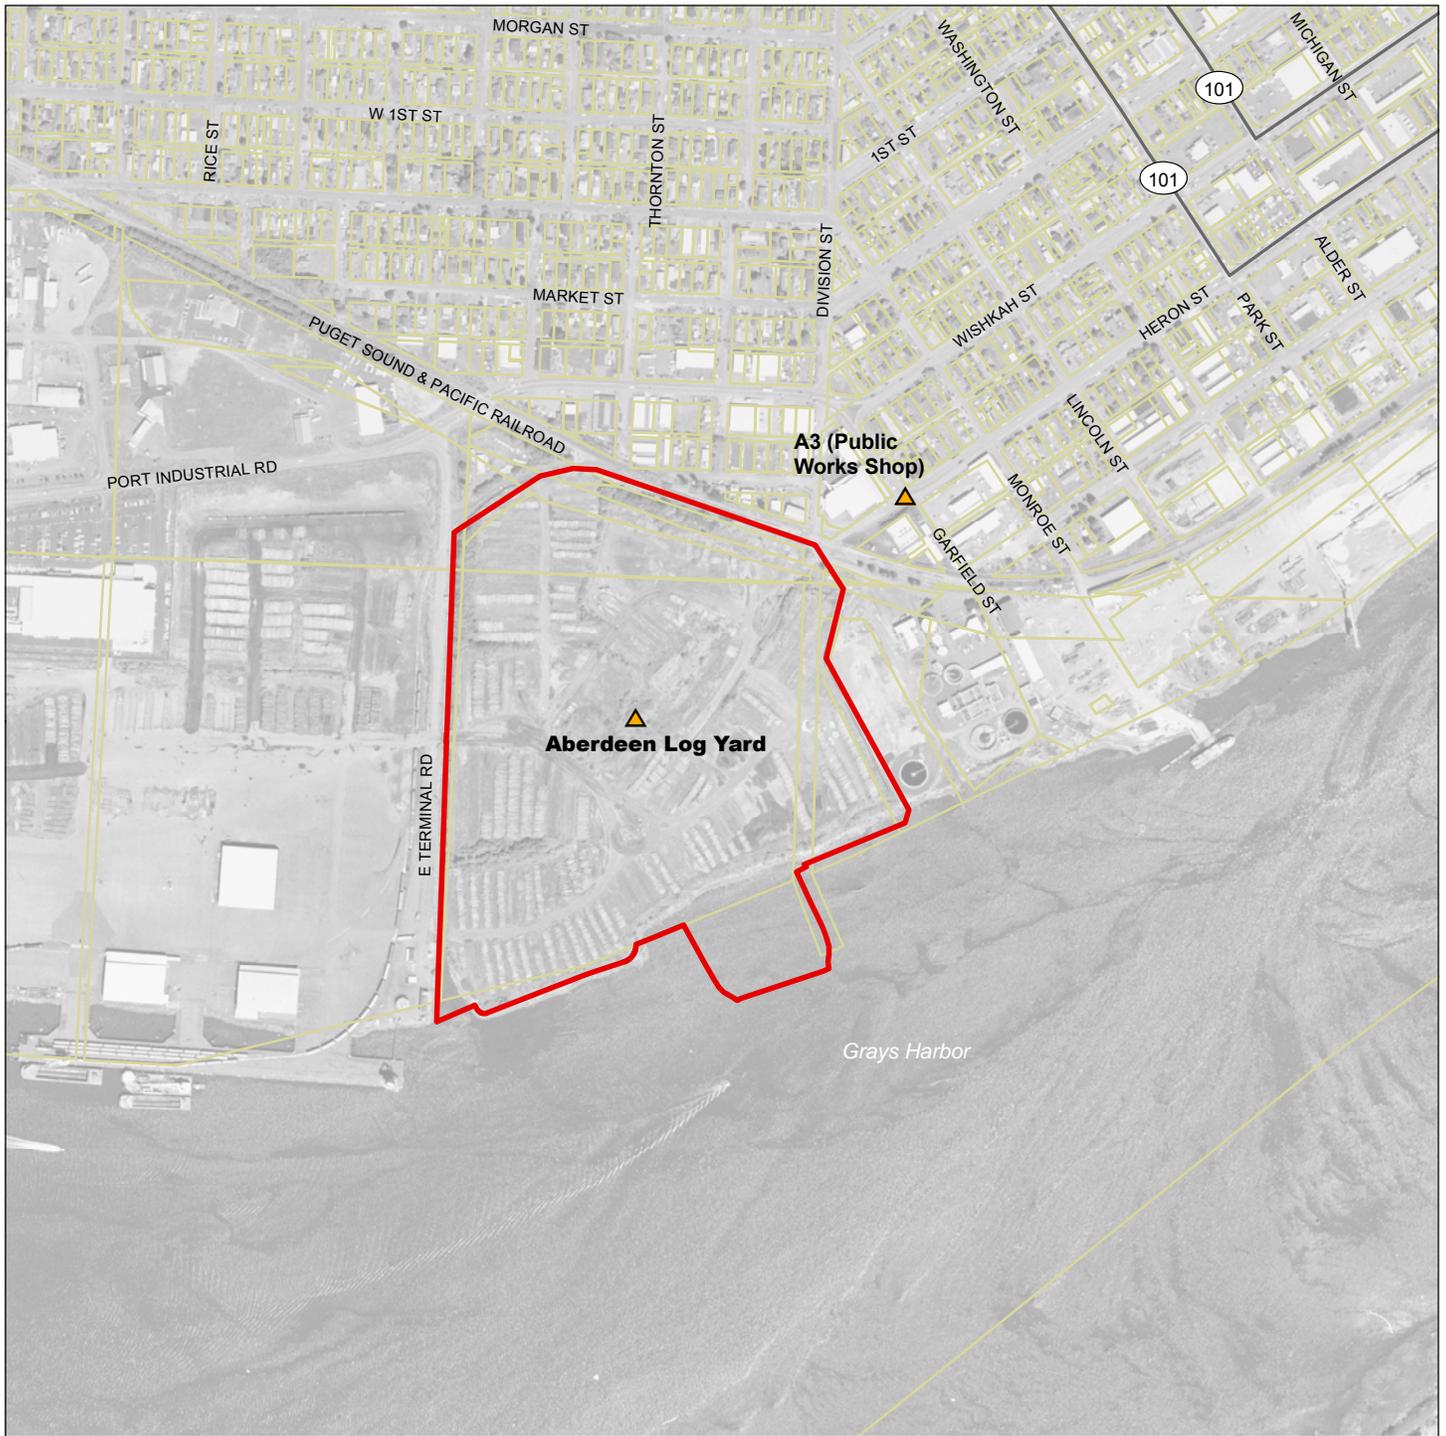
Sites with USTs within One-Quarter Mile of the Aberdeen Log Yard Alternative Site

- ▲ Low- to moderate-impact site
- Build Alternative Site
- Parcel
