I-5 – SR 161/SR 18 Triangle Improvements Project Stream (Corrington Streams) Mitigation Site

USACE NWP (23) NWS-2009-181

2015 MONITORING REPORT

Issued March 2016

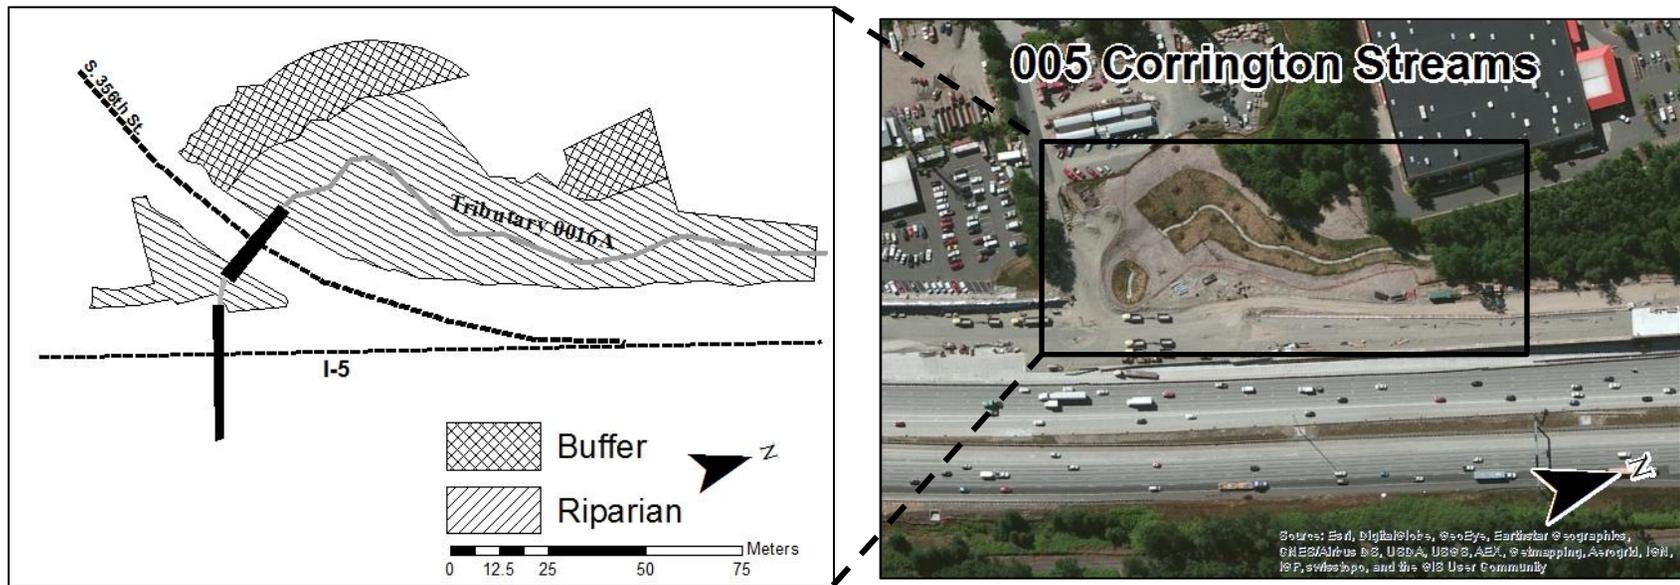
Figure 1 Site Sketch

The I-5 Corrington Streams Mitigation Site contains riparian and riparian buffer areas on the west side of I-5. Appendix 1 includes site directions.

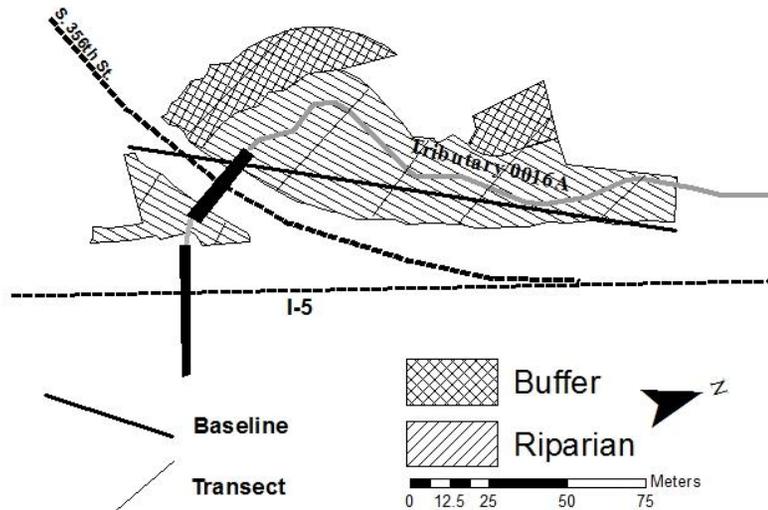
Figure 2 Site Sampling Design (2015)

Placement of Baseline: The baseline was placed parallel to I-5 on the decommissioned road.
Length 130m Transects 1-6

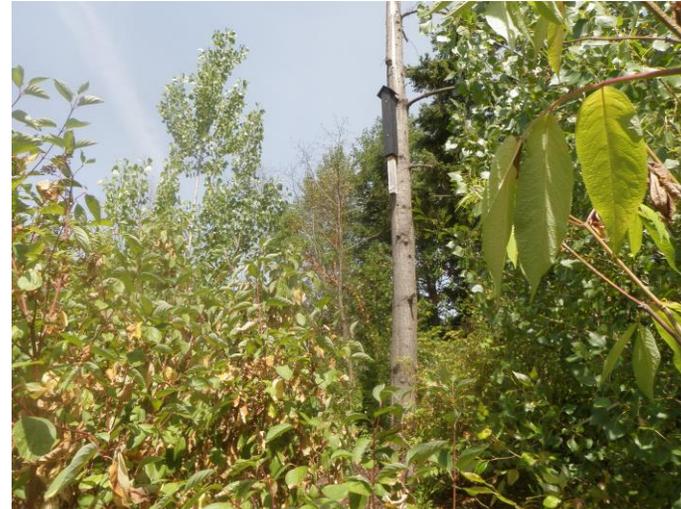
Photo 1
Habitat structure (July 2015)

All habitat features are present and installed according to plan. (Photo 1)

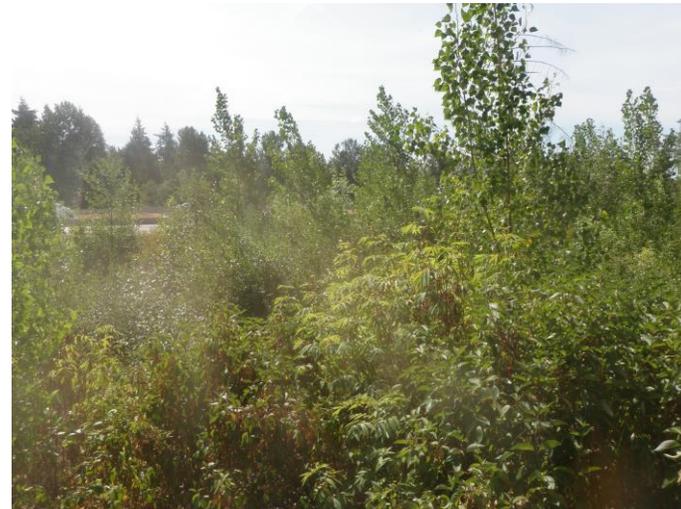
Photo 2
Density of native woody species in the riparian areas (July 2015)

Density of native, woody plant species across the site is estimated at 8.1 plants per 100 square feet (CI_{80%}= 6.8-9.4). This value exceeds the performance standard target. Dominant species include redosier dogwood (*Cornus alba*), Nootka rose (*Rosa nutkana*), western red cedar (*Thuja plicata*), salmonberry (*Rubus spectabilis*), and Pacific ninebark (*Physocarpus capitatus*). (Photo 2)

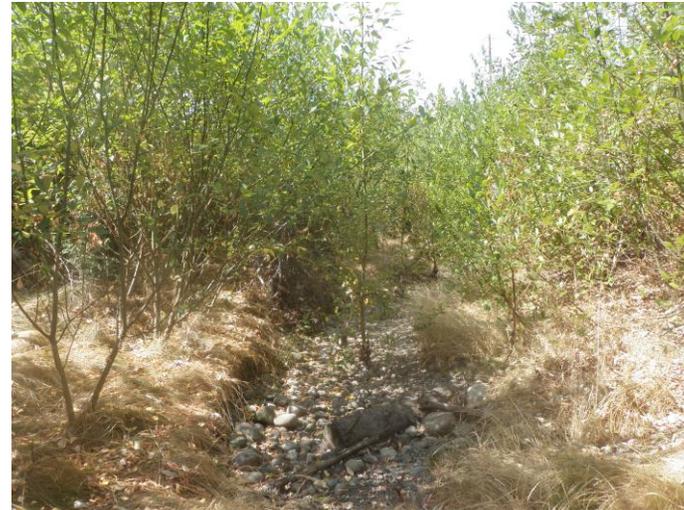
Photo 3
Survival in the riparian enhancement area (July 2015)

Survival in the riparian enhancement planting areas is high, with many volunteers. Qualitatively, there is estimated twice as many woody plants as what was planted. Density of native woody plants across the site is estimated at 8.1 plants per 100 square feet (CI_{80%}= 6.8-9.4). Dominant species include black cottonwood (*Populus balsamifera*) and redosier dogwood. (Photo 3)

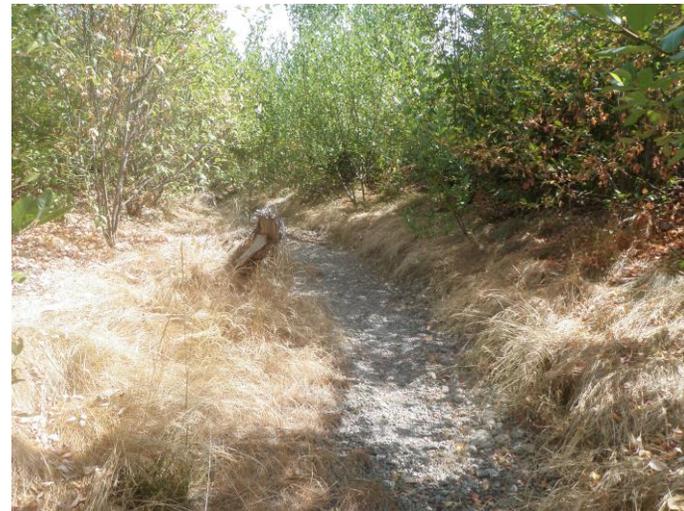
Photo 4
Dry stream channel (July 2015)

The stream was dry at the time of monitoring, although drift deposits were observed. In-stream structures are present and intact, and no signs of erosion were observed. (Photo 4)
