SR 539 Potter Road Mitigation Site

2010 MONITORING REPORT

Wetland Assessment and Monitoring Program

Issued March 2011

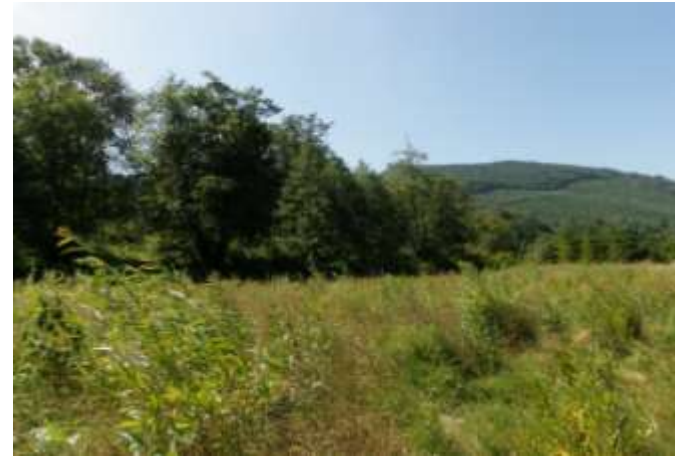
Photo 1
Woody cover in the wetland north of Olson's Slough (July 2010)

Survival of planted woody species in the wetland is 90 percent. Replanting occurred in January and February of 2011 achieving the performance standard (Photo 1). Black cottonwood (*Populus balsamifera* ssp. *trichocarpa*) stakes in the southern unit display a high rate of mortality and appear to be struggling. Garden vetch (*Vicia sativa*) is engulfing a number of the plantings and may pose a threat to woody species establishment. It was also noted that within the northern unit Sitka spruce (*Picea sitchensis*) and western red cedar (*Thuja plicata*) appeared stressed.

Infill live stake replanting occurred in January and February 2011 in the wetland area south of the channel. Mulching efforts are planned and have partially occurred in the buffers areas. Ongoing weed control is planned throughout the 2011 growing season. Additional replanting efforts are planned for fall of 2011.

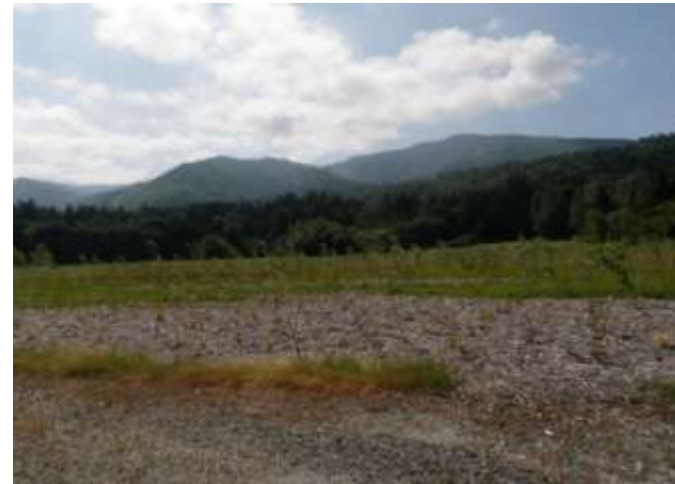
Photo 2
Woody cover in the buffer south of Olson's Slough (July 2010)

Survival of planted woody species in the buffer is 95 percent (Photo 2). If all dead woody plantings are replaced, the performance standard will be met. It should be noted that the plantings in the southern unit do not coincide with those listed on the planting plans. Pacific willow (*Salix lucida* ssp. *lasiandra*), one of the dominant species in the buffer, is not listed in the planting plans. Beaked hazelnut (*Corylus cornuta*) and red elderberry (*Sambucus racemosa*) appear to be completely absent from the buffer in the southern section. The planted woody species in the northern unit appear to be in direct competition with a dense herbaceous layer. Treatment and mulching around the plantings may reduce water and nutrient competition and benefit tree and shrub establishment. Limited numbers of western hemlock (*Tsuga heterophylla*) were observed and those that were present appear stressed.
