RE: SR 167 North Sumner Interchange Wetland Mitigation Site
Department of Ecology Water Quality Certification #1998-4-00422

The Washington State Department of Transportation completed qualitative monitoring of the SR 167 North Sumner mitigation site on July 15, 2014, to address Year-10 (2015) performance standards. Monitoring activities included vegetation observations and photo documentation. This Year-9 report is being issued for compliance with the reporting requirements of the Department of Ecology Water Quality Certification #1998-4-00422.

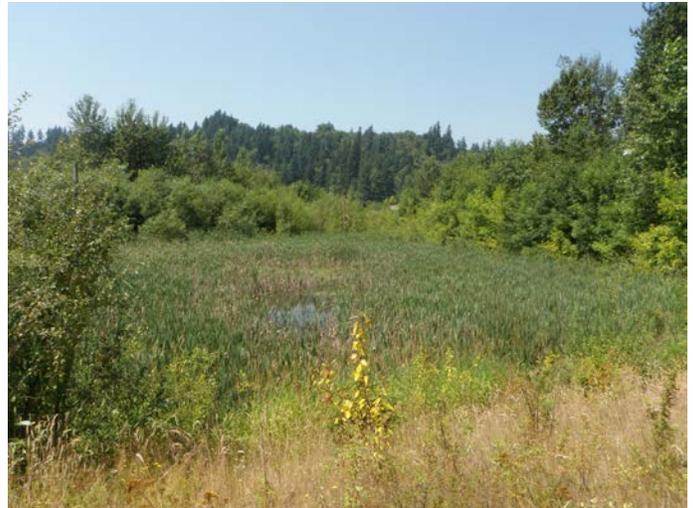
Photo 1 – Cover in the emergent wetland
(July 2014)

Cover is visually estimated at 65 percent. This value is below the performance standard target. This community appears to have stable cover and has not significantly increased since the last year. Broadleaf cattail (*Typha latifolia*) is the dominant emergent species in this zone (Photo 1).

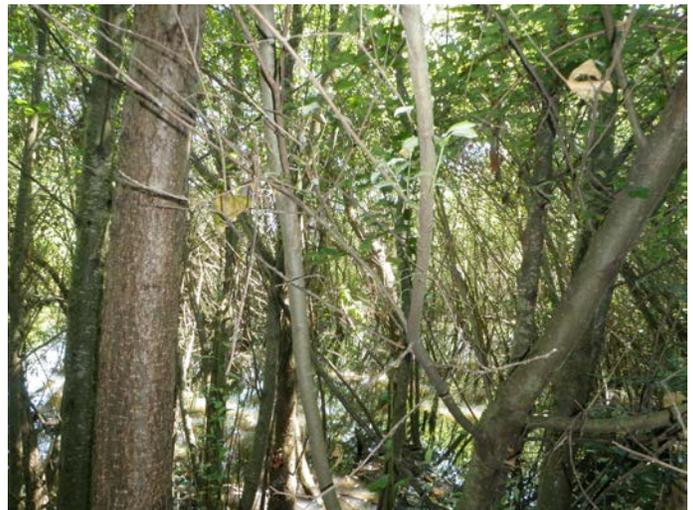
Photo 2 – Cover in the forested wetland
(July 2014)

Total cover for the forested wetland and scrub-shrub wetland is visually estimated at 100 percent and 90 percent respectively (Photo 2). This exceeds the performance standard target. Dominant trees that are likely providing at least five percent cover each include: Oregon ash (*Fraxinus latifolia*), black cottonwood (*Populus balsamifera*), western red cedar (*Thuja plicata*), Sitka spruce (*Picea sitchensis*), and red alder (*Alnus rubra*). Dominate shrubs that are likely providing at least 10 percent cover each include: Pacific willow (*Salix lasiandra*), Sitka willow (*Salix sitchensis*), Scouler's willow (*Salix scouleriana*), and redosier dogwood (*Cornus alba*).

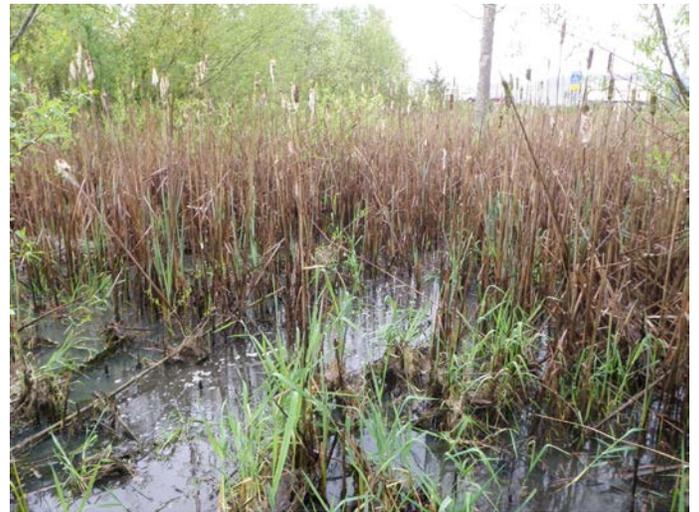
Photo 3 – Inundation (April 2014)

The site showed hydrology within the top 12 inches of the soil surface or inundation on all three visits on March 12 and 26, and April 17, 2014 (Photo 3).

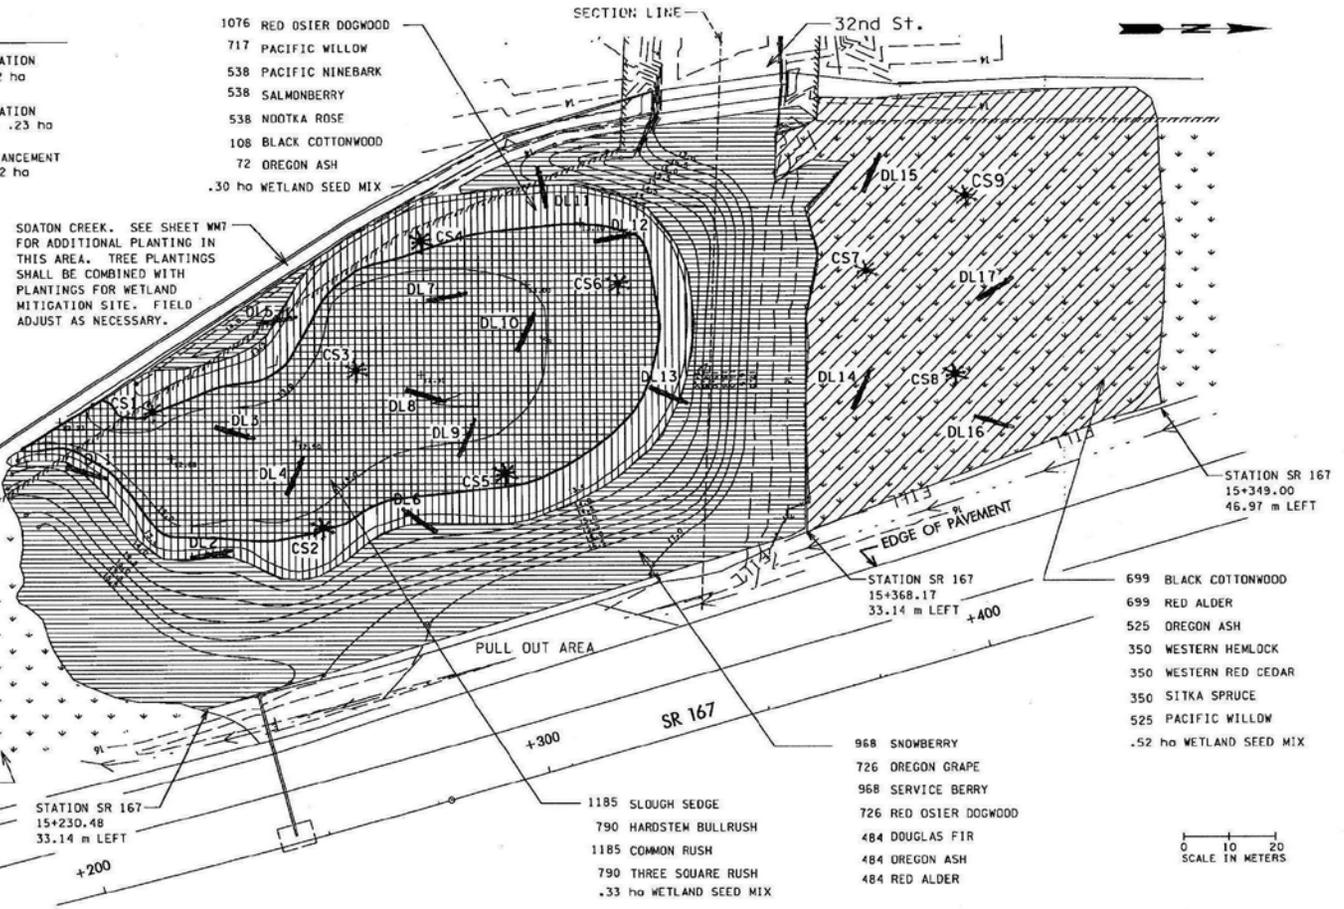
PLANTING PLAN

SECTION 14 AND SECTION 12, T 20N R 4E
 Planting Zones Were Field Adjusted Based on Actual Water Regime

AS BUILT

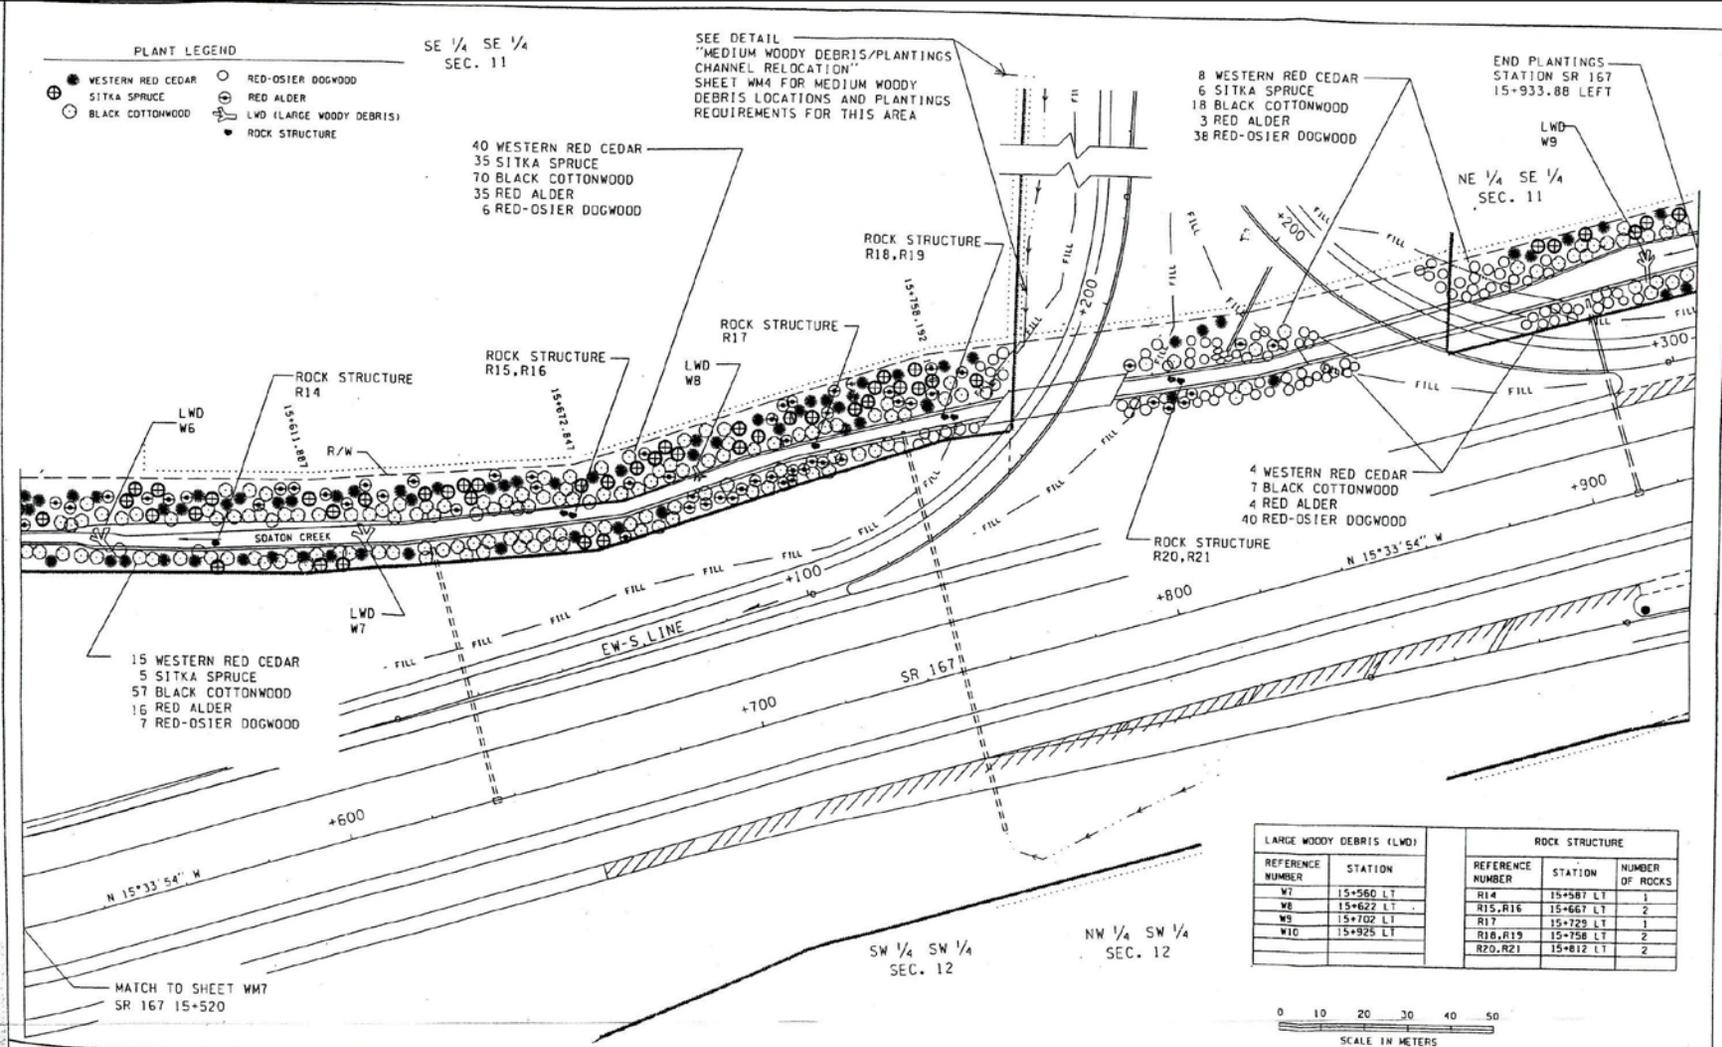
SR 167
 NORTH SUMMER I/C
 SOATON CREEK PLANTING PLAN
 WMB
 SHEET 13

LARGE WOODY DEBRIS (LWD)		ROCK STRUCTURE		
REFERENCE NUMBER	STATION	REFERENCE NUMBER	STATION	NUMBER OF ROCKS
W7	15+560 LT	R14	15+587 LT	1
W8	15+622 LT	R15, R16	15+667 LT	2
W9	15+702 LT	R17	15+729 LT	1
W10	15+925 LT	R18, R19	15+758 LT	2
		R20, R21	15+812 LT	2
