RE: Interstate 5 Everett HOV, SR 526 to SR 2 Vicinity Mitigation Site

HPA Control Number 100266-1

The Washington State Department of Transportation completed qualitative monitoring of the Interstate 5 Everett HOV, SR 526 to SR 2 Vicinity mitigation site on August 24, 2010 to address Year-3 (2011) performance standards. Monitoring activities included an assessment of wetland hydrology, vegetation observations, and photo documentation. HPA Control 100266-1 was addressed quantitatively, a total count of live stems was compared to the total number of alive and dead stems combined. This Year-2 report is being issued for compliance with the reporting requirements of the HPA Control 100266-1 and as an update with the USACE permit 200401448.

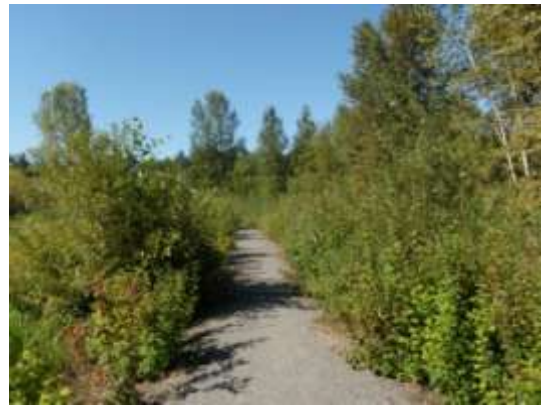
Photo 1 – Woody density in the buffer (August 2010)

The density of native woody species in the buffer is qualitatively estimated at 9 plants per 100 square feet. This greatly exceeds the performance standard for Year-3 (Photo 1). The buffer is composed of a diverse community with snowberry (*Symphoricarpos albus*) and red flower currant (*Ribes sanguineum*), as the dominant species.
