I-405, NE 8TH STREET TO SR 520 IMPROVEMENT PROJECT
VISUAL QUALITY TECHNICAL MEMORANDUM

Appendix C:
Visual Quality Assessment Matrices

Appendix D: Wall Treatments

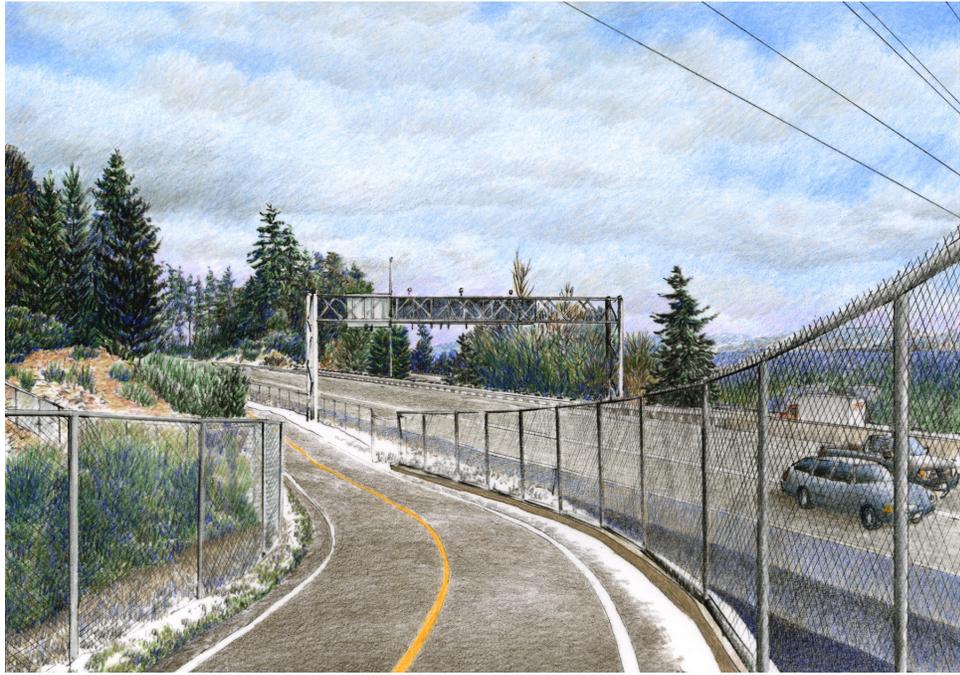
Exhibit B-17: Representative View T3: SR 520 Trail facing southeast (existing)

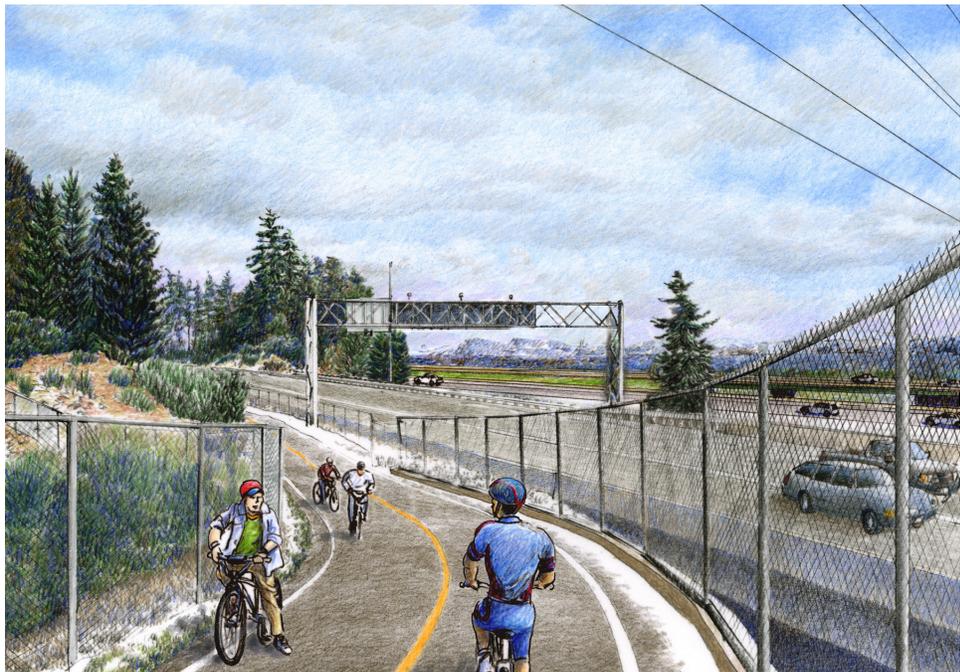
Exhibit B-18: Representative View T3: SR 520 Trail facing southeast (proposed)

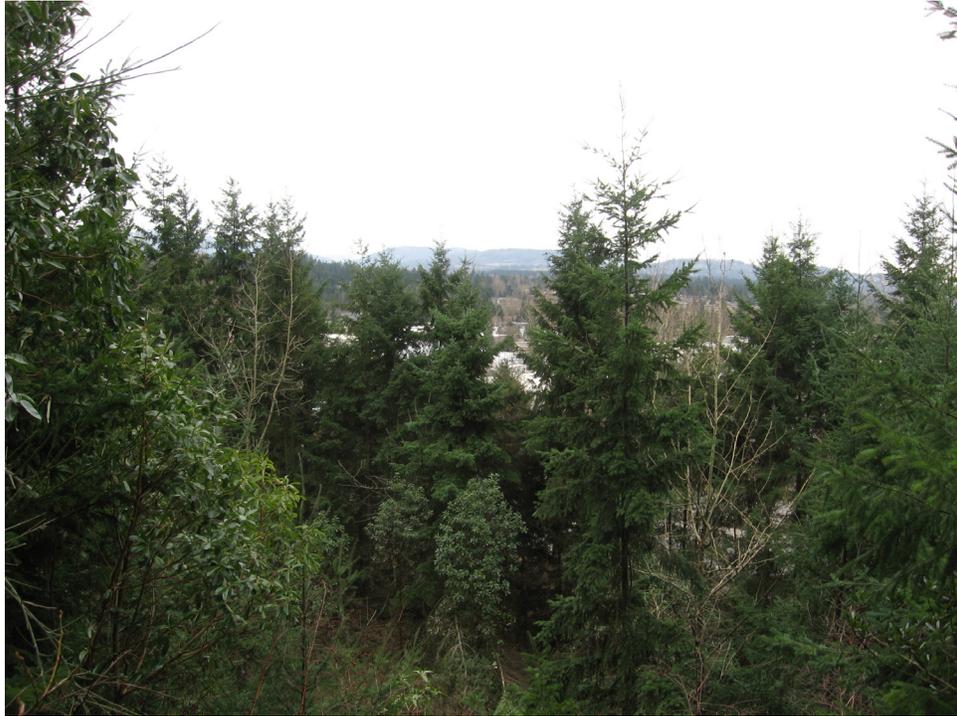
Exhibit B-19: Representative View T4: Viewpoint Park facing southeast (view toward SR 520) (existing and proposed)

Note: The proposed project will not be visible from the scenic viewpoint in Viewpoint Park. There will be no change to overall visual quality.

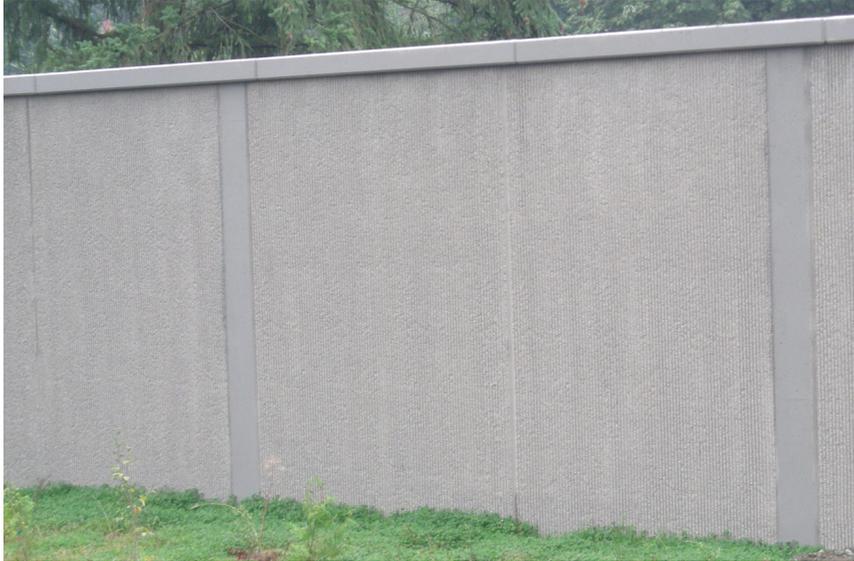
Exhibit D-1: Noise wall: I-405 corridor side

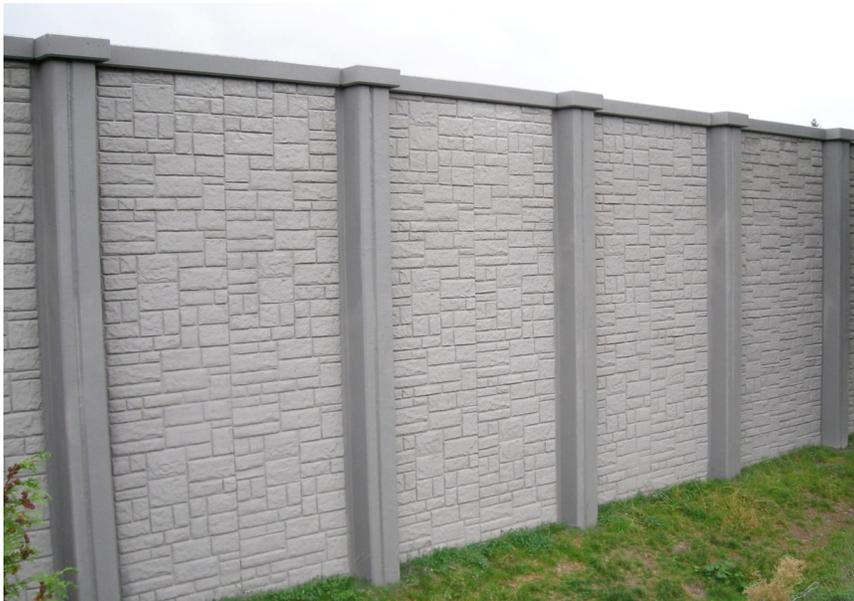
Exhibit D-2: Noise wall: I-405 community side

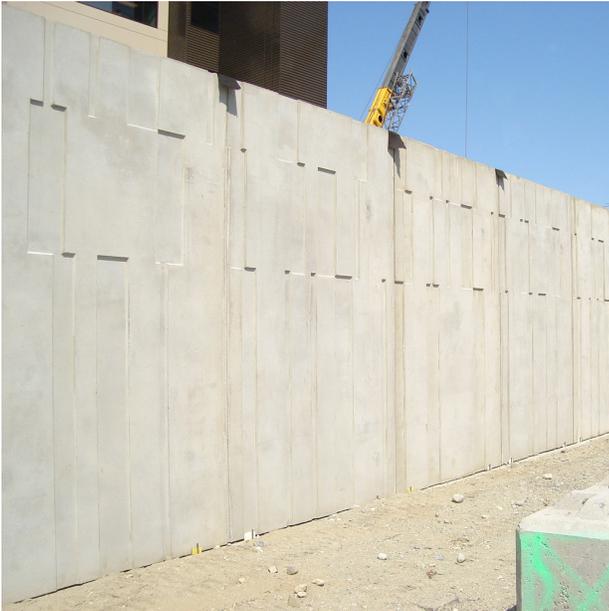
Exhibit D-3: Retaining wall: I-405 corridor side

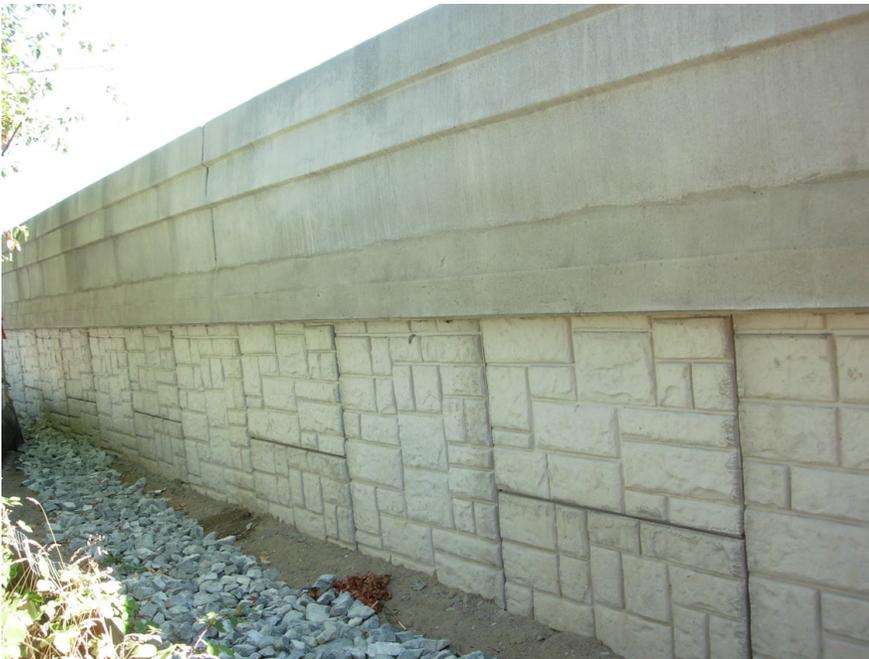
Exhibit D-4: Retaining wall: community side

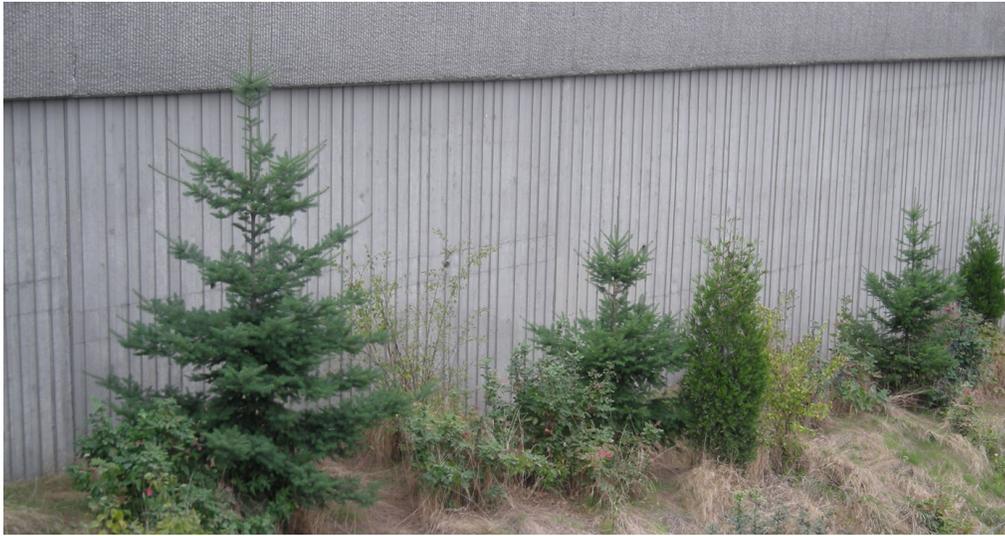
Exhibit D-5: Walls along SR 520
