**February 19, 2015**

**Weekly Update to Constituents: SR 305 Agate Pass Bridge**

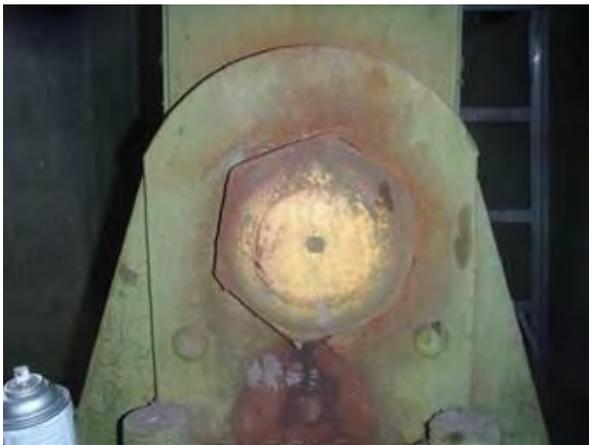
This photo shows an area of the bridge before the rust was removed.

Crews are now turning their attention to removing rust, in preparation for an in-depth bridge inspection. They use specialized air-powered tools that grind the rust away and contain it in a connected vacuum system. After the rust is removed, they apply a zinc coating that galvanizes (oxidizes), which then helps protect the underlying steel from future rust.

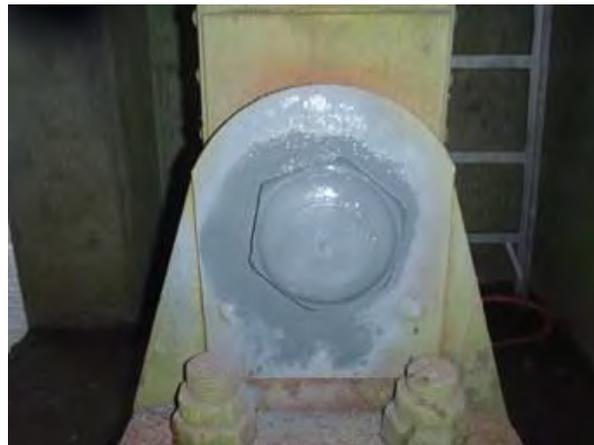
Following rust removal, crews treated the area with a zinc-based product to protect the underlying steel.
