SR 539 Potter Road Mitigation Site

2010 MONITORING REPORT

Wetland Assessment and Monitoring Program

Issued March 2011

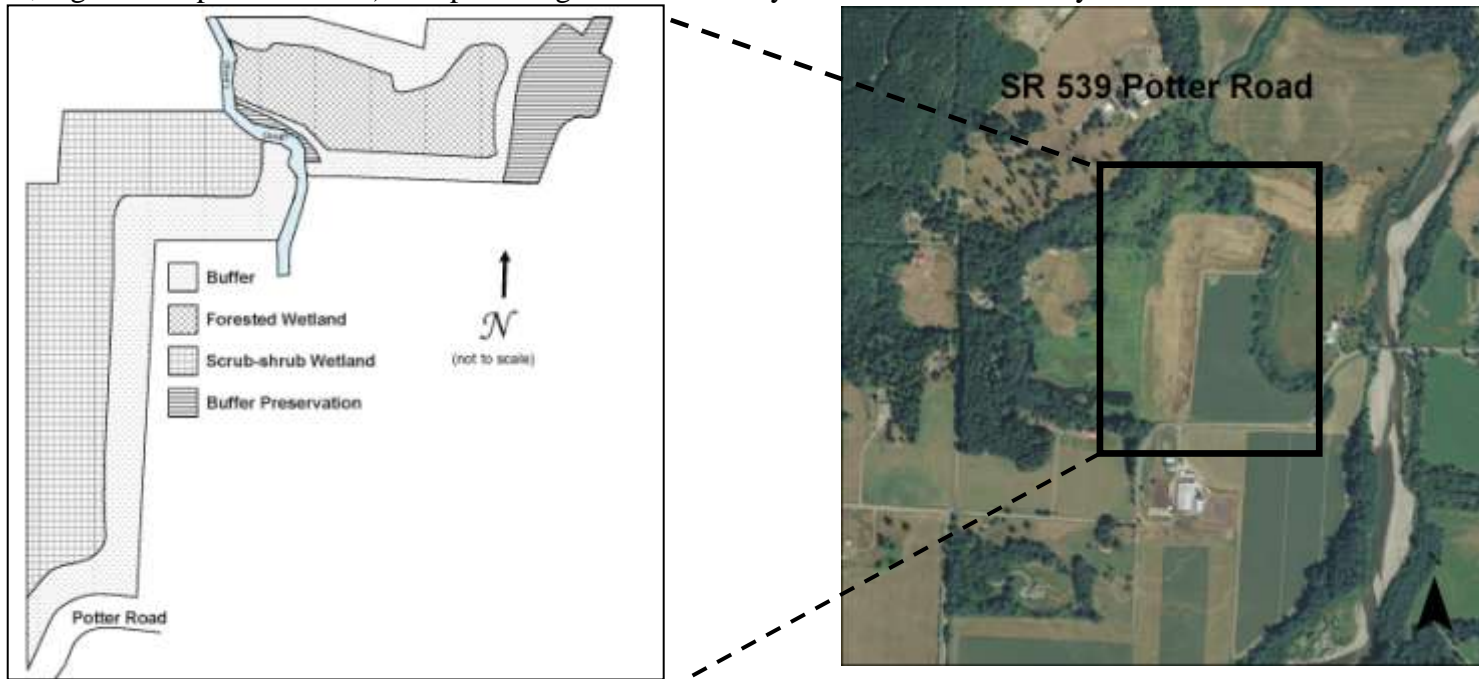
Figure 1 Site Sketch

The SR 539 Potter Road Mitigation Site consists of a scrub-shrub and forested wetland and upland buffer. The site is bisected by Olson's Slough, which drains to the South Fork of the Nooksack River.

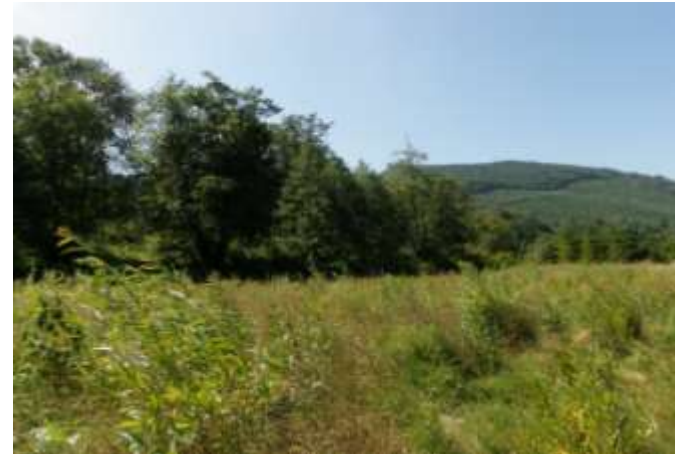
Photo 1
Woody cover in the wetland north of Olson's Slough (July 2010)

Survival of planted woody species in the wetland is 90 percent. Replanting occurred in January and February of 2011 achieving the performance standard (Photo 1). Black cottonwood (*Populus balsamifera* ssp. *trichocarpa*) stakes in the southern unit display a high rate of mortality and appear to be struggling. Garden vetch (*Vicia sativa*) is engulfing a number of the plantings and may pose a threat to woody species establishment. It was also noted that within the northern unit Sitka spruce (*Picea sitchensis*) and western red cedar (*Thuja plicata*) appeared stressed.

Infill live stake replanting occurred in January and February 2011 in the wetland area south of the channel. Mulching efforts are planned and have partially occurred in the buffers areas. Ongoing weed control is planned throughout the 2011 growing season. Additional replanting efforts are planned for fall of 2011.

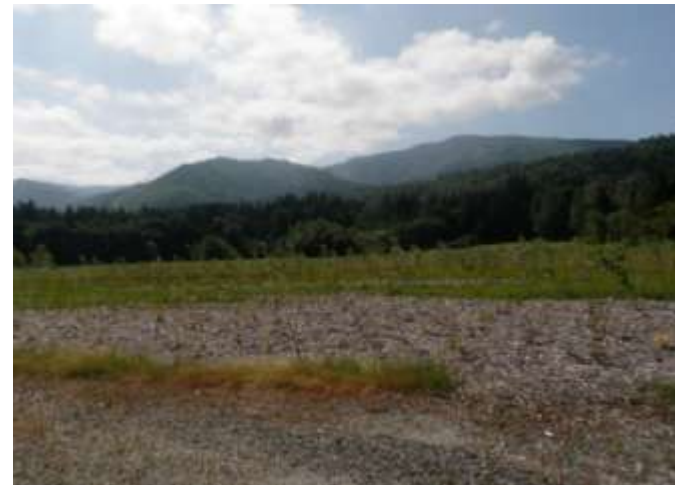
Photo 2
Woody cover in the buffer south of Olson's Slough (July 2010)

Survival of planted woody species in the buffer is 95 percent (Photo 2). If all dead woody plantings are replaced, the performance standard will be met. It should be noted that the plantings in the southern unit do not coincide with those listed on the planting plans. Pacific willow (*Salix lucida* ssp. *lasiandra*), one of the dominant species in the buffer, is not listed in the planting plans. Beaked hazelnut (*Corylus cornuta*) and red elderberry (*Sambucus racemosa*) appear to be completely absent from the buffer in the southern section. The planted woody species in the northern unit appear to be in direct competition with a dense herbaceous layer. Treatment and mulching around the plantings may reduce water and nutrient competition and benefit tree and shrub establishment. Limited numbers of western hemlock (*Tsuga heterophylla*) were observed and those that were present appear stressed.
