**I-405/I-5 to SR169 Stage 1 Widening Stream
(Renton Stage 1) Mitigation Site**

USACE NWP (23) 200600097

2010 MONITORING REPORT

Wetland Assessment and Monitoring Program

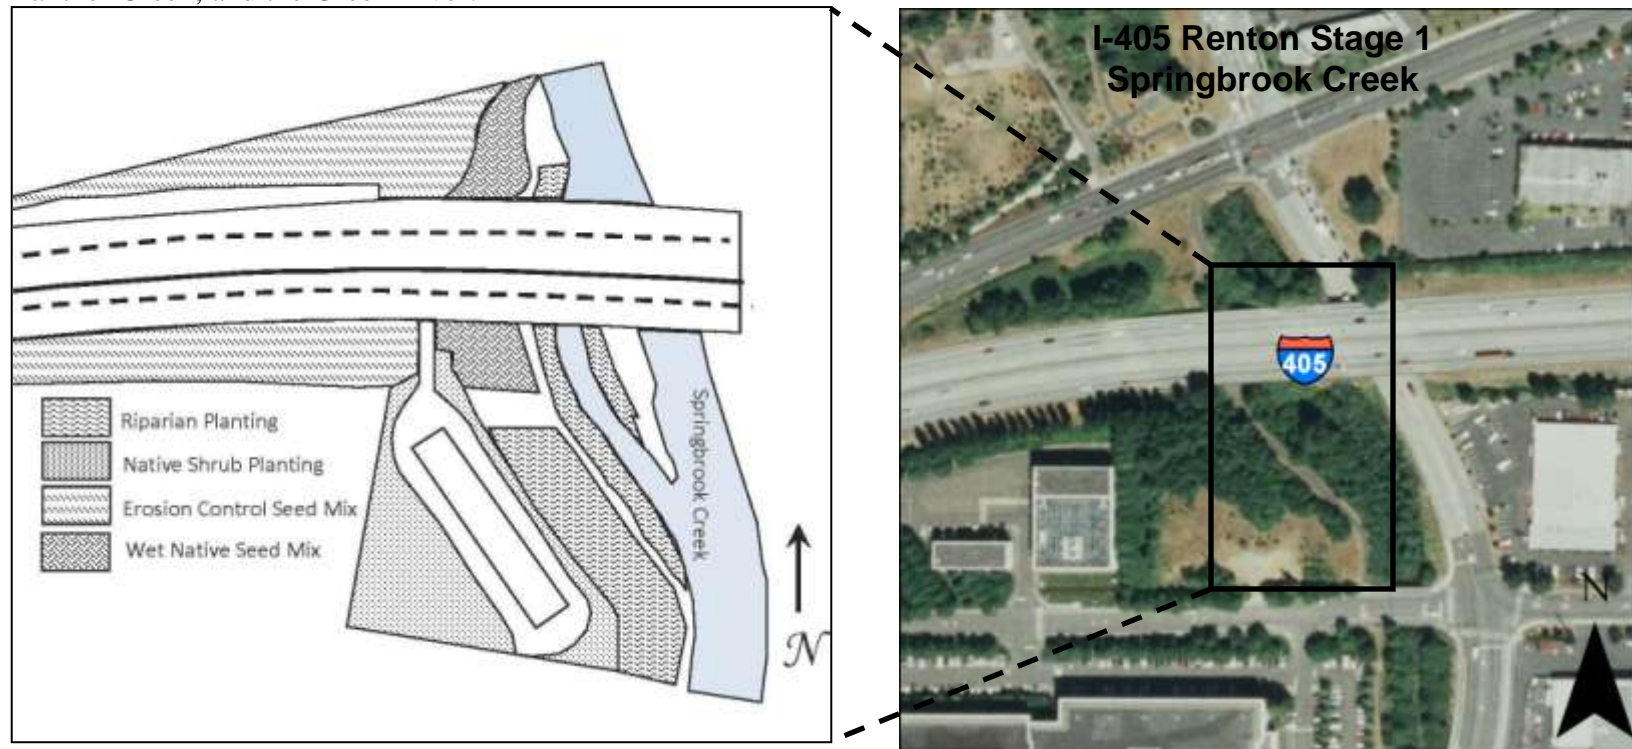
Figure 1 Site Sketch

This stream mitigation site, Springbrook Creek (Figure 1), will remove a box culvert creating natural stream bed of 160 linear feet and 9,000 square feet. This site was created to compensate for impacts to stream channel, shading, and stream buffer due to road improvements along I-405 and SR 167. The created side channel and enhanced riparian plantings are designed to provide habitat improvement opportunities of increased riparian diversity of trees and shrubs, create high quality pools in the side channel, increase potential for year-round off-channel rearing, and provide large woody debris revetment along the side channel. An additional 2.22 acres of urban forest riparian plantings and 0.59 acre of understory plantings are located on Gilliam Creek, West Panther Creek, and the Green River.

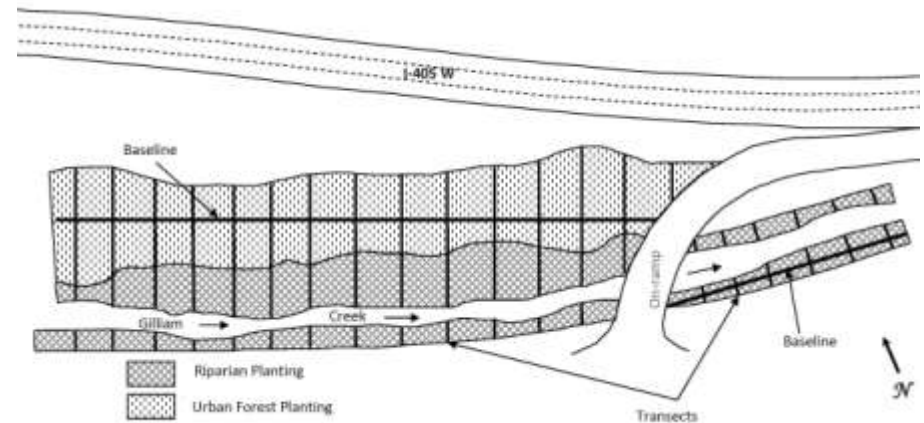
Figure 2 Site Sampling Design Gilliam Creek (2010)

To evaluate criteria for vegetative survival two separate methods were utilized. To evaluate survival at Springbrook Creek, West Panther Creek and the Green River a total count of live stems was compared to the total number of alive and dead stems combined (Performance Standard 1 and Permit Requirement 1). To evaluate survival at Gilliam Creek a 174-meter segmented baseline was placed on either side of the on-ramp to I-405 (Figure 2). Twenty-four 1-meter wide sampling transects were randomly placed perpendicular to the baseline. The unequal-area belt transect method was used to estimate survival of planted woody species (Permit Requirement 1). Qualitative aerial cover estimates for non-native, invasive species were completed at each of the four locations (Performance Standard 2, Permit Requirements 2 and 3). Photographs were taken to evaluate tree and shrub growth.

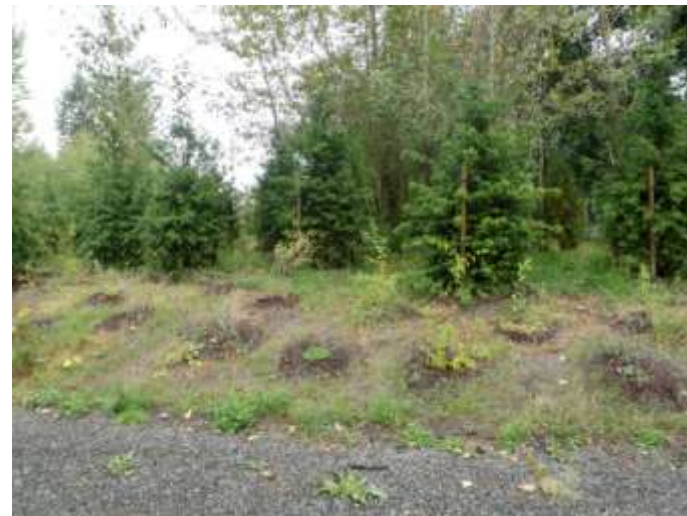
Survival of woody plantings at the Springbrook Creek planting area is 91 percent. The riparian plantings appear to be struggling and woody species establishment and growth in this zone has been slow. However, the plantings near the detention pond appear healthy and showed vigorous growth (Photo 1).

Photo 1 – Springbrook Creek woody cover near detention pond (July 2010)

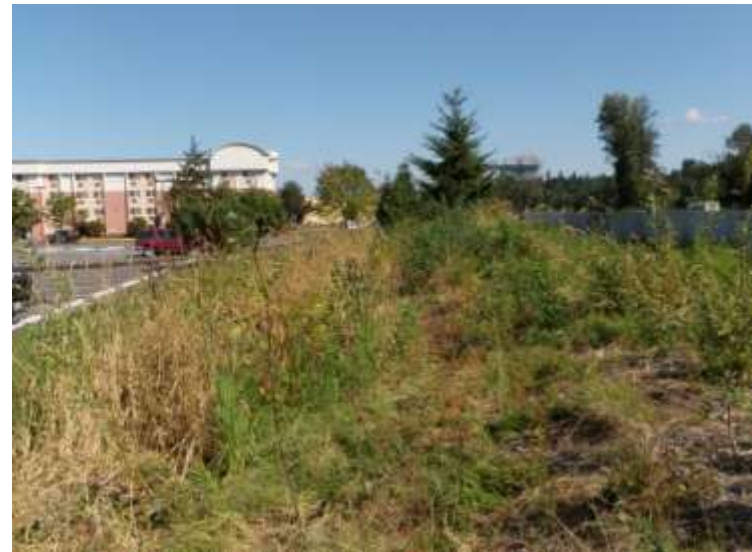
Aerial cover of Reed canarygrass, purple loosestrife, Scot's broom, and Japanese knotweed is qualitatively estimated at 30 percent. Treatment of reed canarygrass is recommended (Photo 2). Himalayan blackberry (*Rubus armeniacus*) and climbing nightshade (*Solanum dulcamara*), while not listed in the performance standard, are present on site.

Photo 2- Reed canarygrass (*Phalaris arundinacea*), at West Panther Creek (July 2010)

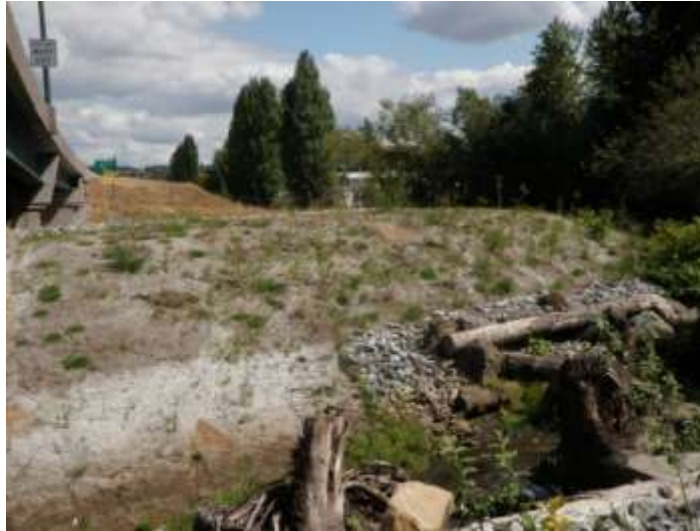
All bank logs and boulder clusters are present according to plan (Photo 3).

Photo 3-Bank logs in Springbrook Creek (July 2010)
