**RE: I-5 Scatter Creek and Maytown Safety Rest Areas
 USACE IP Number NWS-2007-284-SOD**

The Washington State Department of Transportation completed monitoring of the I-5 Scatter Cr and Maytown Safety Rest Areas site on September 7, 2010 to determine survival of planted species for compliance with the above-listed USACE IP.

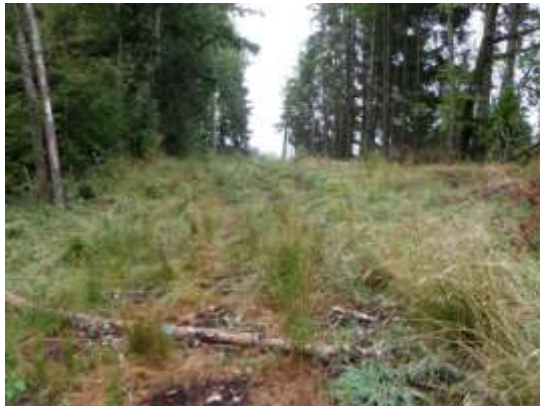
Photo Point 1

The photographs below were taken from permanent photo-points on September 5th, 2010 and document current site development.
