## Chapter Four

# *Affected Environment*

Final Environmental Impact Statement

**Vancouver Rail Project**

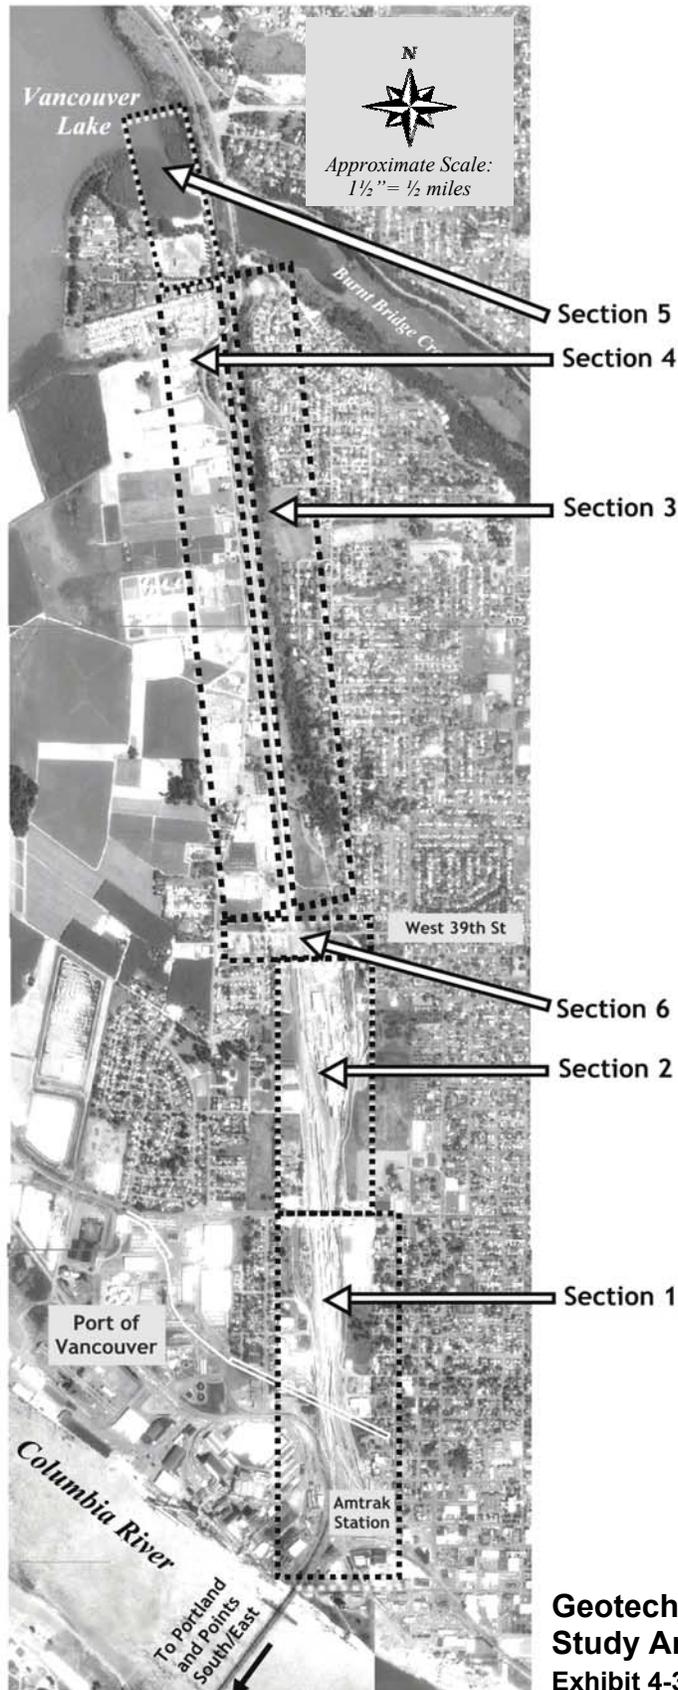
**Geotechnical Sections of Study Area**  
Exhibit 4-3

A range of geotechnical conditions exist in the study area. **Exhibit 4-3** identifies six general sections in the study area that have similar geotechnical conditions. The following discussion presents some general elements for each of these sections.<sup>8</sup>

**Section 1:** The seismic hazard rating for this section is rated as D – Least Relative Hazard. No other geologic hazards were identified over this section.

No indications of deep-seated slope instability and only minor evidence of previous slope failures were noted along this section. Major slope hazard is not anticipated based on the apparently satisfactory performance of the existing low cut slopes along the track.

The seismic hazard rating for this section is mapped as Zone B with lesser portions of Zone A – Greatest Relative Hazard. No other geologic hazards were identified over this section.

**Section 4:** Geological hazards over this section relate mainly to seismic hazard, and are mapped as Zone A – Greatest Relative Hazard.

Further hazards relate to the potential for settlement of sections of track where thick fill placement is required, resulting in consolidation of the underlying compressible alluvial soils. No other geologic hazards were identified over this section.

**Section 5:** Visual assessment of the area indicated that organic soils and soft sediments should be expected in this area. In addition, the seismic hazard rating for this section is mapped as Zone A – Greatest Relative Hazard. Therefore, the potential for lateral spreading or a flow slide in a major earthquake must be evaluated.

**Section 6:** Conditions vary from Columbia River alluvium in the lowlands on the west of the alignment, to terrace material on the more high-lying ground to the east. In addition, a thin fill layer covers the entire area.

The major geological hazards over this area relate to the compressibility of the underlying soils to support bridge foundations, and the stability of the foundation soils under a design level earthquake. In this regard, the seismic hazard rating for this section is mapped as Zone A – Greatest Relative Hazard. Therefore, the potential for liquefaction of the foundation soils is a significant hazard.

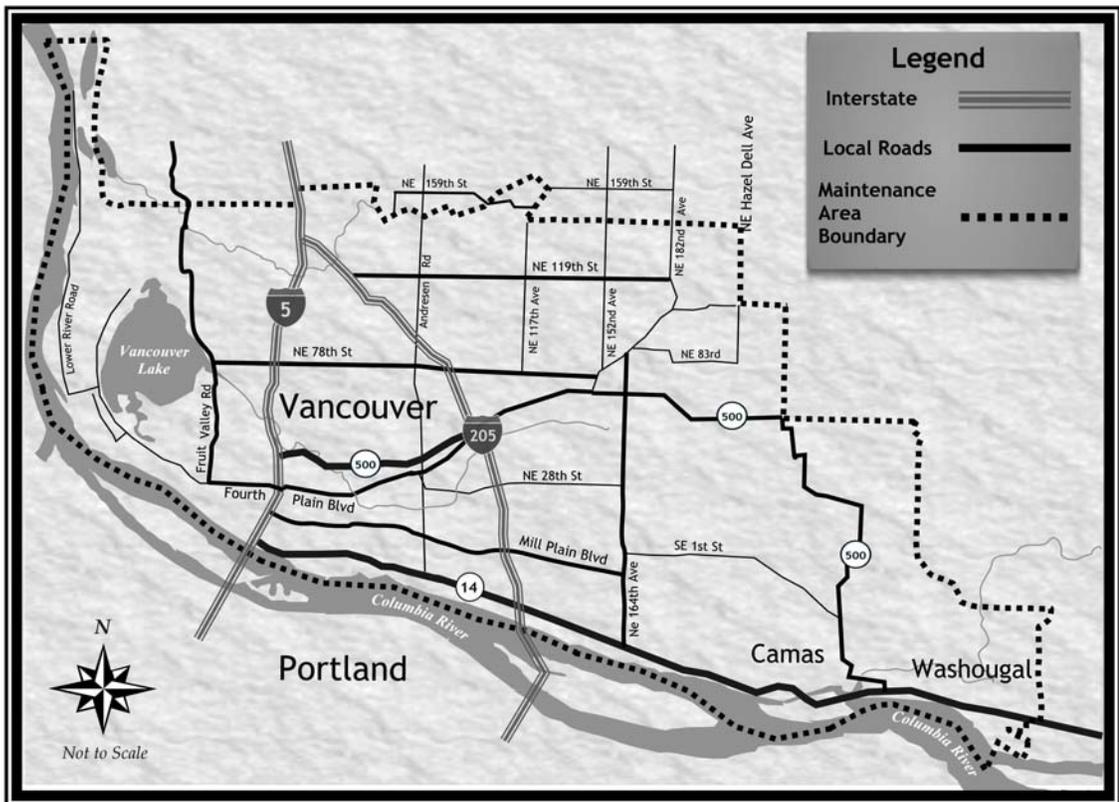
## Vancouver Air Quality Maintenance Area

A maintenance area is one that has been re-designated by the EPA from non-attainment to attainment as a result of both a ten-year record of monitored attainment (no exceedences of standard) and an EPA approved maintenance plan. Because the **Vancouver Rail Project** is located within ozone and CO maintenance areas, the project must conform to air quality implementation plans. As required by the Federal Clean Air Act, Ecology, and SWAPCA have submitted both the ozone and the CO SIP's to EPA for review, and the plans have been approved.

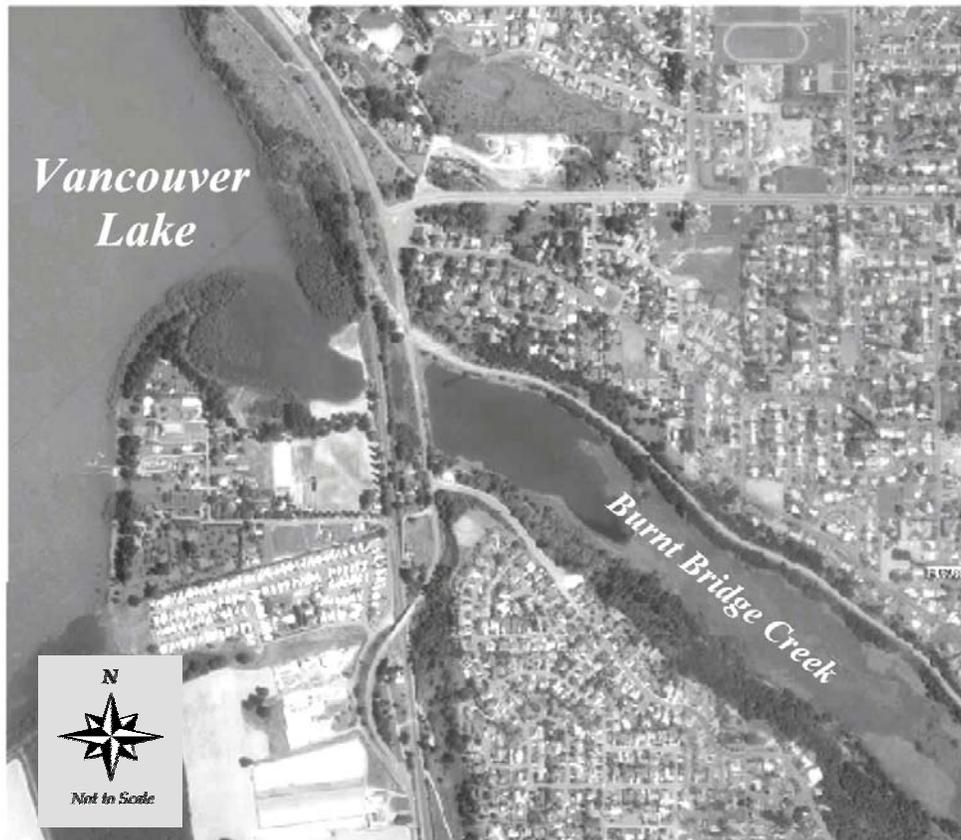
**Surface Water Features in the Study Area**  
**Exhibit 4-7**

Four culverts were observed within the project vicinity. One ten-foot arch culvert connects Burnt Bridge Creek and Vancouver Lake under the existing tracks. The Burnt Bridge Creek culvert appears to function properly and was designed to allow the passage of the 100-year flood. The second and third culverts are minor drainage culverts located north of the Burnt Bridge crossing, at the north end of the study area. These culverts also appear to be functioning properly. The fourth culvert is a minor drainage culvert located at West 39th Street; the culvert, or its collection system, may be functioning improperly.

coincides with the seasonally high lake elevation. Vancouver Lake is connected by a system of sloughs to the main stem of the Columbia River. The railbed is approximately ten feet above the top of the Burnt Bridge Creek culvert. The Burnt Bridge Creek watershed drains an area of approximately 23 square miles.<sup>10</sup>

Vancouver Lake is approximately one half mile from the northern end of the study area. Vancouver Lake is not on the 303(d) list as a threatened and/or impaired waterbody. Vancouver Lake Wildlife Area is located across the lake, approximately one mile west of the Vancouver Rail Project. **Exhibit 4-7** shows the Burnt Bridge Creek and Vancouver Lake area.

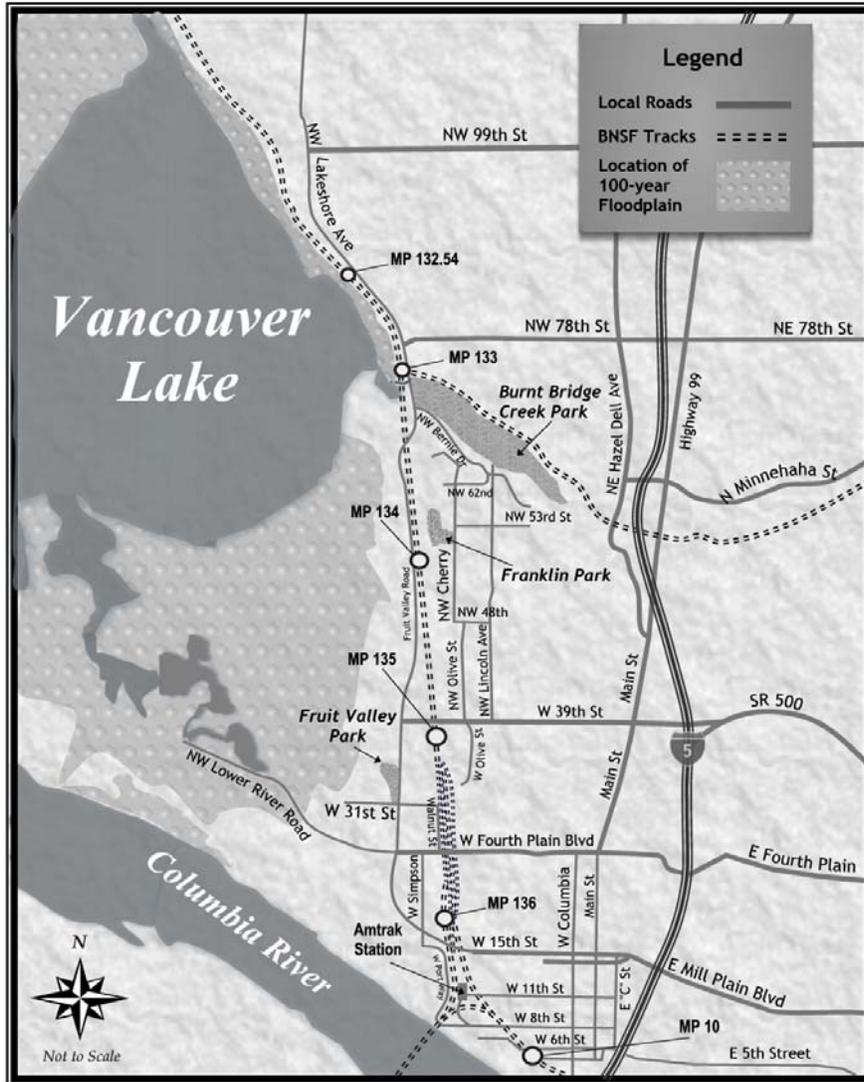
**Location of 100-Year Floodplain**  
**Exhibit 4-9**

Based on Federal Emergency Management Agency (FEMA) maps of the area (**Exhibit 4-9**), the 100-year floodplain lies adjacent to the study area from Burnt Bridge Creek to the northern terminus of the study area. An eight-foot box culvert connects Burnt Bridge Creek and Vancouver Lake. The culvert is functioning

properly and was designed to convey the 100-year flood flows. The railbed above the culvert is at an elevation of 42 feet and the 100-year floodplain is at an elevation of approximately 32 feet, which coincides with the top of the culvert.

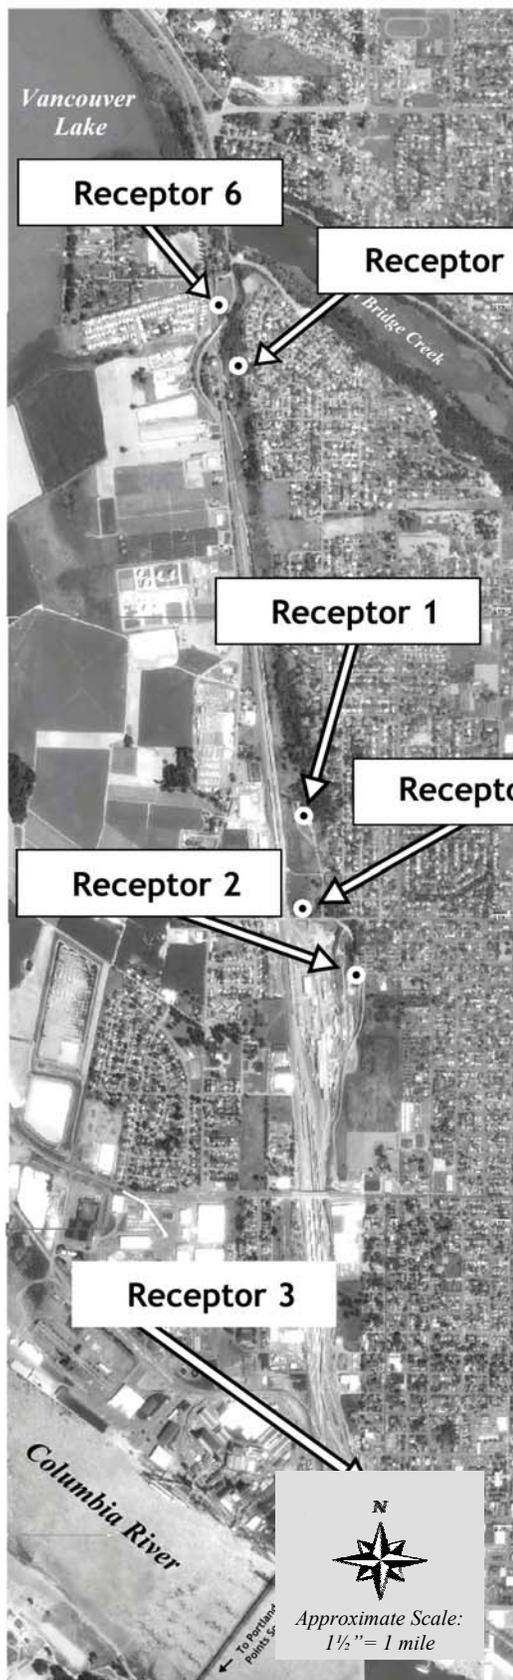
**Approximate Location of Noise Monitoring Sites**  
**Exhibit 4-14**

RECEPTOR ID	LOCATION	LDN
1	Two isolated residences east of the track at Northwest 44th Street.	67 dBA
2	Along the top of the bluff near the new Columbia Crest housing development.	63 dBA
3	Residences adjacent to the commercial land that is east of the track between West 11th Street and West Fourth Plain Boulevard	78 dBA
4	North side of 39 <sup>th</sup> Street, on the hill above the rail yard, west of Rose Street	72 dBA
5	1730 NW Trillium Lane	73 dBA
6	West side of rail tracks, across from 1901 NW 69 <sup>th</sup> Circle (formerly 6801 Whitney Lane)	70 dBA

This 24-hour monitoring data includes all freight train activity in the Vancouver yard area. Locomotive horns used at the grade crossing are included in this data, as are stationary trains preparing for crew changes. The monitoring data also includes noise from sources that are not related to the Vancouver yard activities. This includes jet engines (from airplanes), vehicular traffic from nearby roadways, and any noise from people and animals (like dogs barking) near the monitoring location.

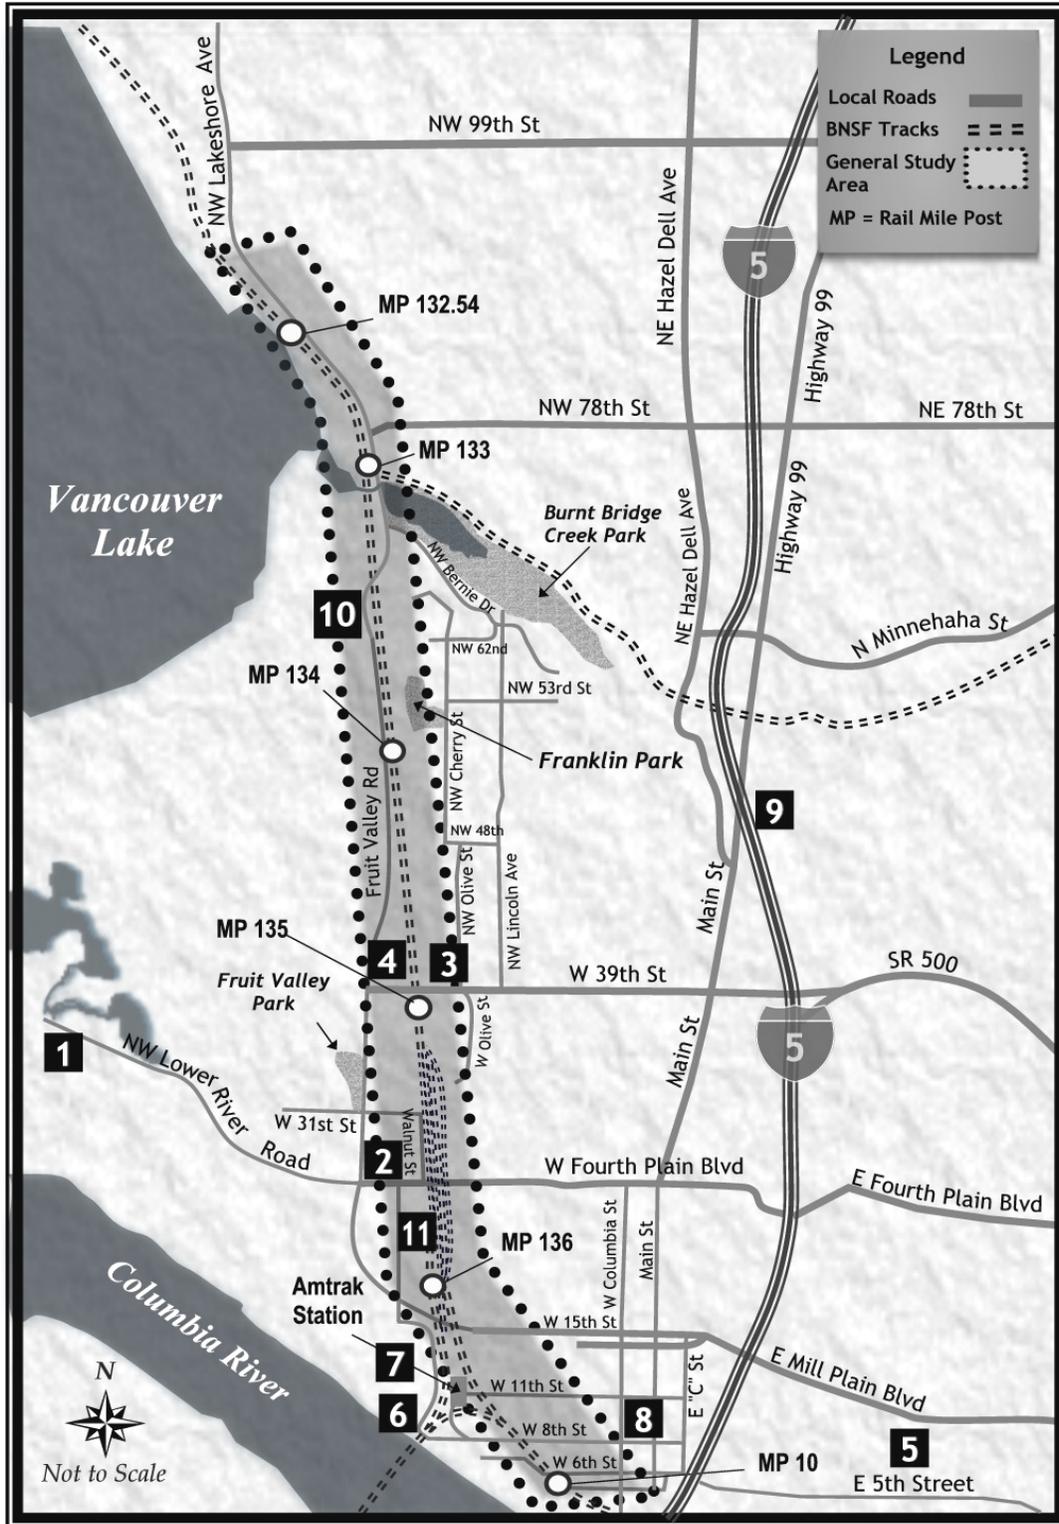
**General Location of Selected Hazardous Materials Sites**  
**Exhibit 4-18**

10	Winsel Farms 6112 West Fruit Valley Road Vancouver, WA 98660 (.5 miles west of right-of-way)	Former metal, soil & groundwater contamination, clean up conducted, contamination not detected in closest well.
11	2001 NE Roosevelt Property 2001 Northeast Roosevelt Street Vancouver, WA 98660 (.25 mi west of right-of-way)	Soil & groundwater contamination, near UP tracks, west of BNSF lines, clean up conducted.

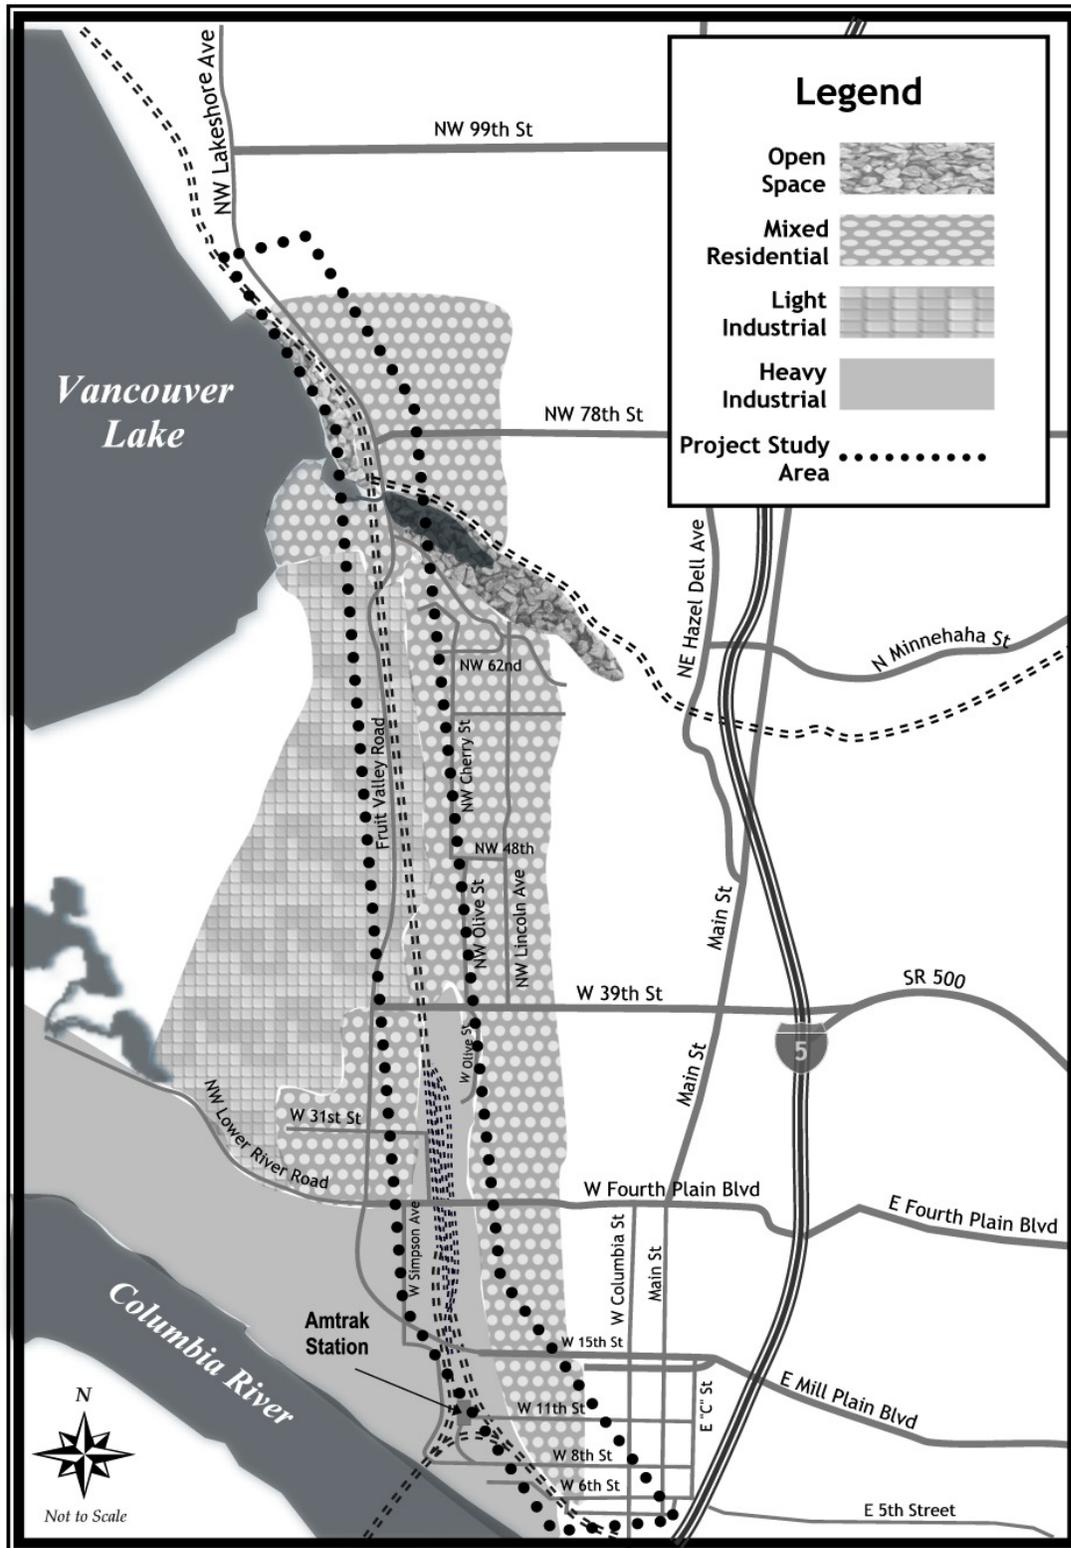
**General Zoning and Land Use in the Study Area**  
 Exhibit 4-20

Prior to crossing the Burnt Bridge Creek/Vancouver Lake confluence area, the rail right-of-way is bordered by an Urban Low Residential (R-1) zoning district to the

west and east, in addition to Franklin Park, a Park zoning district to the east. The area north of Rye Junction surrounding the rail corridor is also an Urban Low Residential district. This zoning allows for utilities as a conditional use. Fruit Valley Road runs in a north/south direction adjacent to the west side of the rail line and crosses at approximately Northwest 65th Street.

The Burnt Bridge Creek Greenway area is a Park (P) zoning district. Vancouver Lake is located northwest of the City of Vancouver between the rail corridor and the Columbia River. The City of Vancouver Shoreline Management Master Program designates the shoreline of Burnt Bridge Creek as Urban Conservancy, Urban High Intensity and in some adjacent areas, Urban Medium Intensity. Transportation corridors, including rail, are permitted within these shoreline designations.
