**WETLAND DELINEATION REPORT  
HIGHWAY 101 AT FERN ROAD  
PORT ANGELES, WASHINGTON 98362  
ASSESSOR'S PARCEL # 053013-419245 AND #053013-419255  
CLALLAM COUNTY, WASHINGTON**

November 2011

**WASHINGTON STATE DEPARTMENT OF TRANSPORTATION  
OLYMPIC REGION REAL ESTATE SERVICES  
P.O. Box 47440  
Olympia, Washington 98504**

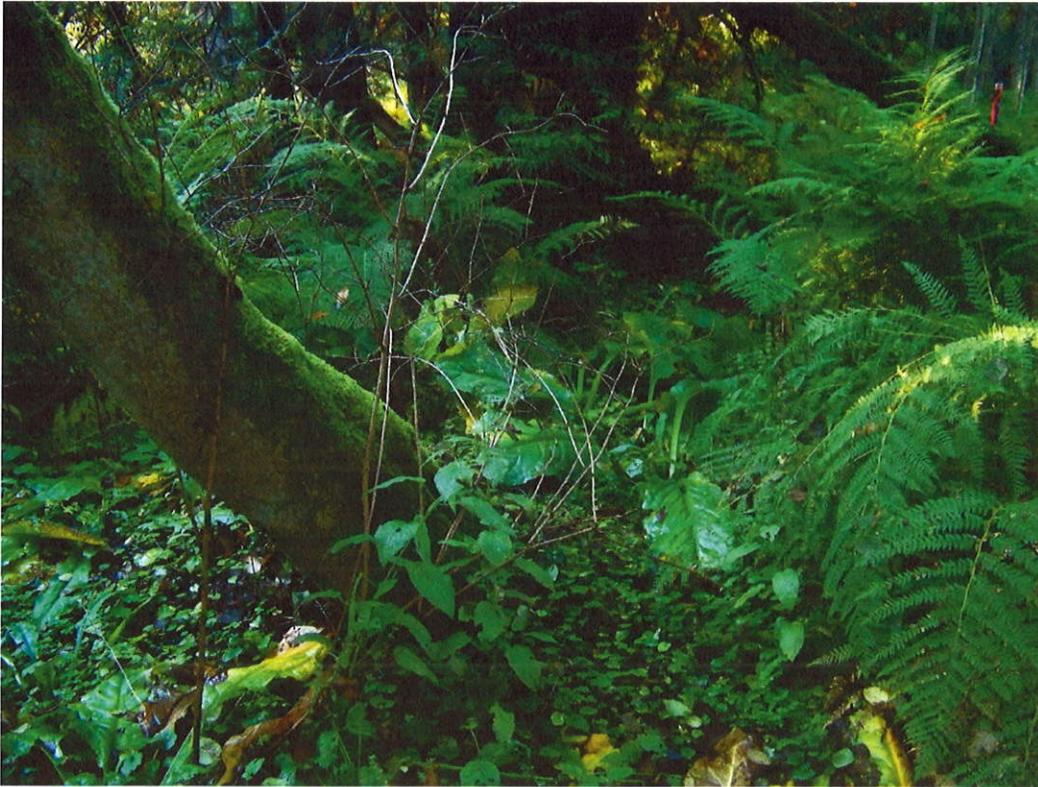
Two distinct plant communities are found in this wetland. The on-Site portion of the wetland is a wooded wetland community dominated by red alder (*Alnus rubra*) and western red cedar (*Thuja plicata*) in the tree layer; salmon berry (*Rubus spectabilis*) and Hooker's willow (*Salix hookeriana*) in the shrub layer; and lady fern (*Arthyrium filix-femina*), skunk cabbage (*Lysichiton americanum*) and piggy-back plant (*Tolmiea menziesii*) in the herb layer. Other herbaceous plants present include common horsetail (*Equisetum arvense*), duckweed (*Lemna minor*), water parsley (*Oenanthe sarmentosa*) and creeping buttercup (*Ranunculus repens*).

1) View of Vegetation in On-Site Wetland

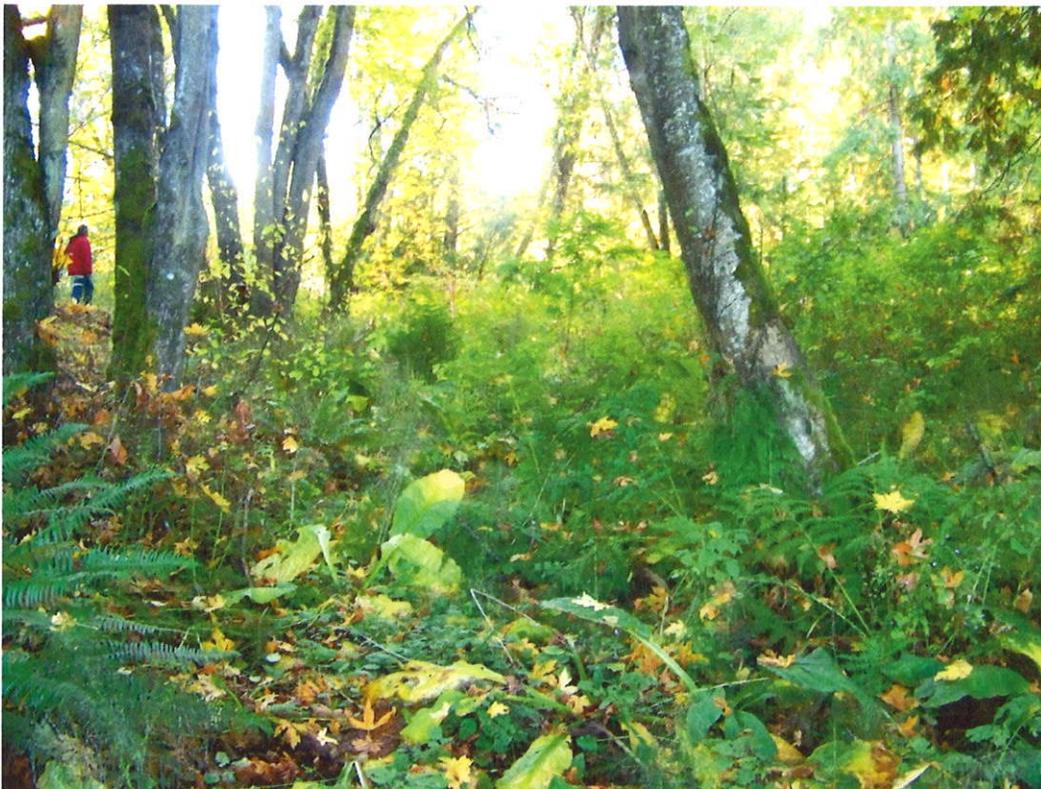
2) View of On-Site Wetland Vegetation

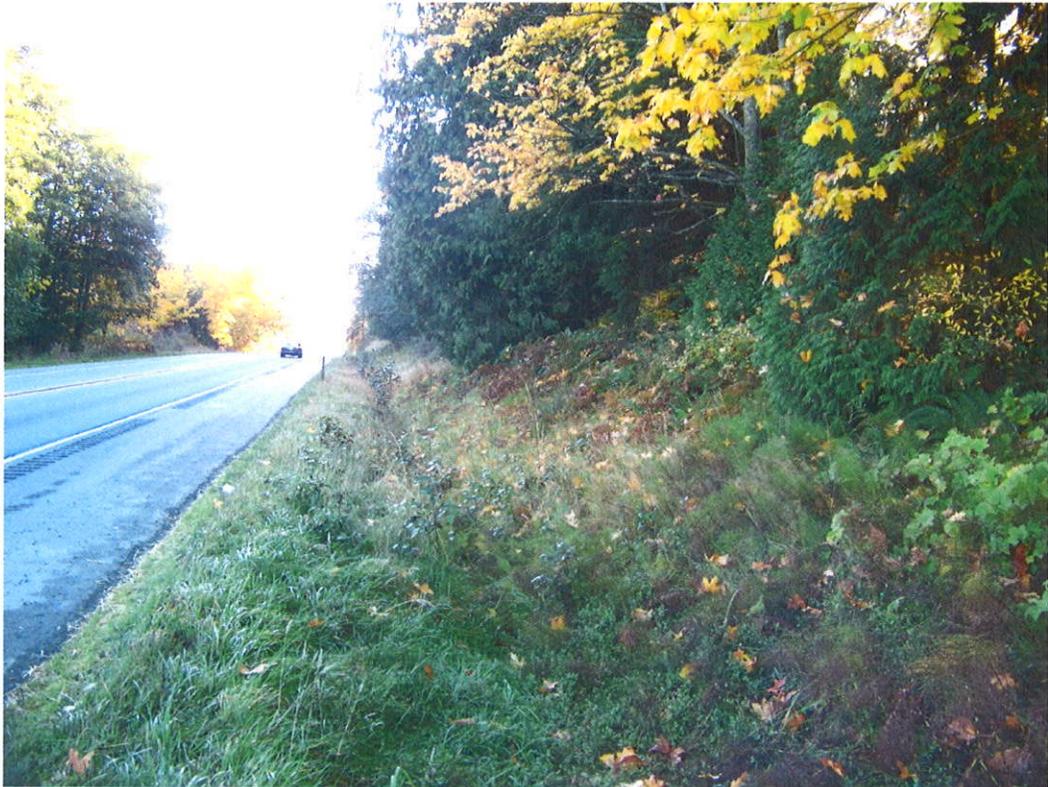
3) View of Highway 101 Adjacent to Wetland.

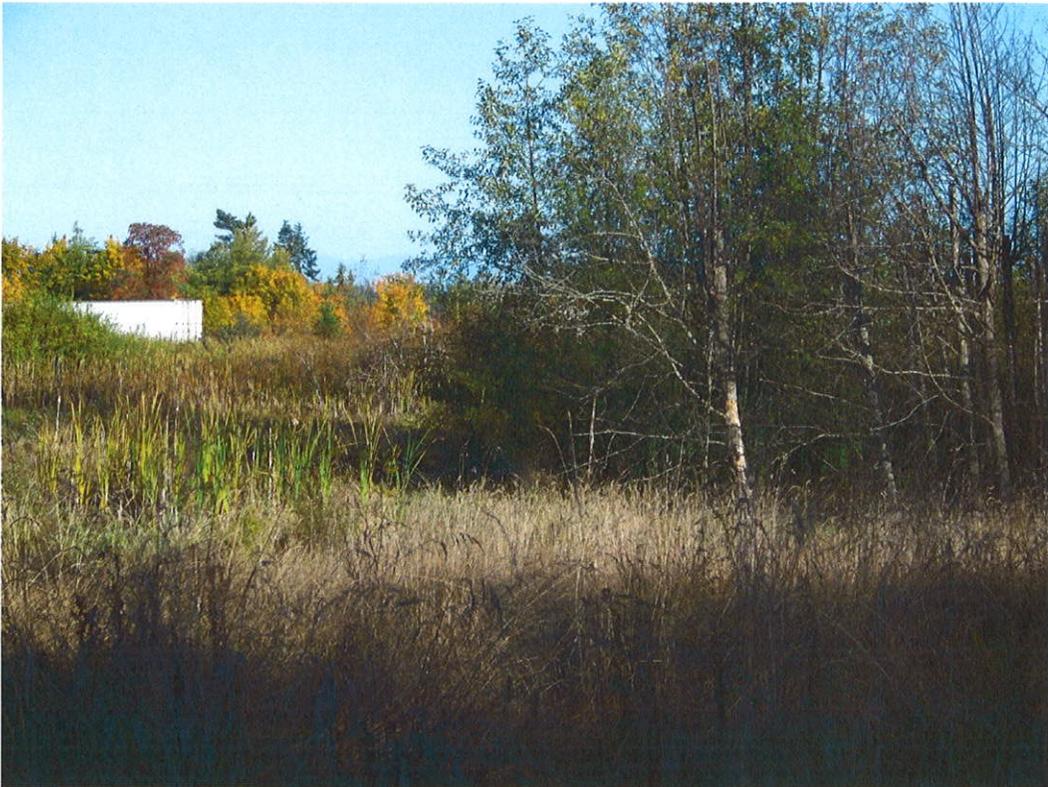
properties to the west and to Fern Road, where it is channeled into a drainage pipe and runs to the property to the west of Fern Road. The wetland on the Fern Road side has a hydrology and vegetation pattern distinct from that of the on-Site wetland. It appears to be a slope wetland located in a field that has been previously cleared. Dominant vegetation consists of pockets of cattail, grasses and willow trees. Some horsetail and Nootka rose were also observed in this portion of the wetland. This area was not studied in the same detail as the on-Site wetland because it appeared to be private property.

4) Portion of Wetland West of Fern Road
