# Highway Safety: Quarterly Update

## Cable Median Barriers Performance: Annual Update

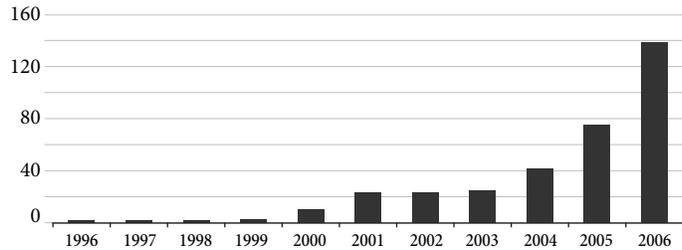
### Cable Median Barrier Washington State Highways 1996-2006

Total number of miles by year

By the end of 2006, WSDOT had placed a total of 138 miles of cable barrier in highway medians. Of the 138 miles, a little more than 35 miles have been in place over six months. This period is long enough to evaluate before and after collision history and cable median barrier performance. Sections that were in place fewer than six months are not included in this study.

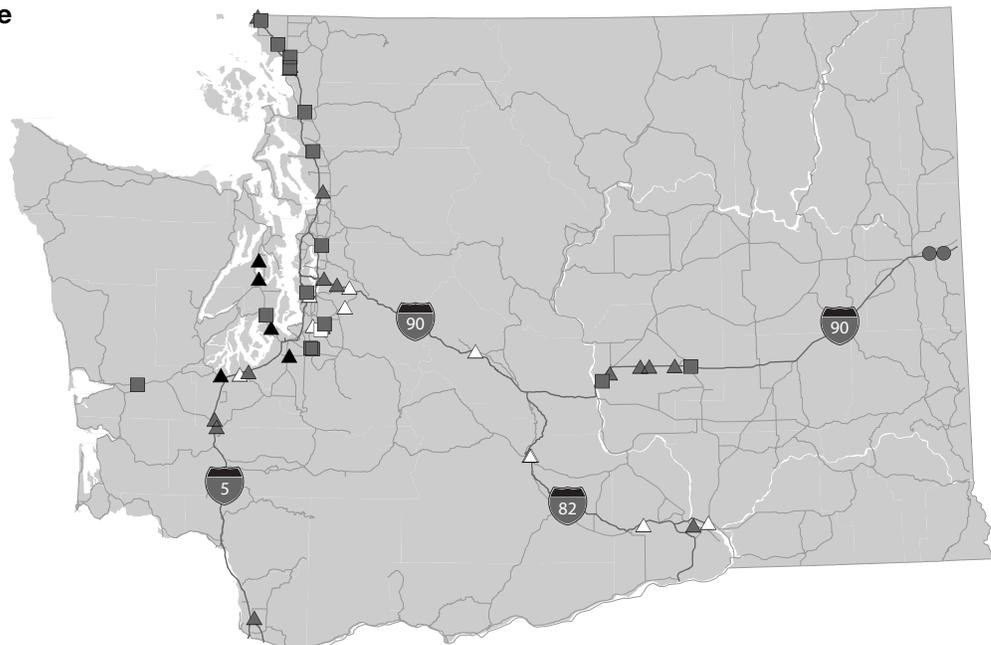
### Locations of Washington State Cable Median Barriers

- TPA, Completed
- ▲ PEF, Completed
- TPA, Future
- ▲ PEF, Under Construction
- Nickel, Completed
- △ PEF, Future

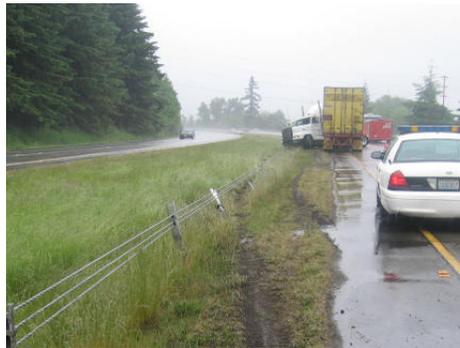
A cable median barrier restrains a semi truck on I-5 at mile post 252.
